# Arboricultural Appraisal Report

## Subsidence Damage Investigation at:

Flat 1, 94 Stapleton Hall Road  
London  
N4 4QA

CLIENT: Crawford & Company  
CLIENT REF: 1881888 / SU2000002  
MWA REF: SUB260410-18425  
MWA CONSULTANT: Andy Clark  
REPORT DATE: 05/06/2026

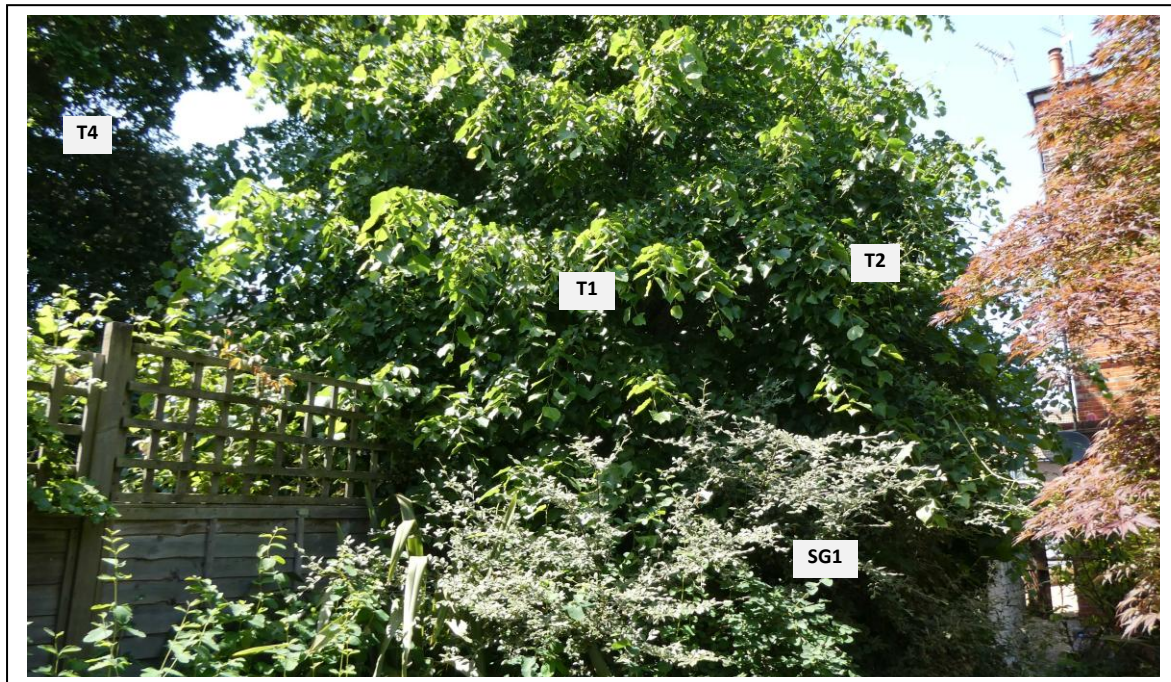
| Tree No. | Species | Height (m) | Dia (mm) | Crown Spread (m) | Dist. to building (m) | Age Classification | Ownership |
|---|---|---|---|---|---|---|---|
| SG1 | Mixed spp. shrub group of mostly Rose, Snowberry, Cotoneaster and Dogwood | Up to 2.5 | Up to 20 | Up to 2.0 | 2.5 | Younger than Property | Policy Holder |

View of SG1 shrub group with T1 Lime and T2 Lime visible beyond and T4 Oak to left of frame

| Tree No. | Species | Height (m) | Dia (mm) | Crown Spread (m) | Dist. to building (m) | Age Classification | Ownership |
|---|---|---|---|---|---|---|---|
| Recommendation | | Re-pollard to previous points at approx. 2.0m and thereafter re-pollard on a triennial cycle to maintain at broadly reduced dimensions. | | | | | |

| Tree No. | Species | Height (m) | Dia (mm) | Crown Spread (m) | Dist. to building (m) | Age Classification | Ownership |
|---|---|---|---|---|---|---|---|
| Recommendation | | Maintain broadly at no larger than current dimensions by periodic pruning. | | | | | |

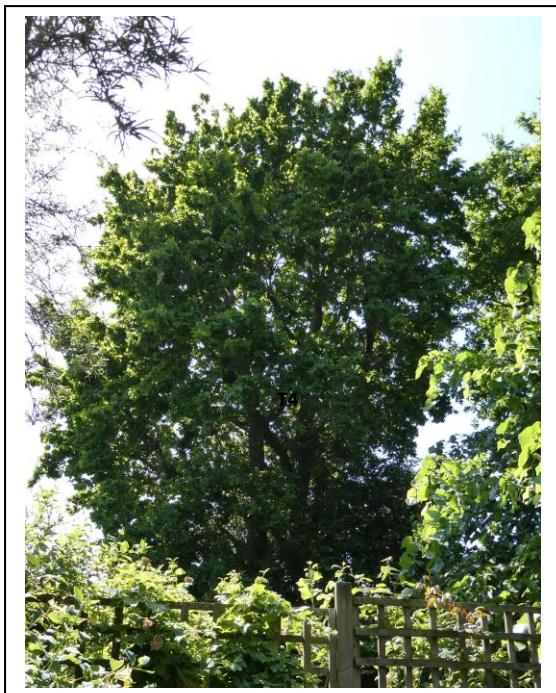
If an arboricultural solution is to be implemented to mitigate the influence of the implicated trees/vegetation considered to be responsible for the damage, we repeat our previous recommendations that T1 and T2 are re-pollarded and that T3 Oak is removed. Recommendations are also escalated to include the removal of T4 Oak, which also stands within influencing distance of the building.

| Tree No. | Species | Height (m) | Dia (mm) | Crown Spread (m) | Dist. to building (m) | Age Classification | Ownership |
|---|---|---|---|---|---|---|---|
| T4 | Oak | 16.5 * | 700 * | 11.0 | 14.0 * | Older than extension(s) | Third Party<br>92A Stapleton Hall Road<br>N4 4QA |

View of T4 Oak

| Tree No. | Species | Height (m) | Dia (mm) | Crown Spread (m) | Dist. to building (m) | Age Classification | Ownership |
|---|---|---|---|---|---|---|---|
| Recommendation | | Remove (fell) to near ground level and treat stump to inhibit regrowth. | | | | | |

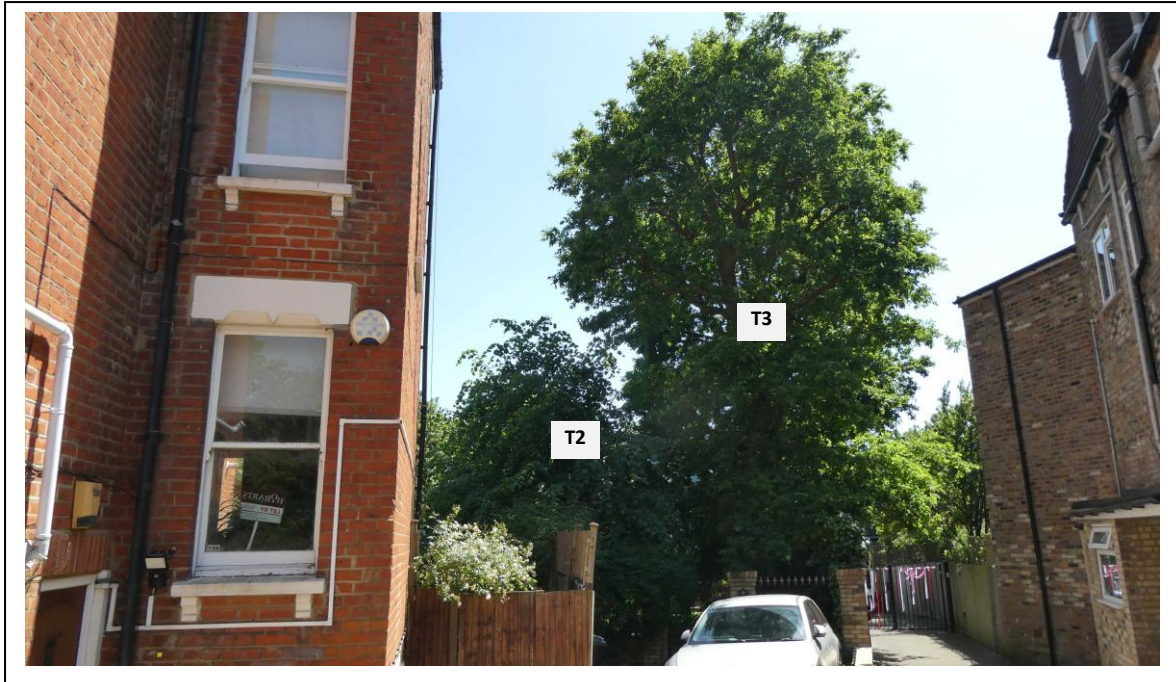
Roots were also observed to 1.8m bgl in the more recent TP/BH1B, with recovered samples again being identified as either *Quercus* spp. or [the related] *Castanea* spp. Given the absence of any nearby *Castanea* spp. vegetation and as T3 Oak remains in situ, it will be the source of the retrieved samples.

| Tree No. | Species | Height (m) | Dia (mm) | Crown Spread (m) | Dist. to building (m) | Age Classification | Ownership |
|---|---|---|---|---|---|---|---|
| T3 | Oak | 16.5 * | 700 * | 11.0 * | 8.0 * | Older than extension(s) | Third Party<br>92A Stapleton Hall Road<br>N4 4QA |

View of T2 Lime and T3 Oak

| Tree No. | Species | Height (m) | Dia (mm) | Crown Spread (m) | Dist. to building (m) | Age Classification | Ownership |
|---|---|---|---|---|---|---|---|
| Recommendation | | Remove (fell) to near ground level and treat stump to inhibit regrowth. | | | | | |
