## ARBORICULTURAL REPORT

*Mechanical Decay Detection — Sonic Tomography & Resistograph Drilling  
Quantitative Tree Risk Assessment (QTRA) | BS 5837:2012*

### **108 CROUCH HILL**

| <b>Report Title</b> | <i>TCR/1107 — 108 Crouch Hill Mechanical Decay Detection Report<br/>2026</i> |

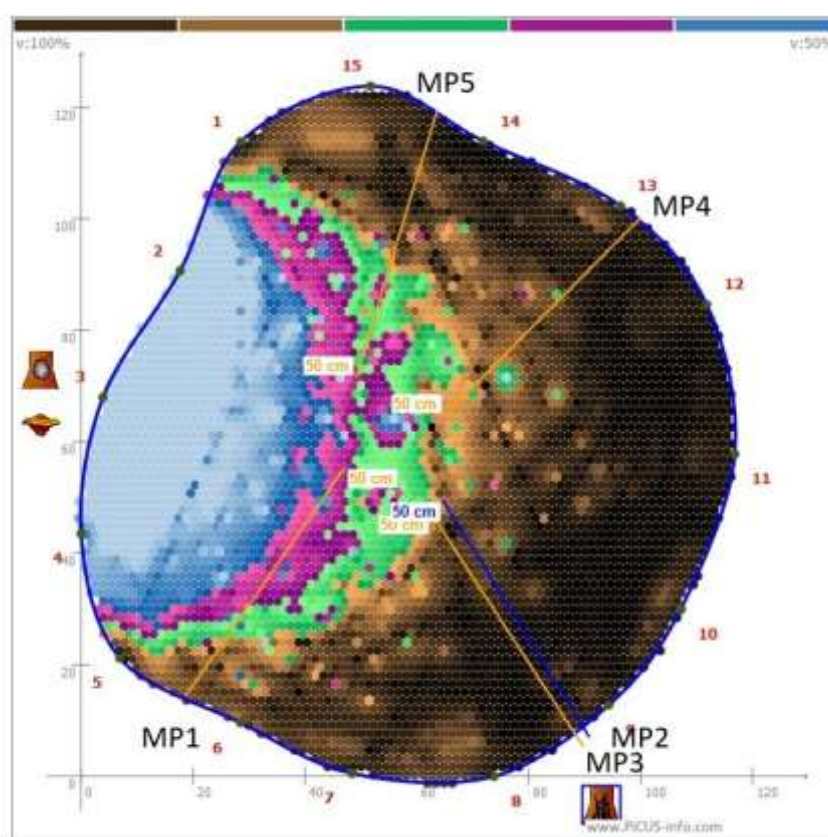
At the time of the March 2025 mechanical decay detection survey, good residual wood volume was recorded on the eastern aspect of the stem. Data obtained on 16 August 2026 shows that this residual sound wood volume has now significantly reduced. Most significantly, approximately 50% of the crown is now without leaf, with the dead portion concentrated in the north-western half of the canopy — mirroring the location of the principal area of stem dysfunction. This pattern is consistent with a progressive, ongoing loss of vascular function through the decayed portion of the stem, and represents a marked deterioration since the last full inspection.

*Figure 5: T001 Sonic Tomogram at approximately 0.5–0.6 m, annotated with Resistograph measuring point locations MP1–MP5. The tomogram shows a substantial zone of reduced sonic velocity (green/pink/blue shading) affecting the western half of the cross-section, with brown (apparently sound) wood recorded across the eastern half. As set out below, the Resistograph data indicates that this tomogram under-represents the true extent of internal dysfunction at four of the five measuring points.*

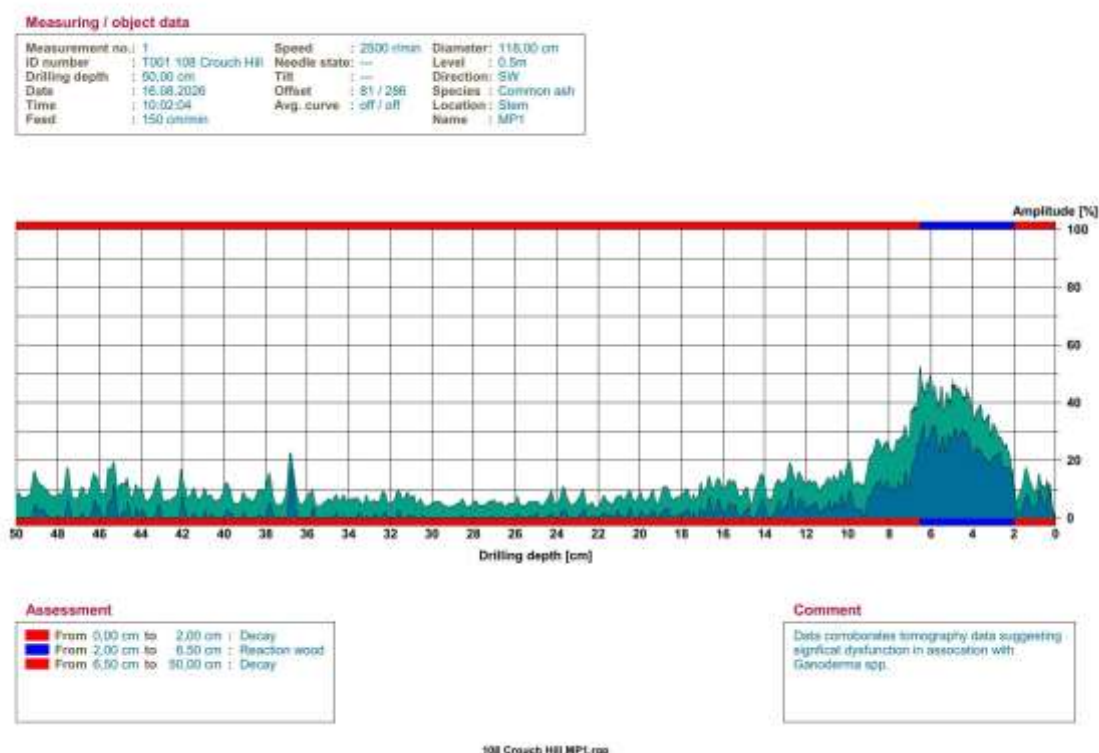
**MP1 — Stem, 0.5 m, SW aspect**

| Species | Location | Drilling depth | Assessment (bark to full depth) |
|---|---|---|---|
| Common ash | Stem, 0.5 m, SW aspect | 50.00 cm | 0.00–2.00 cm: Decay 2.00–6.50 cm: Reaction wood 6.50–50.00 cm: Decay |

*Figure 7: T001 Resistograph Trace — MP1 (Stem, 0.5 m, SW aspect). Data corroborates the tomography data, suggesting significant dysfunction in association with *Ganoderma* spp. This is the only measuring point at which the Resistograph and tomography data are in agreement.*

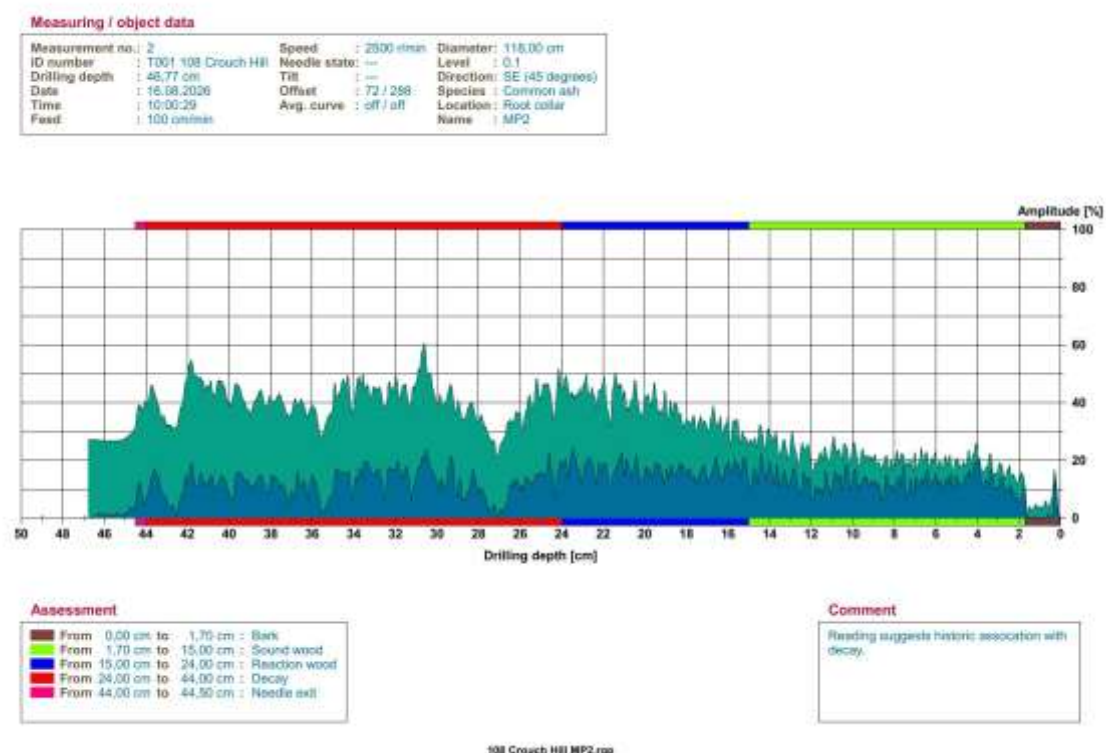
**MP2 — Root collar, 0.1 m, SE aspect (45°)**

| Species | Location | Drilling depth | Assessment (bark to full depth) |
|---|---|---|---|
| Common ash | Root collar, 0.1 m, SE aspect (45°) | 46.77 cm | 0.00–1.70 cm: Bark 1.70–15.00 cm: Sound wood 15.00–24.00 cm: Reaction wood 24.00–44.00 cm: Decay 44.00–44.50 cm: Needle exit |

Figure 9: T001 Resistograph Trace — MP2 (Root collar, 0.1 m, SE aspect (45°)). Reading suggests a historic association with decay at the root collar. The extent of decay recorded (a 20 cm zone from 24–44 cm depth) is greater than would be inferred from the tomography data alone.

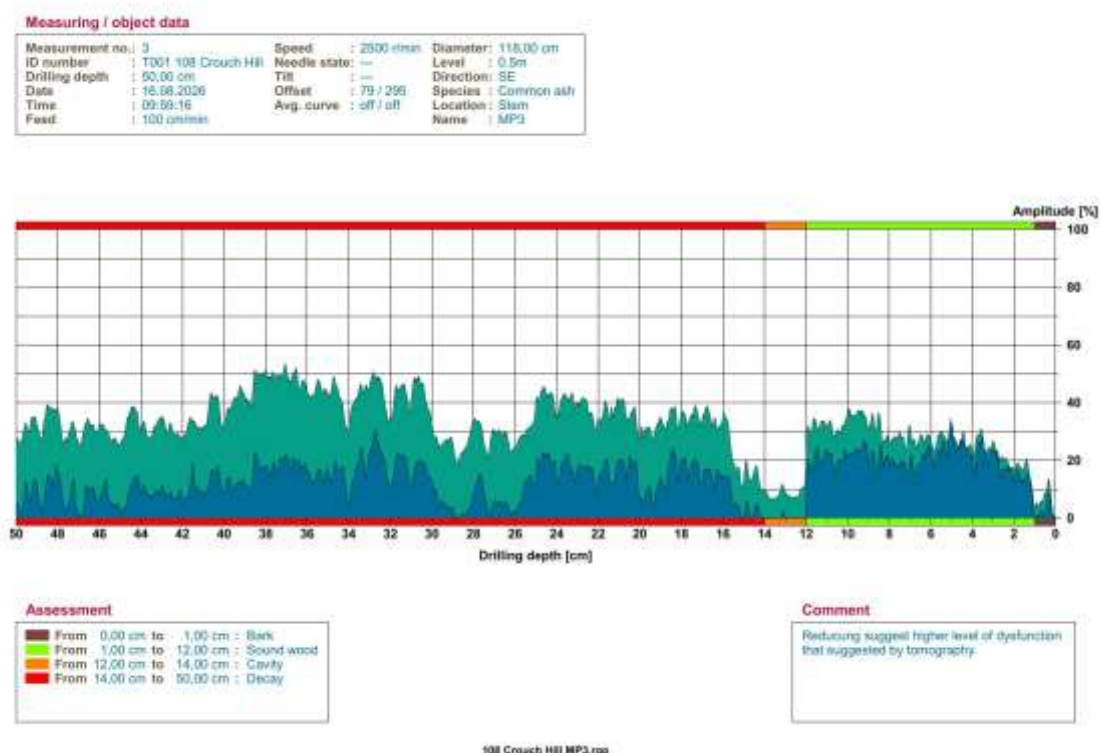
**MP3 — Stem, 0.5 m, SE aspect**

| Species | Location | Drilling depth | Assessment (bark to full depth) |
|---|---|---|---|
| Common ash | Stem, 0.5 m, SE aspect | 50.00 cm | 0.00–1.00 cm: Bark 1.00–12.00 cm: Sound wood 12.00–14.00 cm: Cavity 14.00–50.00 cm: Decay |

Figure 11: T001 Resistograph Trace — MP3 (Stem, 0.5 m, SE aspect). Reading suggests a higher level of dysfunction than indicated by the tomography, with a sound wood shell of only approximately 12 cm before a cavity and extensive decay are encountered.

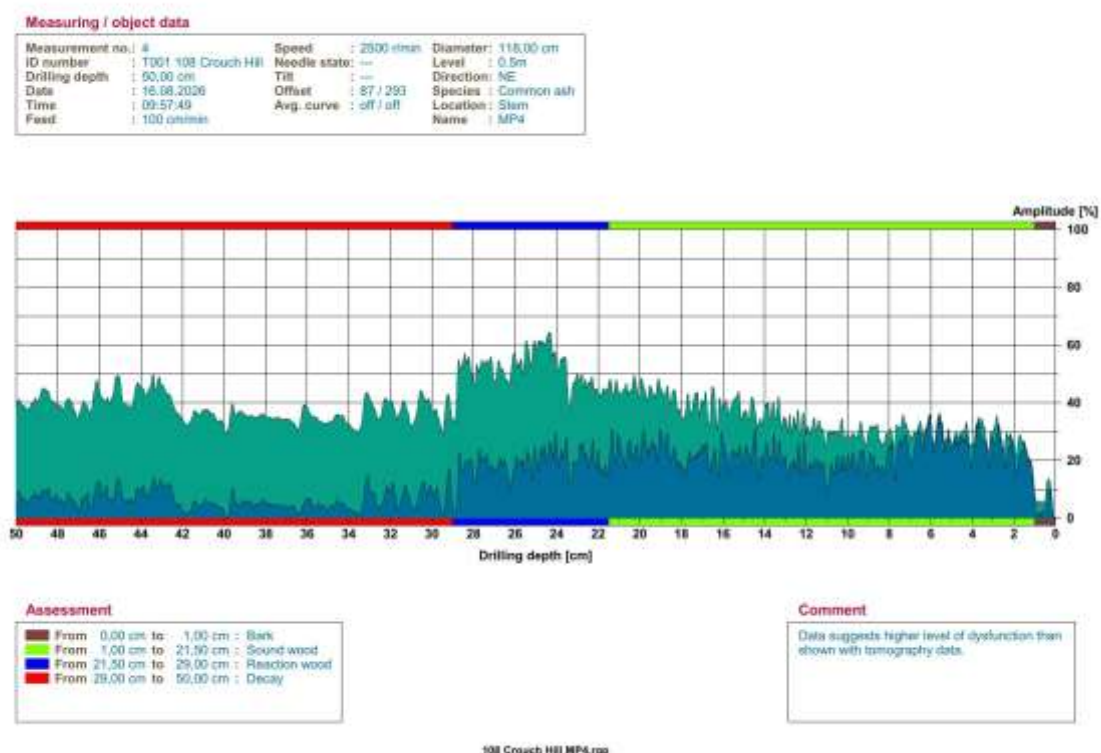
**MP4 — Stem, 0.5 m, NE aspect**

| Species | Location | Drilling depth | Assessment (bark to full depth) |
|---|---|---|---|
| Common ash | Stem, 0.5 m, NE aspect | 50.00 cm | 0.00–1.00 cm: Bark 1.00–21.50 cm: Sound wood 21.50–29.00 cm: Reaction wood 29.00–50.00 cm: Decay |

*Figure 13: T001 Resistograph Trace — MP4 (Stem, 0.5 m, NE aspect). Data suggests a higher level of dysfunction than shown by the tomography data at this location.*

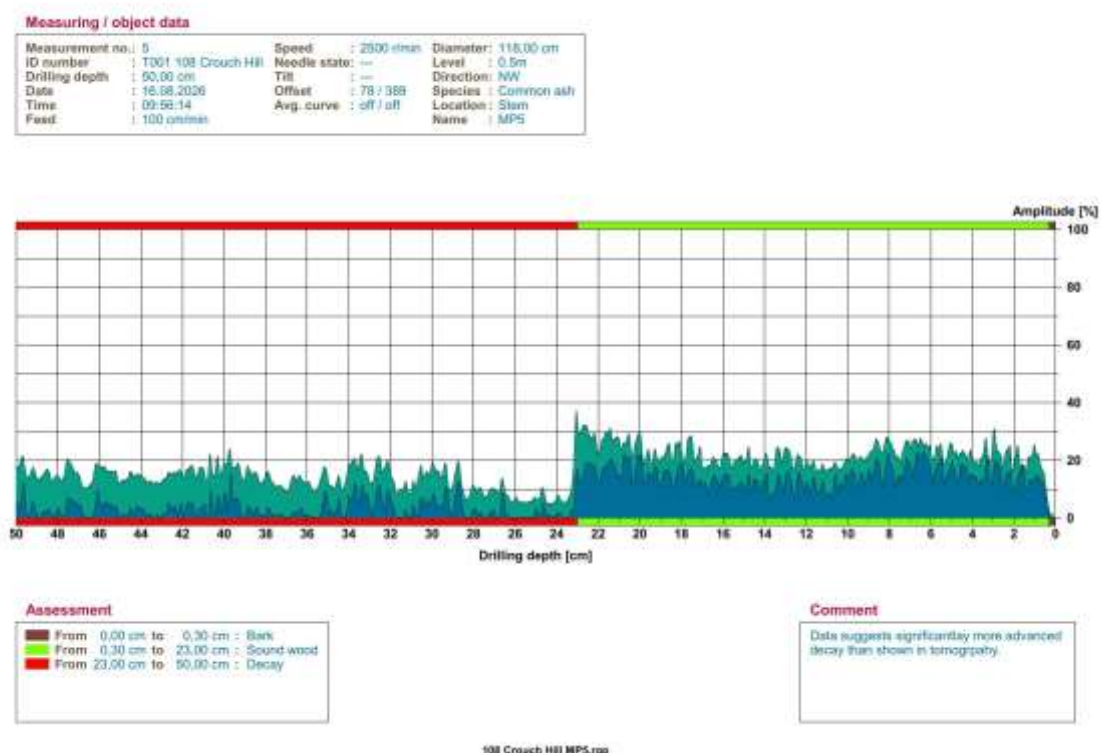
**MP5 — Stem, 0.5 m, NW aspect**

| Species | Location | Drilling depth | Assessment (bark to full depth) |
|---|---|---|---|
| Common ash | Stem, 0.5 m, NW aspect | 50.00 cm | 0.00–0.30 cm: Bark 0.30–23.00 cm: Sound wood 23.00–50.00 cm: Decay |

Figure 15: T001 Resistograph Trace — MP5 (Stem, 0.5 m, NW aspect). Data suggests significantly more advanced decay than shown in the tomography at this location — the NW aspect corresponds with the area of the crown that has died back.

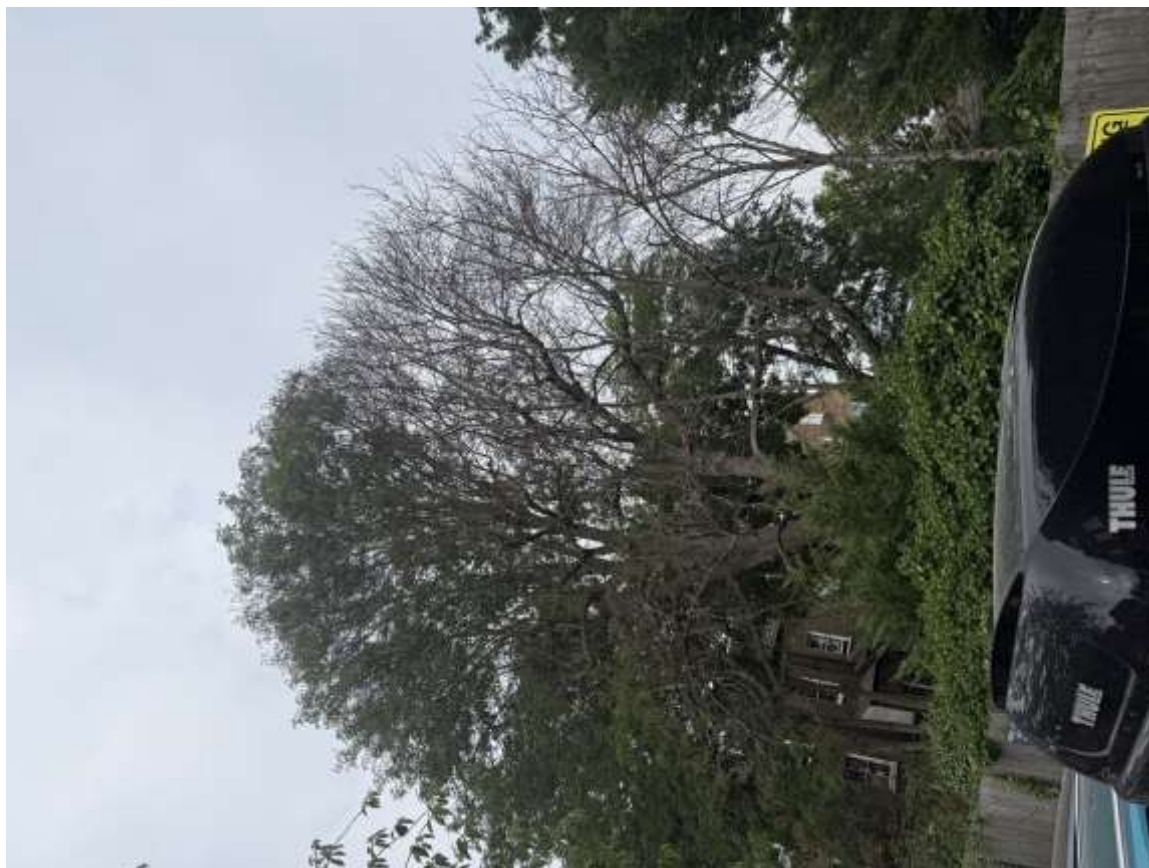
*Plate 1: T001 in context, 16 August 2026, showing the approximately 50% crown dieback affecting the northern/eastern portion of the canopy (right of image) against the remaining live foliage (left of image).*

| Ref. | Species | Measurements | Priority | Recommended Works | Due |
|---|---|---|---|---|---|
| T001 | Common ash<br>( <i>Fraxinus excelsior</i> ) | H: 18 m CR: 8 m<br> DBH: 60 cm <br>Mature | Urgent | Option A: Fell tree and provide a suitable replacement. Sectional dismantling will be required given the proximity of the dwelling, car park and footpath targets. | Immediate |

Both options are recorded as urgent, with works due to commence without delay. Should the Client wish to retain deadwood habitat value on site (see Section 1.3 regarding bat and bird considerations), Option B may be preferred, subject to a further specific assessment confirming that a 5 m monolith would not present an unacceptable risk to the dwelling, car park and footpath targets identified at Appendix 3. In light of the extent of basal and lower-stem decay recorded at MP1–MP3, this assessment should be carried out by a suitably qualified arboricultural consultant before monolithing proceeds, and may conclude that Option A (felling) is the only appropriate course of action if the retained monolith cannot be shown to be stable given the targets present.

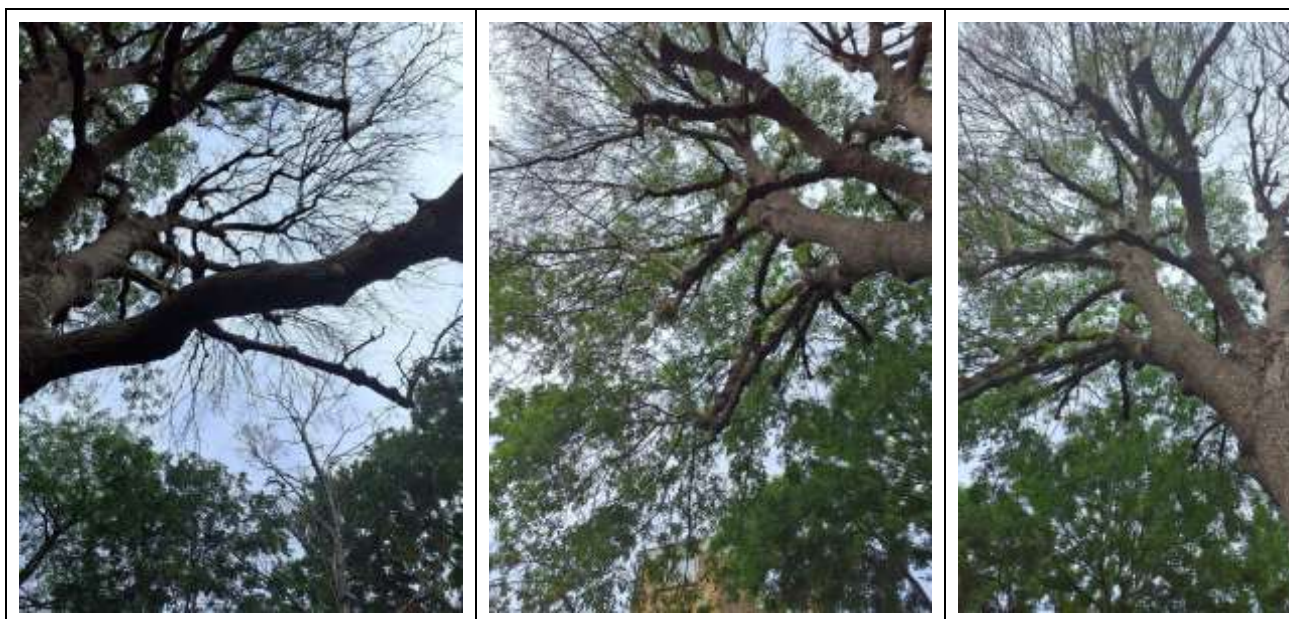
*Plate 2: Dead scaffold branches within the crown, against live foliage below*

*Plate 3: Crown detail showing a mix of live foliage and dieback*

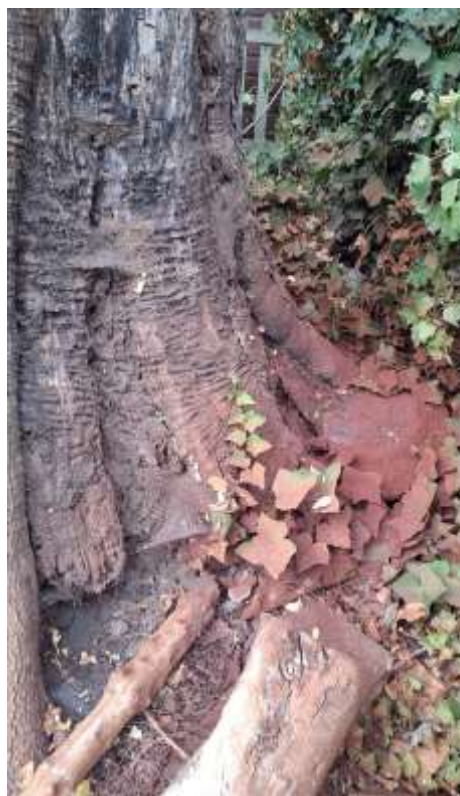
Honey fungus (*Armillaria mellea*) has historically been recorded at the base of the tree on the south-west aspect, and rhizomorphs have also been recorded more widely in the adjacent garden, including in high volume in a wood stack approximately 15 m from the base of T001. A large historic area of decay is present at the base of the stem to approximately 1 m on the north-west aspect, in association with *Ganoderma* spp.; this dysfunction is believed to originate from historic fire damage. Fruiting bodies of *Daldinia concentrica* (King Alfred's cakes) have also been recorded at this basal defect. Significant adaptive (buttress) growth has developed around the base of the stem in response to this historic dysfunction.

*Plate 5: Basal cavity and decayed wood at the historic fire-damage site, consistent with the dysfunction identified at MP1/MP5 and by the tomography*

- Stump treatment: Given the association with *Ganoderma* spp. and *Armillaria mellea*, stump grinding should be undertaken if the tree is felled (Option A) to reduce the residual fungal inoculum source in the garden and facilitate any replacement planting.

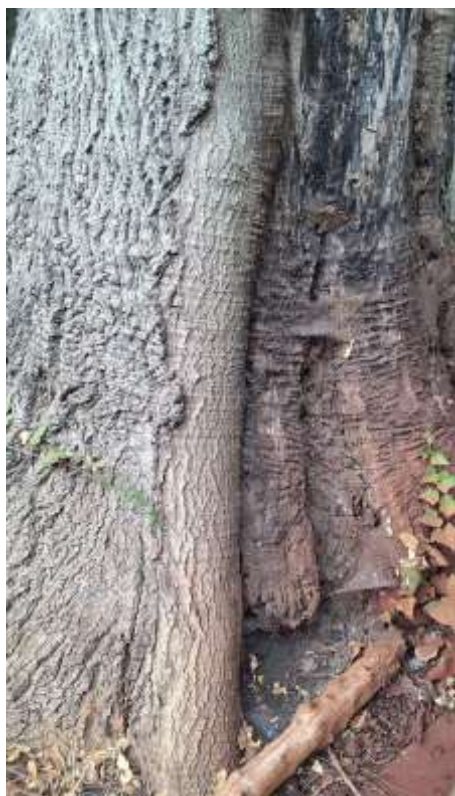
*Plate 6: Further detail of the basal cavity and decayed/charred wood at the base of the stem*
