# Arboricultural Consultancy for Lloyds Bank

| Insured | Ms Sarah Gibbs | Address | 29 Orchard Road, London, N6 5TR | | |
| ES Ref | SA-258021 | Consultant | Keith Burgess | Contact No. | 0330 380 1036 |
| Report Date | 09/02/2026 | | | | |

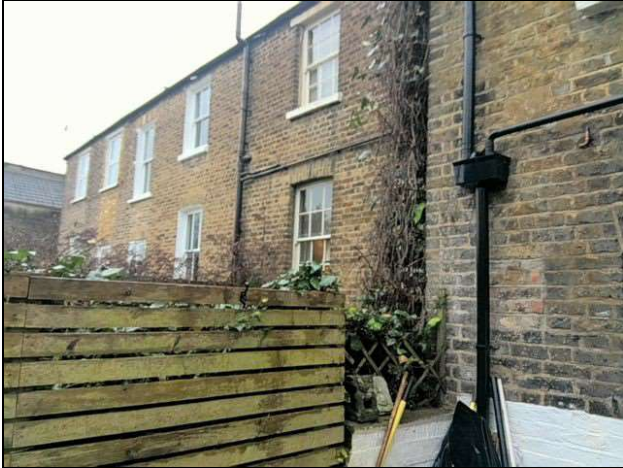
| Tree No. | Species | Age Cat | Approx. Height (m) | Distance to Building (m) * | Ownership | Action | Requirement |
|---|---|---|---|---|---|---|---|
| CG1 | Mixed species climbers | 1 | 7 | 0.1 | A - Third Party<br>26 Holmesdale Road | Remove | Remove close to ground level and treat stump(s) to inhibit regrowth. |

CG1 - Mixed species climbers

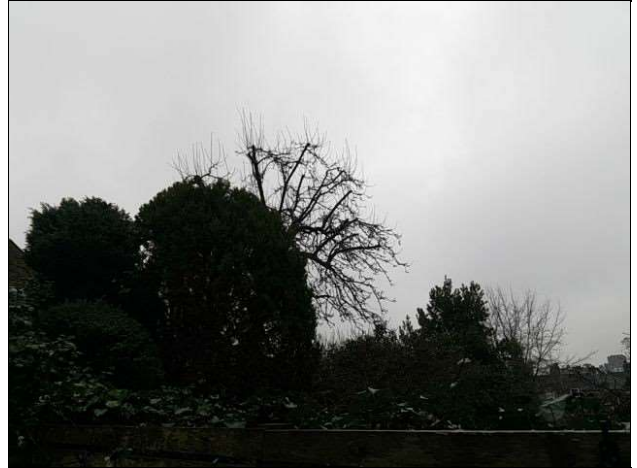
| Tree No. | Species | Age Cat | Approx. Height (m) | Distance to Building (m) * | Ownership | Action | Requirement |
|---|---|---|---|---|---|---|---|
| T1 | Apple | 1 | 8 | 8.5 | A - Third Party<br>26 Holmesdale Road | Remove | Remove close to ground level and treat stump(s) to inhibit regrowth. |

T1 - Apple

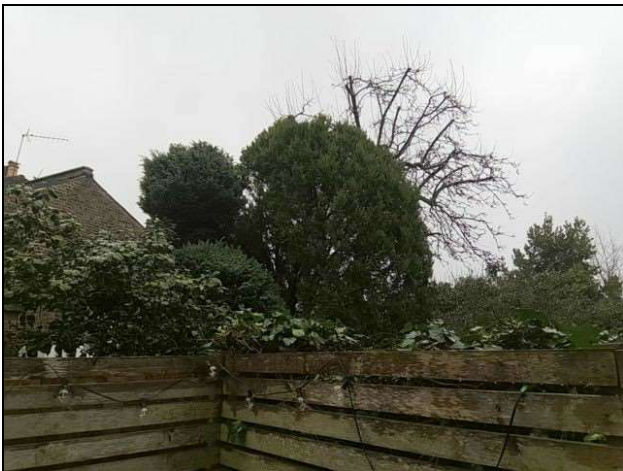
| Tree No. | Species | Age Cat | Approx. Height (m) | Distance to Building (m) * | Ownership | Action | Requirement |
|---|---|---|---|---|---|---|---|
| TG1 | Cypress | 1 | 7 | 7.5 | A - Third Party<br>26 Holmesdale Road | Remove | Remove close to ground level. |

TG1 - Cypress

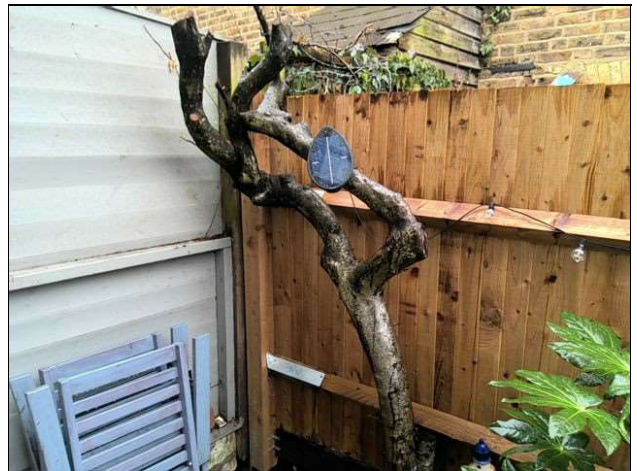
| Tree No. | Species | Age Cat | Approx. Height (m) | Distance to Building (m) * | Ownership | Action | Requirement |
|---|---|---|---|---|---|---|---|
| S1 | Pyracantha | 1 | 2 | 2.3 | C - Insured | Action to avoid future risk | Maintain at broadly current dimensions by way of regular pruning. |

S1 - Pyracantha

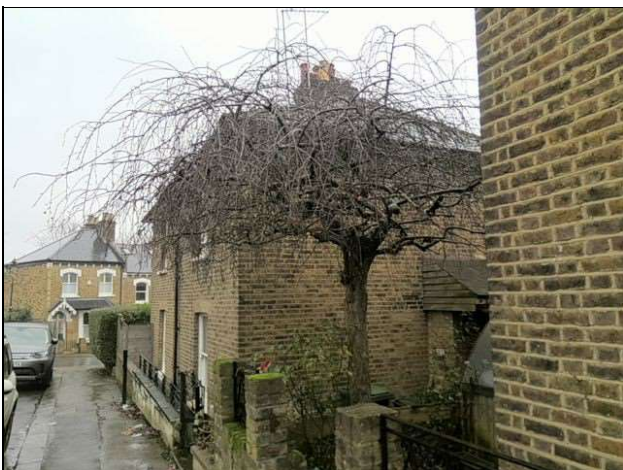
| Tree No. | Species | Age Cat | Approx. Height (m) | Distance to Building (m) * | Ownership | Action | Requirement |
|---|---|---|---|---|---|---|---|
| T2 | Apple (Crab) | 1 | 4 | 1.9 | C - Insured | Action to avoid future risk | Maintain at, or below current dimensions by way of regular pruning. |

T2 - Apple (Crab)
