**The Printworks - Restoration of four listed buildings (sub-contractor for remedial works: Palliass Ltd)**

Regarding Emergency Removal of Lath and Lime Plaster Ceiling, First Floor Bedroom, Building 819, The Printworks, 819-829 High Road, Tottenham, London, N17 8ER

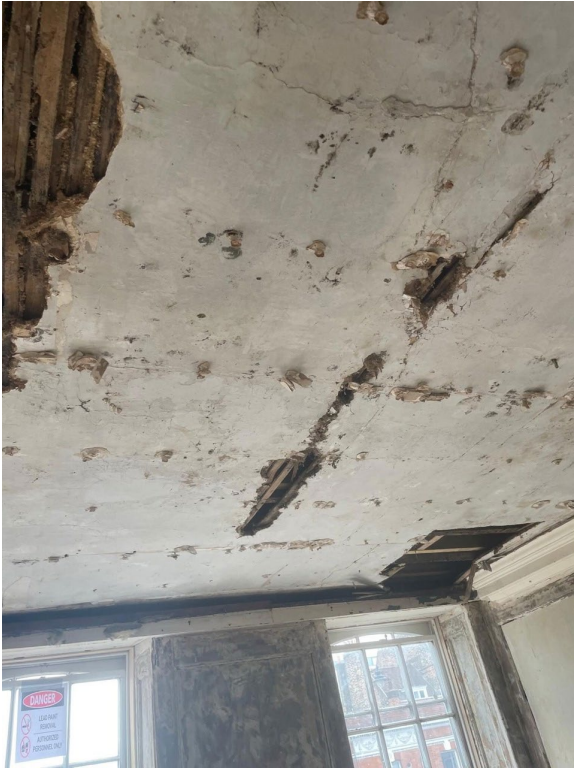
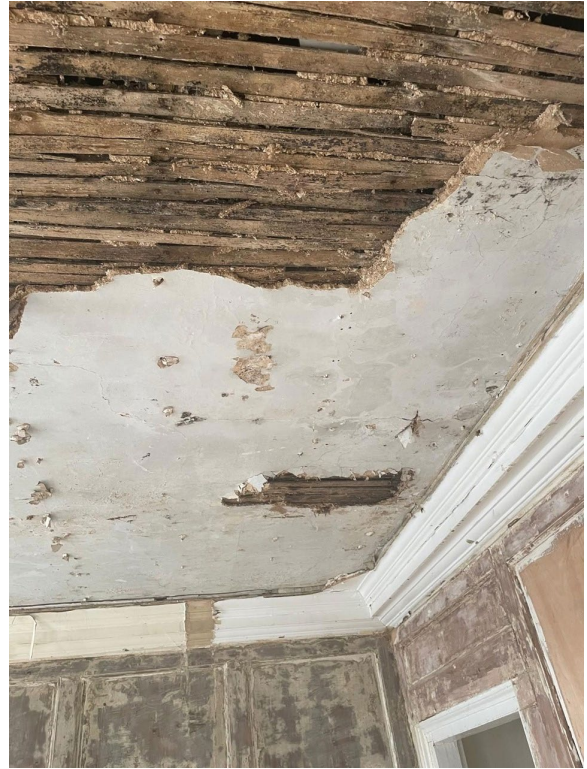
- the ferrous nails securing the laths to the joists corrode, losing their capacity to hold the laths in position.
- 3.2 Each of these mechanisms was present here, and their effect is cumulative and irreversible: once the nibs have sheared and the fixings corroded, the plaster is retained by little more than friction and the later plasterboard beneath it. The enclosed photographs additionally show fractured and displaced laths and widespread dark staining consistent with prolonged saturation of the ceiling structure (Figs 1-4 included below).

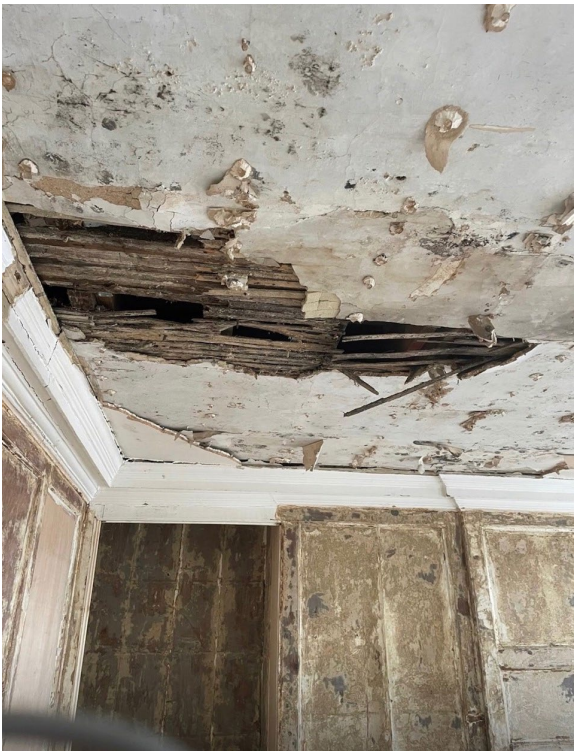
Fig.3 (left): Fractured and displaced laths with extensive dark staining consistent with prolonged water saturation of the ceiling structure. Fig.4 (right): Openings through the ceiling exposing the laths, with perforations from fixings across the plaster surface (Source: Palliass Ltd, July 2026).

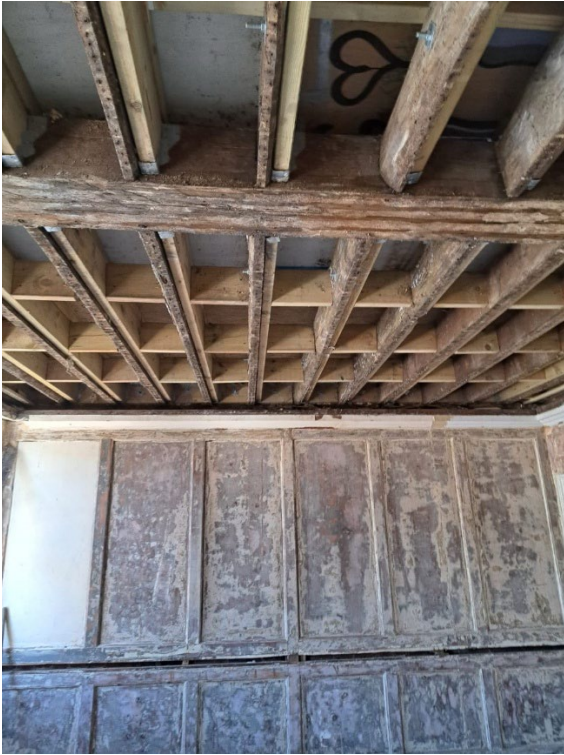
- 2.3 The ceiling has had long-term condition issues prior to the over boarding with modern plaster board, which can be seen in Fig.5. The modern timbers visible in the photograph had been fitted alongside and between the historic ceiling joists – using modern joist hangers and threaded bolts and installed with access from the floor above – in order to strengthen the ceiling structure. The fact that such an intervention was considered necessary at some point prior to the recent works is clear evidence that the ceiling had been experiencing structural difficulties over an extended period.

*Fig.5 (right): The ceiling as existing with the laths fully removed and the structure cleaned ready for the ceiling reinstatement. Note the modern timbers fitted alongside and between the historic ceiling joists (fitted before the recent works with access from the floor above) using modern joist hangers and threaded bolts to strengthen the structure, evidencing the ceiling required strengthening and stabilisation works.*
