## REPORT

ON: 91 UPPER TOLLINGTON PARK, LONDON,  
N4 4LP

FOR: Folgate Insurance Company Ltd  
(C/o Quadra Claims Services)

DATE: 6<sup>th</sup> FEBRUARY 2024

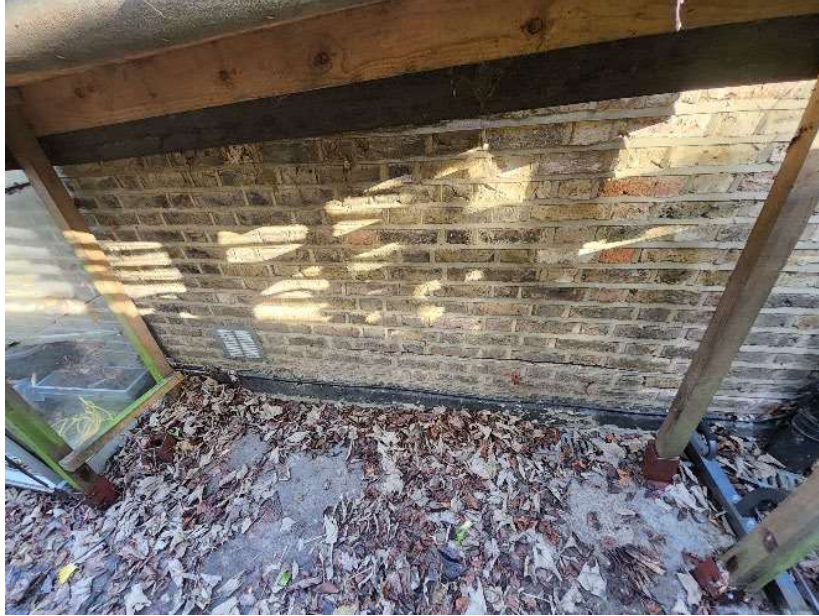
***'3.1. There was a horizontal crack in the south flank wall of the rear extension. The crack was located approximately 4 to 5 brick courses above ground level, and stepped down at either ends of the crack. The crack varied in width, with the maximum crack width being around 15 to 20mm, measured towards to the centre the crack.***

***3.2. The brickwork below the horizontal crack mentioned above had rotated outwards and was projecting by around 10mm further outward to that of the brickwork above the crack.***

*Photograph 1: (below left), showing the general location of horizontal cracking to the southern flank wall; and*

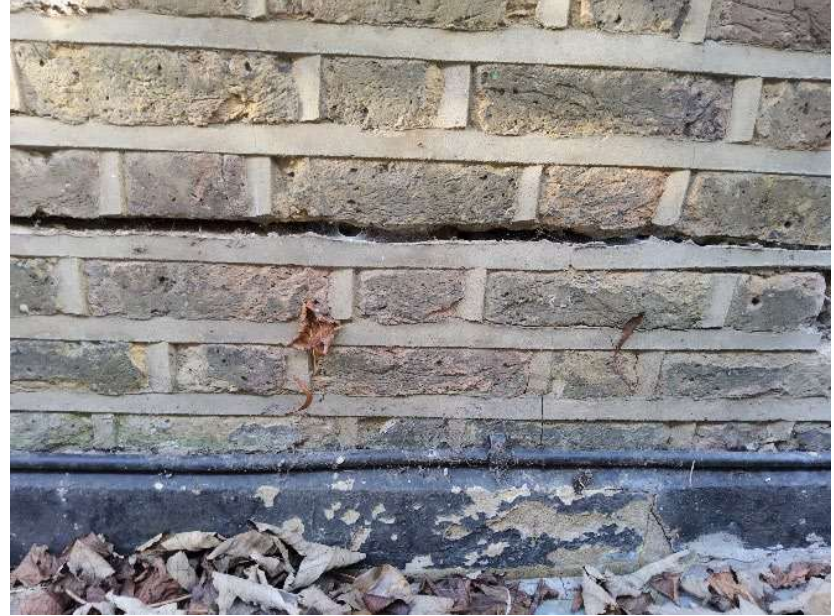
*Photograph 2: (below right), showing a close up of the horizontal cracking.*

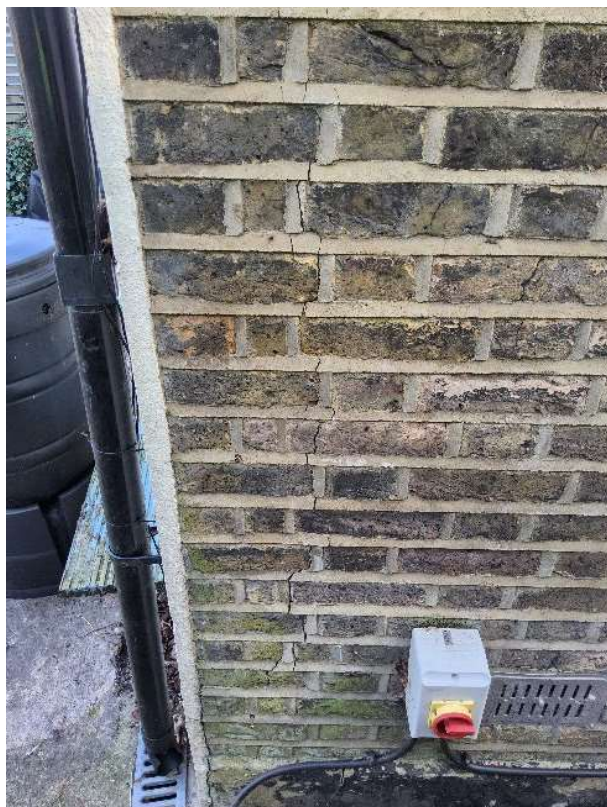
*Photograph 3: (below left), showing broadly vertical cracking in the south-west corner of the property; and*

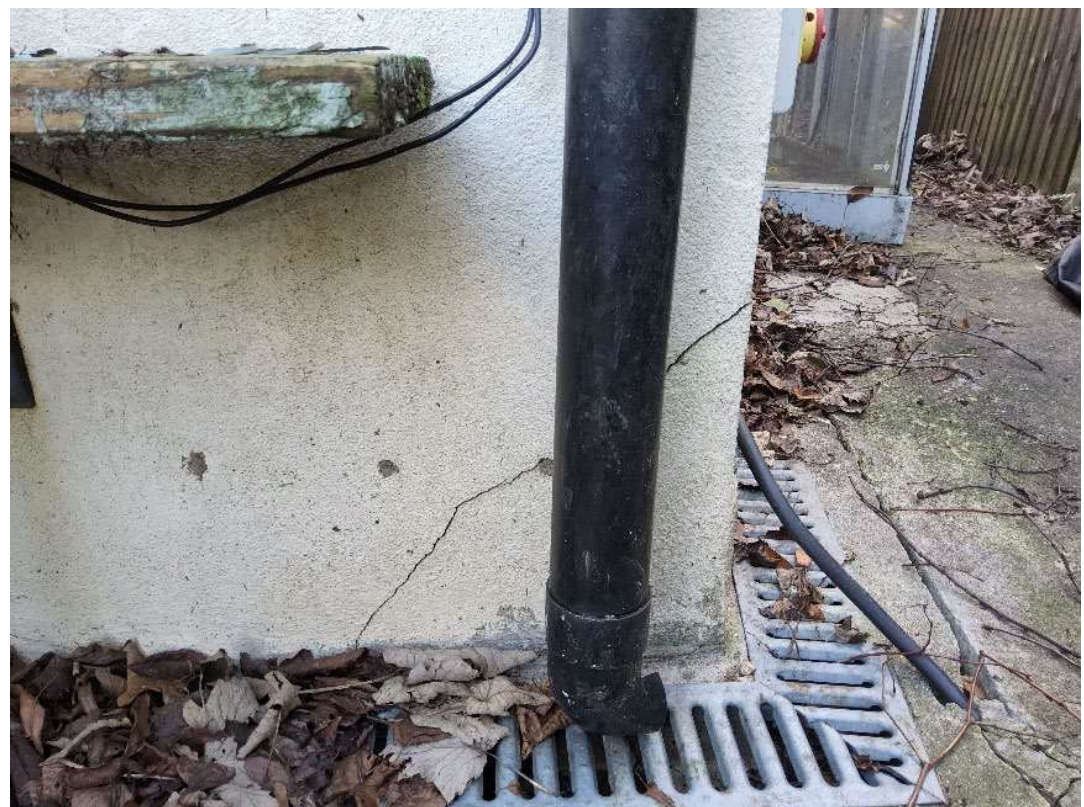
*Photograph 4: (below right), looking eastward at the south-west corner, showing ascending cracking.*

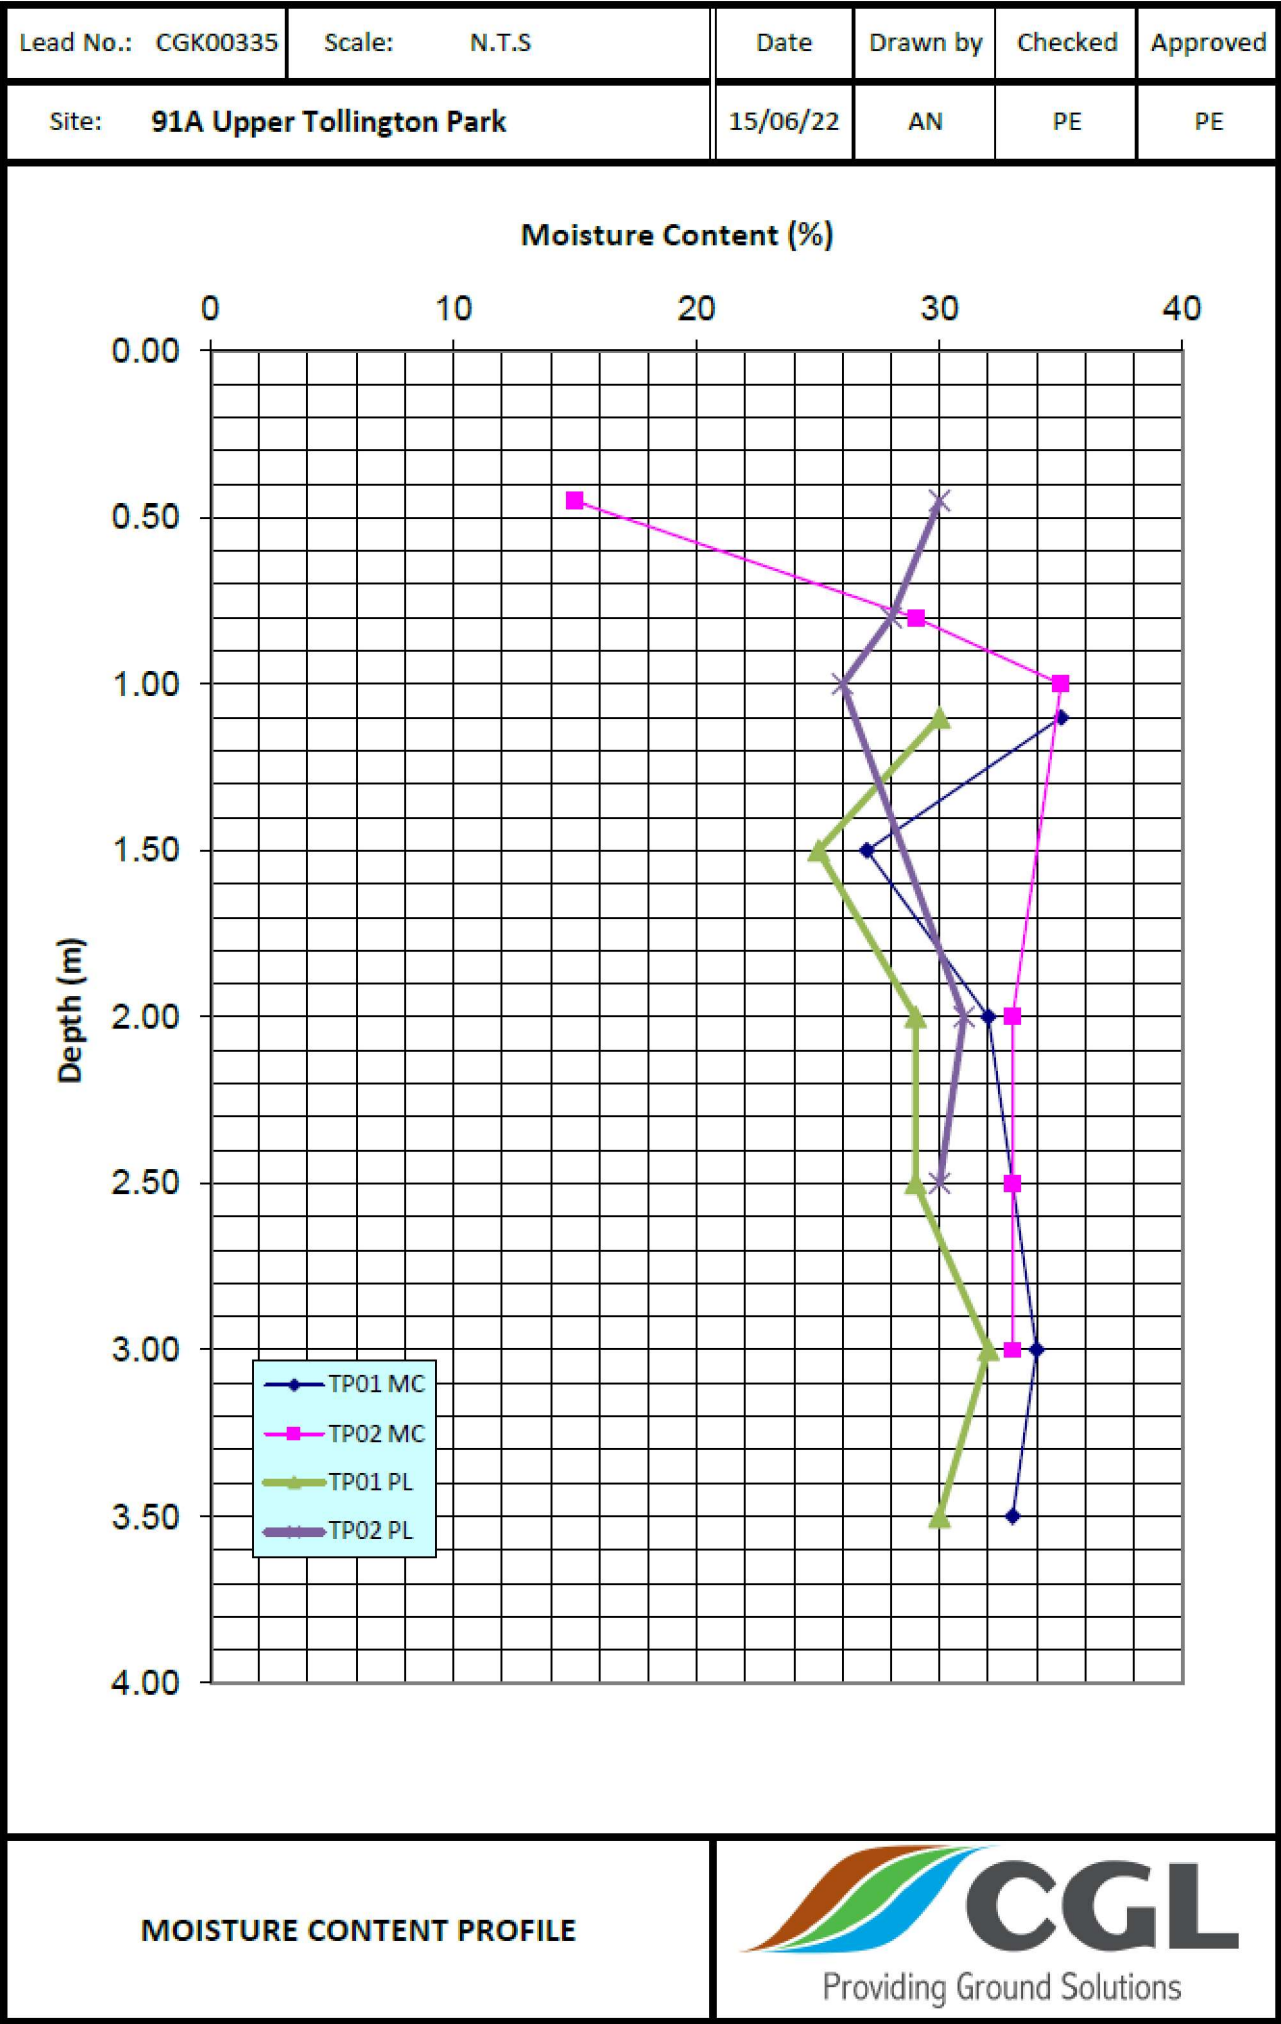
Figure 4: showing the soil moisture profiles included within the CGL report.

4.2.5 This is illustrated by the moisture content profiles included in the CGL report which appears to show a lack of significant desiccation, as shown below.

4.2.6 The above shows that within TP01, located approximately midway along the southern elevation, a reduction in moisture content is observed at 1.5m below ground levels; this is consistent with the expected depth of the majority of tree roots (Roberts, Jackson, & Smith, 2006), and so a slight reduction in

moisture at the depth would not normally be cause for concern. However, from 1.5m to 3.5m, moisture levels increase slightly and are more consistent with those found at 1m.

4.2.7 The findings of TP02, located at the south-western corner of the property, show only a very minimal reduction in moisture content between 1m and 3m.

4.2.8 Based on the damage observed, and the proximity of the adjacent trees, I would expect a seasonal drying pattern to occur, and so a similar geotechnical inspection carried out at the end of the summer months, could plausibly provide a significantly altered illustration of soil moisture content.
