Structural Survey Report

# 182-184 St Ann's

CF2 Studio Project Reference  
0021

Issuing Date  
07/10/2026

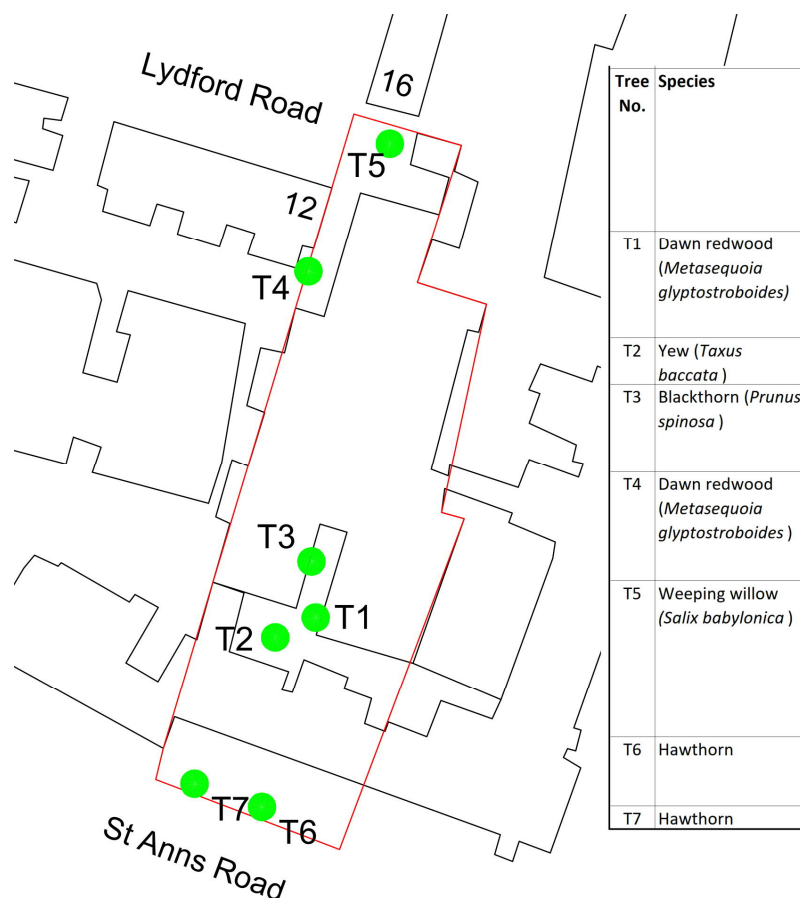
Figure 1 - Existing Trees on Site

The existing tree is a Dawn Redwood tree (T1), it's a mature tree and on the plan below it's possible to understand the tree location in relation to the existing buildings.

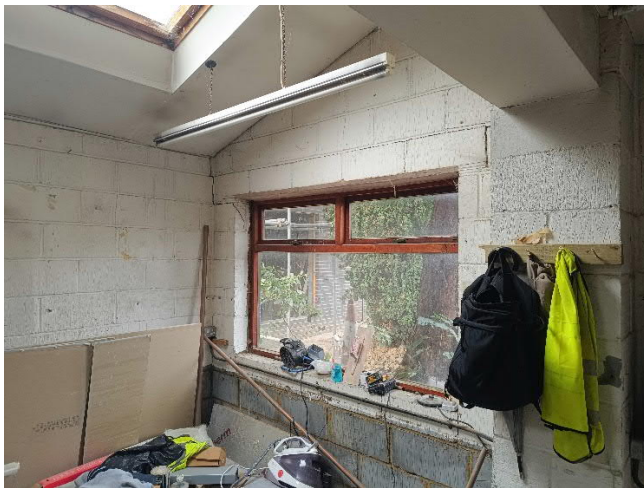
**P01 – Internal – Single Storey Building**

**Element:** Single storey building adjacent to the existing tree

**Defect:** *Evidence of Cracks due to movement of the structural elements*

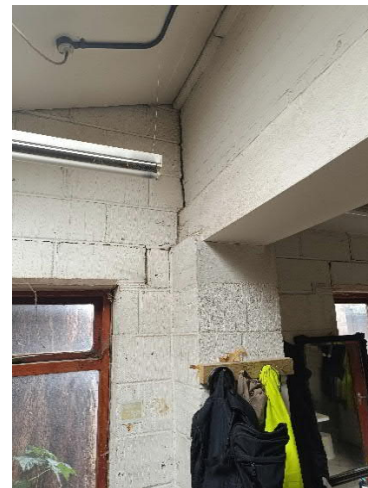
**P02 – Internal – Single Storey Building**

**Element:** Single storey building adjacent to the existing tree

**Defect:** *Evidence of Cracks due to movement of the structural elements*

The walls of the existing neighbouring structures to the existing Redwood Tree (T1) have several cracks that are in line with the expected patterns for ground movement on the existing foundations. In one location it's possible to see the crack is increasing in height which is indicative of differential movement between the different structural elements (shown on photo P02).

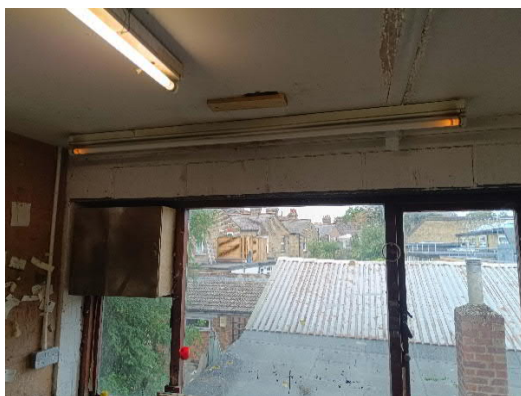
**P03 – Internal – Double Storey Building**

**Element:** Double storey building adjacent to the existing tree

**Defect:** *Evidence of Cracks due to movement of the structural elements*

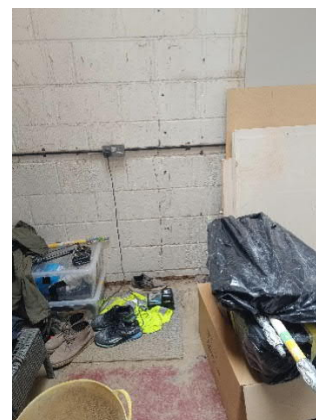
**P04 – Internal – Double Storey Building**

**Element:** Double storey building adjacent to the existing tree

**Defect:** *Evidence of Cracks due to movement of the structural elements*

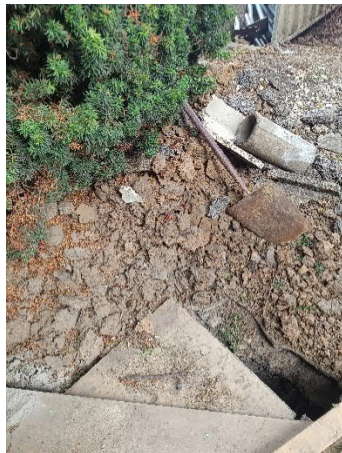
**P05 – External – Ground Conditions near the tree**

**Element:** Ground conditions found near the tree

**Defect:** *This photo identifies the ground to be clay which might be of high potential volume change.*

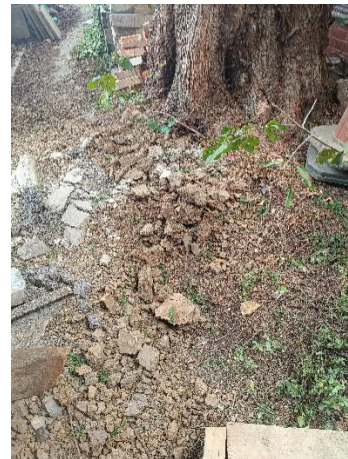
**P06 – External – Ground Conditions near the tree**

**Element:** Ground conditions found near the tree

**Defect:** *This photo identifies the ground to be clay which might be of high potential volume change.*

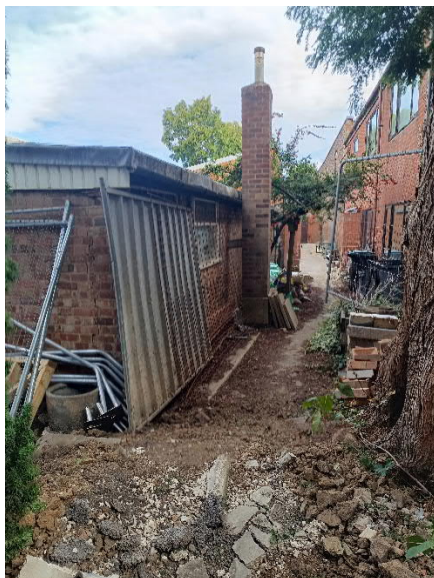
**P07 – External – Nearby Structure Opposite to Tree location**

**Element:** Existing external wall

**Defect:** The existing external wall shows signs of cracks and slight lean forward which can be linked to ground movement due to the tree presence

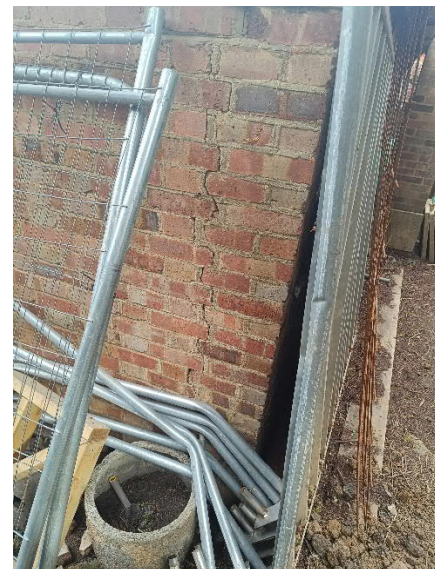
**P08 – External – Nearby Structure Opposite to Tree location**

**Element:** Existing external wall (Close up photo)

**Defect:** The existing external wall shows signs of cracks and slight lean forward which can be linked to ground movement due to the tree presence
