**TREE REPORT**  
**AT THE PIANO FACTORY, 182 & 184 ST ANN'S ROAD, LONDON, N15 5RP**

Prepared for Mr Harry Westbrook

**By A.T. Coombes Associates Ltd.**

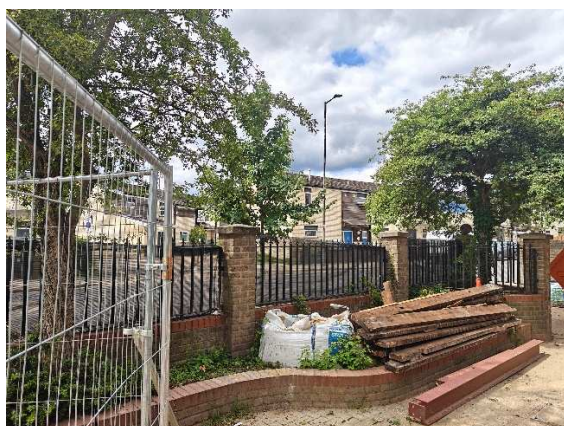
Fig 1: Hawthorn on site frontage

- 2.2 There is a fence to the front on a small brick plinth, with two hawthorn and other shrubs within a small raised bed on the southern boundary with St Ann's Road (Fig 1). There is a small crack adjacent to one of the hawthorn (T6) in the retaining wall of the raised bed (Fig 2).

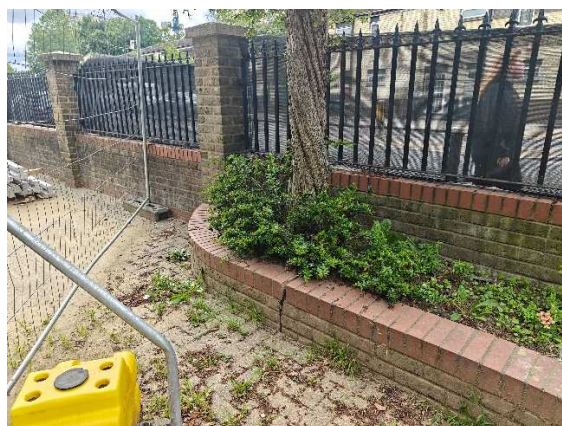
Fig 2: Crack adjacent to stem of hawthorn in small planter

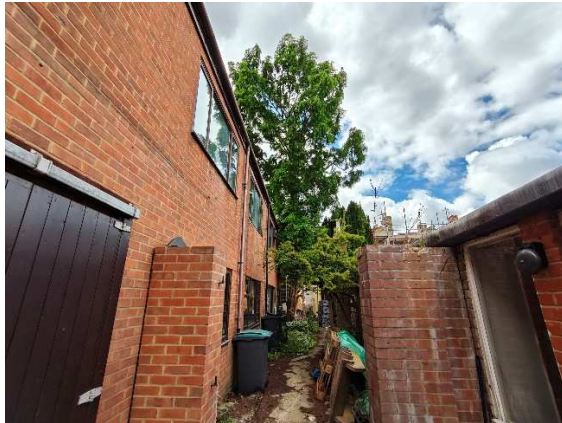
Fig 3: Dawn redwood adjacent to existing building

- 2.3 Behind the building at the front of the site is a dawn redwood situated approximately 1m to the west of an existing building (Fig 3). This tree has now grown to be significantly taller than the adjacent buildings (Fig 4).
- 2.4 There are cracks visible in the brickwork of this building on both the west-facing and south-facing walls (Fig 5 and 6).

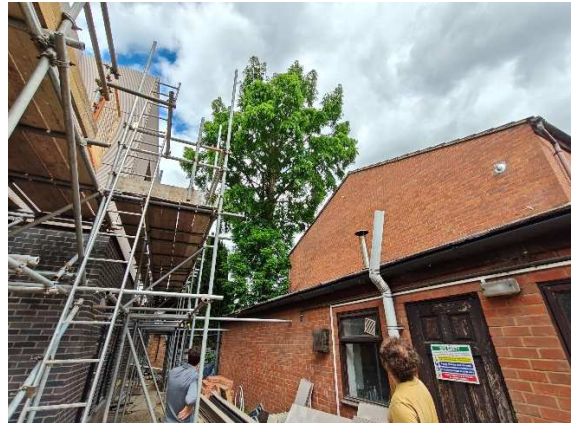
Fig 4: Dawn redwood above adjacent buildings

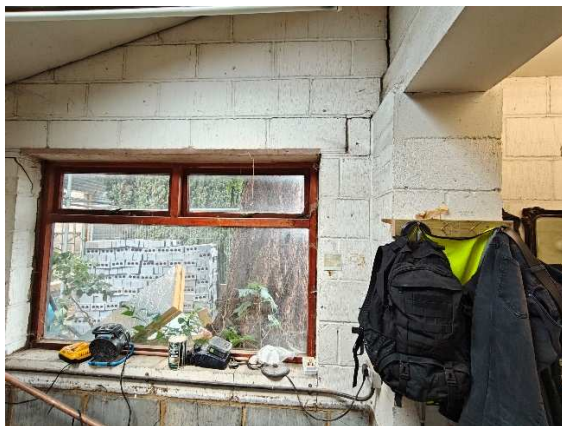
Fig 5: Cracks visible to blockwork inside the building

- 5.2 Trees present on site are generally in good condition.
- 5.3 However, there is cracking noted on buildings close to the dawn redwood T1. This tree is noted as being 1m from the wall of the adjacent building. The British Standard (BS5837:2012 – Trees in relation to design, demolition and construction; Recommendations) states that, for a tree with a diameter over 600mm, buildings should be located greater than 1.2m from the stem of the tree to avoid the risk of direct damage. The tree is within this distance, and therefore it is likely to be implicated in the damage visible on the building.

- 5.4 Given this finding, it is recommended to remove T1 to ground level.
- 5.5 A structural engineer should be consulted as to whether the removal of the tree is likely to cause soil heave, which may further affect the structural integrity of the building. Heave can take place when previously dehydrated soil takes up water and swells, and can happen after the felling or removal of vegetation.

- 7.1 Given the presence of cracks in the wall of adjacent buildings, and the close proximity of the tree to the buildings, it is recommended that T1 is removed to ground level.
- 7.2 As there are a number of mature trees on site, the owner of the property has a duty of care to ensure, as far as practicable, that the trees do not pose significant risks to residents, visitors and third parties. As such it is recommended that further professional inspections are carried out on a 3-year basis. It is also recommended that the owner of the site visually checks the condition of the trees regularly, particularly after any extreme weather events such as gales etc . If any changes to the condition or appearance of the tree take place, it is recommended that a qualified arboriculturist is contacted.

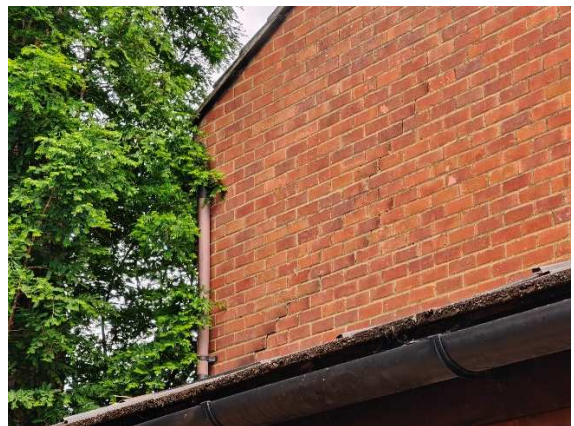
Fig 6: Cracks visible in brickwork on south-facing wall

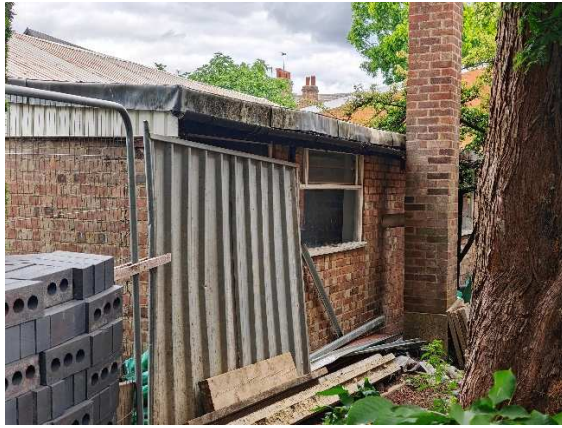
- 2.5 There is a smaller building situated to the west of the redwood, and this is approximately 2.2m from the stem of the redwood (Fig 7). There are also cracks visible in the south-facing wall of this building (Fig 8). There is a footpath between the tree and the building that has been heavily disturbed.

Fig 7: Building to west of dawn redwood

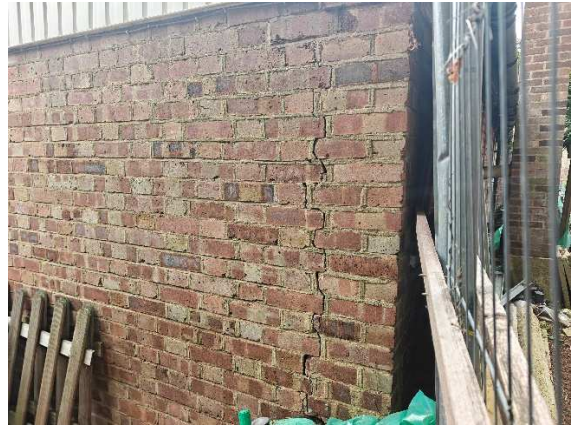
Fig 8: Cracks visible in brickwork

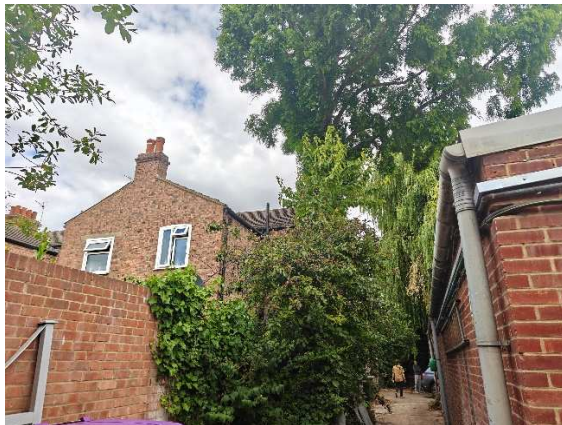
- 2.6 Another dawn redwood is situated within a raised planter towards the northwestern corner of the site, adjacent to the boundary with 12 Lydford Road (Fig 9). Close to the northern boundary of the site, adjacent to 16 Lydford Road is a mature weeping willow that has been pollarded frequently (Fig 10).

Fig 9: Dawn redwood close to western boundary of site

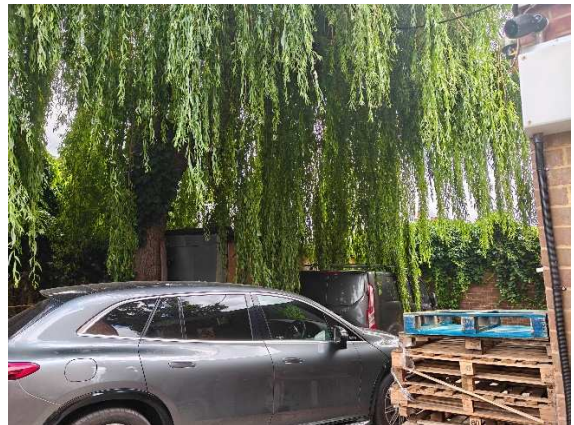
Fig 10: Weeping willow close to northern boundary of site
