**CCTV REPORT FOR: 8 HASLEMERE ROAD  
LONDON  
N8 9QX**

**Site Visit:** 28-Feb-25  
**Report Date:** 01-Apr-25

Address: **8 HASLEMERE ROAD, LONDON, N8 9QX**

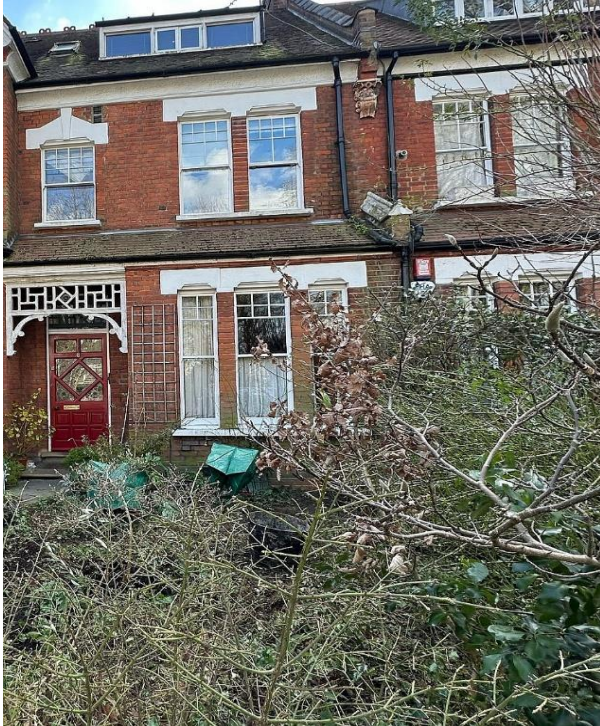
RWG1 accepts run off from the shared roof line and it would appear from probing that the outlet pipe runs off over the right hand boundary.

Down pipes from shared roof line

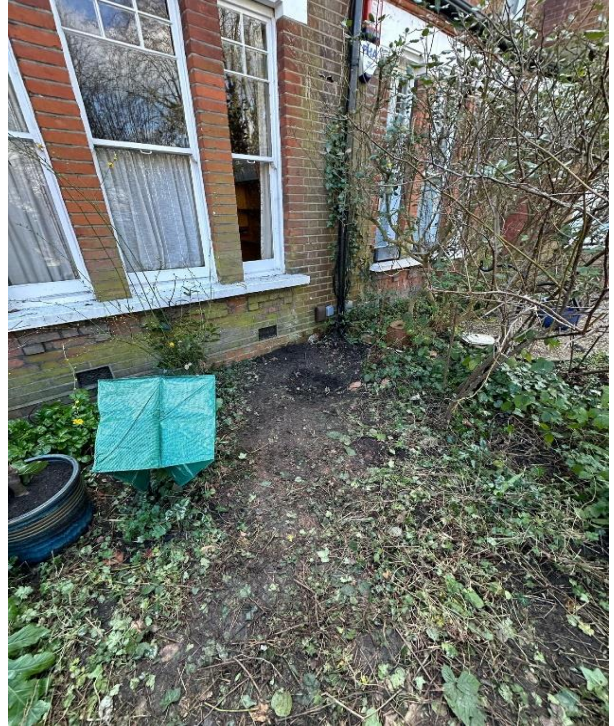
RWG1 location

We attempted a CCTV survey from RWG1 downstream but our camera was unable to negotiate the gully trap and no survey was possible.

Excavate and replace RWG1 allowing for up to 1.0m of pipework downstream.

Carry out high pressure water jetting as required before performing a CCTV survey of the remaining drainage downstream, reporting further on the condition and destination of the pipework.

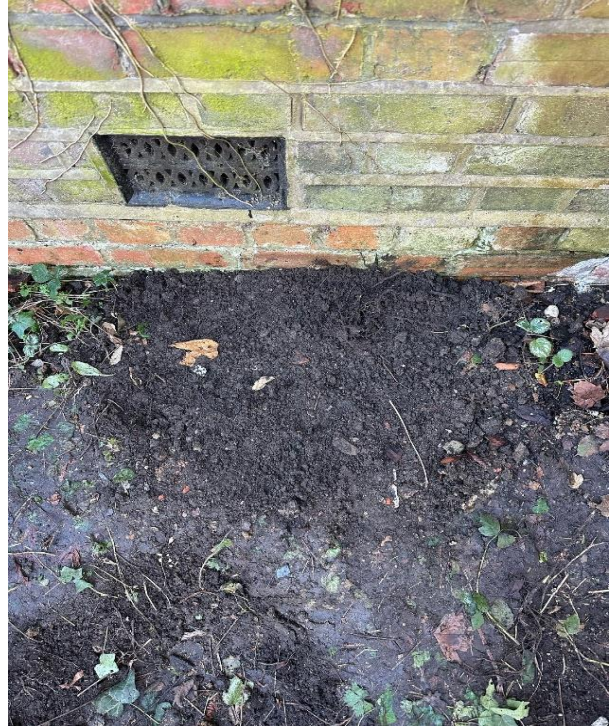
T/H1 reinstated
