**ADDENDUM TECHNICAL REPORT**  
Retained

| OUR REFERENCE NO: | 72230964 |

| POLICYHOLDER DETAILS | |
|---|---|
| Supposed cause: | Subsidence |

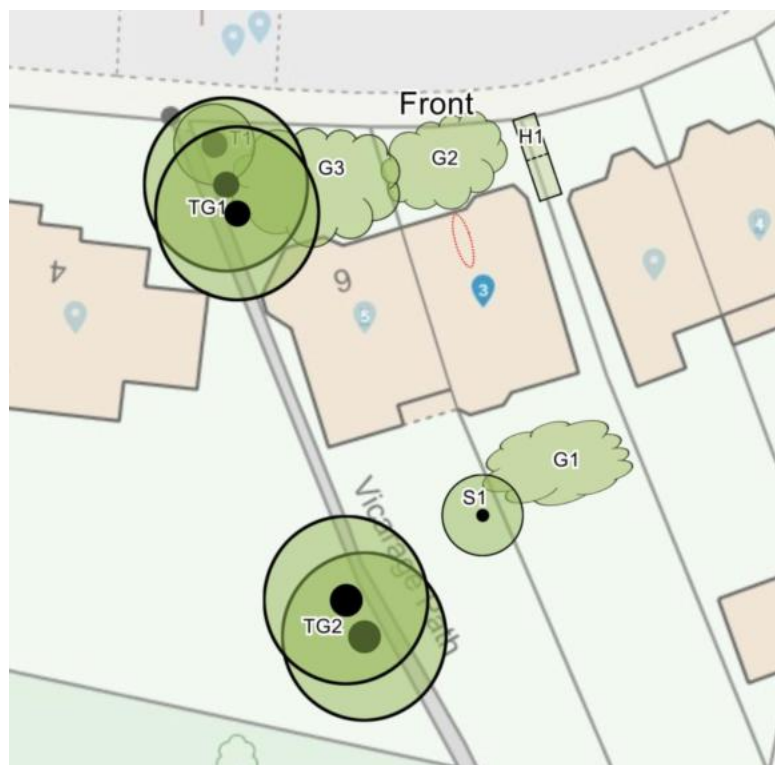
| Tree No. | Species | Ht (m) | Dia (mm) | Crown Spread (m) | Dist. to building (m) | Age Classification | Ownership |
|---|---|---|---|---|---|---|---|
| TG1 | Sycamore x 2 | 18 * | 1000 * | 14 | 16 * | Younger than Property | Third Party<br>6 Haslemere Road<br>N8 9QX |
| Management history | | Subject to past management/pruning. Attributed to previous subsidence claim 25 years ago and subject to tree preservation orders. | | | | | |

| Tree No. | Species | Ht (m) | Dia (mm) | Crown Spread (m) | Dist. to building (m) | Age Classification | Ownership |
|---|---|---|---|---|---|---|---|
| Recommendation | | Remove pending the results of a site investigation and evidence of seasonal movement from level monitoring data. | | | | | |

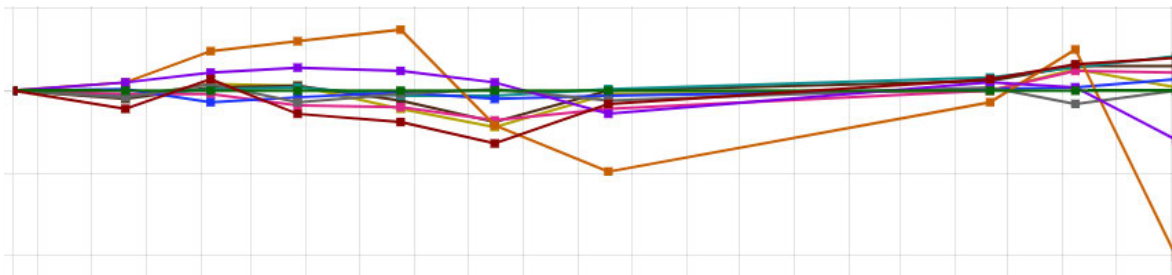
The latest level monitoring dated 4<sup>th</sup> August 2026 has shown that point 3 (rhs of the bay) has seen a significant downward movement since the previous reading in June with a 12.6mm downward movement recorded.

This timing of movement is typical for soils that are influenced by nearby vegetation.
