## Addendum Arboricultural Report

### Subsidence Damage Investigation at:

8 Haslemere Road  
London  
N8 9QX

| MWA REF: | SUB241031-15788Rev01 |

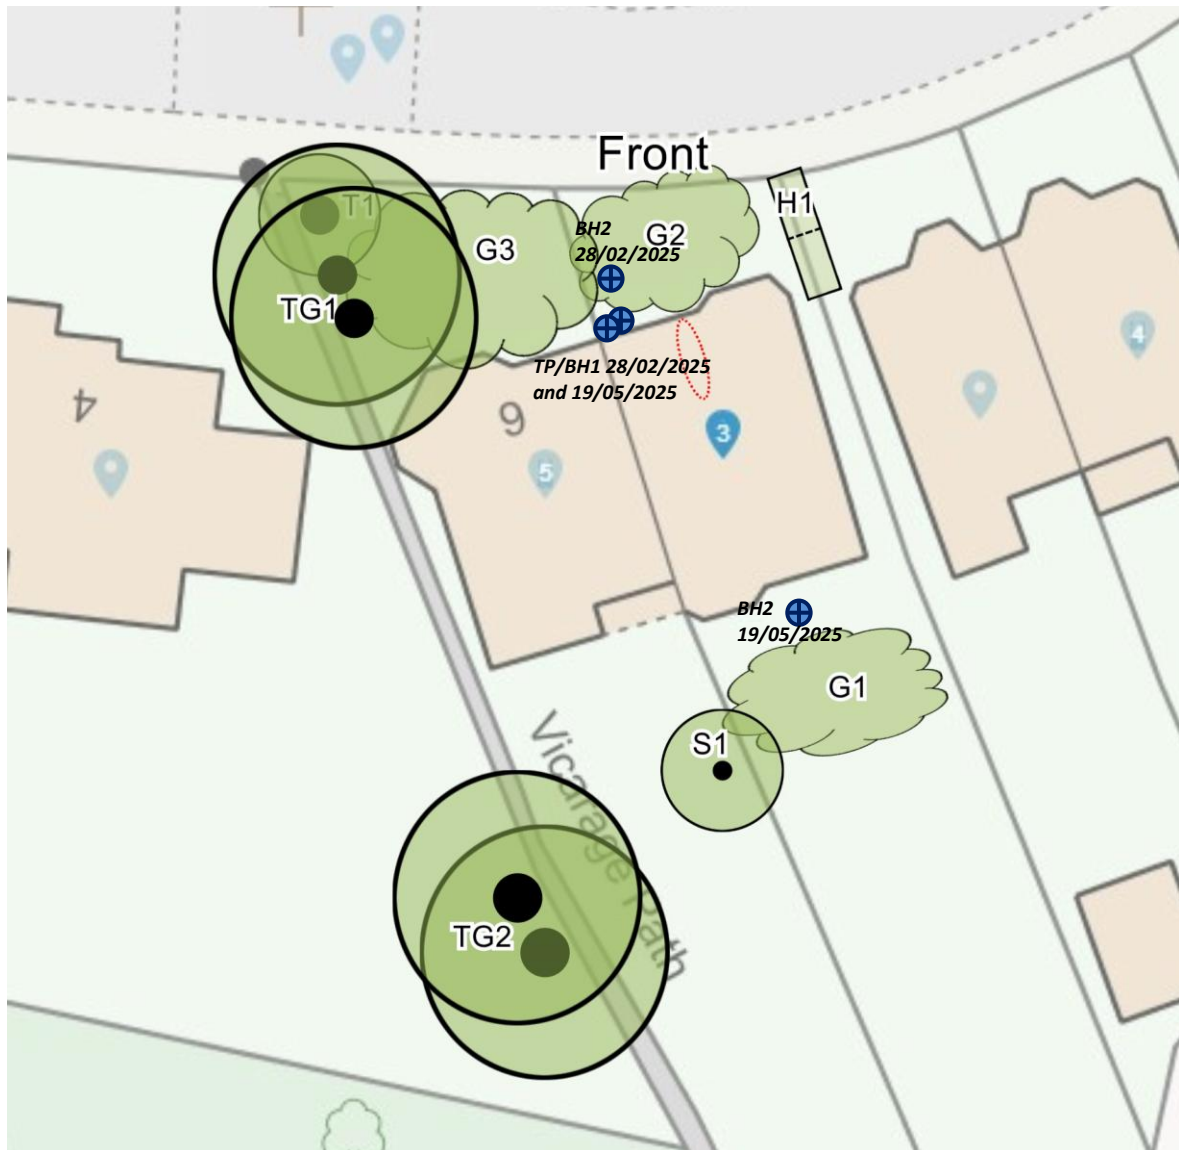
## Site Plan

Approximate areas of damage

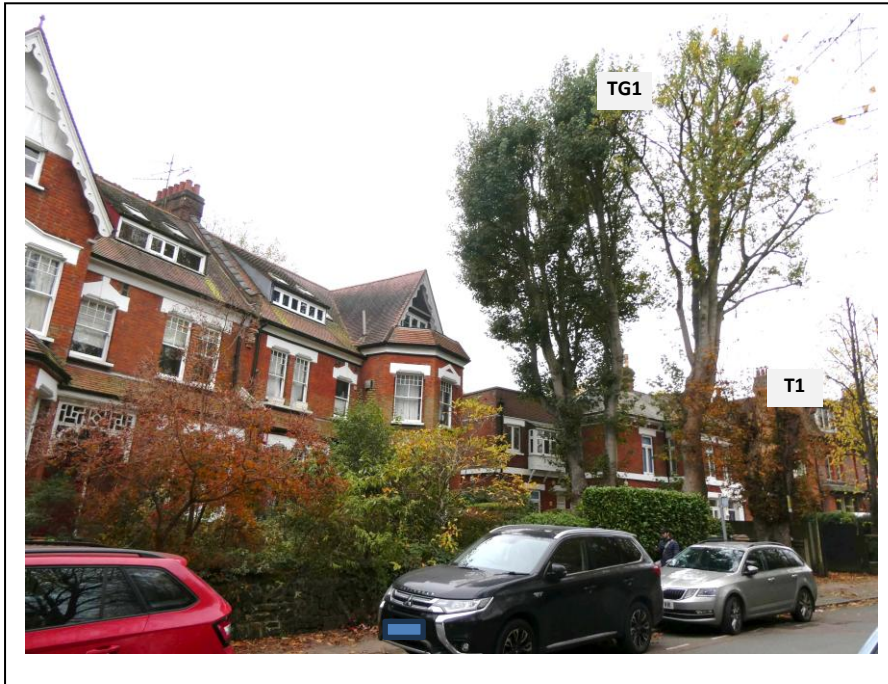
Based on the information currently available, engineering opinion and our own site assessment we conclude there is damage consistent with shrinkage of the clay subsoil exacerbated by the soil drying effects of vegetation. It is our opinion that Sycamore group TG1 is the principal cause of or is significantly contributing to the current building movement and damage. There may be a contribution from Horse Chestnut T1, but this is a comparatively smaller pollarded tree that is likely to exert a lesser influence than the much larger Sycamores forming TG1.

TG1 was previously implicated in subsidence damage that led to partial underpinning of the front bay around 25 years ago. The current damage is within closer proximity to trees in TG1.

View of T1 and TG1 in relation to the front elevation.

| Tree No. | Species | Ht (m) | Dia (mm) | Crown Spread (m) | Dist. to building (m) | Age Classification | Ownership |
|---|---|---|---|---|---|---|---|
| Recommendation | | Remove (fell) to ground level and treat stumps to inhibit regrowth. | | | | | |

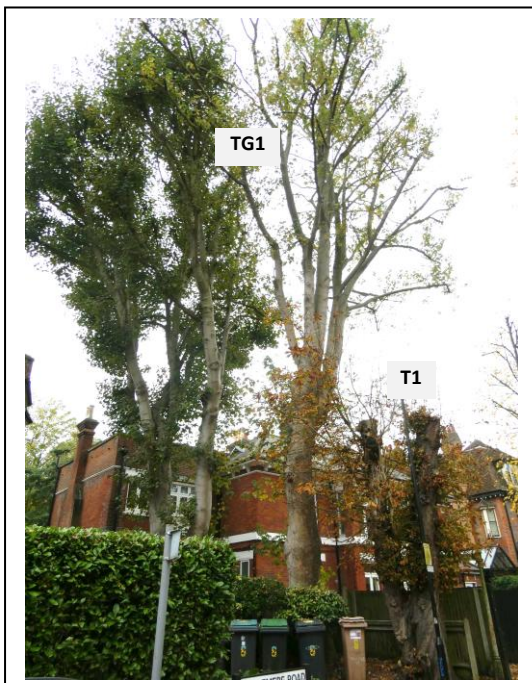
View of T1 and TG1.

| Tree No. | Species | Ht (m) | Dia (mm) | Crown Spread (m) | Dist. to building (m) | Age Classification | Ownership |
|---|---|---|---|---|---|---|---|
| Recommendation | | Maintain broadly at no more than current dimensions by biannual re-pollarding (in accordance with BRE IP7/06 "Pruning trees to reduce water use). | | | | | |

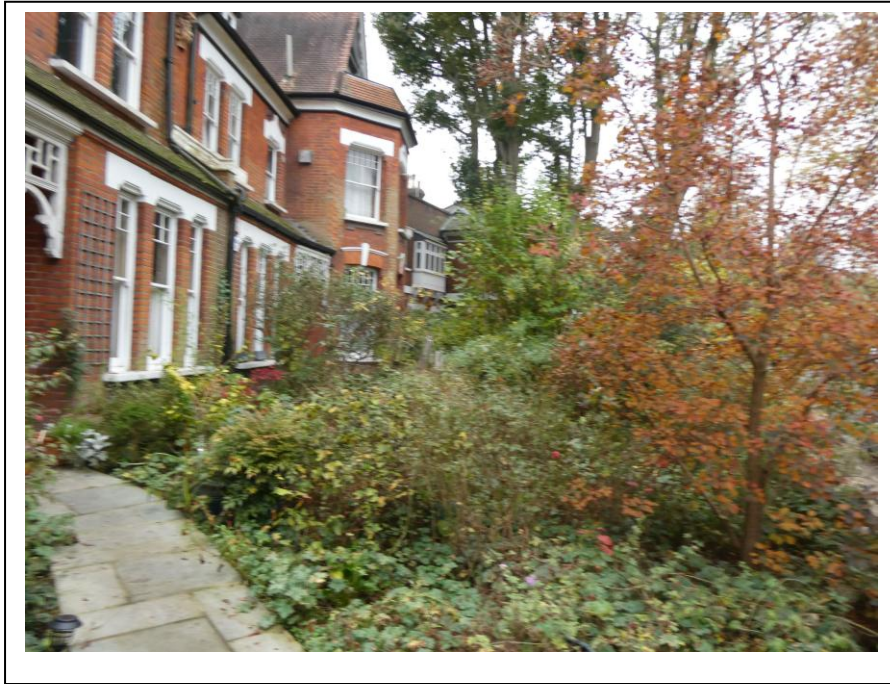
View of G2 in the front garden.

| Tree No. | Species | Ht (m) | Dia (mm) | Crown Spread (m) | Dist. to building (m) | Age Classification | Ownership |
|---|---|---|---|---|---|---|---|
| Recommendation | | Remove the Oak. Maintain other elements at broadly at no more than current dimensions by periodic pruning. | | | | | |

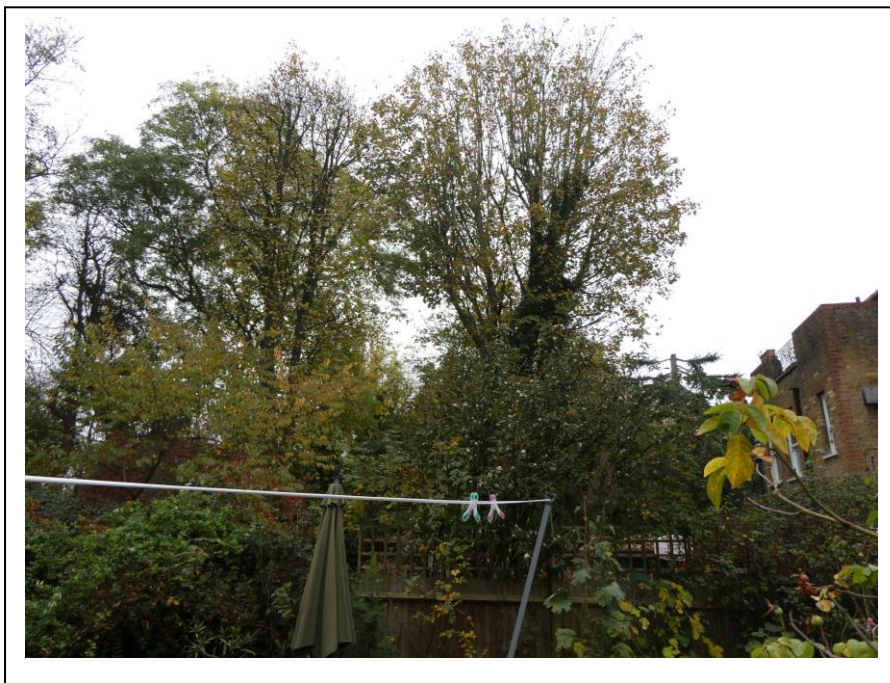
View of TG2 from the rear garden.

| Tree No. | Species | Ht (m) | Dia (mm) | Crown Spread (m) | Dist. to building (m) | Age Classification | Ownership |
|---|---|---|---|---|---|---|---|
| Recommendation | | Maintain broadly at no more than current dimensions by periodic pruning. | | | | | |
