## Refurbishment to Existing Metal Shutter.

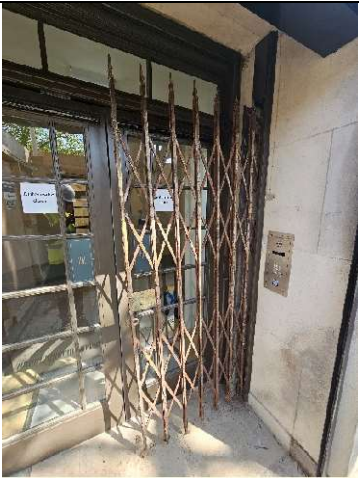
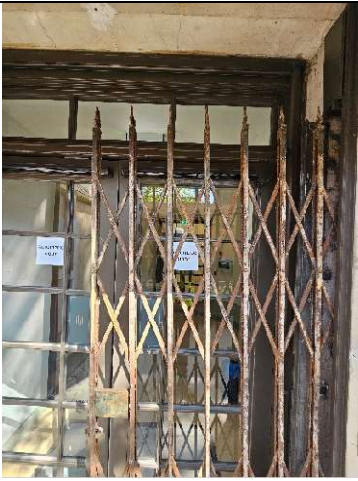
| Left-Hand Shutter - Closed Position | Left-Hand Shutter - Closed Position |

The finish to the left-hand shutter is in poor condition. With obvious signs of peeling, weathering, and a general mucky condition.

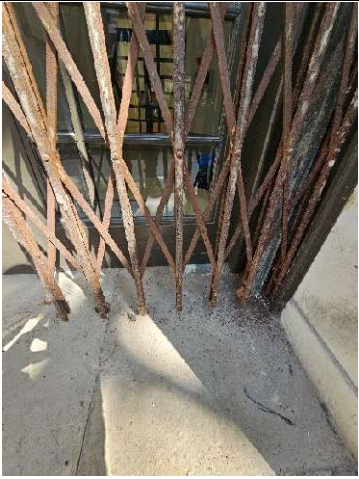
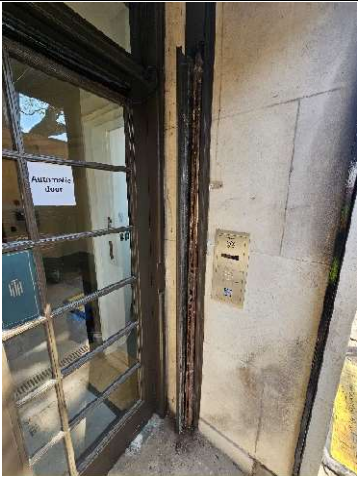
| Left Hand Shutter - Closed Position | Left Hand Shutter - Open Potion |

The left-hand side shutter is in working order, presenting a fully closed state and retractable open state.

There is some difficulty in fully closing the door when the left-hand shutter is in a fully retractable state.

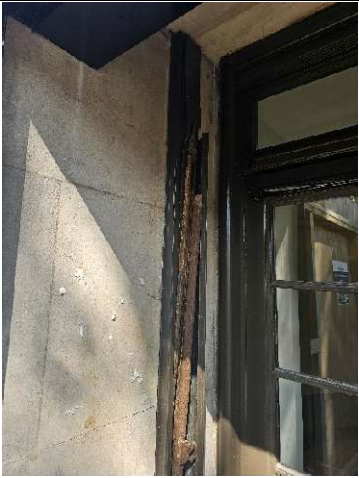
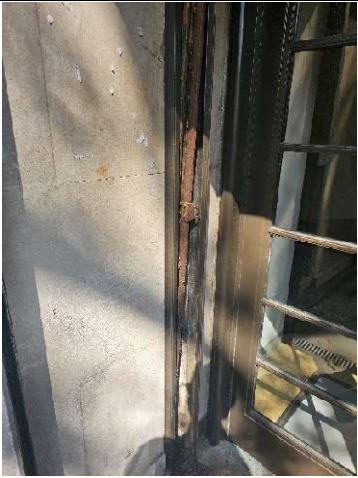
| Right Hand Shutter - Close Position | Right Hand Shutter - Close Position |

The right-hand shutter is in poor working order. Currently unable to be pulled out of its housing within the wall due to a broken opening mechanism.

Closer inspection inside the housing shows the finishes to be of a similarly poor condition to the left-hand side shutter.

The right-hand door to the housing shows signs of damage, with bending to the fixed top panel of the door.
