**Structural Appraisal Report for****Ivy House, 128 Highgate Hill, London N6 5HD**

Ref: 231165/H Hawker

23 Nov 2023

Version 1

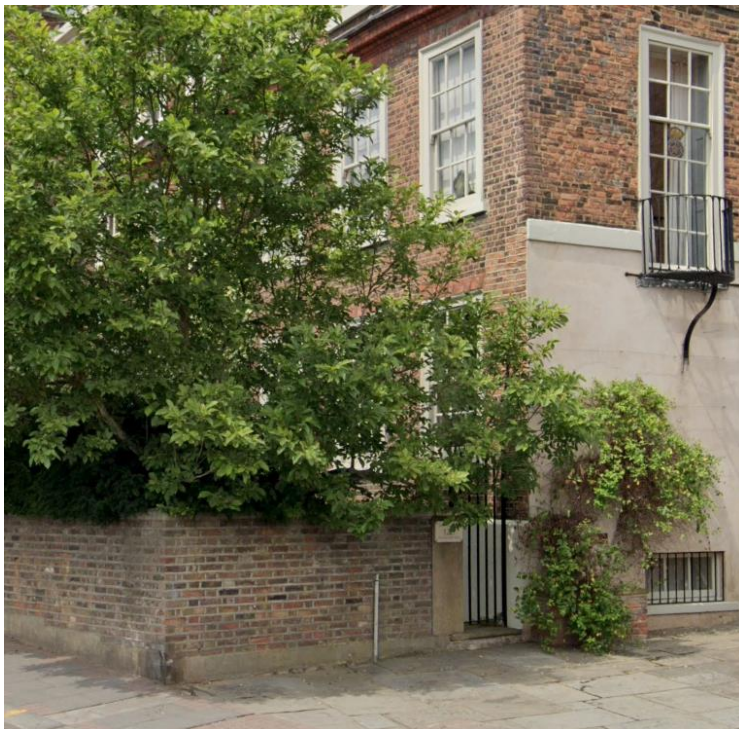
2 Google maps 2019

- 4.2 On google maps street view, the crack can first be clearly identified in 2019, and in many of the images a darker patch is visible on the base of the wall on the return on Highgate Hill side, this is most likely damp penetrating the wall from the retained soil.

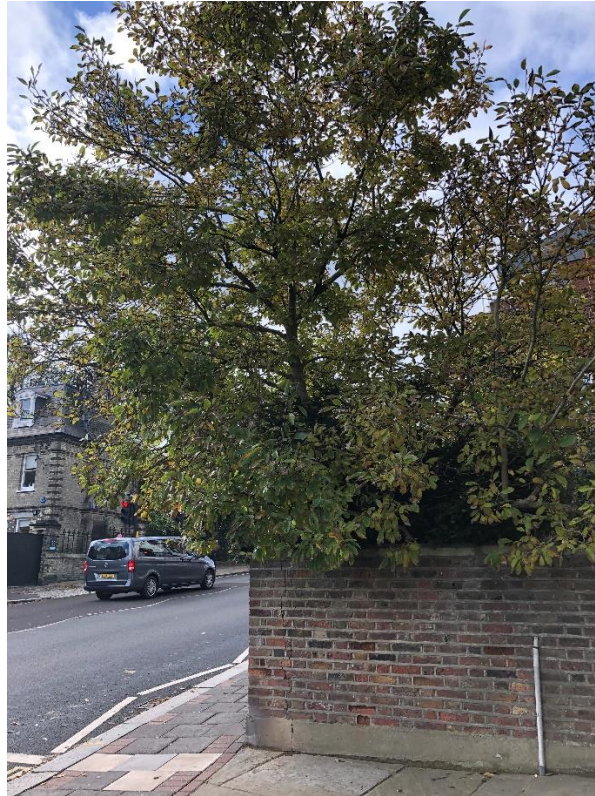
Photo taken on 9.11.23

- 3.1 There is a vertical crack to the return of the wall, 10mm wide at the top and 4mm close to the bottom.

- 5.1 It is most likely that the physical growth of the tree has caused the cracking, given the proximity of the tree to the wall, and that its trunk /root system is exerting pressure on the wall which has caused the cracking.
- 5.2 The wall is still visibly plumb, and so is not considered structurally insecure at this time.

- 6.3 The crack may be repaired with, and wall return strengthened with stainless steel Heli-bars (or similar) to every third bed joint, extending min 600mm from the crack and about the return. The crack filled with proprietary crack filler, and the joints repointed in mortar to match the existing so that the repair is not visible. Bricks which are cracked through maybe either replaced with like or repaired by using a colour matched repair mortar.

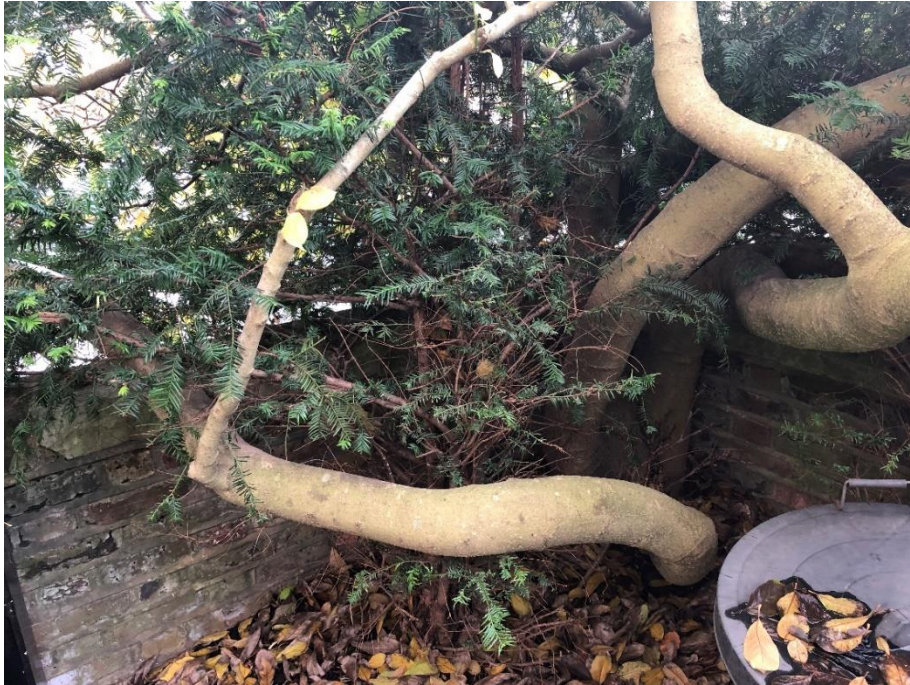
- 4.1 There is a mature magnolia tree just inside the return of the wall, planted in the retained soil. It has a thick multi-stemmed trunk, which is within 100mm of the wall. It is clear looking at historic images available on google-maps street that the tree has matured considerably over the past few years, and rather than gaining height has been gained girth, with branches over hanging the wall increasing in size.

View to rear of wall - magnolia

- 6.1 An arboriculturist will be able to advise on the predicted growth of the magnolia, especially in terms of its girth, over the life expectancy of tree. As the magnolia is in a restricted quadrant of soil, this may affect the tree in certain conditions, e.g. in times of draught, which could affect the growth and condition of the tree.

- 6.2 An arboriculturist will also be able to advise on whether maintaining the tree e.g., reducing its canopy, will reduce increase in the girth of the trunks and therefore slow down the pressure the tree is exerting on the wall. It must be noted that the yews may also grow considerably, albeit at a slower rate, and advice should be sought on how these are ma.
