BRUCE CASTLE MUSEUM

## GROUND FLOOR DOOR SCHEDULE

Document Ref : 7440-321

September 2023

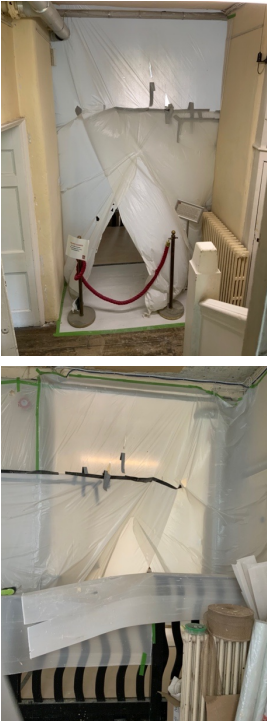
| Door ref. | Room ref. | Photos | Door Size | Min. Panel Thickness | Description of existing door | Notes/Existing condition | Fire Resistance Required (Aspirational requirement) | Proposed Works | Ironmongery |
|---|---|---|---|---|---|---|---|---|---|
| G1.Do4 | G1<br>OLD KITCHEN | | Existing opening size<br><br>1950 wide x 3300mm high<br><br>Proposed door size<br><br>2no 494 x 2108 x 58mm | N/A | Existing opening with plastered reveals. No door present. | | FD6oS | <b>Proposal for this opening:</b><br><br>Allow for infilling this existing opening in 1hr fire rated metal framed partition (Gypwall single frame system ref: A2o6o16 (A)(EN) or similar approved) to take a pair of double doors by Longden Doors UK Ltd (Allow approx. 1100 x 2165mm O/A structural opening size).<br><br>Doors to be FD6oS rated 3 panel, flat panels with beaded surrounds - designed to match adjacent opening G12.Do3.<br><br>Note that the existing radiator will need to be relocated away from this opening to achieve the line of fire compartmentation. | <b>Proposed:</b><br><br>3no fire rated brass hinges per leaf.<br><br>2no unlacquered polished brass pull handles<br><br>2no push plates<br><br>Allow for supply and fix of new Dorguard Smartsound Fire door retainers to base of each door leaf to enable doors to be held open when room is in use and close upon activation of the fire alarm.<br><br>Supply and fix new 76mm dia. 'Automatic fire door keep clear' signage in polished brass finish to both faces of each door leaf. |

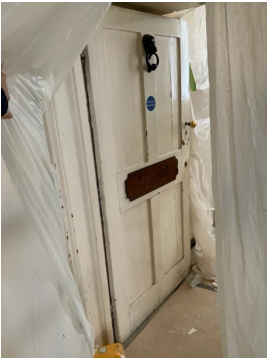
| Door ref. | Room ref. | Photos | Door Size | Min. Panel Thickness | Description of existing door | Notes/Existing condition | Fire Resistance Required (Aspirational requirement) | Proposed Works | Ironmongery |
|---|---|---|---|---|---|---|---|---|---|
| G2.Do1 | G2<br>KITCHEN | | <b>Existing door leaf:</b><br><br>835 x 1810 x 35mm<br><br><b>New door leaf:</b><br><br>835 x 1810 x 58mm | Unknown | 4 panel leaf with square shoulders. | Door not inspected on site.<br>Panels appear to be split | FD6oS | <b>Repairs to door leaf/frame/reveals:</b><br><br>Existing door is to be removed and handed back to the employer.<br><br>Carefully remove existing timber linings to the reveals, head and door threshold and install PFC Corofil CW mineral fibre insulation slabs to voids, fixed in place using CW galvanised steel retaining brackets in accordance with manufacturers details and recommendations. Carry out repairs as necessary to reveal linings and reinstate in full prior to redecoration.<br><br>Allow for supply and fix of new flush FD6oS leaf within existing door frame. | <b>Proposed:</b><br><br>3no fire rated brass hinges<br><br>1no unlacquered polished brass pull handle<br><br>1no push plate<br><br>Allow for supply and fix of new Dorguard Smartsound Fire door retainers to base of each door leaf to enable doors to be held open when room is in use and close upon activation of the fire alarm.<br><br>Supply and fix new 76mm dia. 'Automatic fire door keep clear' signage in polished brass finish to both faces of each door leaf. |

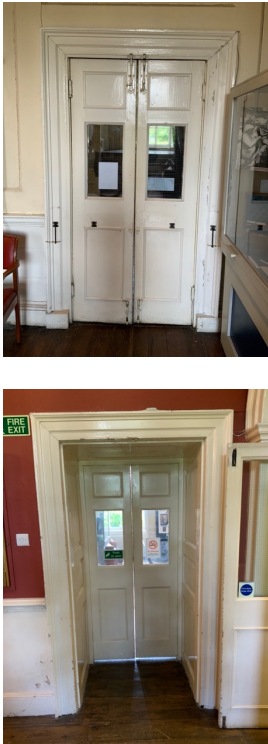
| Door ref. | Room ref. | Photos | Door Size | Min. Panel Thickness | Description of existing door | Notes/Existing condition | Fire Resistance Required (Aspirational requirement) | Proposed Works | Ironmongery |
|---|---|---|---|---|---|---|---|---|---|
| G4.Do4 | G4<br>MAIN GALLERY | | 470 x 2030 x 55mm<br>(2 leaves) | Unknown | Pair of 3 panel doors, central panel is Georgian wired glazed, remaining panels are flush with beaded surrounds. Panels to G4 face have been previously upgraded (assumed for fire).<br><br>Head and side reveals on G10 face are timber lined with raised and fielded panels. | Doors are held open generally on cabin hooks but when released they do not close in a controlled manor and are a Health and Safety Risk, they also do not close together fully.<br><br>Services penetrations through frame.<br><br>No fire and smoke seals. | FD30S | <b>Repairs to door leaf/frame/reveals:</b><br><br>Existing doors are to be retained.<br><br>Carefully remove existing timber linings to the reveals, head and door threshold and install PFC Corofil CW mineral fibre insulation slabs to voids, fixed in place using CW galvanised steel retaining brackets in accordance with manufacturers details and recommendations. Carry out repairs as necessary to reveal linings and reinstate in full prior to redecoration.<br><br>Carry out making good to any areas on the door leafs / frame / architraves which have been affected by previous fixings or ironmongery removal, allow also for piecing in new timber to any previous repairs which have been carried out using filler.<br><br>Allow for removal of redundant ironmongery and for timber piece repairs/making good to leaf/frame/architrave as necessary (following removal).<br><br>Allow for planting a hardwood lipping onto underside of leaf to reduce the threshold gap between door and floor.<br><br>Prepare and redecorate all in a satinwood finish.<br><br>Ease door to prevent binding and allow it to close into frame - allow for straightening leaf to ensure that door fits well into the frame all round and that it latches closed.<br><br>Allow for fire stopping any penetrations through frame with a suitable intumescent product.<br><br><b>Upgrade works to door leafs:</b><br><br>Allow for carrying out intumescent paint upgrade to both door leafs. Paint to be applied to both faces of the leaf. <b>Refer to Fig. 1.0 in Appendix A of this document for details of intumescent paint system.</b> Door leafs to be finished with top coat of satinwood. Application to be in full accordance with Envirograf details and specification.<br><br>Allow for routing out door leaf (sides and head) to take a new combined fire and smoke seal -<br><br>Head: 1no 15x4mm Lorient LP1504DS (white)<br><br>Jambs: 1no 15x4mm Lorient LP1504DS (white)<br><br>Meeting Stile (1no leaf only) : 1no 10x4mm Lorient LP1004 and 1no 10x4mm Lorient LP100DS (white)<br><br><u>NOTE:</u> Fire and smoke seals must not be painted. | <b>Existing:</b><br><br>2 no large hinges per leaf (self closing)<br><br>Large sliding bolt to head and base of each leaf.<br><br>Cabin hook and eye to each leaf.<br><br><b>Proposed:</b><br><br>Existing hinges to be removed, make good door leafs / frame as necessary and replace with 3no fire rated brass hinges per leaf.<br><br>Allow for the supply and fix of 2no unlacquered polished brass pull handles and 2no push plates.<br><br>Remove existing cabin hooks and make good fixing positions to joinery on both door leafs and architraves.<br><br><b>Allow for supply and fix of new Dorguard Smartsound Fire door retainers to base of each door leaf to enable doors to be held open when room is in use and close upon activation of the fire alarm.</b><br><br>Supply and fix new 76mm dia. 'Automatic fire door keep clear' signage in polished brass finish to both faces of each door leaf. |

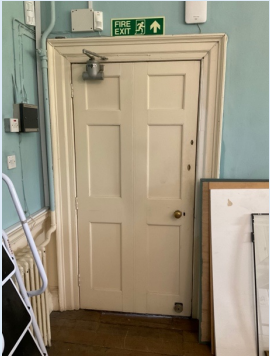
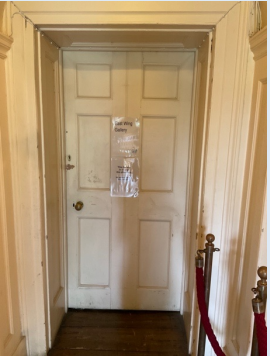
| Door ref. | Room ref. | Photos | Door Size | Min. Panel Thickness | Description of existing door | Notes/Existing condition | Fire Resistance Required (Aspirational requirement) | Proposed Works | Ironmongery |
|---|---|---|---|---|---|---|---|---|---|
| G6.Do1 | G6<br>EAST WING<br>GALLERY | | 950 x 2035<br>x 48mm | 10mm | <p>Appears to be a historic door leaf.</p> <p>6 panel leaf, flat panels with beading to panel edges.</p> <p>Door reveals and head are timber panelled with beading to edges of panels.</p> | <p>Some minor opening-up along joint lines to panels/stiles/rails.</p> <p>Section of frame has been pieced in previously and there is cracking to joints.</p> <p>Original doorstop has been added to, to increase depth (see survey).</p> <p>Cable penetrations through door frame / linings.</p> <p>Intumescent seals exist to both edges and top of door leaf. Groove on closing stile is slightly too large for seal.</p> <p>20mm gap at bottom of door.</p> | FD3oS | <p><b>Repairs to door leaf/frame/reveals:</b></p> <p><b>Existing door to be retained.</b></p> <p>Carefully remove existing timber linings to the reveals, head and door threshold and install PFC Corofil CW mineral fibre insulation slabs to voids, fixed in place using CW galvanised steel retaining brackets in accordance with manufacturers details and recommendations. Reinstate timber linings in full and redecorate.</p> <p>Allow for removal of redundant ironmongery and for timber piece repairs/making good to leaf/frame/architrave as necessary (include for filling any gaps from items which have previously been removed).</p> <p>Allow for any adjustments to the leaf to ensure that door fits well into the frame all round and that it latches closed.</p> <p>Carry out minor repairs to door leaf and plant hardwood lipping onto underside of leaf to reduce the threshold gap between door and floor to max. 10mm.</p> <p>Prepare and redecorate all in a satinwood finish.</p> <p>Allow for fire stopping any penetrations through frame with a suitable intumescent product.</p> <p><b>Upgrade works to door leaf:</b></p> <p>Allow for carrying out intumescent paint upgrade to this door leaf. Paint to be applied to both faces of the leaf. <b>Refer to Fig. 1.0 in Appendix A of this document for details of intumescent paint system..</b> Door leaf to be finished with top coat of satinwood. Application to be in full accordance with Envirograf details and specification.</p> <p>Allow for removal and replacement of existing intumescent seals (sides and head) to take new combined fire and smoke seals (include for additional routing out as necessary to take new seals) -</p> <p>Head: 1no 10x4mm Lorient Lp10o4DS (white)</p> <p>Jambs: 1no 10x4mm Lorient Lp10o4DS (white)</p> <p><u>NOTE:</u> Fire and smoke seals must not be painted.</p> | <p><b>Existing:</b></p> <p>3 no. 102 x 35mm hinges (painted) all screws intact.</p> <p>Brass bun knobs operating latch. Allow for overhaul or replacement. All screws missing from rose backplate on G4 face.</p> <p>Keyhole (no escutcheons) to operate deadlock alongside knob latch.</p> <p>Separate union deadlock, operated by Key (brass escutcheons to both sides) at higher level in s/s finish.</p> <p>Redundant lock higher up on door (see photo), no keep exists for this lock.</p> <p>Overhead closer- old type Briton C in painted silver/grey colour.</p> <p>Magnetic hold open device fitted to bottom of leaf which is bracketed off floor.</p> <p><b>Proposed:</b></p> <p>Remove redundant lock and make good joinery and fixing positions.</p> <p>Remove existing magnetic hold open device and all redundant services to this location. Remove existing overhead closer and make good fixing positions to joinery. Supply and install new combined overhead closer and hold open device linked to the fire alarm system. <i>Note: Location of magnetic release button is to be agreed on site.</i></p> <p>All remaining ironmongery to be assessed and removed if redundant or overhauled /replaced as necessary.</p> <p>Supply and fix new 76mm dia. 'Automatic fire door keep clear' signage in polished brass finish to both faces of door leaf.</p> |

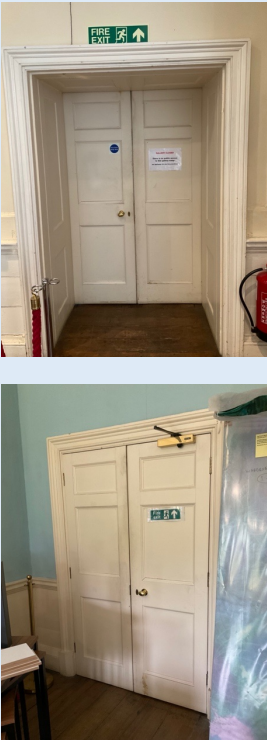
| Door ref. | Room ref. | Photos | Door Size | Min. Panel Thickness | Description of existing door | Notes/Existing condition | Fire Resistance Required (Aspirational requirement) | Proposed Works | Ironmongery |
|---|---|---|---|---|---|---|---|---|---|
| G6.Do6 | G6<br>EAST WING<br>GALLERY | | 2 no. leafs<br>627 x 2008<br>x 53mm | 17mm | Replacement door leaf.<br><br>Pair of 3 panelled doors, flat panels with beading and rebated meeting stiles.<br><br>Door reveals and head are also timber panelled. | Leading leaf has intumescent seal to hinge stile (section between bottom and mid hinge is missing). No seal to top (rebate for seal exists). No seal (or rebate) to closing edge.<br><br>Slave leaf has intumescent seal to hinge stile (section between bottom and mid hinge is missing). No seal to top (rebate for seal exists). Closing stile has intumescent seal (section missing between lock and lower bolt).<br><br>Gap at bottom approx. 12mm. | FD30S | <b>Repairs to door leaf/frame/reveals:</b><br><br><b>Existing doors are to be retained.</b><br><br>Carefully remove existing timber linings to the reveals, head and door threshold and install PFC Corofil CW mineral fibre insulation slabs to voids, fixed in place using CW galvanised steel retaining brackets in accordance with manufacturers details and recommendations. Reinstate timber linings in full and redecorate.<br><br>Allow for removal of redundant ironmongery and for timber piece repairs/making good to leaf/frame/architrave as necessary (include for filling any gaps from items which have previously been removed).<br><br>Allow for any adjustments to both leafs to ensure that doors fit well into the frame all round and they latch closed.<br><br>Carry out minor repairs to door leaf and plant hardwood lipping onto underside of both leafs to reduce the threshold gap between doors and floor to max. 10mm.<br><br>Prepare and redecorate all in a satinwood finish.<br><br>Allow for fire stopping any penetrations through frame with a suitable intumescent product.<br><br><b>Upgrade works to door leaf:</b><br><br>Allow for carrying out intumescent paint upgrade to both leafs. Paint to be applied to both faces of the doors. <b>Refer to Fig. 1.0 in Appendix A of this document for details of intumescent paint system..</b> Door leaf to be finished with top coat of satinwood. Application to be in full accordance with Envirograf details and specification.<br><br>Allow for removal and replacement of existing intumescent seals (sides and head) to take a new combined fire and smoke seals (include for additional routing out as necessary to take new seals) -<br><br>Head: 1no 10x4mm Lorient Lp1004DS (white)<br><br>Jambs: 1no 10x4mm Lorient Lp1004DS (white)<br><br><u>NOTE:</u> Fire and smoke seals must not be painted. | <b>Existing:</b><br><br>3 no. brass hinges to each leaf, all screws present.<br><br>Leading leaf has oval brass knobs, brass escutcheons, and a deadlock.<br><br>Additional arm at head of leading leaf- to hold open?<br><br>Leading leaf has Briton 2005 S overhead door closer in brass finish.<br><br>Slave leaf has top and bottom recessed bolts fitted in door edge.<br><br><b>Proposed:</b><br><br>Remove existing overhead closer and make good fixing positions to joinery. Supply and install new combined overhead closer and hold open device linked to the fire alarm system to each leaf. <i>Note: Location of magnetic release button is to be agreed on site.</i><br><br>All remaining ironmongery to be assessed and removed if redundant or overhauled as necessary.<br><br>Supply and fix new 76mm dia. 'Automatic fire door keep clear' signage in polished brass finish to both faces of each door leaf. |

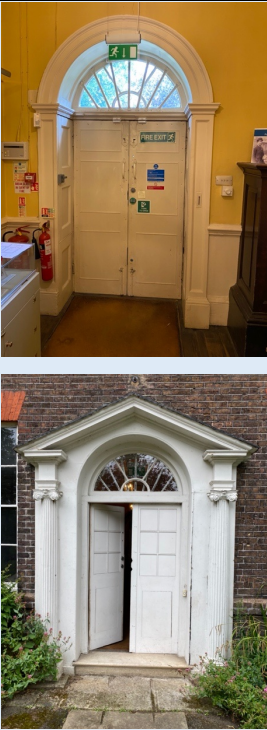
| Door ref. | Room ref. | Photos | Door Size | Min. Panel Thickness | Description of existing door | Notes/Existing condition | Fire Resistance Required (Aspirational requirement) | Proposed Works | Ironmongery |
|---|---|---|---|---|---|---|---|---|---|
| G7.Do1 | G7<br>EXTERNAL<br>ESCAPE | | 2no leafs<br>585 x 1950 x 44mm | N/A | <p>Pair of existing external doors with arched glazed fanlight over. Doors</p> <p>Internally the doors have painted sheet metal panels fixed over internal faces with applied beading to give the impression of 3 panelled doors.</p> <p>Externally the doors appear to have originally been 2 panel with glazed upper panels (2 x 3 panes) which have been infilled with timber panels. Lower panel is almost flush with stiles / rails.</p> <p>Painted metal plate also located (full height) along closing edge of 1no door leaf as security feature.</p> | <p>Difficult to determine approximate age of these doors.</p> <p>These doors have numerous locks and bolts which shouldn't be present on emergency exit doors <b>UNLESS</b> there is a clear Management strategy in place for when the building is occupied.</p> | N/R | <p>Existing doors are to be removed and handed to the Employer.</p> <p>Existing frame is to be adapted to suit new outward opening single door leaf in accordance with drawing no: 7440-260.</p> | <p><b>Existing:</b></p> <p>2no. hinges to each leaf.</p> <p>Leading leaf has 3no deadlocks, 1no emergency exit 'Turn to open' lock, 1no painted pull handle, top and bottom bolts, 3no escutcheons and a peephole viewer.</p> <p>Slave leaf has 1no painted pull handle and top and bottom bolts.</p> <p>Existing bolts to top of each leaf appear to be original and are quite decorative.</p> <p><b>Proposed:</b></p> <p>New escape hardware is to be provided on these doors and agreed with the Fire Officer / Building Control.</p> |

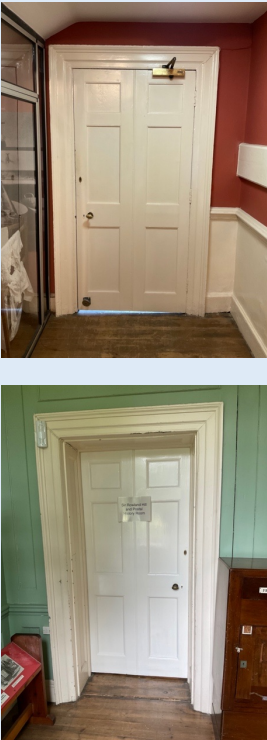
| Door ref. | Room ref. | Photos | Door Size | Min. Panel Thickness | Description of existing door | Notes/Existing condition | Fire Resistance Required (Aspirational requirement) | Proposed Works | Ironmongery |
|---|---|---|---|---|---|---|---|---|---|
| G9.Do1 | G9<br>POSTAL HISTORY | | 977 x 2085 x 55mm | 15mm | <p>Appears to be historic door leaf.</p> <p>6 panel leaf, flat panels with beading to edges. Door reveals and head are also timber panelled.</p> <p>Appears to have been upgraded (panels) previously. Stops to room face aren't original.</p> <p>Frame stops have been added to – Assumed as part of previous upgrade.</p> <p>Gap at base of door varies between 20-25mm.</p> <p>Minimum panel thickness = 15mm (this includes previous upgrade). Original panel thickness assumed to be 7mm.</p> | <p>Some minor splitting exists to mid rail on room side of door.</p> <p>Intumescent seals exist to both edges and the top of the door, the seals to the side edges have all been painted over and require replacement.</p> | FD30S | <p><b>Repairs to door leaf/frame/reveals:</b></p> <p><b>Existing door to be retained.</b></p> <p>Carefully remove existing timber linings to the reveals, head and door threshold and install PFC Corofil CW mineral fibre insulation slabs to voids, fixed in place using CW galvanised steel retaining brackets in accordance with manufacturers details and recommendations. Reinstate timber linings in full and redecorate.</p> <p>Allow for removal of redundant ironmongery and for timber piece repairs/making good to leaf/frame/architrave as necessary (include for filling any gaps from items which have previously been removed).</p> <p>Allow for any adjustments to leaf to ensure that door fits well into the frame all round and it latches closed.</p> <p>Carry out minor repairs to door leaf and plant hardwood lipping onto underside of leaf to reduce the threshold gap between door and floor to max. 10mm.</p> <p>Prepare and redecorate all in a satinwood finish.</p> <p>Allow for fire stopping any penetrations through frame with a suitable intumescent product.</p> <p><b>Upgrade works to door leaf:</b></p> <p>Allow for carrying out intumescent paint upgrade to both leafs. Paint to be applied to both faces of the door. <b>Refer to Fig. 1.0 in Appendix A of this document for details of intumescent paint system.</b> Door leaf to be finished with top coat of satinwood. Application to be in full accordance with Envirograf details and specification.</p> <p>Allow for removal and replacement of existing intumescent seals (sides and head) to take a new combined fire and smoke seals (include for additional routing out as necessary to take new seals) -</p> <p>Head: 1no 10x4mm Lorient Lp1004DS (white)</p> <p>Jambs: 1no 10x4mm Lorient Lp1004DS (white)</p> <p><u>NOTE:</u> Fire and smoke seals must not be painted.</p> | <p><b>Existing:</b></p> <p>3 hinges all painted out, 1no. screw is missing from bottom hinge plate. Hinges appear to be original- size is approx. 110x30mm.</p> <p>Oval, brass knobs, G10 side has no screw fixings to rose. Both knobs require overhaul or replacement.</p> <p>Knobs operate latch, which also has a deadbolt facility with 2no. escutcheons – painted over on each face.</p> <p>Chubb 5 lever Mortice lock in satin, stainless-steel finish with 2no. oval escutcheons in a brass finish.</p> <p>Overhead closer – Britain 2002 S brass finish – closes well into frame.</p> <p>Magnetic hold open device fitted to the bottom of leaf which his bracketed off the floor.</p> <p><b>Proposed:</b></p> <p>All ironmongery to be assessed and removed if redundant or overhauled as necessary.</p> <p>Remove existing magnetic hold open device and all redundant services and fixings to this location. Remove existing overhead closer and make good fixing positions. Supply and install new combined overhead closer and hold open device linked to the fire alarm system. <i>Note: Location of magnetic release button to be agreed on site</i></p> <p>Supply and fix new 76mm dia. 'Automatic fire door keep clear' signage in polished brass finish to both faces of door leaf.</p> |

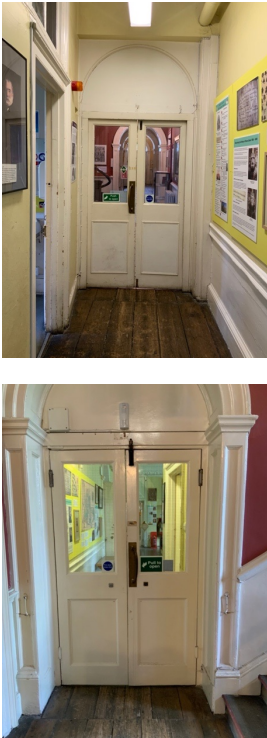
| Door ref. | Room ref. | Photos | Door Size | Min. Panel Thickness | Description of existing door | Notes/Existing condition | Fire Resistance Required (Aspirational requirement) | Proposed Works | Ironmongery |
|---|---|---|---|---|---|---|---|---|---|
| G10.Do1 | G10 | | 590 x 1990 x 45mm<br>(2 leaves) | Unknown | <p>Pair of 2 panel doors, upper panel is Georgian wired glazed, remaining panels are flush with beaded surrounds. Panels to G12 face have been previously upgraded (assumed for fire).</p> <p>Head and side reveals on G10 face are timber lined with raised and fielded panels.</p> <p>Opening is arched on G10 face, with arched infill panel above doors.</p> | <p>Doors are held open generally on cabin hooks but when released they snap closed and are a Health and Safety Risk, they also do not close together fully.</p> <p>Services penetrations through frame and head panel.</p> <p>No fire and smoke seals.</p> | FD30S | <p><b>Repairs to door leaf/frame/reveals/head panel:</b></p> <p>Existing doors are to be retained.</p> <p>Carefully remove existing timber linings to the reveals, head and door threshold and install PFC Corofil CW mineral fibre insulation slabs to voids, fixed in place using CW galvanised steel retaining brackets in accordance with manufacturers details and recommendations. Carry out repairs as necessary to reveal linings and reinstate in full prior to redecoration.</p> <p>Carry out making good to any areas on the door leaves / frame and architraves which have been affected by previous fixings or ironmongery removal, allow also for piecing in new timber to any previous repairs which have been carried out using filler.</p> <p>Allow for removal of redundant ironmongery and for timber piece repairs/making good to leaf/frame/architrave as necessary (following removal).</p> <p>Allow for planting a hardwood lipping onto underside of leaf to reduce the threshold gap between door and floor.</p> <p>Prepare and redecorate all in a satinwood finish.</p> <p>Allow for fire stopping any penetrations through frame with a suitable intumescent product.</p> <p>Existing over panel is to be upgraded on G12 face to provide 30 minute fire resistance using 15mm Supalux board (or similar), in painted finish to match existing.</p> <p><b>Upgrade works to door leaves:</b></p> <p>Allow for carrying out intumescent paint upgrade to both door leaves. Paint to be applied to both faces of the leaf. <b>Refer to Fig. 1.0 in Appendix A of this document for details of intumescent paint system.</b> Door leaves to be finished with top coat of satinwood. Application to be in full accordance with Envirograf details and specification.</p> <p>Allow for routing out door leaf (sides and head) to take a new combined fire and smoke seal -</p> <p>Head: 1no 15x4mm Lorient LP1504DS (white)</p> <p>Jambs: 1no 15x4mm Lorient LP1504DS (white)</p> <p>Meeting Stile (1no leaf only) : 1no 10x4mm Lorient LP1004 and 1no 10x4mm Lorient LP100DS (white)</p> <p><u>NOTE:</u> Fire and smoke seals must not be painted.</p> | <p><b>Existing:</b></p> <p>2 no large hinges per leaf (self closing)</p> <p>Sliding bolt to head and base of one leaf.</p> <p>Brass pull handle with back plate to each side of right hand leaf (viewed from G10).</p> <p>Door retainer (?) to head of right hand leaf (viewed from G10).</p> <p>Cabin hook and eye to each leaf on G10 face.</p> <p><b>Proposed:</b></p> <p>Existing hinges to be removed, make good door leaves / frame as necessary and replace with 3no fire rated brass hinges per leaf.</p> <p>Remove existing cabin hooks and make good fixing positions to joinery on both door leaves and reveal linings.</p> <p>Remove sliding bolts and door retainer and make good fixing positions to joinery and frame.</p> <p><b>Allow for supply and fix of new Dorguard Smartsound Fire door retainers to base of each door leaf to enable doors to be held open when room is in use and close upon activation of the fire alarm.</b></p> <p>Supply and fix new 76mm dia. 'Automatic fire door keep clear' signage in polished brass finish to both faces of each door leaf.</p> |

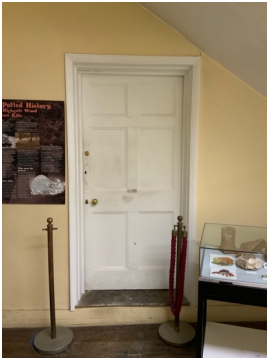
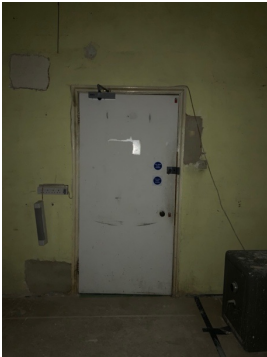
| Door ref. | Room ref. | Photos | Door Size | Min. Panel Thickness | Description of existing door | Notes/Existing condition | Fire Resistance Required (Aspirational requirement) | Proposed Works | Ironmongery |
|---|---|---|---|---|---|---|---|---|---|
| G13.Do1 | G13 | <div></div> | 960 x 2200 x 55mm | Unknown | 6 panel door, panels are flat with beaded surround to panels. G13 face has been overboarded with a flush panel (previous fire upgrade?) | <u>Note:</u> Panel to reverse of leaf contains asbestos (sticker fixed to leaf) | FD3oS | <p><b>Repairs to door leaf / frame and architrave:</b></p> <p>Existing door leaf to be retained.</p> <p>Carefully remove existing timber linings to the reveals, head and threshold and install PFC Corofil CW mineral fibre insulation slabs to voids, fixed in place using CW galvanised steel retaining brackets in accordance with manufacturers details and recommendations. Carry out repairs as necessary to reveal linings and reinstate in full prior to redecoration. Allow for fire stopping any penetrations through frame with a suitable intumescent product.</p> <p>Allow for removal of redundant ironmongery and for timber piece repairs/making good to leaf/frame/architrave as necessary (following removal). Carry out minor repairs to door leaf and plant hardwood lipping onto underside of leaf to reduce the threshold gap between door and floor.</p> <p>Allow for removal of redundant ironmongery and for timber piece repairs/making good to leaf/frame/architrave as necessary (following removal).</p> <p>Prepare and redecorate all in a satinwood finish.</p> <p>Ensure that door leaf fits well into the frame all round and that it latches closed.</p> <p><b>Upgrade works to door leaf:</b></p> <p>Allow for removal and disposal of Asbestos panel (under all necessary licences and in controlled conditions) prior to carrying out intumescent paint and card upgrade to this door leaf. Paint to be applied to both faces of the leaf, card to room face only. <b>Refer to Fig. 1.0 in Appendix A of this document for details of intumescent paint system.</b> Door leaf to be finished with top coat of satinwood. Application to be in full accordance with Envirograf details and specification.</p> <p>Allow for routing out door leaf (sides and head) to take a new combined fire and smoke seal -</p> <p>Head: 1no 15x4mm Lorient Lp15o4DS (white)</p> <p>Jambs: 1no 15x4mm Lorient Lp15o4DS (white)</p> <p><u>NOTE:</u> Fire and smoke seals must not be painted.</p> | <p><b>Existing:</b></p> <p>2 no hinges, painted.</p> <p>Pair of brass bun knobs operating horizontal mortice latch / lock. Asbestos sticker also placed over keyhole position on S13 face, with covered brass escutcheon to S13A face.</p> <p>Redundant deadlock – unsure if lock still exists.</p> <p>Rim nightlatch / lock with round brass escutcheon to S13A face and nightlatch fitting to S13 face in grey / black finish.</p> <p>Modern Briton overhead door closer to S13 face in silver / grey finish.</p> <p><b>Proposed:</b></p> <p>Existing hinges to be removed, make good door leaf / frame as necessary and replace with 3no fire rated hinges.</p> <p>Allow for removal of redundant deadlock casing (if this still exists) from door / frame edge.</p> <p>Remaining ironmongery to be assessed and removed if redundant or overhauled as necessary.</p> <p>Supply and fix new 76mm dia. 'Fire door keep shut' signage in polished brass finish to both faces of door leaf.</p> |

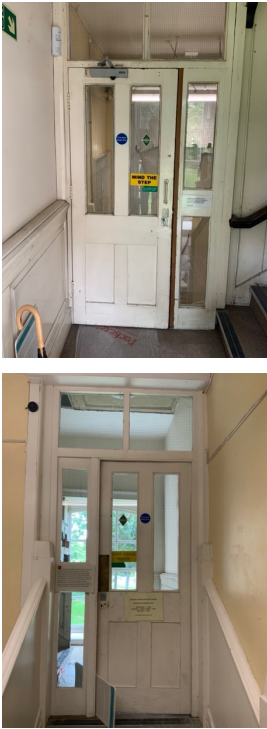
| Door ref. | Room ref. | Photos | Door Size | Min. Panel Thickness | Description of existing door | Notes/Existing condition | Fire Resistance Required (Aspirational requirement) | Proposed Works | Ironmongery |
|---|---|---|---|---|---|---|---|---|---|
| G13A.Do1 | G13A | | 755 x 1965 x 40mm | Unknown | Modern 4 panel door set within modern glazed screen. Glazing is GWG, door has flat panels with square shoulders. | | Not required | Allow for complete removal of the door and associated screen and for any making good works as required to adjacent surfaces and finishes. | |

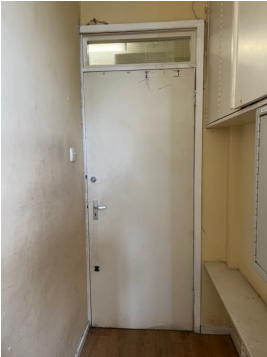
| Door ref. | Room ref. | Photos | Door Size | Min. Panel Thickness | Description of existing door | Notes/Existing condition | Fire Resistance Required (Aspirational requirement) | Proposed Works | Ironmongery |
|---|---|---|---|---|---|---|---|---|---|
| G14.Do2 | G14 | | 800 x 1980 x 44 mm | N/A | Modern flush door leaf with Georgian wired glazed fanlight above. | Existing door is held open on a cabin hook | FD30S | <p><b>New door leaf / repairs to frame:</b></p> <p>Existing door leaf is to be removed and replaced with new FD30S flush fire door with 150x760mm rectangular glass pane, primed for painting on site. Door leaf to incorporate fire and smoke seals.</p> <p>Allow for timber piece repairs/making good to frame and architrave as necessary (following removal of existing door leaf and associated ironmongery).</p> <p>Prepare and redecorate all in a satinwood finish.</p> | <p><b>Existing:</b></p> <p>2 no hinges, painted.</p> <p>Pair of SAA lever handles operating mortice latch / lock.</p> <p>SAA Deadlock with thumbturn release.</p> <p>Black cabin hook.</p> <p><b>New Ironmongery:</b></p> <p>Allow for supply and fix of 3no new fire rated S/S hinges.</p> <p>Allow for supply and fix of 1no pair SAA lever handles with round rose back plate and suitable latch.</p> <p>Allow for supply and fix of new SAA deadlock with thumbturn release.</p> <p>Supply and install new SAA overhead door closer.</p> <p>Allow for supply and fix of new Dorguard Smartsound Fire door retainer to base of door leaf to enable door to be held open when room is in use and close upon activation of the fire alarm.</p> <p>Supply and fix new 76mm dia. 'Automatic fire door keep clear' signage in S/S finish to both faces of door leaf.</p> |

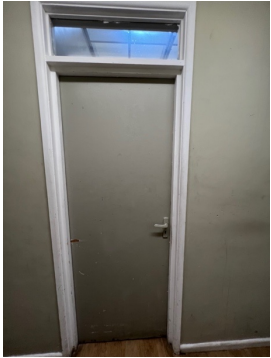
| Door ref. | Room ref. | Photos | Door Size | Min. Panel Thickness | Description of existing door | Notes/Existing condition | Fire Resistance Required (Aspirational requirement) | Proposed Works | Ironmongery |
|---|---|---|---|---|---|---|---|---|---|
| G14.D09 | G14E | | 760 x 1980 x 44 mm | N/A | Modern flush door leaf with Georgian wired glazed fanlight above. | | FD30S | <p><b>New door leaf / repairs to frame:</b></p> <p>Existing door leaf is to be removed and replaced with new FD30S flush fire door, primed for painting on site. Door leaf to incorporate fire and smoke seals.</p> <p>Allow for timber piece repairs/making good to frame and architrave as necessary (following removal of existing door leaf and associated ironmongery).</p> <p>Prepare and redecorate all in a satinwood finish.</p> | <p><b>Existing:</b></p> <p>Assume 2 no hinges, painted.</p> <p>Pair of SAA lever handles operating mortice latch / lock.</p> <p><b>New Ironmongery:</b></p> <p>Allow for supply and fix of 3no new fire rated S/S hinges.</p> <p>Allow for supply and fix of 1no pair SAA lever handles with round rose back plate and suitable latch.</p> <p>Allow for supply and fix of new SAA deadlock with thumbturn release.</p> <p>Supply and install new SAA overhead door closer.</p> <p><del>Allow for supply and fix of new Dorguard Smartsound Fire door retainer to base of door leaf to enable door to be held open when room is in use and close upon activation of the fire alarm.</del></p> <p>Supply and fix new 76mm dia. 'Automatic fire door keep shut' signage in S/S finish to both faces of door leaf.</p> |

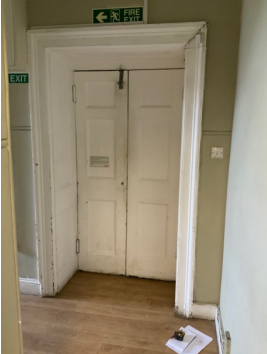
| Door ref. | Room ref. | Photos | Door Size | Min. Panel Thickness | Description of existing door | Notes/Existing condition | Fire Resistance Required (Aspirational requirement) | Proposed Works | Ironmongery |
|---|---|---|---|---|---|---|---|---|---|
| G16.Do1 | G16<br>LECTURE<br>HALL | | 510 x 2030 x 45mm<br>(2 leaf) | Unknown | <p>Pair of 3 panelled doors, flat panels with beading. Assume that meeting stiles are not rebated.</p> <p>Door reveals and head are also timber panelled.</p> | <p>Doors were locked during inspection, condition appears to be ok.</p> <p>Services penetrations through frame and head.</p> | FD30S | <p><b>Repairs to door leaf/frame/reveals/head panel:</b></p> <p>Existing doors are to be retained.</p> <p>Carefully remove existing timber linings to the reveals, head and door threshold and install PFC Corofil CW mineral fibre insulation slabs to voids, fixed in place using CW galvanised steel retaining brackets in accordance with manufacturers details and recommendations. Carry out repairs as necessary to reveal linings and reinstate in full prior to redecoration.</p> <p>Carry out making good to any areas on the door leafs / frame and architraves which have been affected by previous fixings or ironmongery removal, allow also for piecing in new timber to any previous repairs which have been carried out using filler.</p> <p>Allow for removal of redundant ironmongery and for timber piece repairs/making good to leaf/frame/architrave as necessary (following removal).</p> <p>Prepare and redecorate all in a satinwood finish.</p> <p>Ensure that doors fit well into the frame all round and that they close together adequately.</p> <p>Allow for fire stopping any penetrations through frame with a suitable intumescent product.</p> <p><b>Upgrade works to door leafs:</b></p> <p>Allow for carrying out intumescent paint upgrade to both door leafs. Paint to be applied to both faces of the leaf. <b>Refer to Fig. 1.0 in Appendix A of this document for details of intumescent paint system.</b> Door leafs to be finished with top coat of satinwood. Application to be in full accordance with Envirograf details and specification.</p> <p>Allow for routing out door leaf (sides and head) to take a new combined fire and smoke seal -</p> <p>Head: 1no 15x4mm Lorient LP1504DS (white)</p> <p>Jambs: 1no 15x4mm Lorient LP1504DS (white)</p> <p>Meeting Stile (1no leaf only) : 1no 10x4mm Lorient LP1004 and 1no 10x4mm Lorient LP100DS (white)</p> <p><u>NOTE:</u> Fire and smoke seals must not be painted.</p> | <p><b>Existing:</b></p> <p>2 no large hinges, painted.</p> <p>Deadlock with SAA escutcheon.</p> <p>1no large sliding bolt to head of door leaf.</p> <p><b>New Ironmongery:</b></p> <p>Allow for supply and fix of 3no new fire rated S/S hinges.</p> <p>Allow for supply and fix of 2no new SAA finger plates to G15 face of doors with 2no SAA pull handles to room face.</p> <p>Allow for supply and fix of new SAA deadlock with thumbturn release.</p> <p>Supply and install 2no new SAA overhead door closers.</p> <p>Allow for supply and fix of new Dorguard Smartsound Fire door retainers to base of both door leafs to enable doors to be held open when room is in use and close upon activation of the fire alarm.</p> <p>Supply and fix new 76mm dia. 'Automatic fire door keep clear' signage in S/S finish to both faces of door leaf.</p> |
