# Basement Impact Assessment

**69 Grove Avenue, N10 2AL**

**8 December 2023**

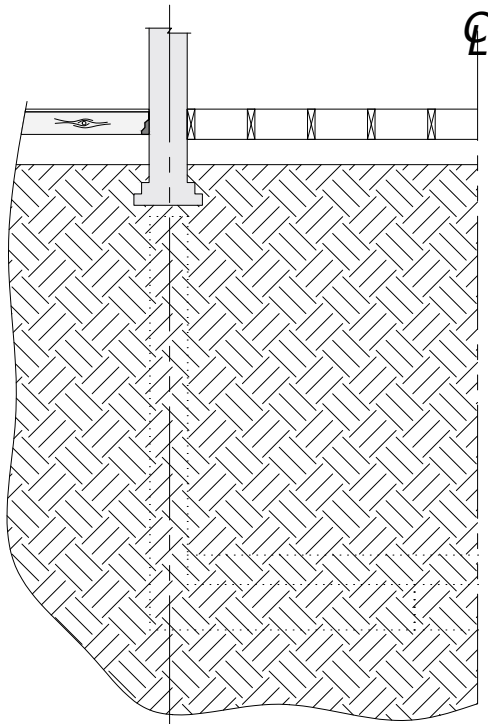
Existing - Before works commence

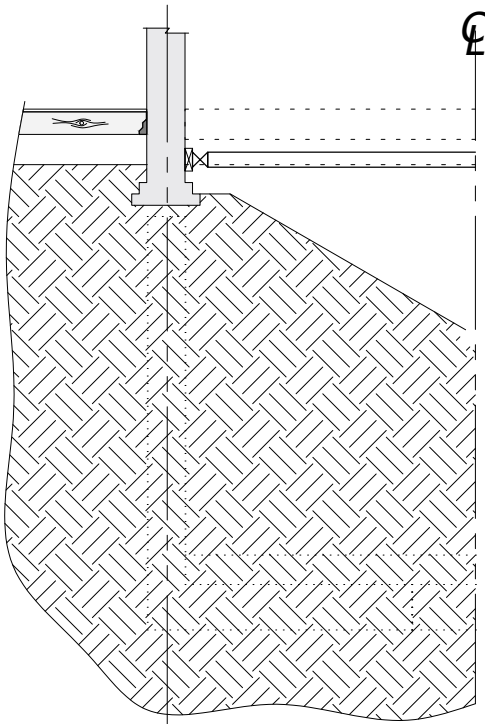
Stage 1 - Reduce ground levels generally throughout and install props between party walls

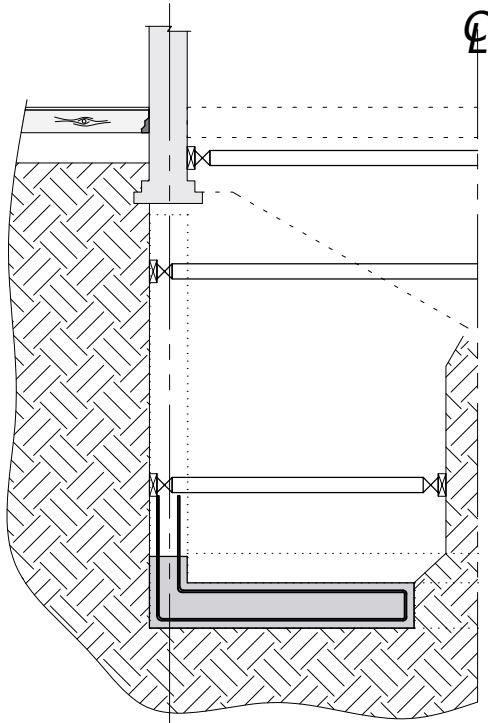
Stage 2 - Excavate to proposed founding depth. Prop any loose material as required. Pour base of retaining wall and form kicker

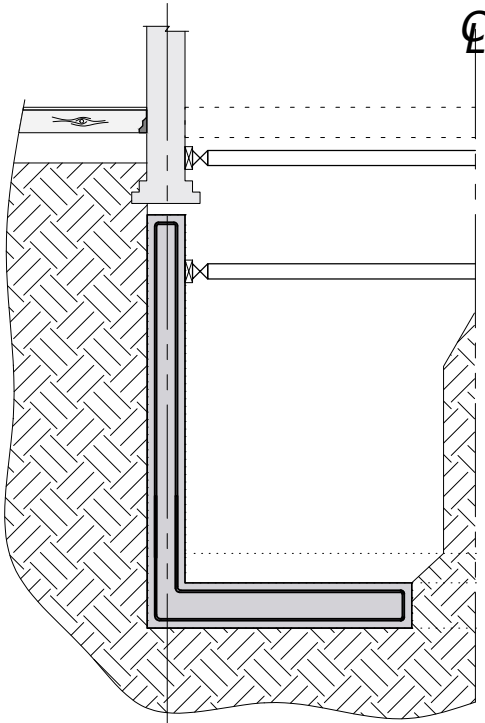
Stage 3 - Pour stem and prop retaining wall off adjacent pins or soil as appropriate

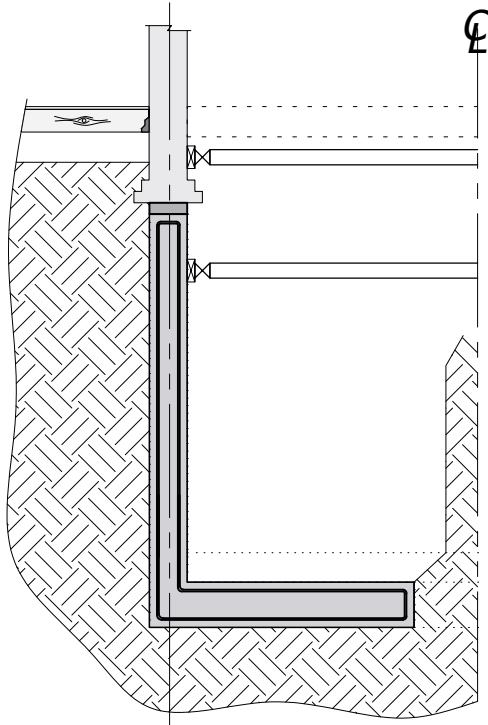
Stage 4 - Tightly dry pack between stem of underpin and underside of existing foundation. Repeat stages 2-4 for all pins

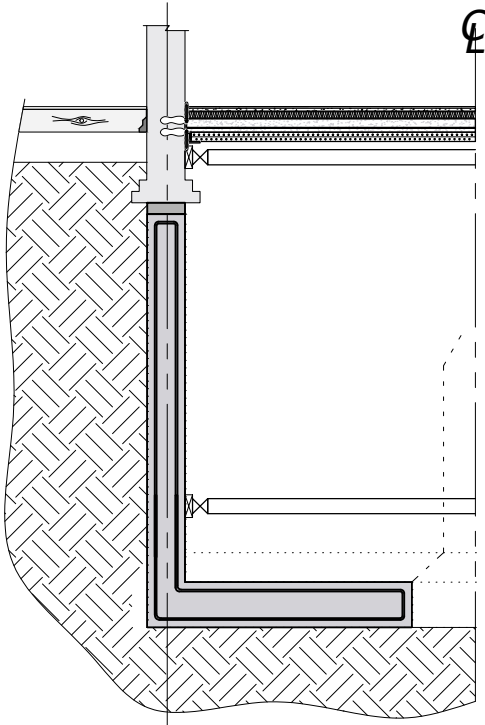
Stage 5 - Reduce level of central soil from front of property to back. Ground floor construction installed, lower props as excavation permits

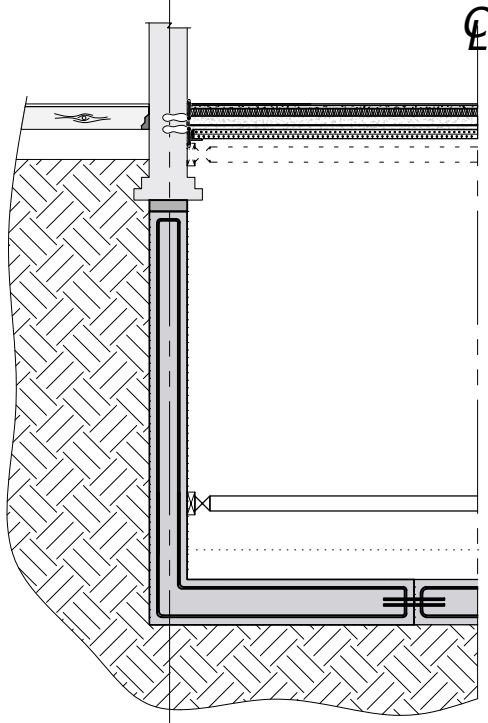
Stage 6 - Once levels fully reduced cast slab throughout with dowels into retaining pins, remove high level props

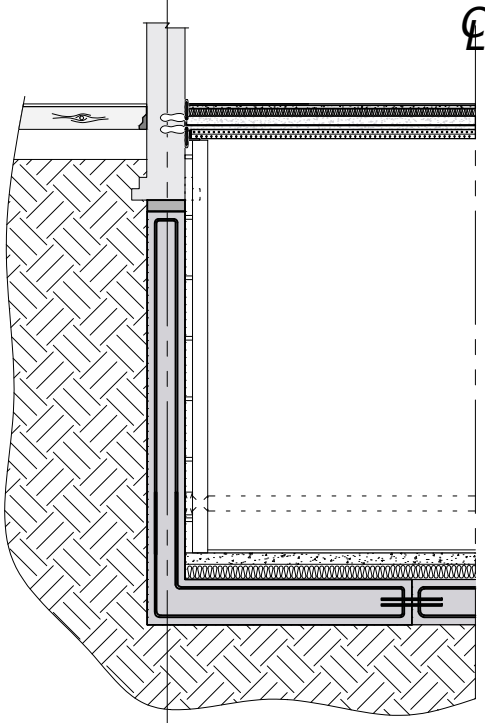
Stage 7 - Once all concrete has cured, remove remaining props and demolish any existing foundations projecting internally. Install waterproofing system, internal insulation, screed, etc. Basement structural works completed

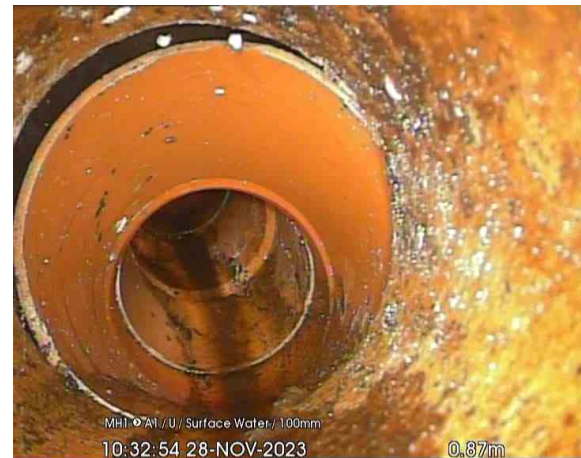
| Comments: | Displaced and open joint at 0.87m might cause leakage | | | | |

1-1-6A, 00:00:17, 0.87 m  
Open joint, medium

| Recommendations: | CIPP patch line open joint | | | | |

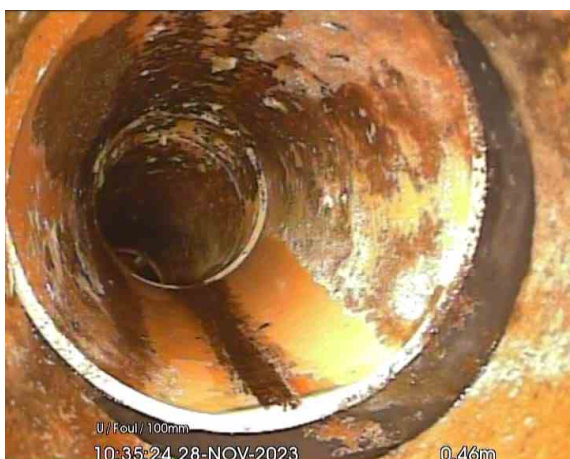
2-1-3A, 00:00:08, 0.14 m  
Joint displaced, medium

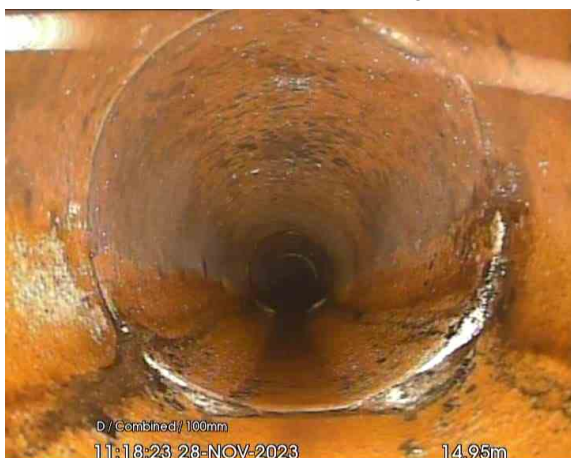
5-1-5A, 00:01:17, 8.23 m  
Crack, circumferential from 2 o'clock to 8 o'clock, Hairline  
crack

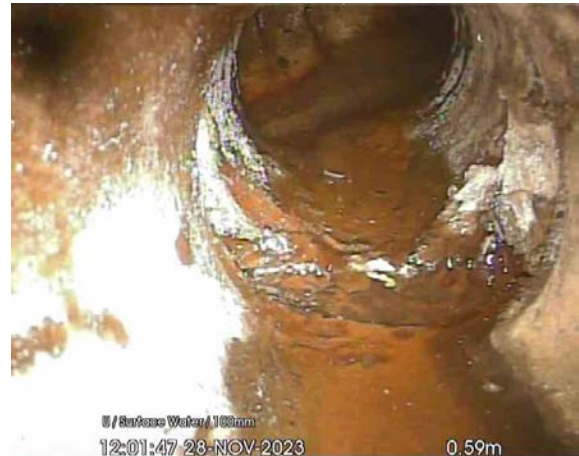
8-1-2A, 00:00:05, 0.14 m  
Joint displaced, medium

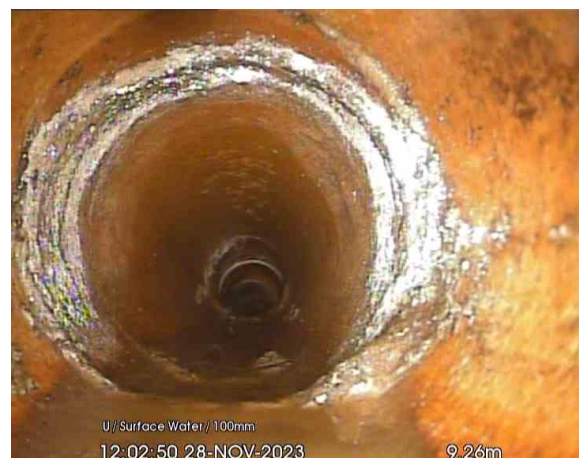
8-1-8A, 00:00:49, 6.13 m  
Attached deposits, other at joint from 3 o'clock to 5 o'clock,  
10% cross-sectional area loss, Jointing intrusions/scale

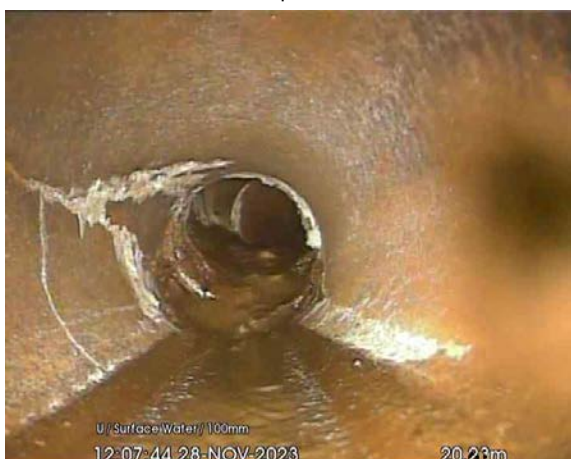
8-1-26A, 00:02:41, 19.71 m  
Joint displaced, medium

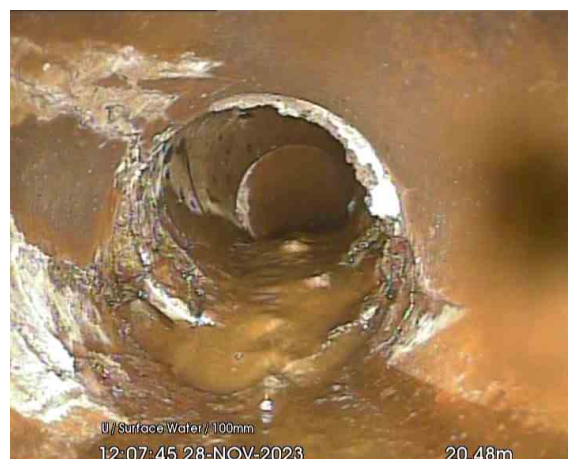
| Scale: | 1:96 | Position [m] | Code | Observation | MPEG | Photo | Grade | |
|---|---|---|---|---|---|---|---|---|
| | | <u>20.38</u> | F02 | CM | Cracks, multiple from 7 o'clock to 12 o'clock, finish | 00:02:46 | | 3 / 2 |

8-1-28A, 00:02:44, 20.23 m  
Cracks, multiple from 7 o'clock to 12 o'clock, start

| Recommendations: | Refer to Thames Water Utilities Limited if necessary | | | | |
