# GEOSHIELD Verification Report

PROJECT REFERENCE: GEO102491

REPORT NUMBER: 006

PROJECT: Blocks D3 & D4. Clarendon Road.

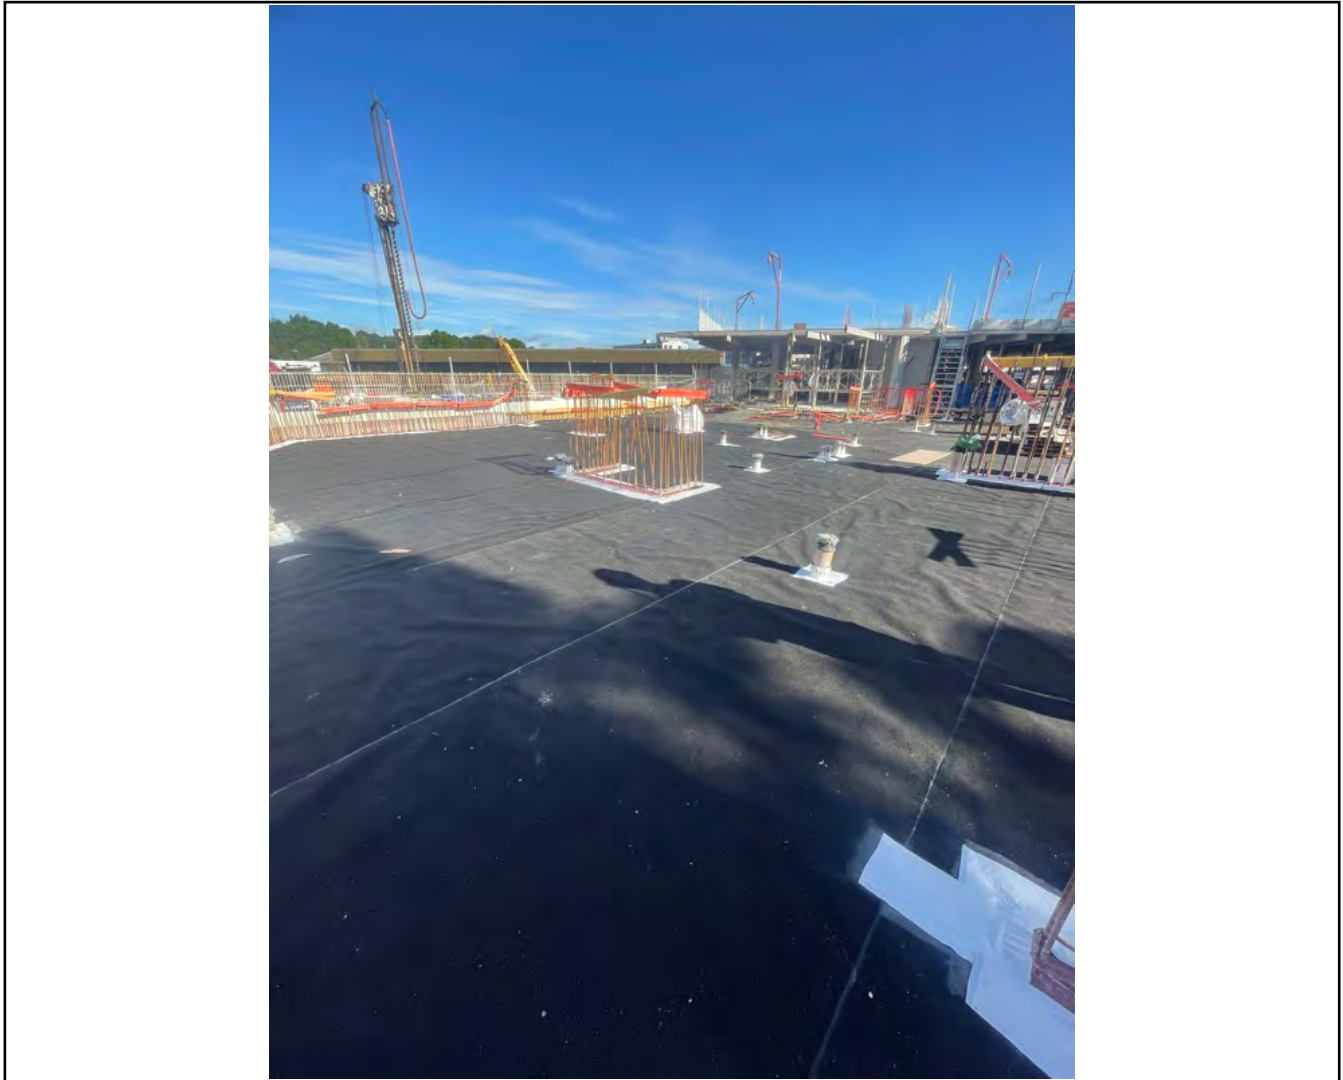
Overview photograph of the area verified during this visit.

Block D3 - GL's; D3-11/D3-17 - D3S/D3K final slab area.

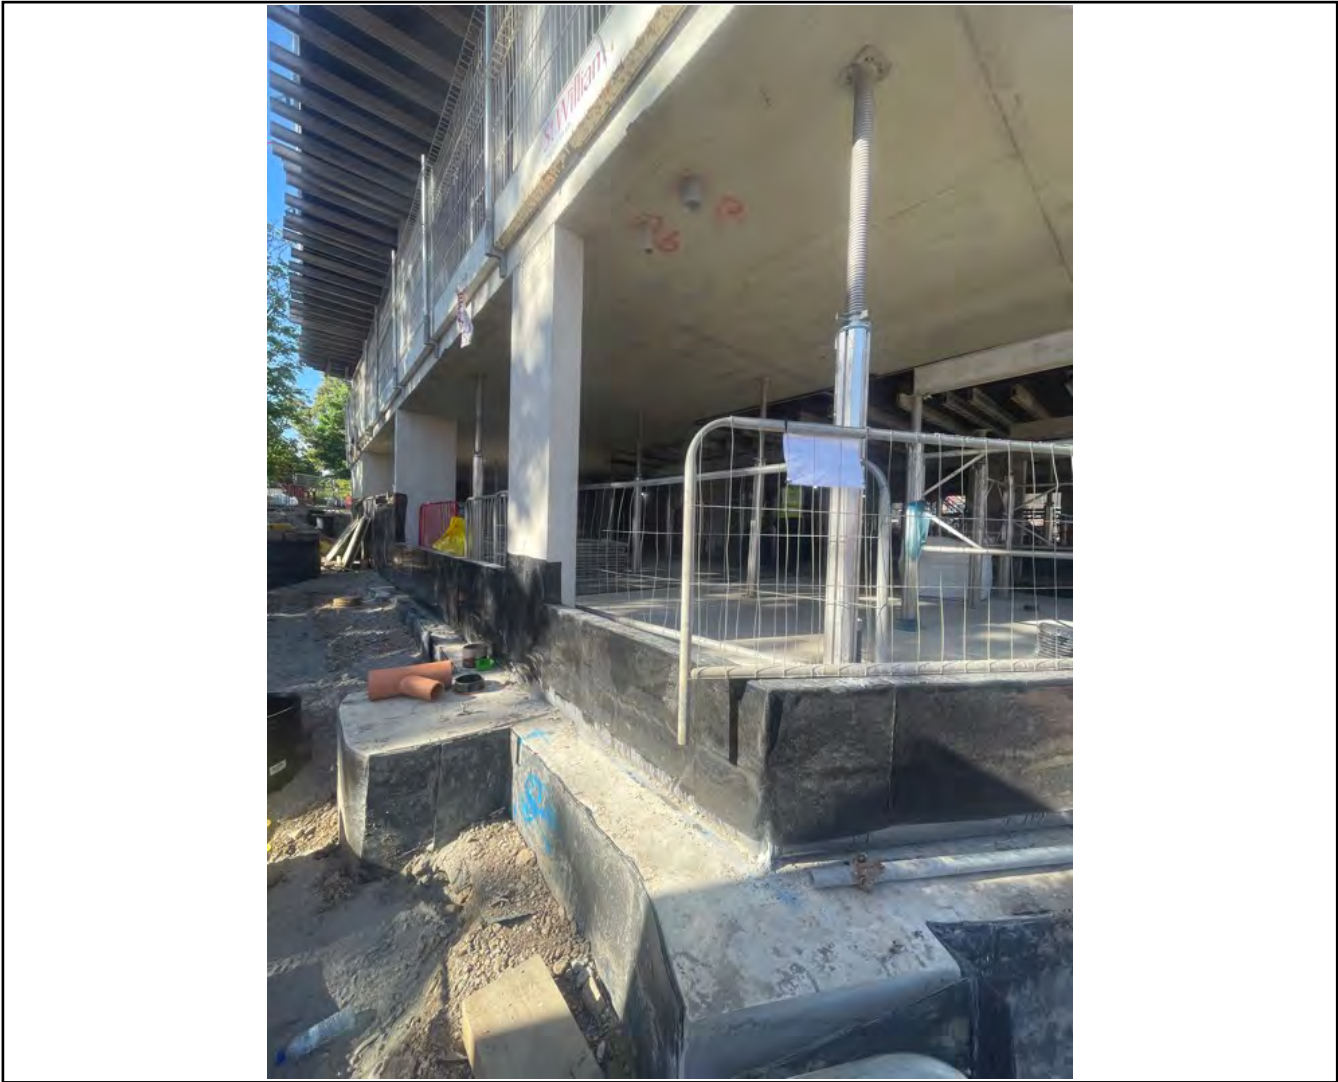
Overview photograph of the area verified during this visit.

Block D3 termination detailing.

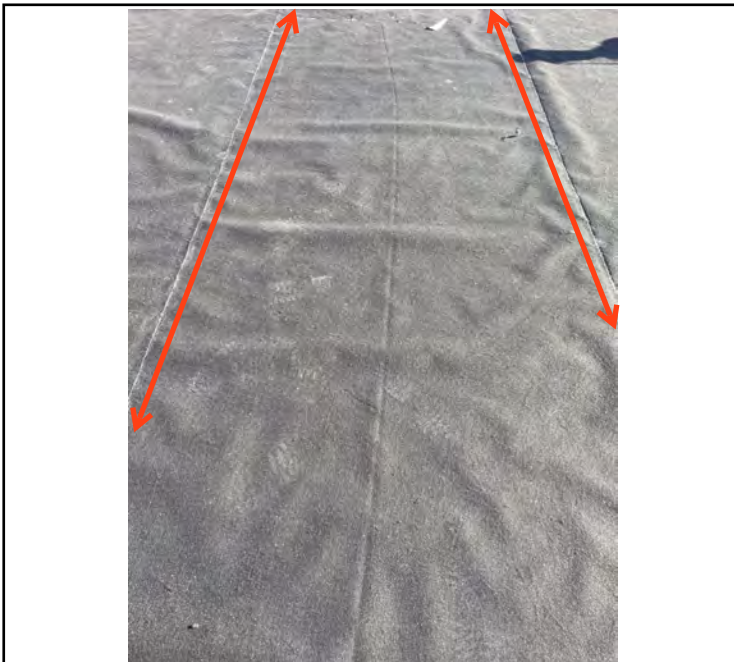
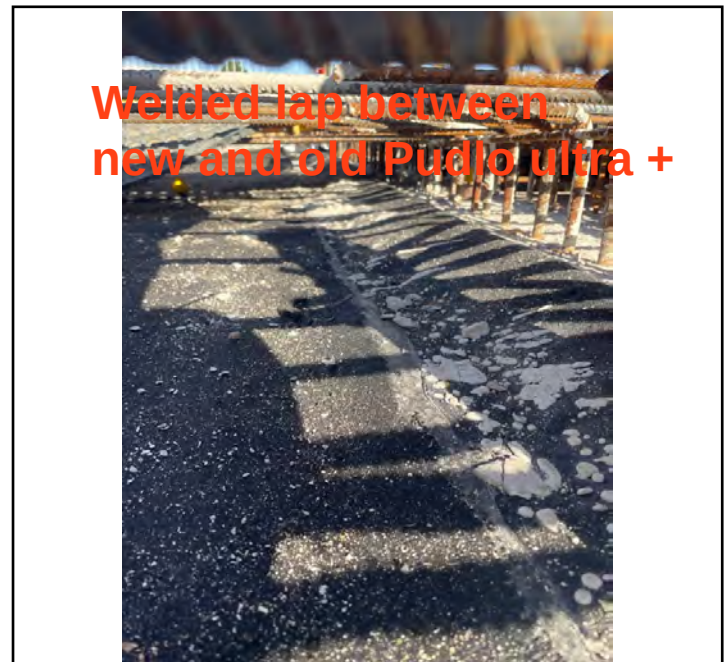
installation of Pudlo ultra + has been completed to the final slab area within Block D3. All overlaps have been welded in accordance to BS8485:2019 using a hot air tool & silicone roller. Like the other areas continuity has been achieved between the adjacent slab areas.

The exposed Pudlo ultra + membrane from the adjacent slab and/or core have been welded between new and old Pudlo ultra plus to create a consistent & continuous seal.

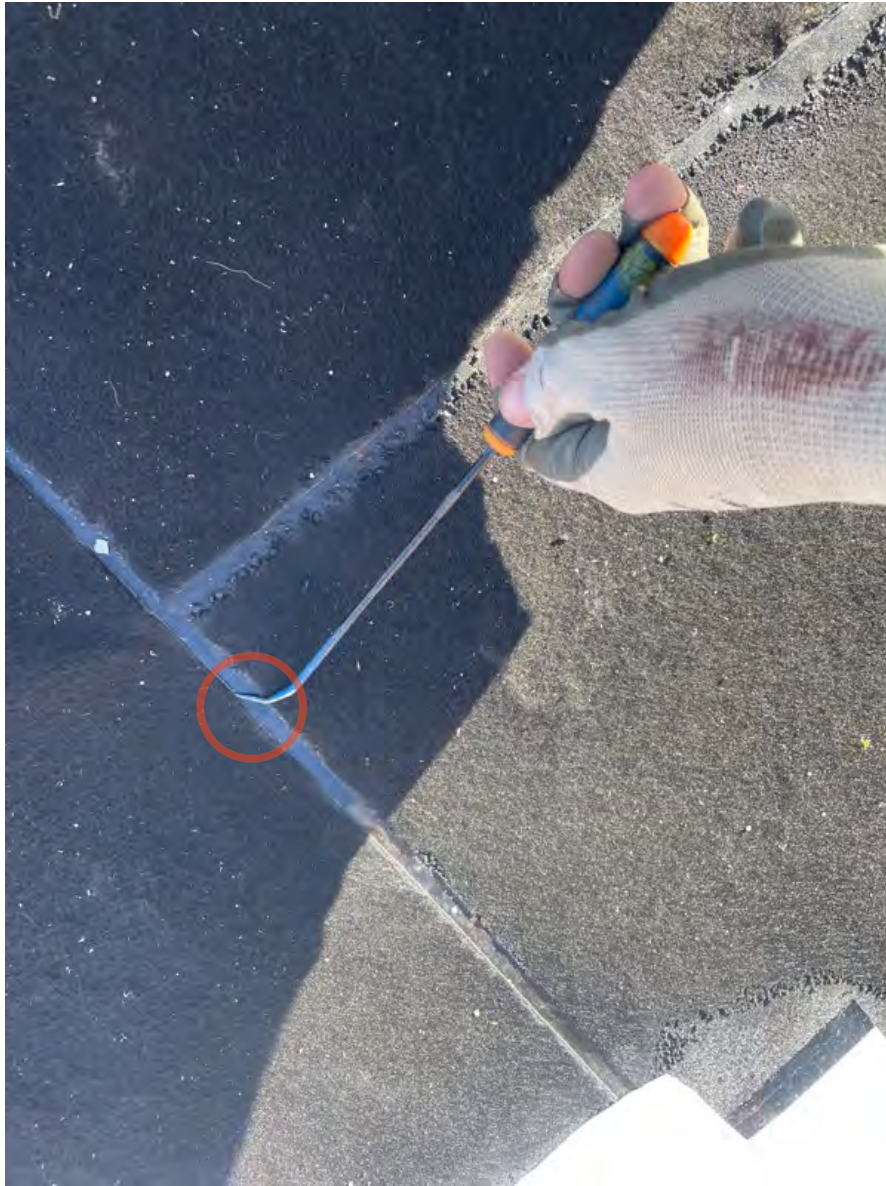
The above photograph displays a mechanical point stress test also known as a pick and probe test being conducted upon a welded lap joint. All overlaps have been a minimum of 100mm conforming to manufactures specification with all welds carried out on selvedged (fleece free) edges of Pudlo ultra plus. Verified in accordance with CIRIA 735.

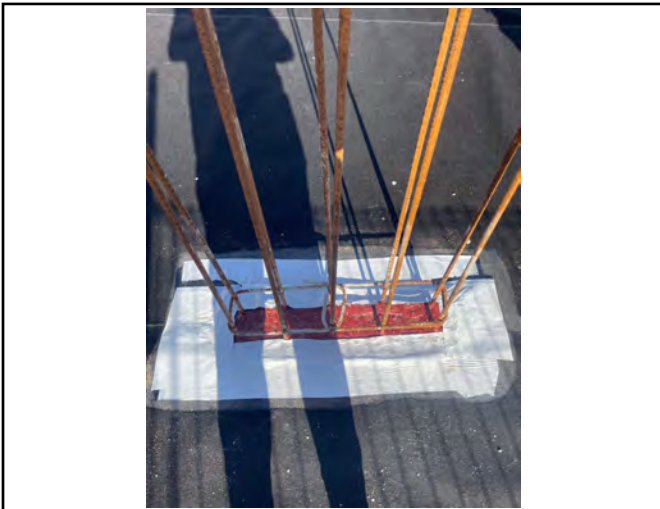
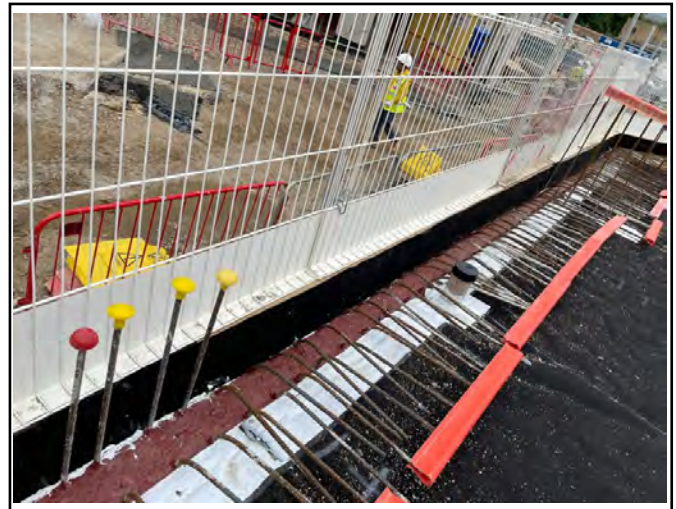
All pile caps and ground beams have received a thick coverage of Pudlo liquid GB and as per detail. Internal termination works have been achieved using Pudlo EXT tape lapping onto the Pudlo ultra plus and Pudlo liquid GB'ed areas as shown below.

Sufficient coverage of Pudlo liquid GB has been achieved with no areas of concrete visually exposed. The perimeter works around the temporary shuttering works has been achieved as per Pudlos section detail lapped 50mm minimum onto the beam and sealed using Pudlo surestop adhesive as per the detail.

Installation successfully carried out in accordance to manufactures specification.

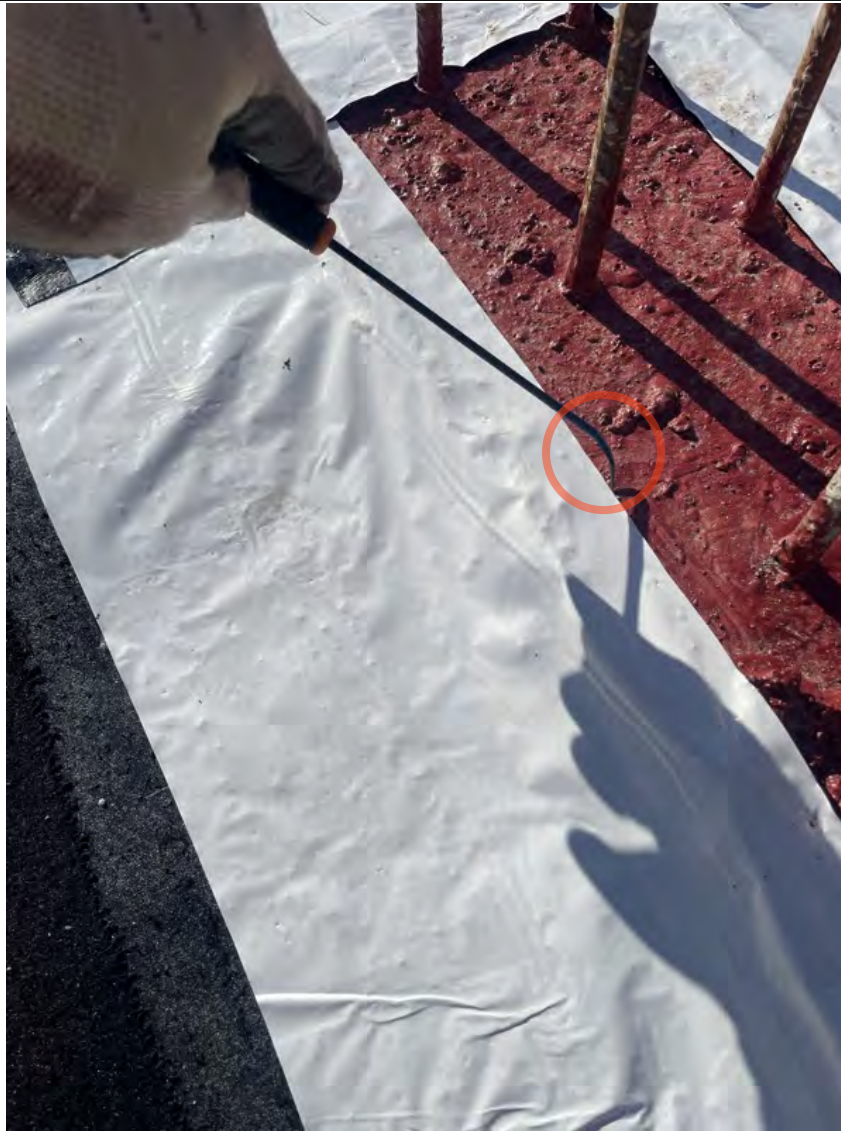
The above photograph displays a mechanical point stress test being conducted upon

a successfully sealed pile cap detail.

The Pudlo ultra EXT tape has successfully adhered upon the Pudlo liquid GB'ed

pile cap & onto the Pudlo ultra plus membrane. Verified in accordance with CIRIA 735.

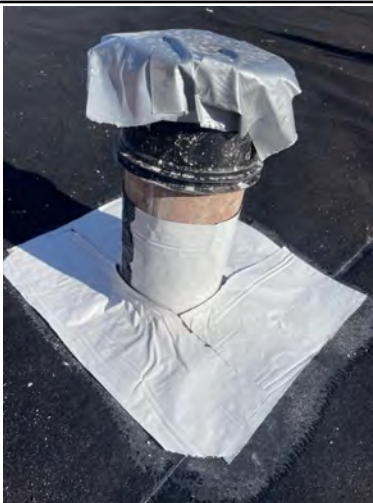
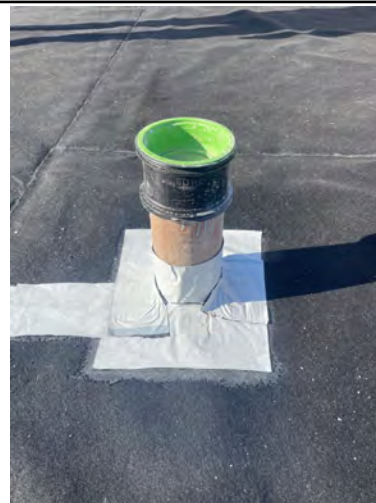
Throughout the Pudlo ultra plus installation a number of pipe penetrations required

sealing. This has been achieved using Pudlo ultra EXT tape which is a gas resistant

self adhesive membrane. The Pudlo ultra+ has been cut tightly around all pipes prior...

to being sealed. The pipe penetrations have been sealed to manufactures specification

and to good NVQ standard as shown in the photographs above.

The photographs above show typical pipe penetration sealed details.

The fleece upon the Pudlo ultra plus membrane has been removed prior to sealing

so that a direct seal has been achieved and not hindered by the fleece surface.

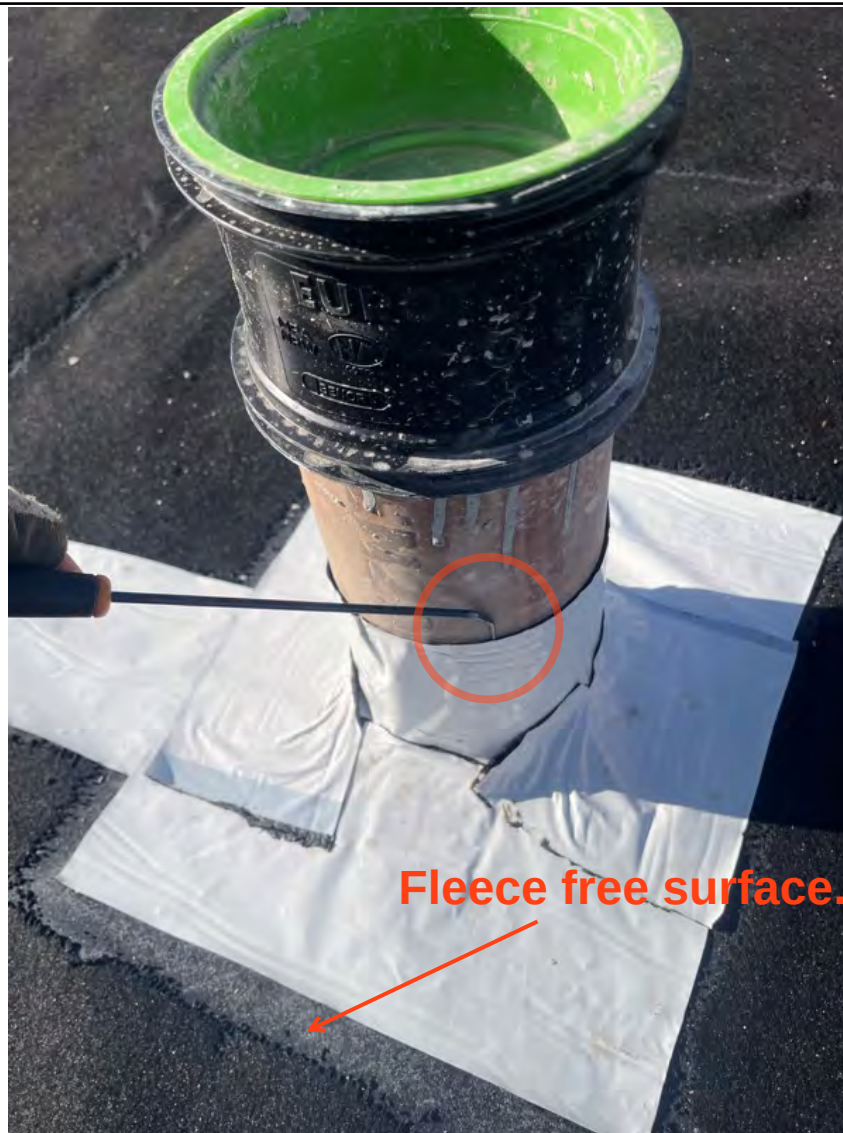
Fleece free surface.

The above photograph displays a mechanical point stress test being conducted upon a pipe penetration which has been sealed in accordance to manufactures specification.

The pudlo ultra EXT tape has been sealed directly upon the membrane to prevent the fleece surface jeopardising the seal. Verified in accordance with CIRIA 735.

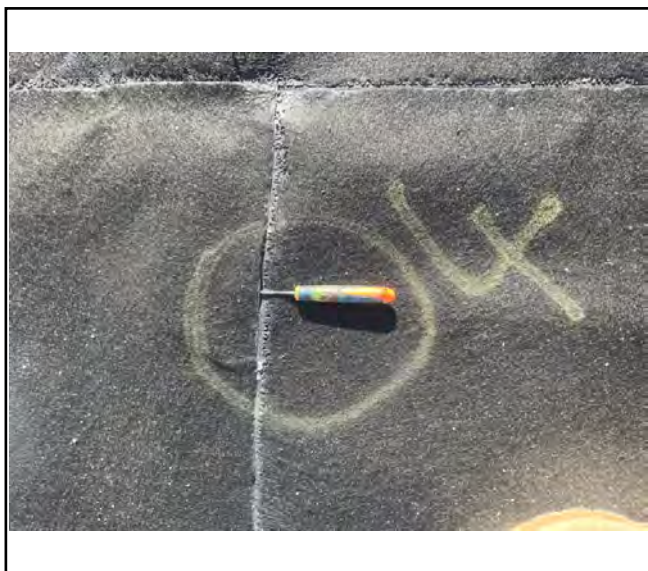
During the visual inspection and thorough pick and probe testing conducted throughout the Pudlo ultra plus installation to the referenced area only 4 faults were identified.

The photograph on the left shows a example of a fault identified- a miswelded lap joint.

Removal of the fleece surface and a 150mm patch repair remediation carried out.

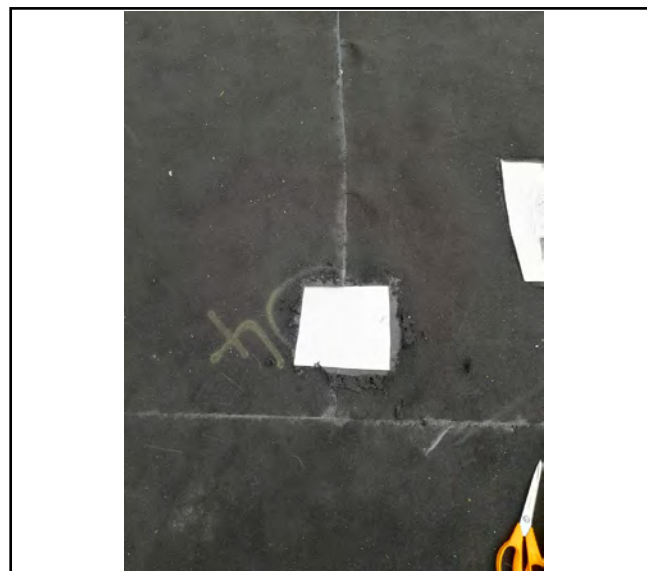
The photograph above on the right shows the completed remediation.

Verified in accordance with CIRIA 735. No outstanding remediations.

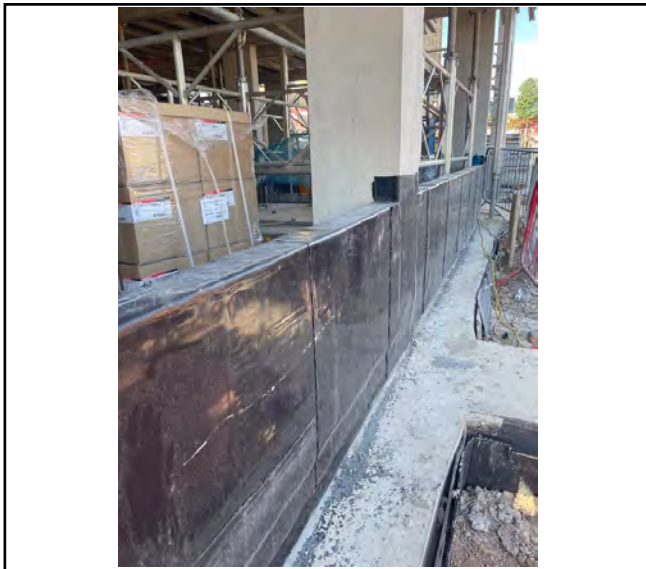
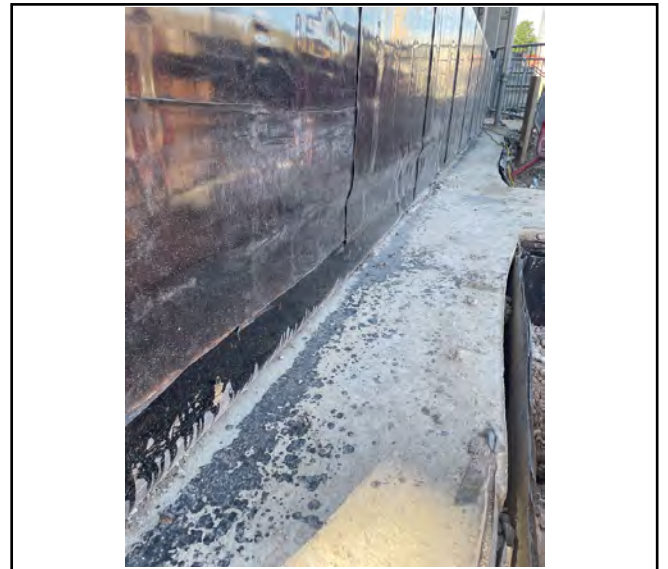
Perimeter termination works have begun on a section of perimeter on Block D3 by FDL

The concrete perimeter upstands have been primed using Pudlo self seal and left to

cure prior to works commencing. The Pudlo ultra seal has been returned from the top...

...of the upstands- sealing the adjacent concrete pillars within the perimeter.

The Pudlo ultra seal has been returned in excess of 150mm onto the exposed

Pudlo ultra plus around the perimeter of the building creating a continuous seal

throughout the perimeter prior to Pudlo DPC works being carried out.

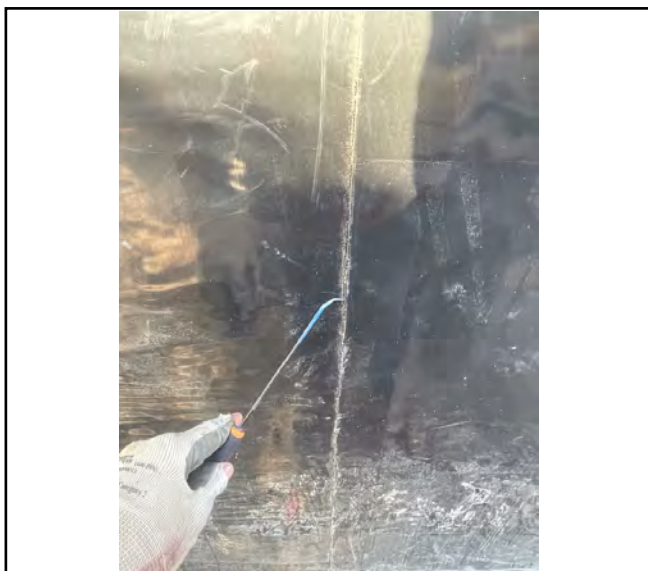
The photograph above on the left shows a pick and probe test being conducted

upon a sealed overlap between sheets of Pudlo ultra seal. No faults identified.

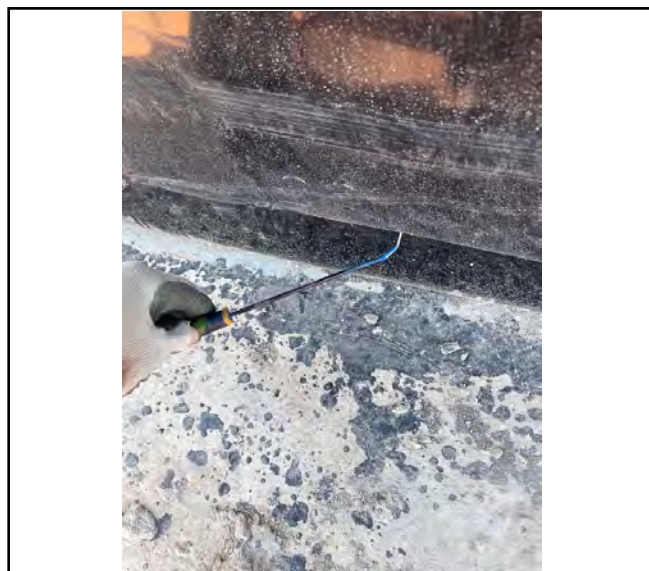
The photograph above on the right shows the Pudlo ultra seal return onto the Pudlo

ultra plus. No faults were identified. Verified & tested in accordance with CIRIA 735.

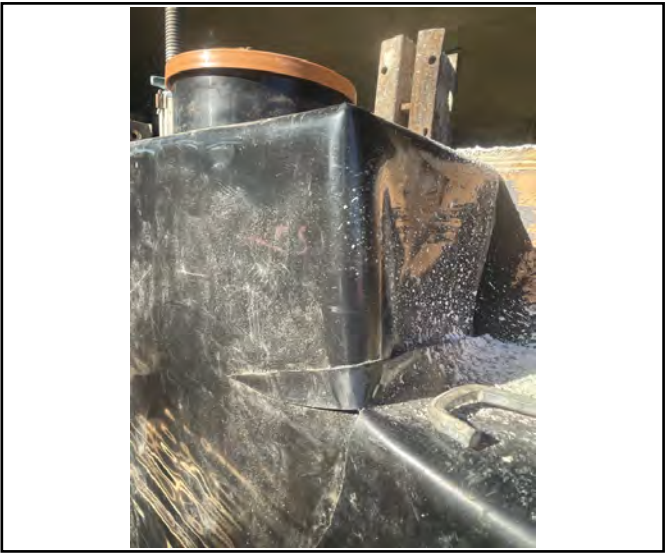
Intricate external corner detailing.

Pudlo ultra seal termination works.

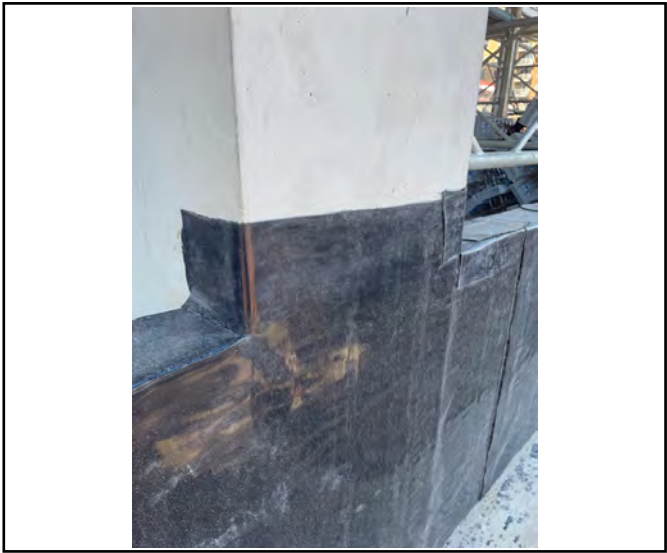
Sealed column detailing.

Pudlo ultra seal termination works.

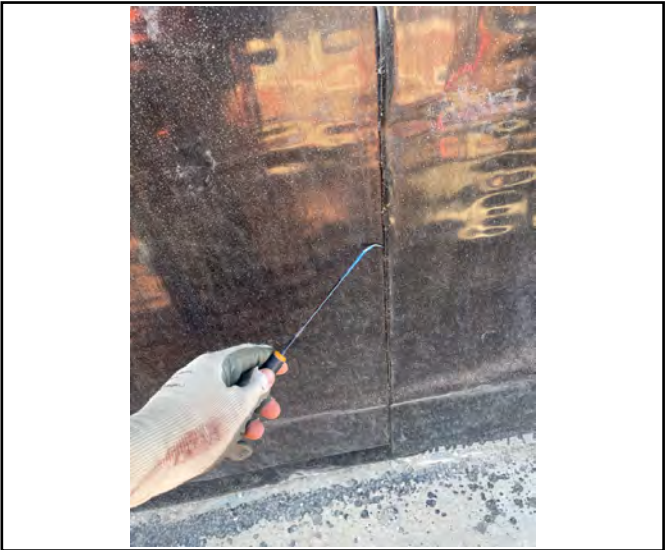
Pick&probe testing to sealed overlap.

Pudlo ultra seal termination works.

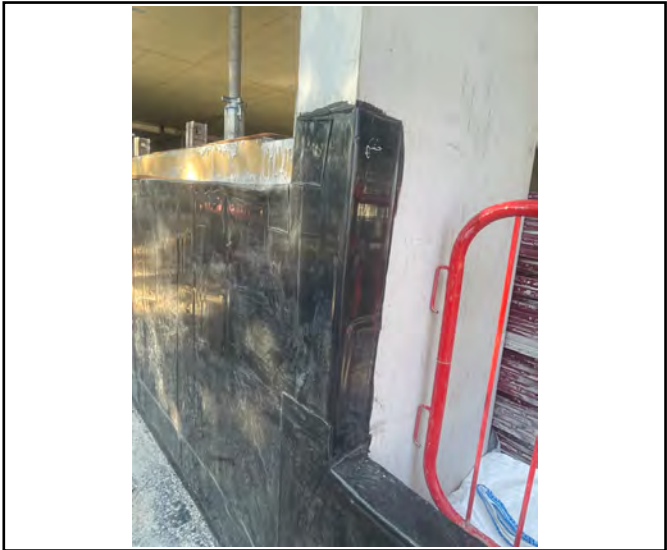
Intricate detailing.

Pudlo ultra seal termination works.

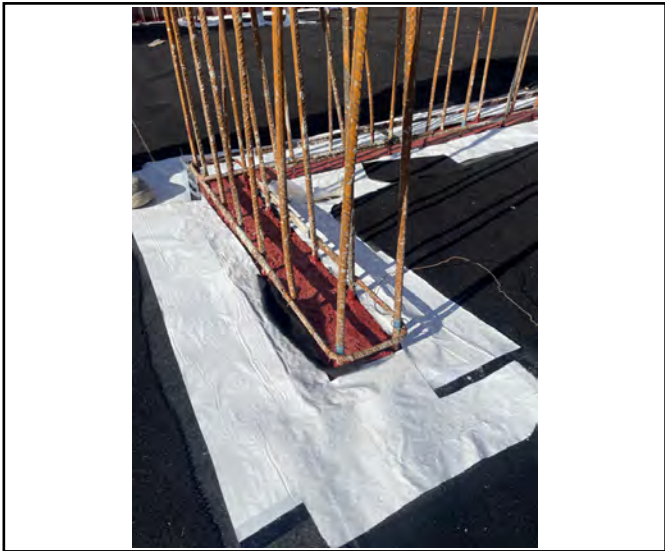
Successfully sealed pilecap detail.

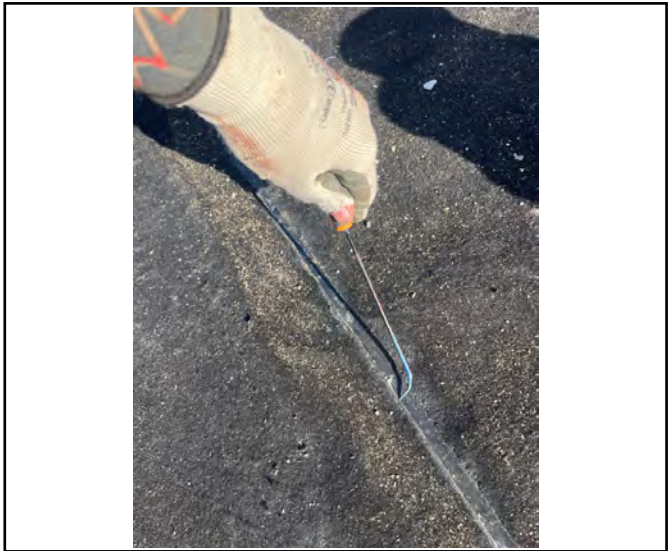
Pick and probe testing to welded

lap joint.

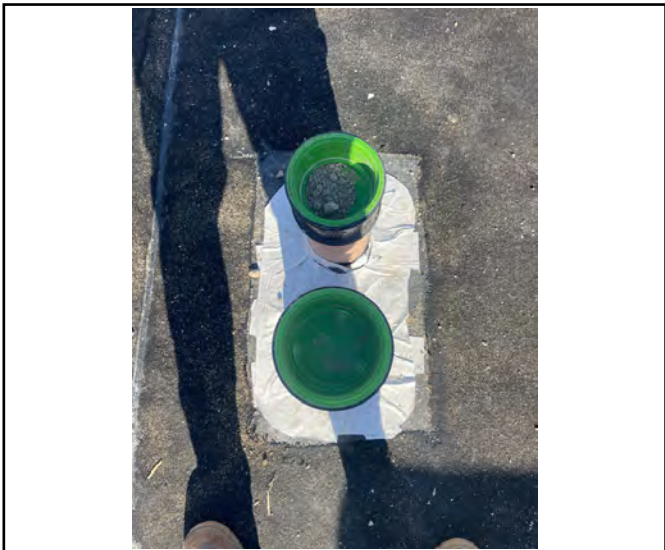
Successfully sealed pipe penetrations.

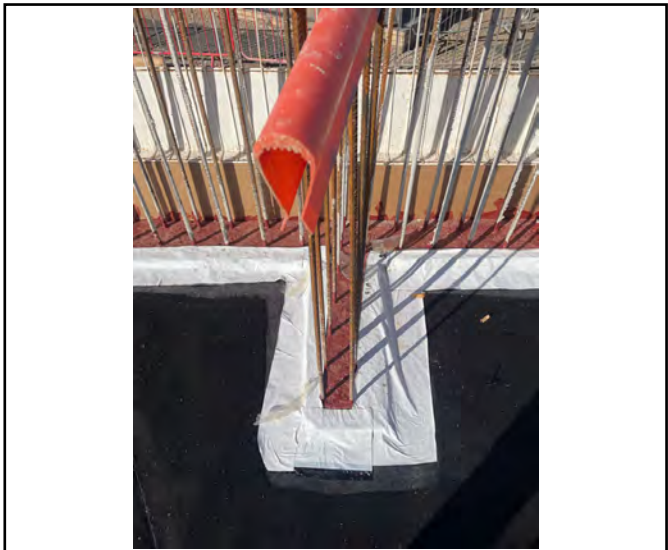
Successfully sealed perimeter beam

detailing (internal)
