# GEOSHIELD Verification Report

002

GCL - Clarendon Road PHASE 3

AREA SURVEYED: Block D1 - Core - Middle and Upper

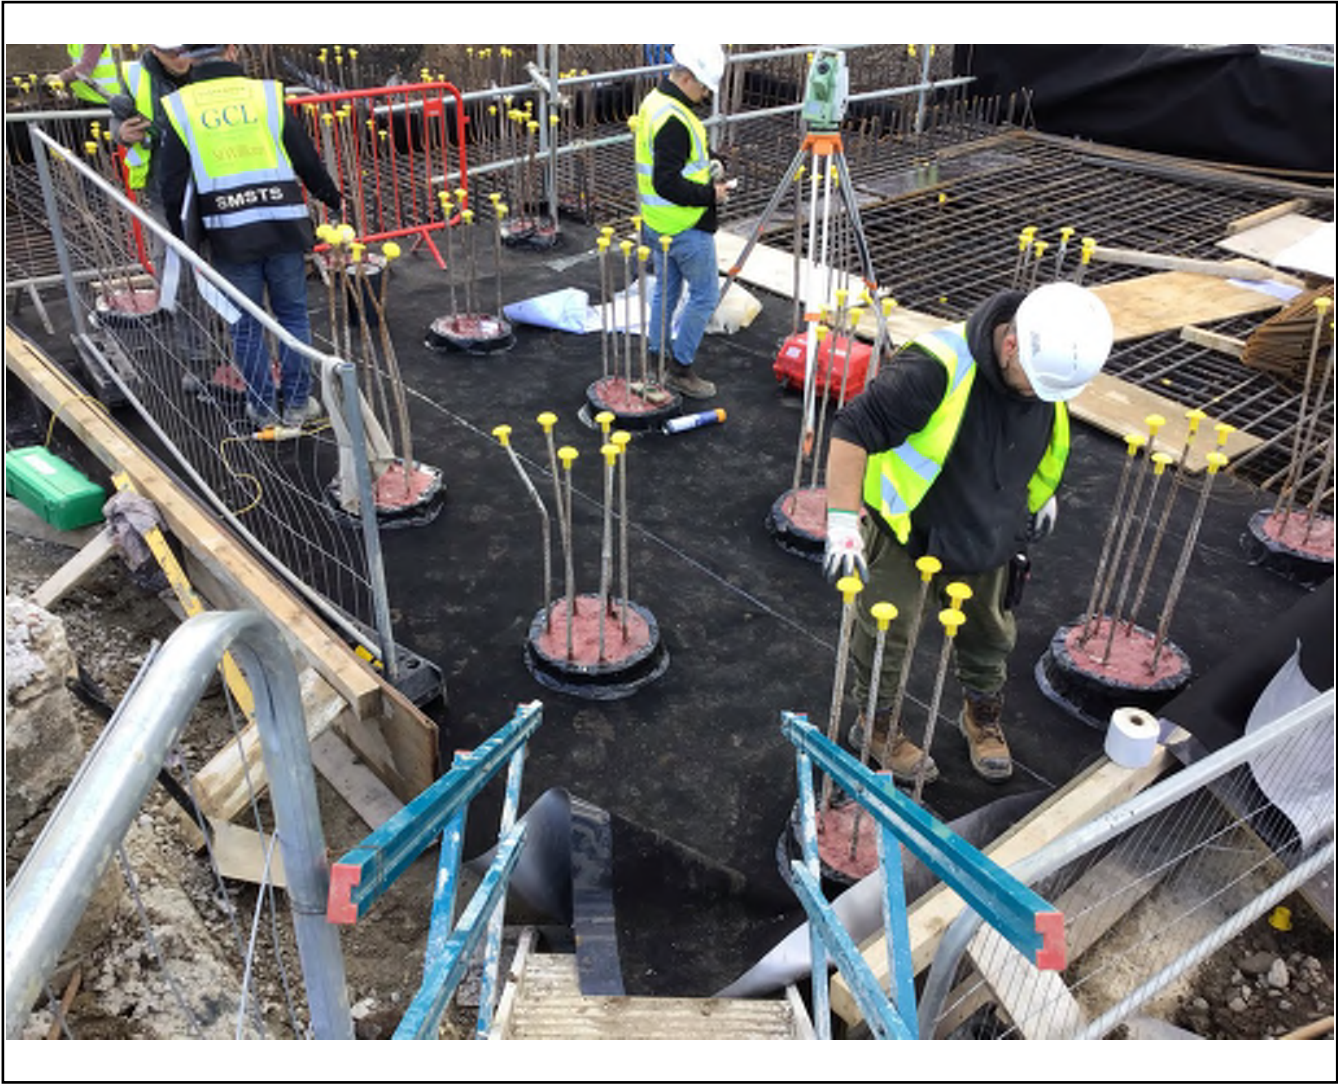
Overview of D1 Core - Upper

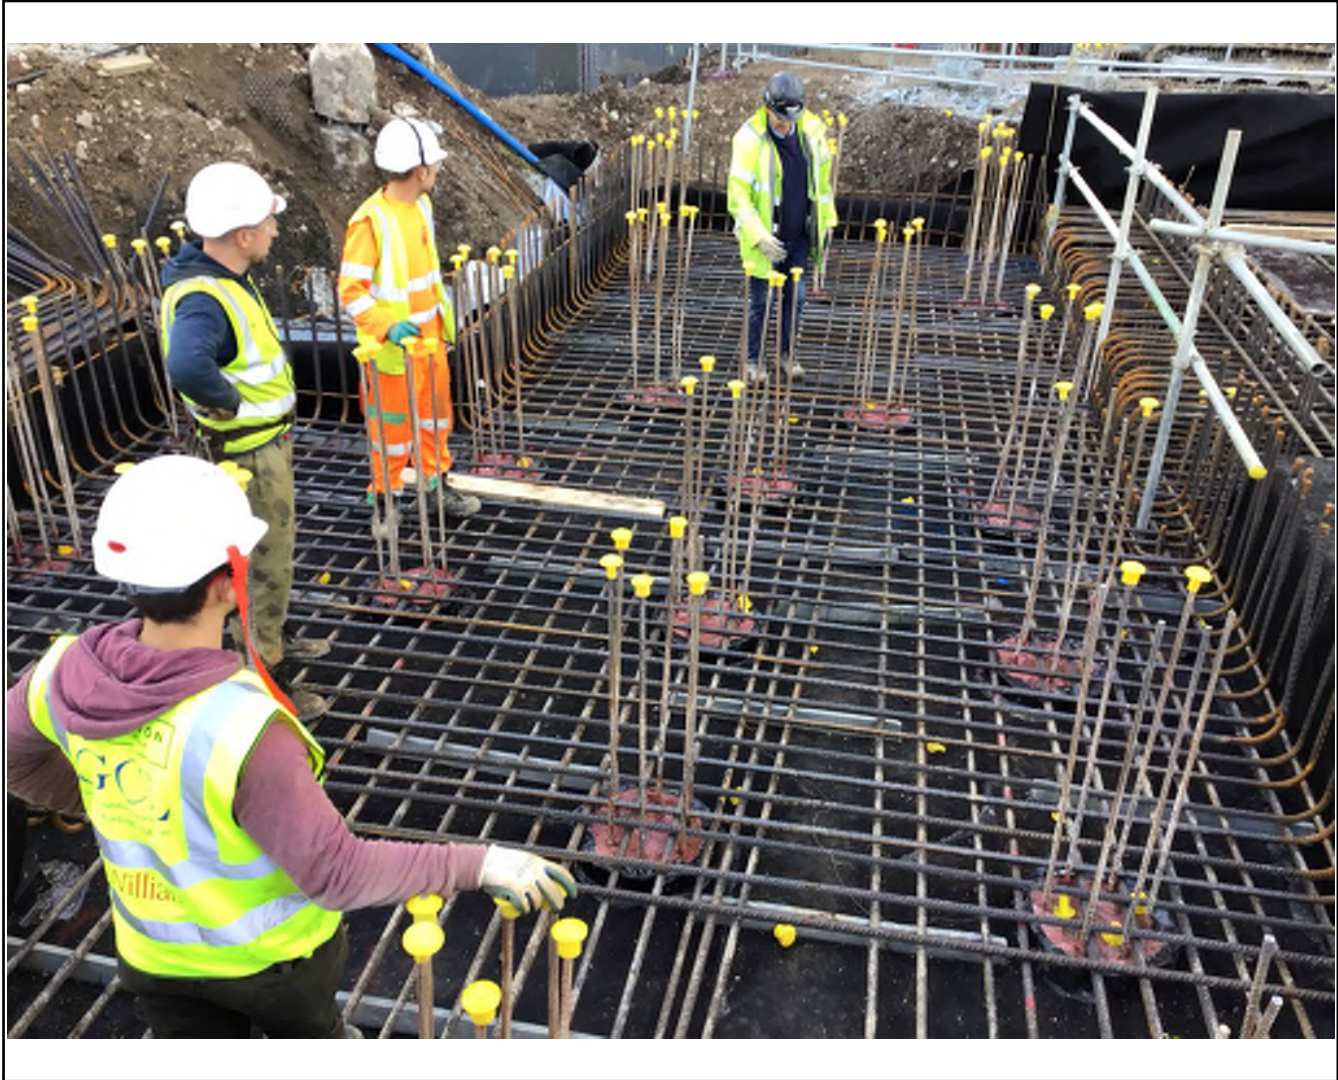
Overview of D1 Core - Middle

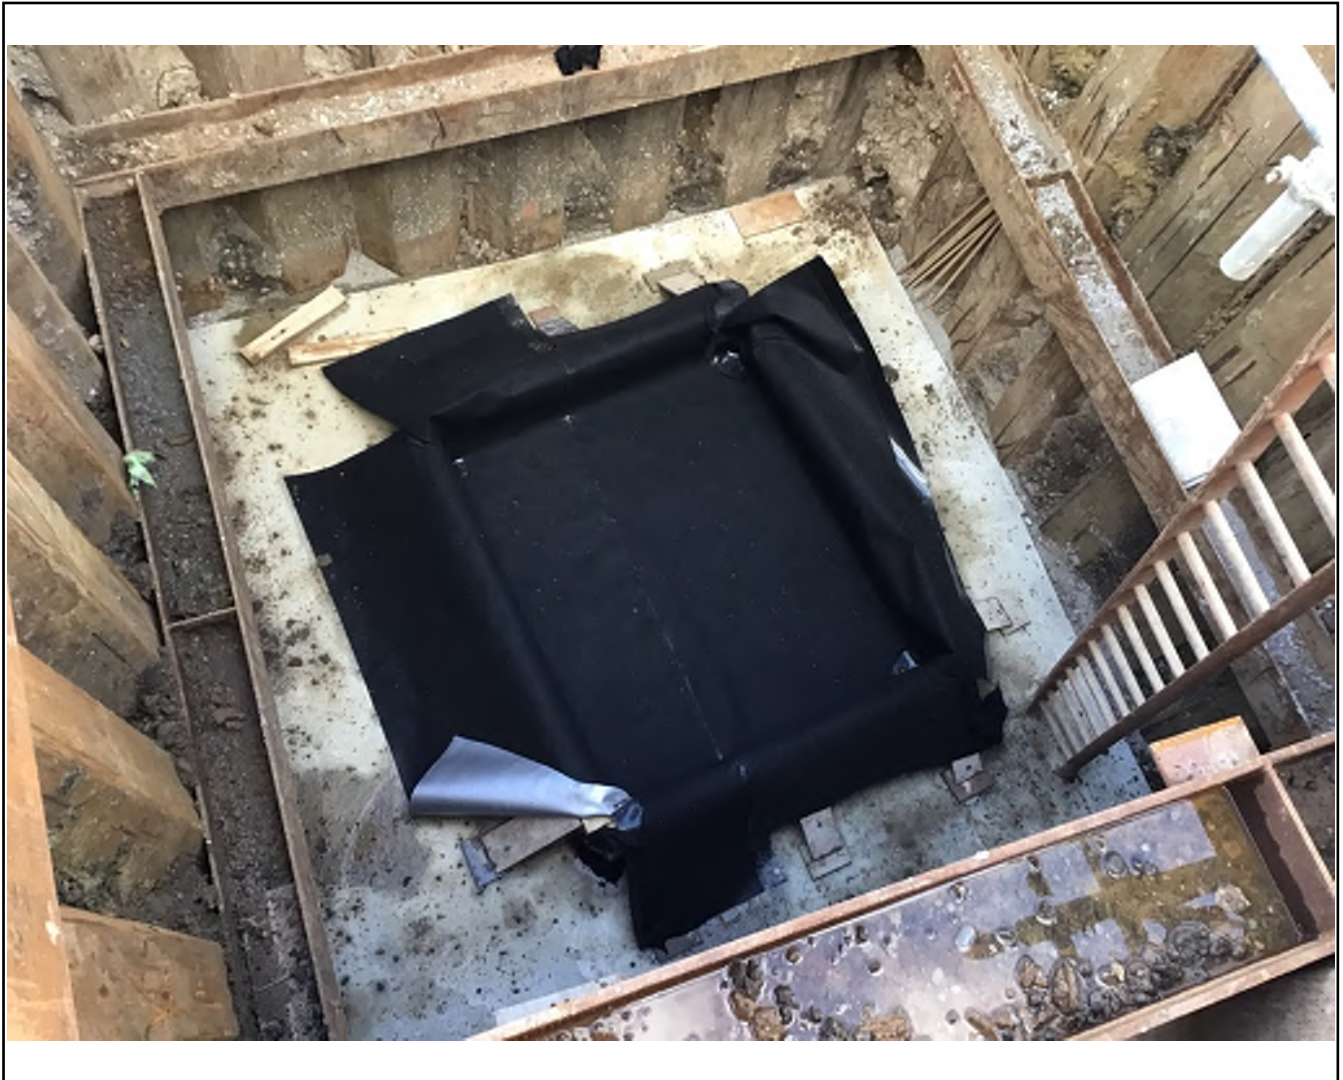
Pump Chamber Base

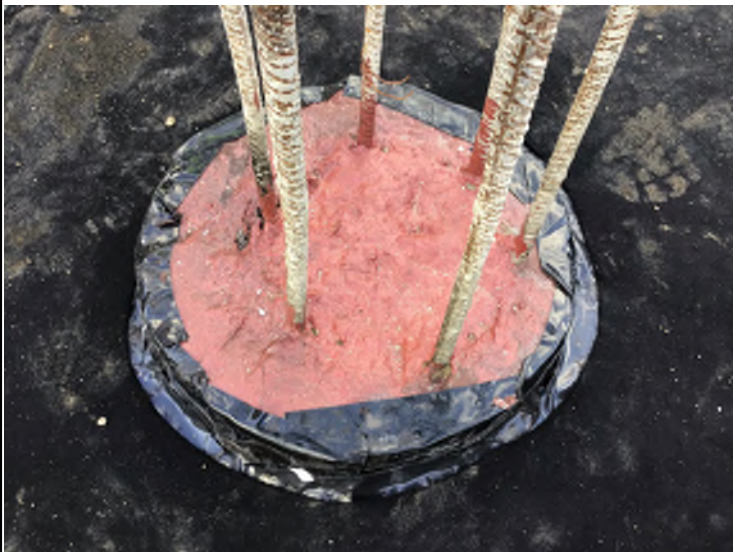
1. Photo evidence

NOTES: Pile heads sealed to high standard. All works visually

inspected and tested with pick and probe to ensure good bond achieved. Double sided

tape installed around all pile heads to seal to Pudlo GP Ultra + Gas Barrier. Good

covering of Pudlo Liquid Gas Barrier to all pile heads.

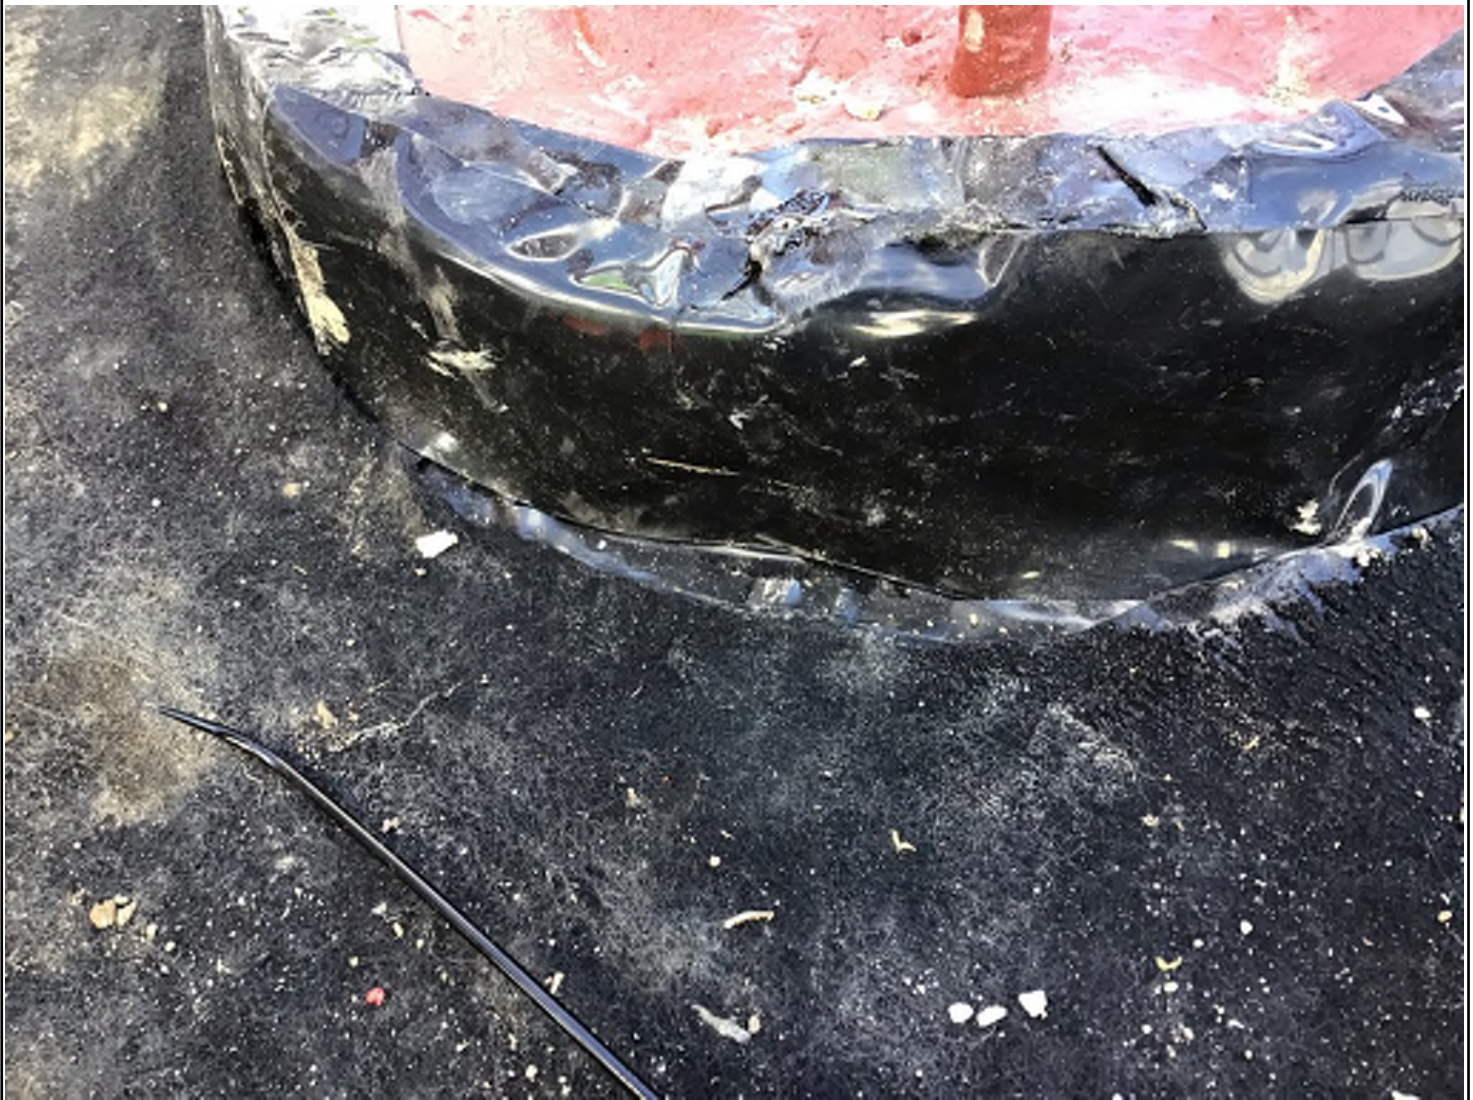
3. Photo evidence. Double sided tape visible. Pick and probe to ensure all the way around pile head and good consistent seal achieved.

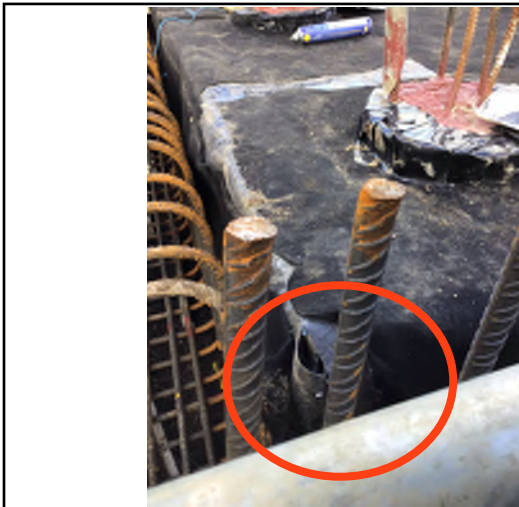
NOTES: All works visually inspected and only one area of damage

detected. Corner damaged during install of rebar. This was patch repaired and sealed

1. Corner of Pudlo GP Ultra+ damaged

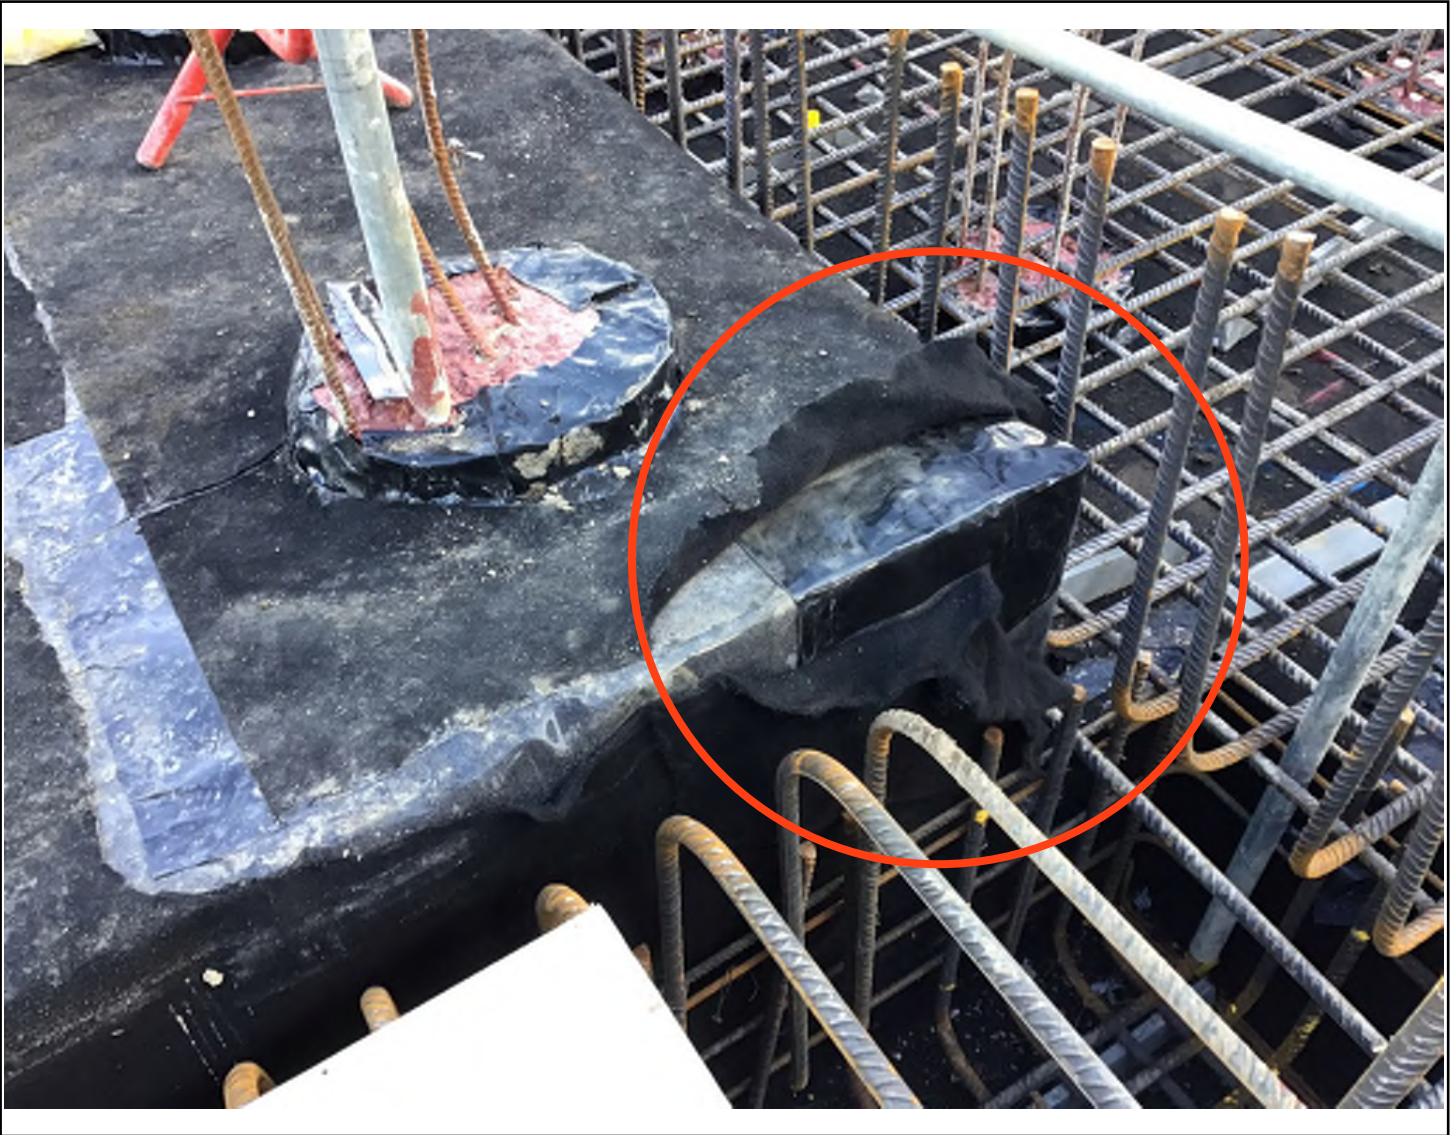
Excellent standard of installation and patch repair.

Passed and verified.

3. Patch repair made during inspection.

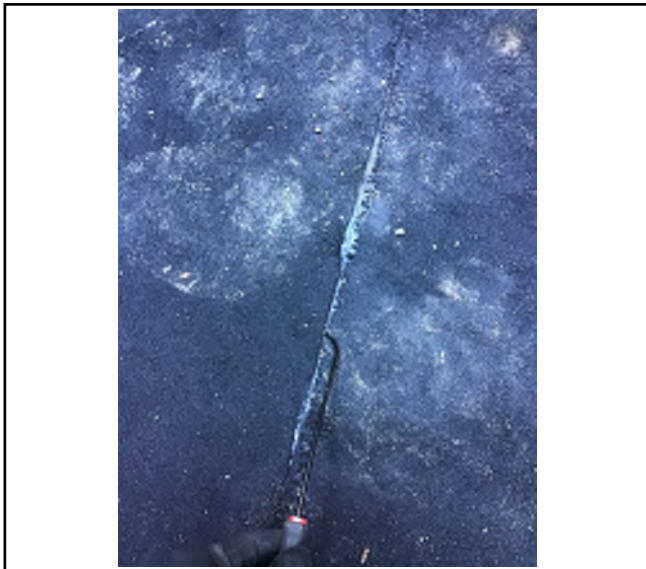
1. Pick and probe test carried out

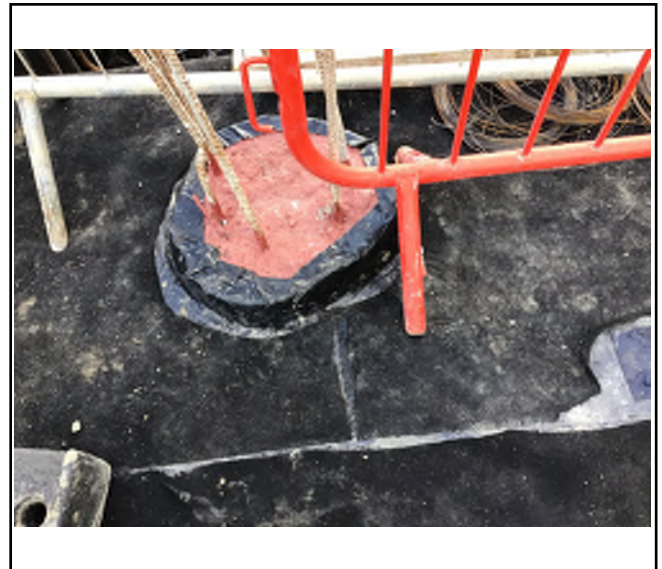
2. Overview of joints and T Junctions all fully sealed

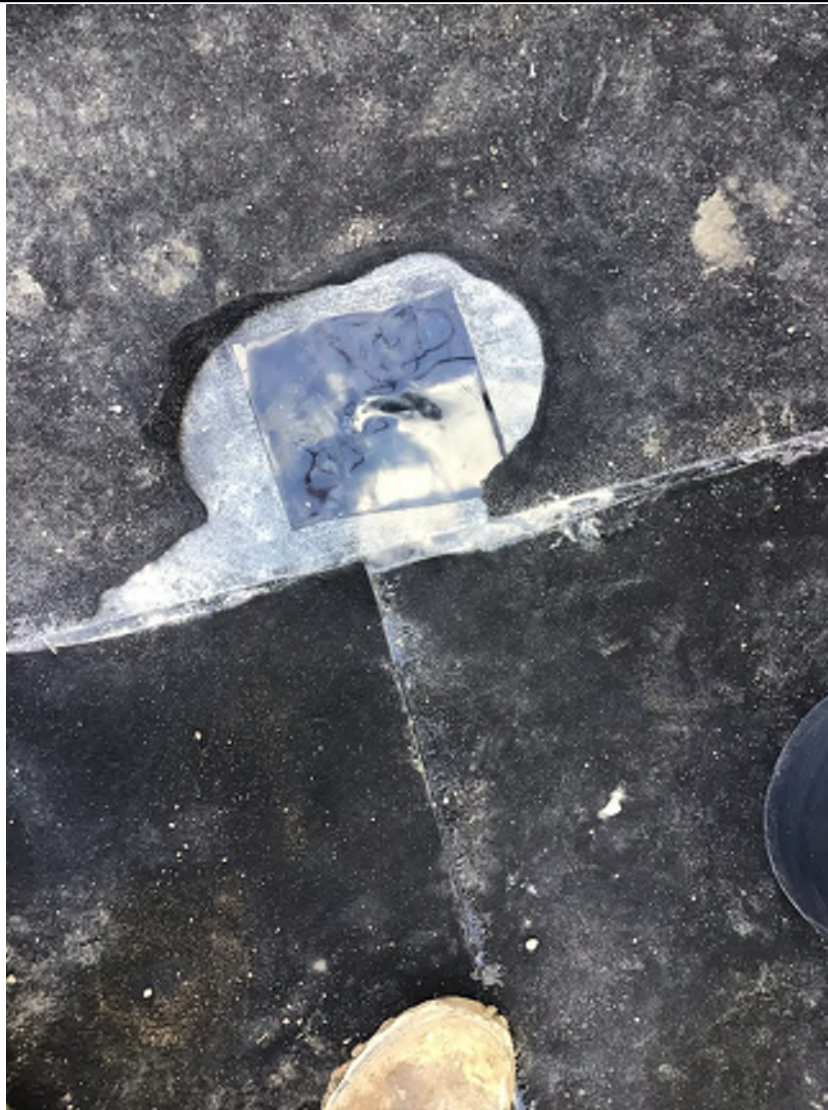
3. Patch repair had been made prior to inspection as installers have taken

great care to ensure membrane fully sealed.

Excellent installation throughout.

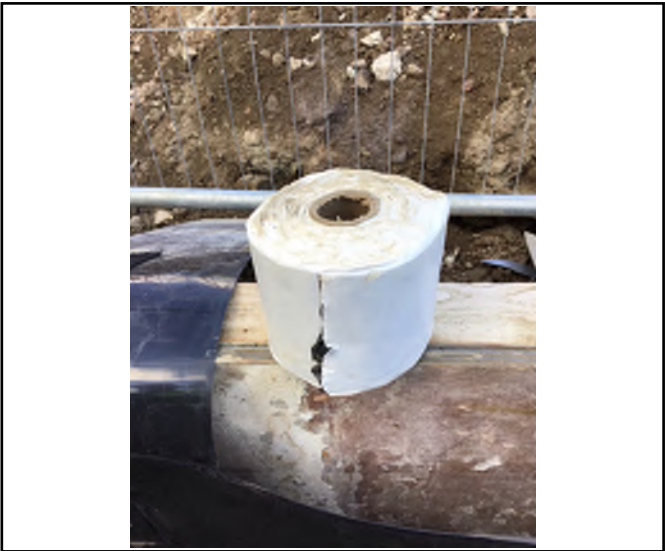
Pudlo 100mm double sided butyl tape

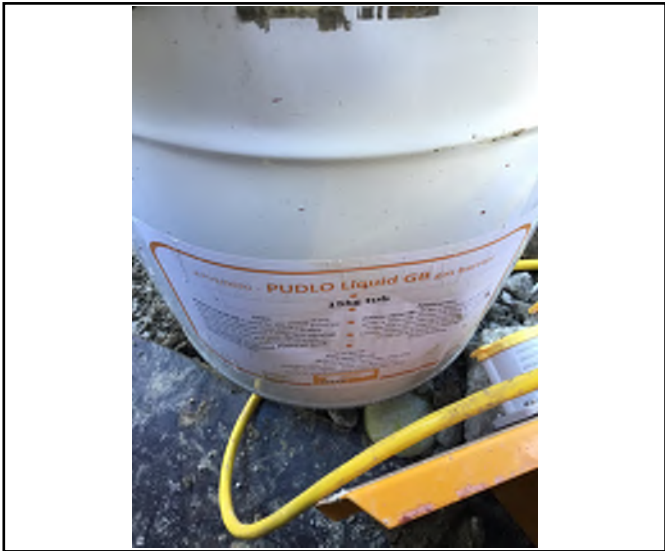
Pudlo Liquid Gas Barrier used on

pile Heads

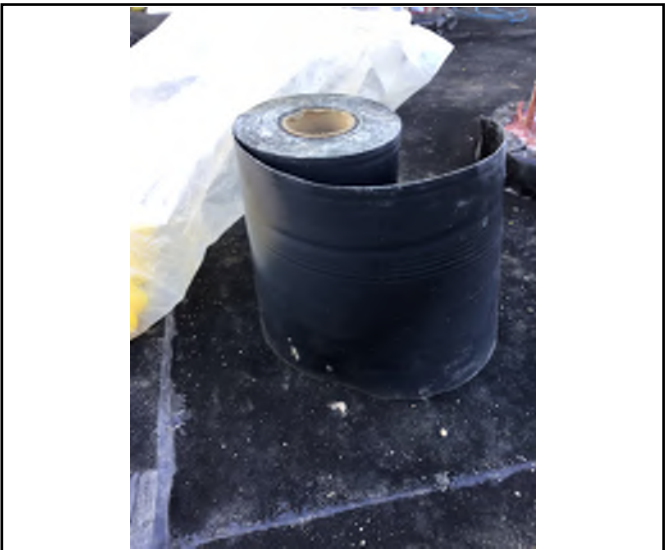
Pudlo jointing tape used on joints and

sealing to sealed pile heads

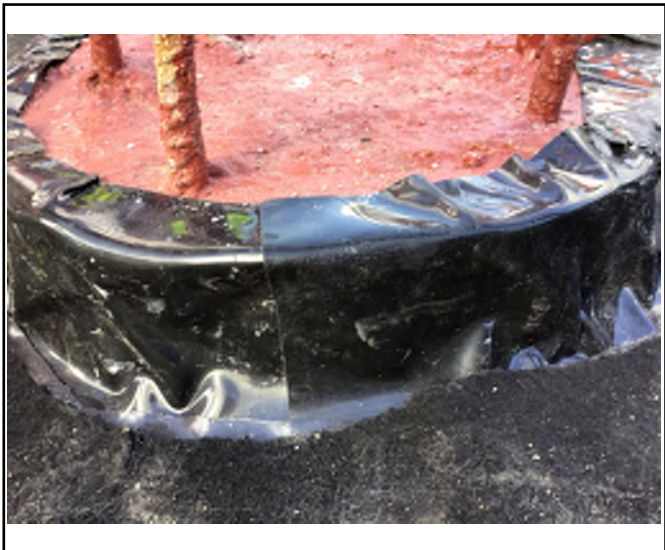
Pile head fully sealed

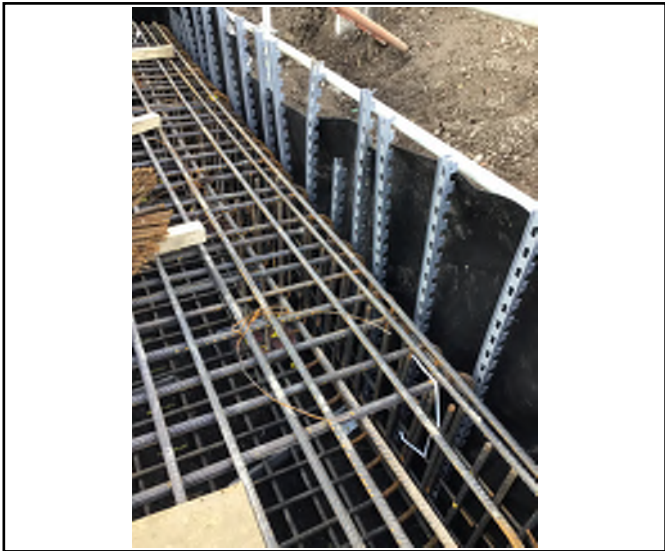
Tric trac spacers to vertical

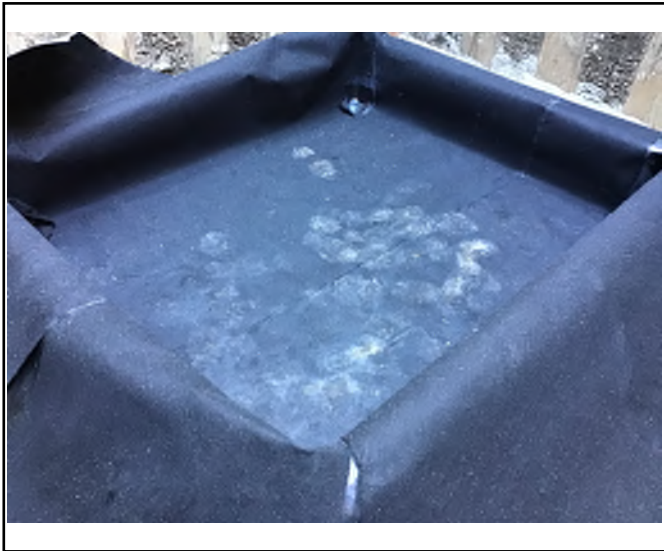
Pump chamber base tested with

pick and probe

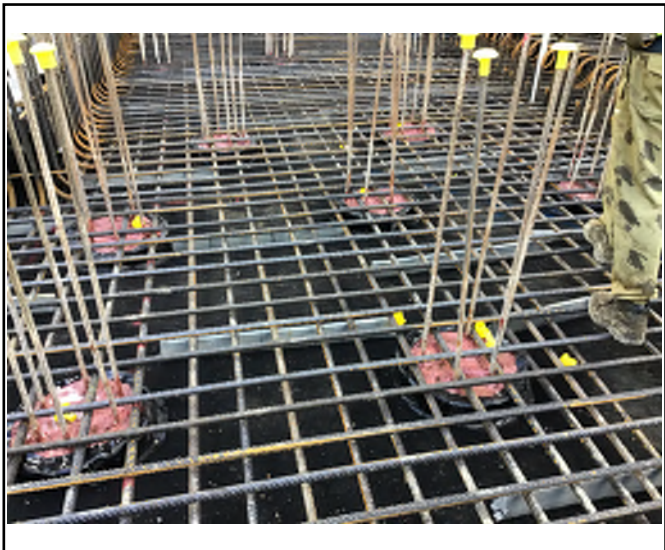
Overview of middle section

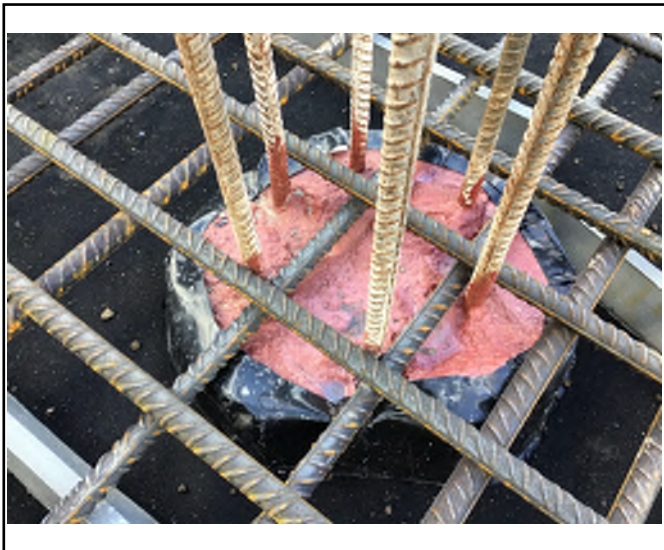
Pile heads all sealed

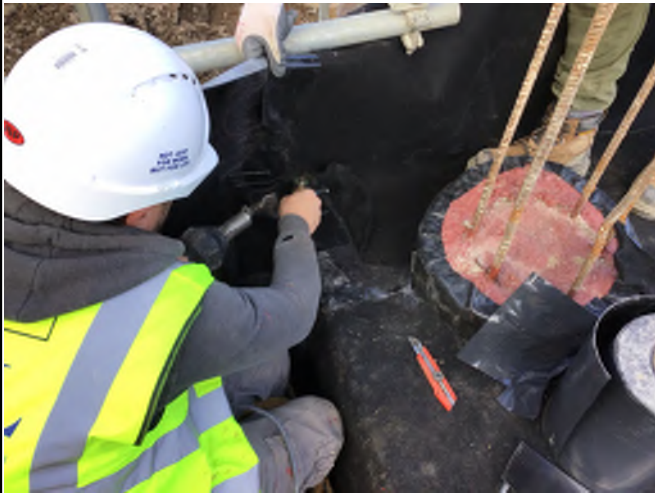
Last section of installation witnessed

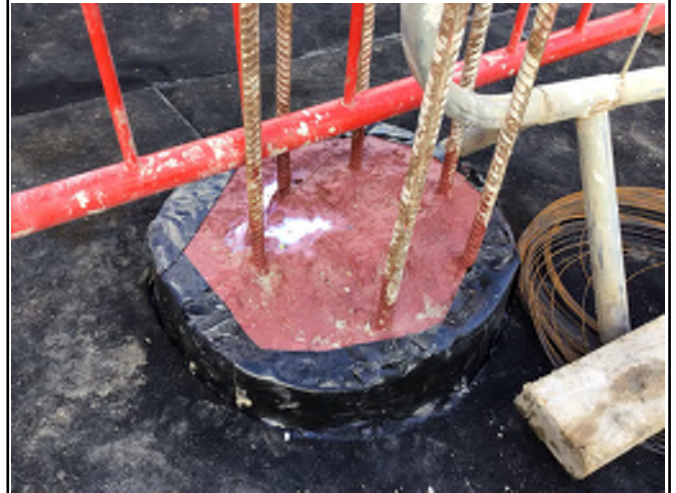
Pile heads fully sealed

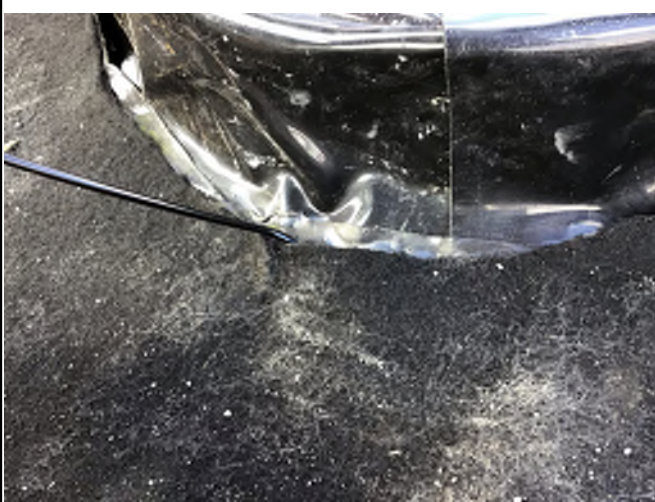
Pile heads fully sealed to Pudlo

GP Ultra +

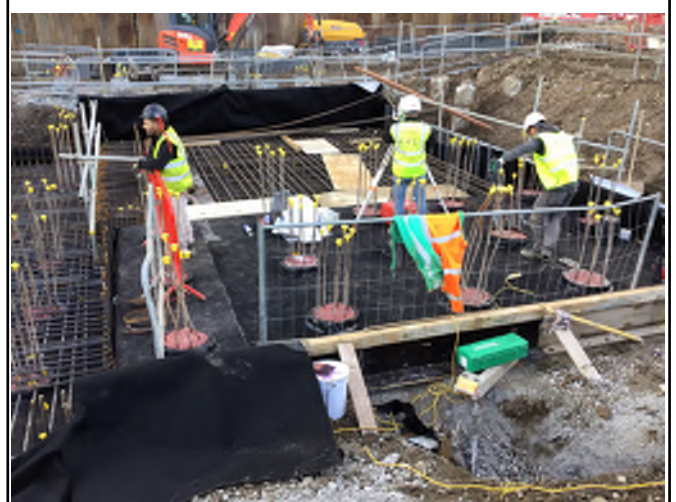
Overview of verified area
