# GEOSHIELD Verification Report

PROJECT REFERENCE: GEO102491

REPORT NUMBER: 001

PROJECT: Blocks D3 & D4. Clarendon Road.

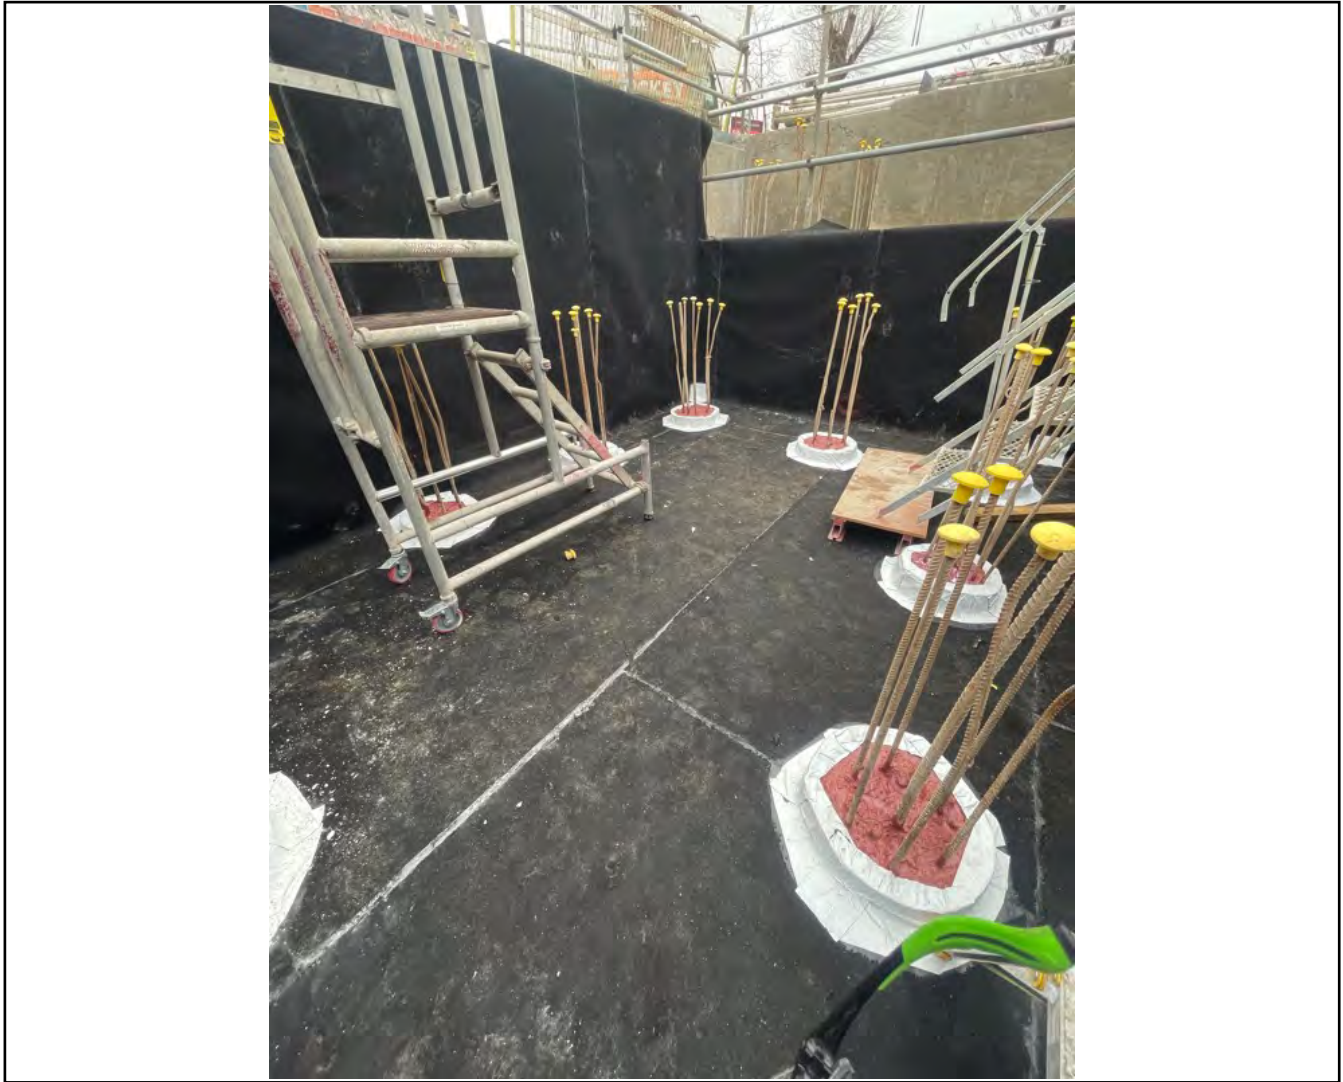
Block D3 core - lower level.

Overview photograph of the area verified during this visit.

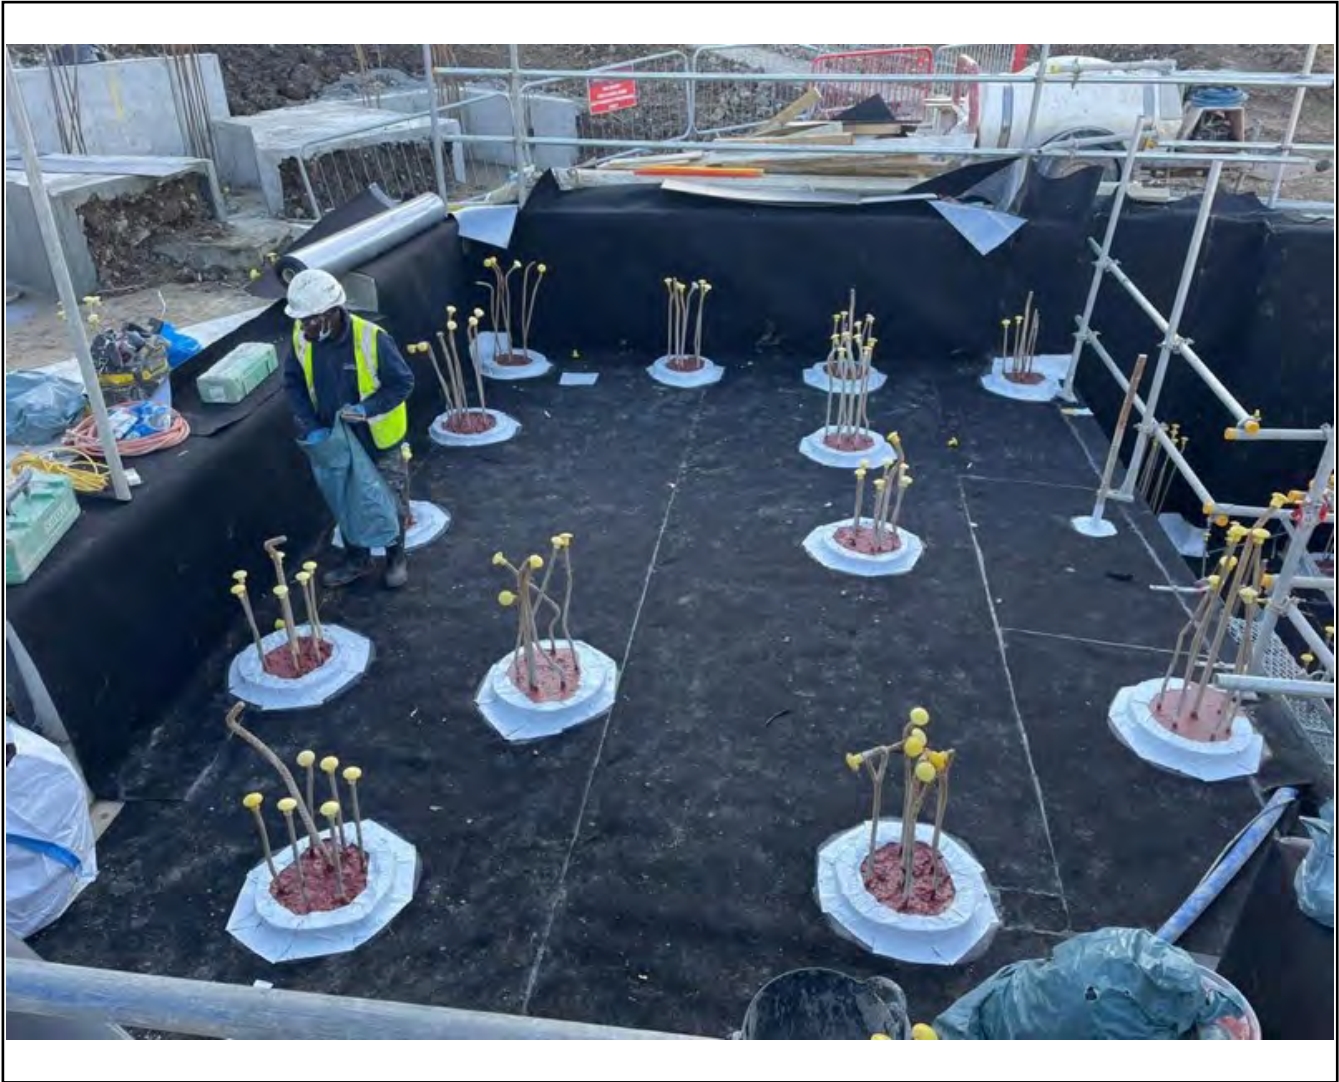
Block D3 core - upper level.

Alternate overview photograph of the area verified during this visit.

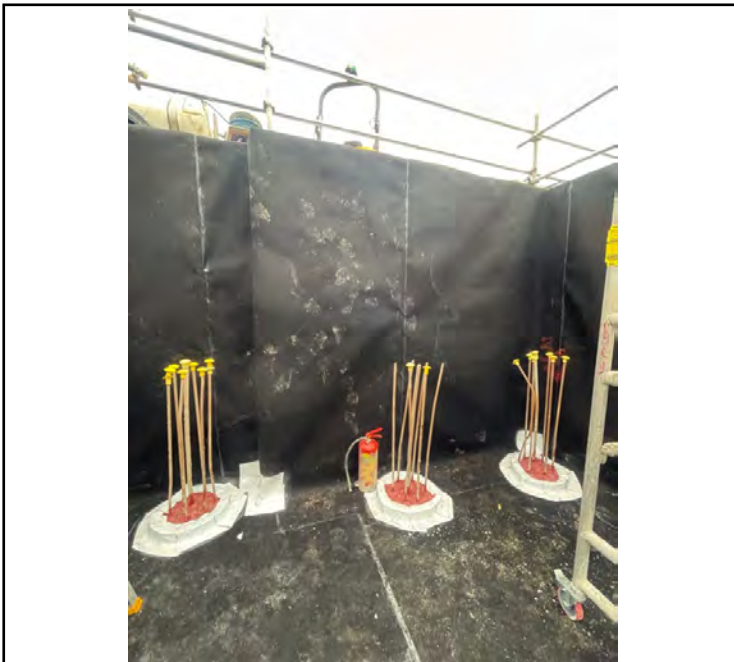
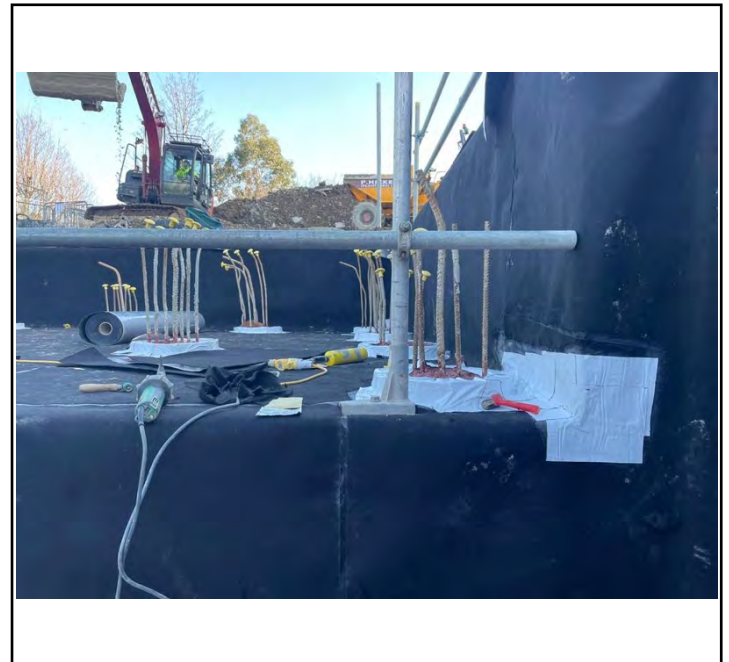
The installation of Pudlo ultra plus membrane has been lined throughout the core. All overlaps between the sheets of membrane have been welded in accordance to BS8485:2019 using a hot air tool and silicone roller. Continuity has been achieved throughout the core...

...as the Pudlo ultra + membrane has been returned up the concrete cast walls and up through the step down between the upper and lower levels of the core.

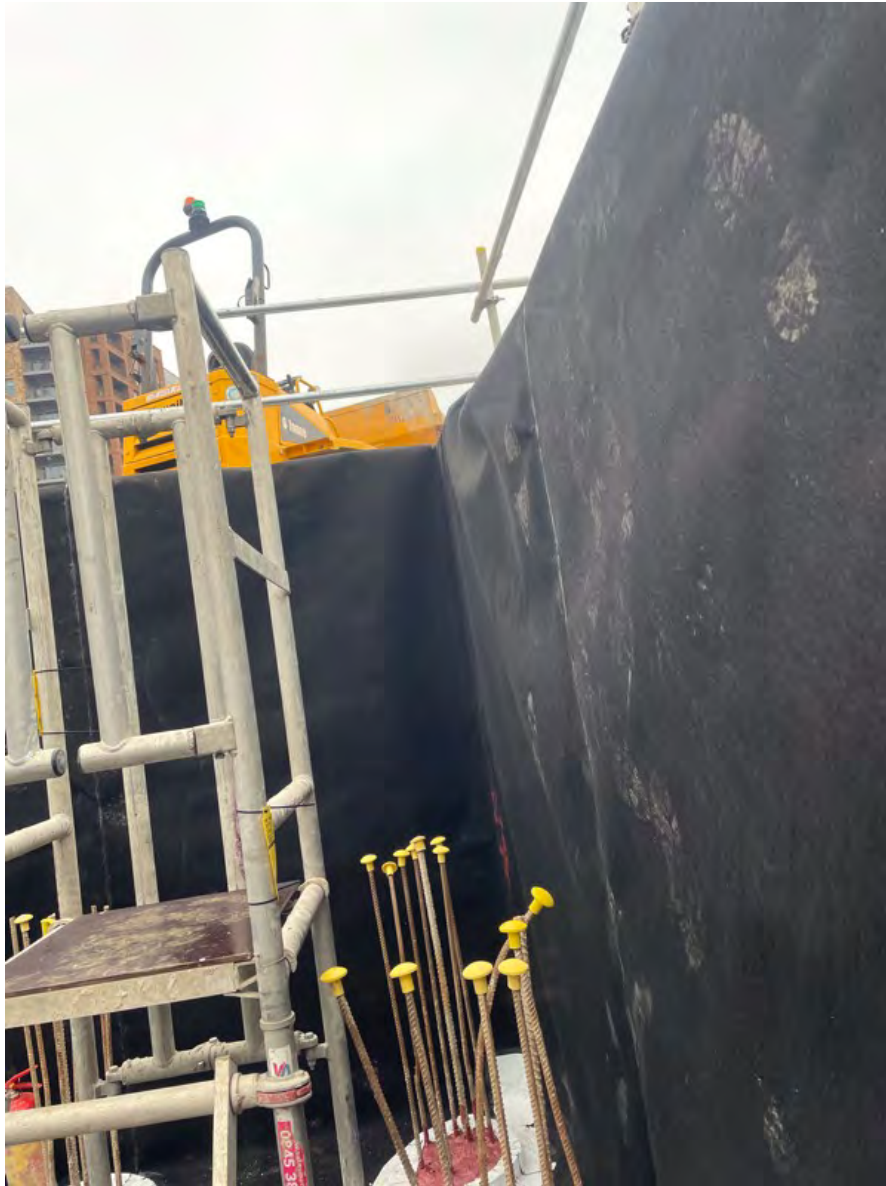
The above photograph displays an overview photograph of the Pudlo ultra + membrane returned up the concrete cast walls. The Pudlo ultra + membrane has been returned in excess of 150mm on to the ground level so a sufficient overlap can be achieved in preparation for the further membrane works to the ground slab areas.

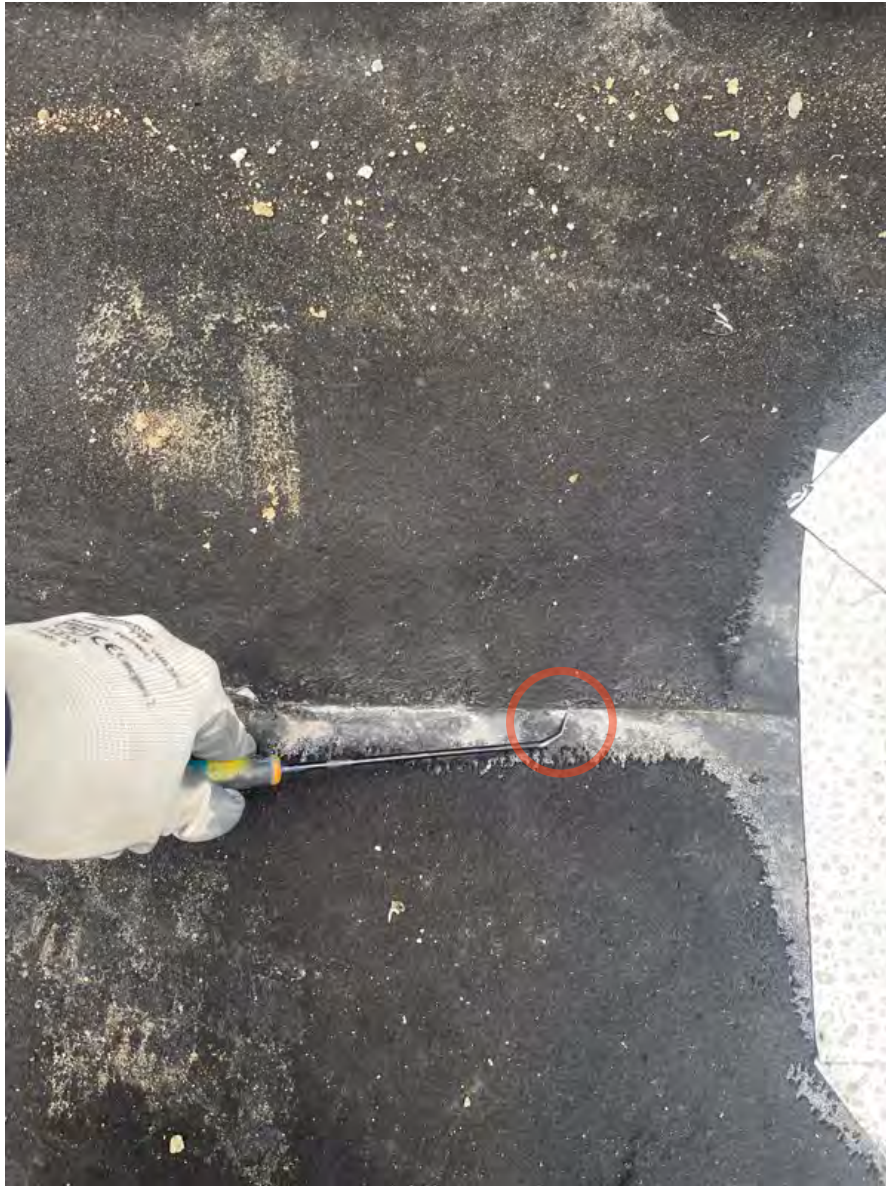
The above photograph displays a mechanical point stress test also known as a pick and probe test being conducted upon a welded lap joint. All overlaps have been a minimum of 100mm and on selvedged edges only to ensure the fleece surface of the Pudlo ultra+ does not hinder the weld. Verified in accordance with CIRIA 735.

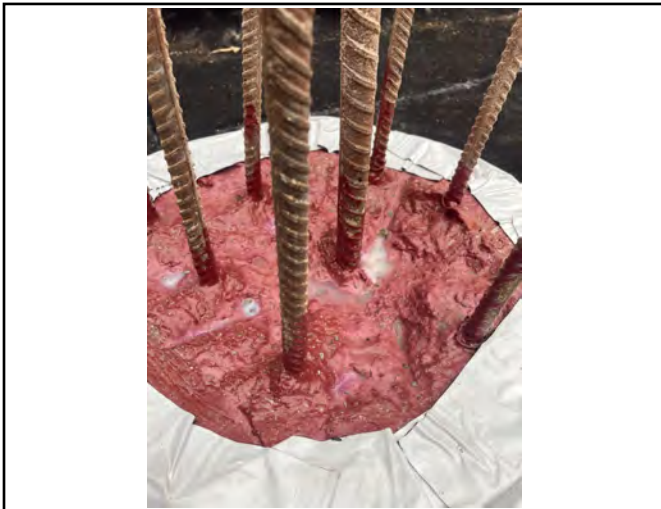
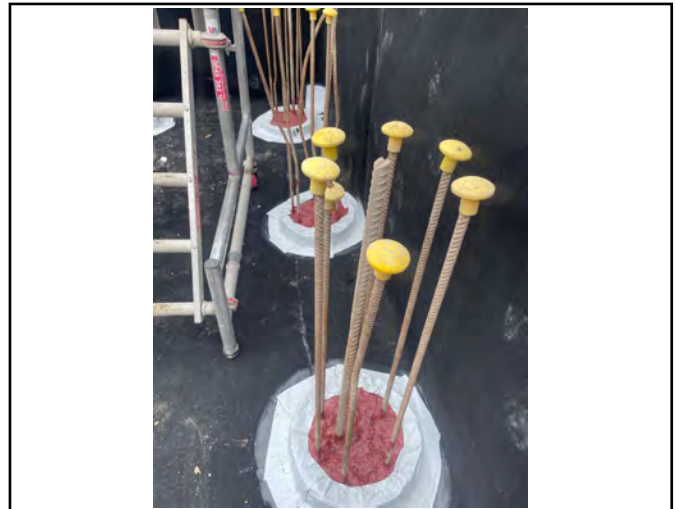
Throughout the core area a number of pile heads required sealing. All of the piles received a thick coat of Pudlo liquid GB which is a liquid membrane and left to cure prior to the Pudlo ultra + being cut tightly around each individual pile head.

The pile heads have then been sealed/terminated to the Pudlo ultra plus membrane using Pudlo ultra EXT tape which is a gas resistant self adhesive membrane.

The fleece has been removed around the perimeter of each pile head so that the fleece surface does not hinder the adherence of the Pudlo ultra EXT tape.

All piles have been sealed in accordance to design details & manufactures specification.

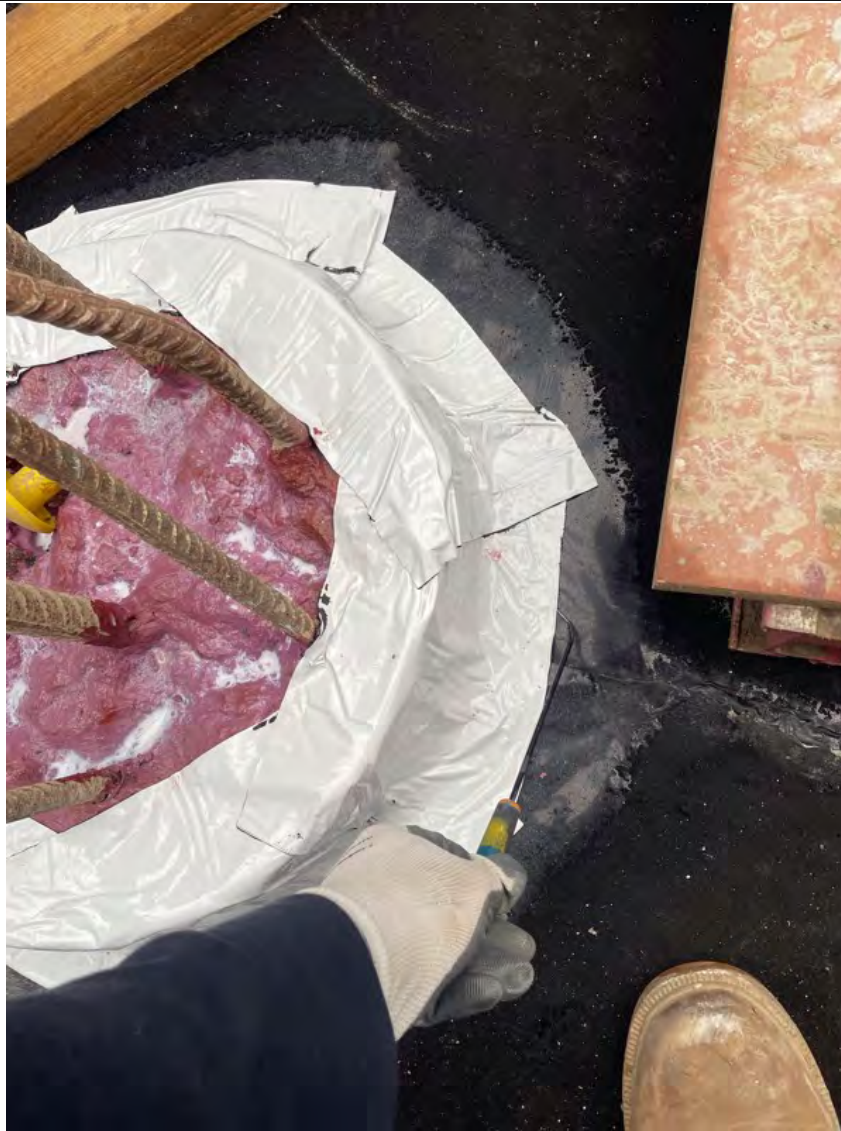
The above photograph displays a mechanical point stress test being conducted upon

a successfully sealed pile head detail.

The Pudlo ultra EXT tape has successfully adhered upon the Pudlo liquid GB'ed pile

heads and onto the Pudlo ultra plus membrane.

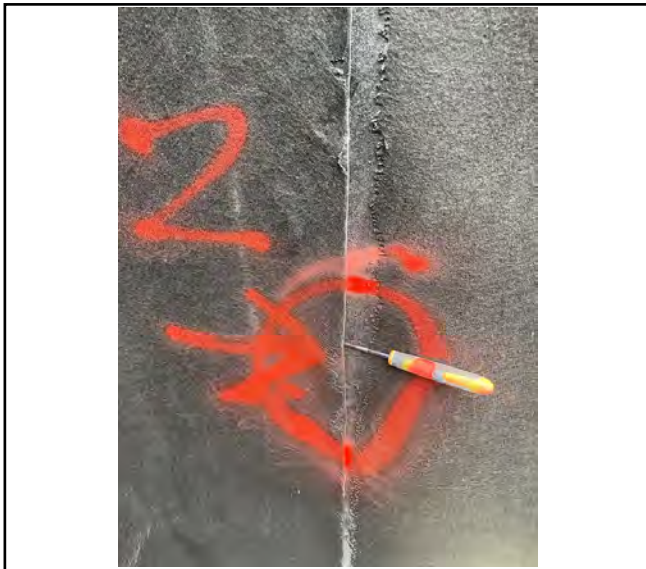
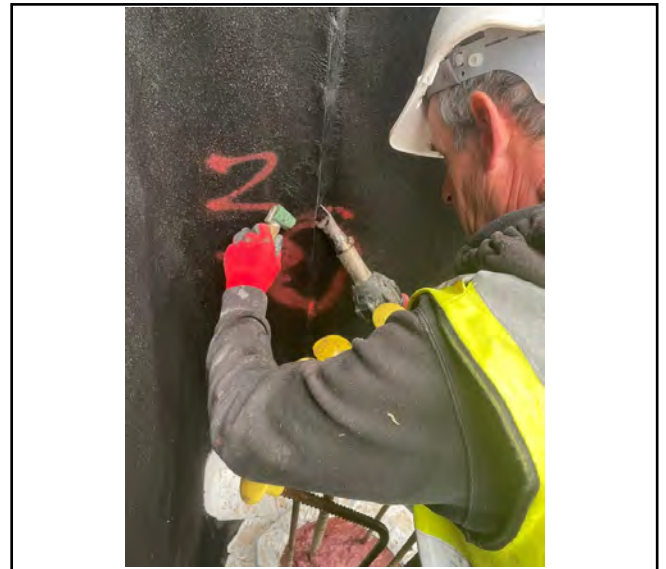
During the visual inspection and thorough pick and probe testing conducted throughout the Pudlo ultra plus installation to the core area a couple of faults were identified. These areas were highlighted so the installers could carry out the necessary remediations.

The photograph on the left shows one of the faults identified (miswelded lap joint)

and highlighted. The photograph on the right shows the NVQ qualified installer

from SWC carrying out the remediation re-welding the lap joint using a hot air tool

and silicone roller. No outstanding remediations.

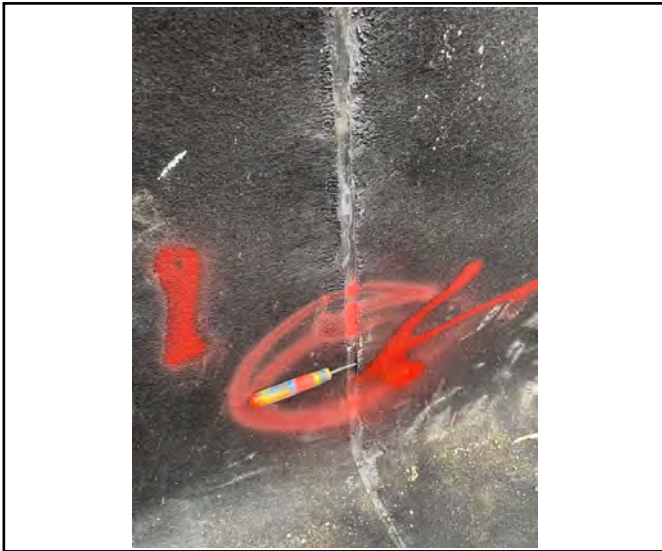
Fault 1 of 2 identified.

Remediated on-site.

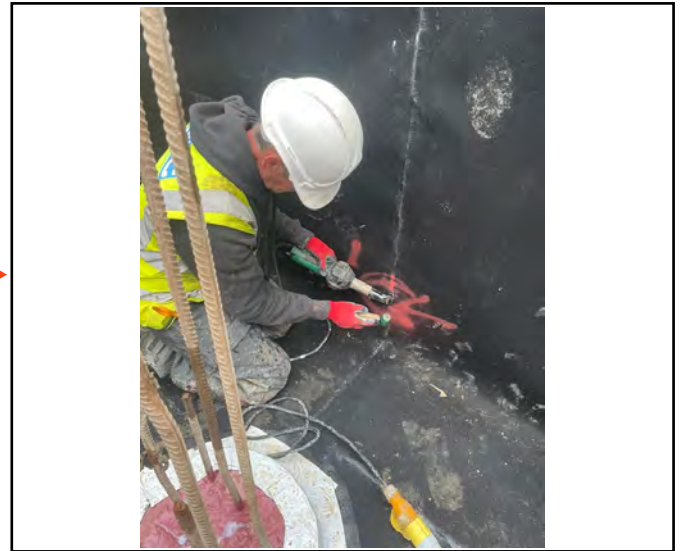
No outstanding remediations.

The installer re-welding the lap joint.

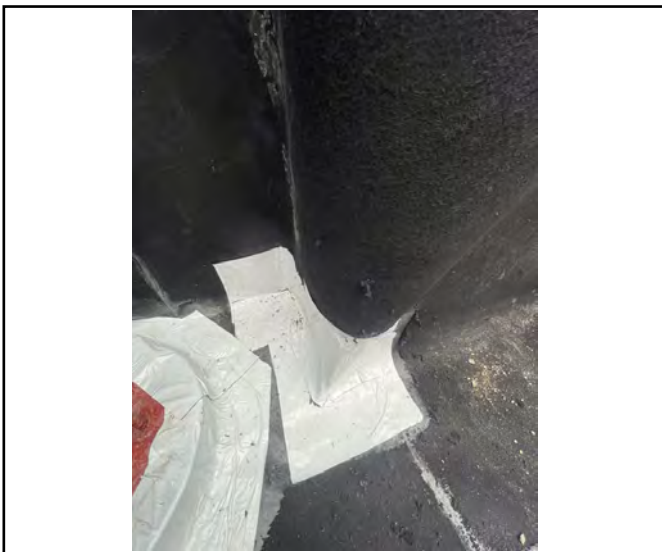
Corner detailing sealed using

Pudlo ultra EXT tape.

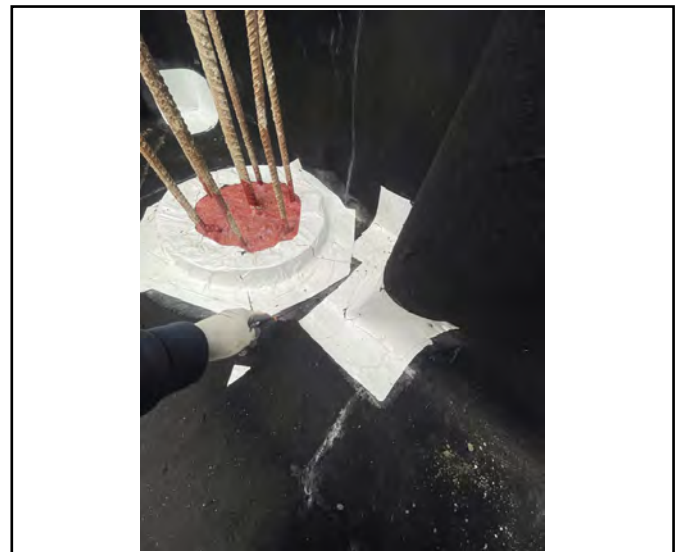
Pick&probe testing to corner detailing.

No faults identified.

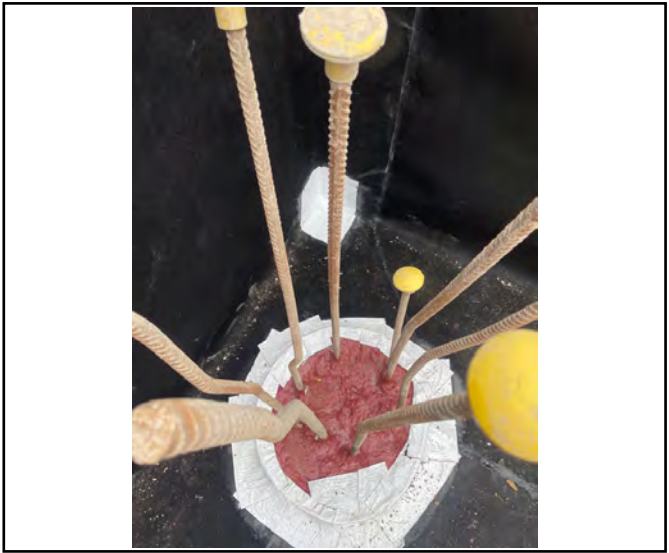
Successfully sealed pile head and

corner detailing.

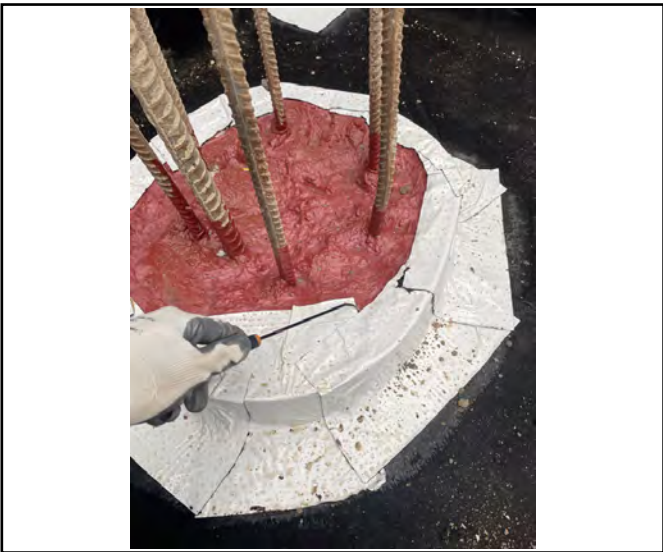
Pick and probe testing to a successfully

sealed pile head. No faults found.
