# Site Investigation Report

144332.1.USI

Auger were commissioned by Crawford & Co to undertake a site investigation and CCTV inspection of the underground drainage within the area of concern (AOC) at the property.

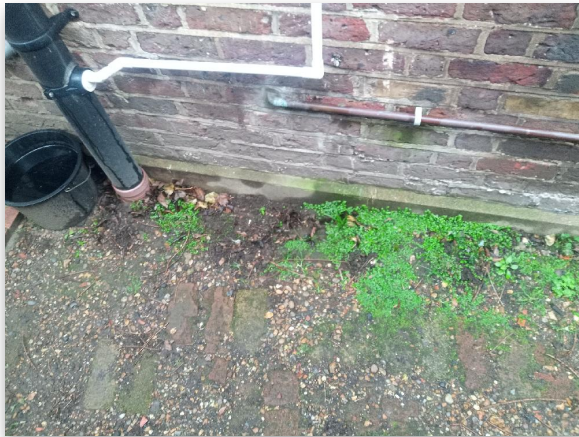
Fig 1.1: Trial Hole 1 Location

Within TH1 we revealed the footing but we were unable to reach the required depth in TH1 because we encountered mass gravel which our engineer could not auger through at 1.5m. The Trial Hole was excavated in the proposed location. We took soil samples but we were unable to collect root samples from TH1 because no roots were present during the trial hole, hence no samples were retrieved. These measurements are shown in Trial Hole Log 1 below.

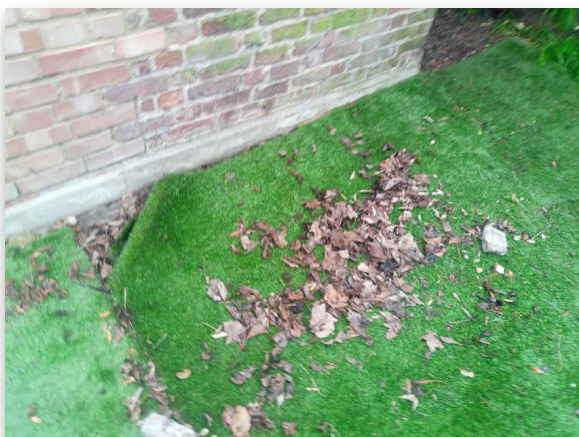
Fig 2.1: Trial Hole 2 Location

Within TH2 we revealed the footing but we were unable to reach the required depth in TH2 because we encountered mass gravel which our engineer could not auger through at 1.4m. The Trial Hole was excavated in the proposed location. We took soil and root samples. These measurements are shown in Trial Hole Log 2 below.

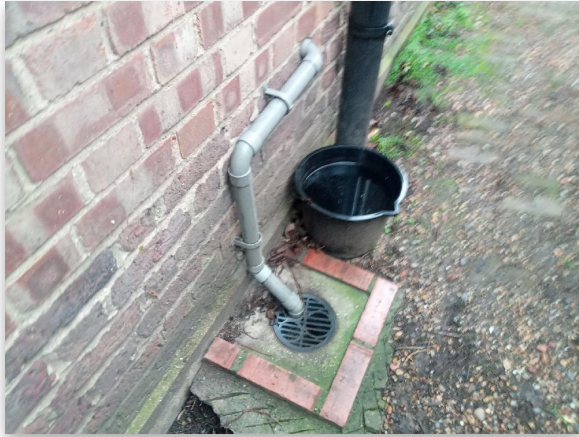
Fig 4.1: WG1

There is a cracked above ground pipe that is expelling into the WG. This is leading to an escape of water down the side of the property wall. We would recommend that a plumber is appointed to resolve this issue. These works will need to be carried out on a private basis

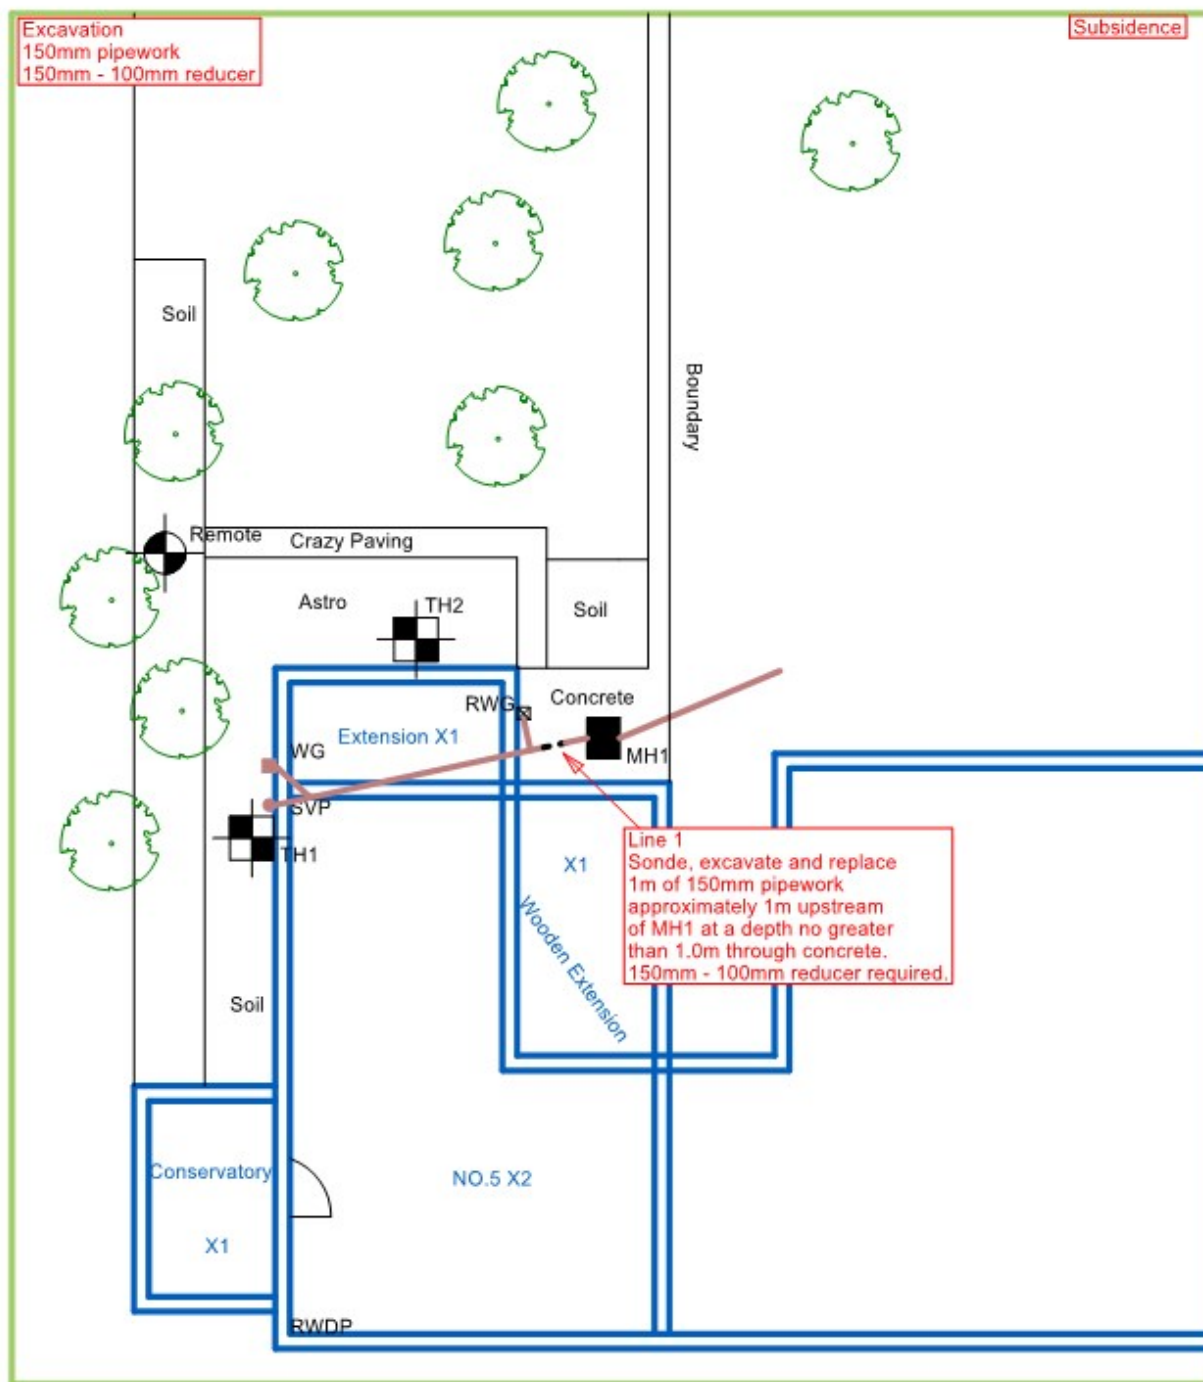
Our survey of line 1 revealed an open joint at 0.7m

The above mentioned defects to the below ground drainage system have been caused by ground movement.

Line 1  
Sonde, excavate and replace  
1m of 150mm pipework  
approximately 1m upstream  
of MH1 at a depth no greater  
than 1.0m through concrete.  
150mm - 100mm reducer required.

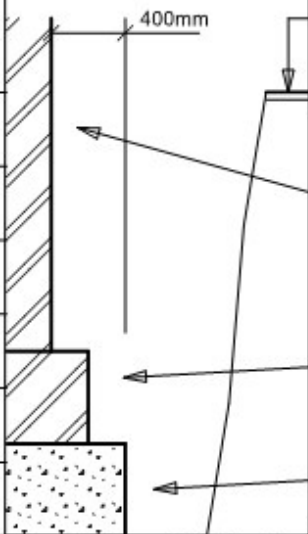
# Trial Hole Log No.1

| Depth<br>(m) | Symbolic Log | Strata Description | Insitu Tests | | Soil<br>Sample | Root<br>Sample |
|---|---|---|---|--|---|---|
| 1.5 | | TRIAL HOLE TERMINATED | | | | |

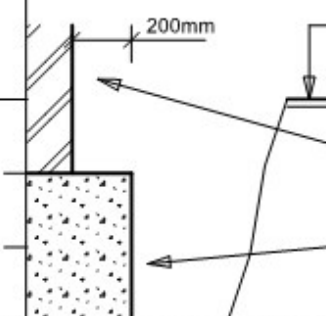
## Trial Hole Log No.2

| Depth<br>(m) | Symbolic Log | Strata Description | Insitu Tests | | Soil<br>Sample | Root<br>Sample |
|---|---|---|---|--|---|---|
| 1.5 | | TRIAL HOLE TERMINATED | | | | |
