# Site Investigation Report

144332.1.USI

Auger were commissioned by Crawford & Co to undertake a site investigation and CCTV inspection of the underground drainage within the area of concern (AOC) at the property.

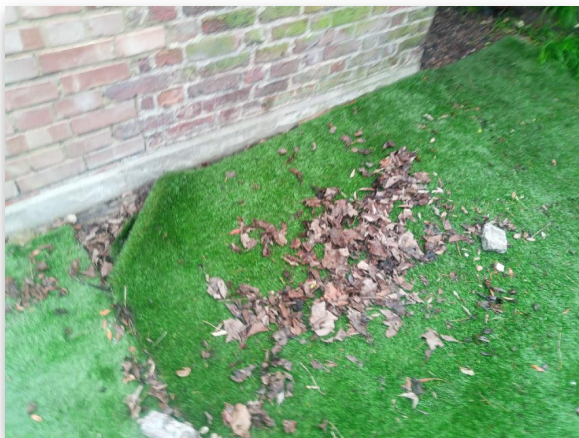
Fig 2.1: Trial Hole 2 Location

Within TH2 we revealed the footing but we were unable to reach the required depth in TH2 because we encountered mass gravel which our engineer could not auger through at 1.4m. The Trial Hole was excavated in the proposed location. We took soil and root samples. These measurements are shown in Trial Hole Log 2 below.

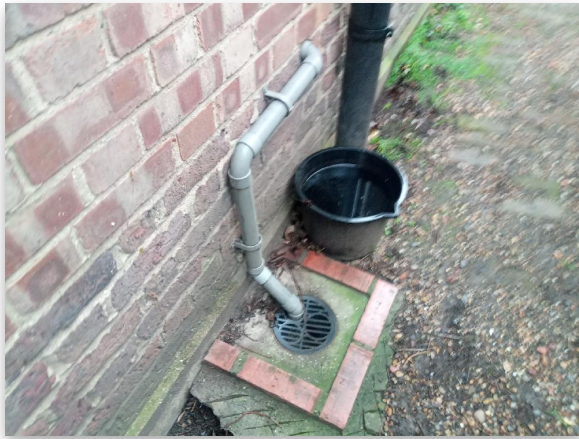
Fig 4.1: WG1

There is a cracked above ground pipe that is expelling into the WG. This is leading to an escape of water down the side of the property wall. We would recommend that a plumber is appointed to resolve this issue. These works will need to be carried out on a private basis

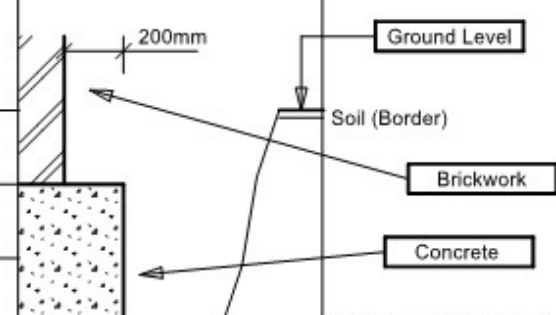
## Trial Hole Log No.2

Location: Rear middle of extension

| Depth<br>(m) | Symbolic Log | Strata Description | Insitu Tests | | Soil<br>Sample | Root<br>Sample |
|---|---|---|---|--|---|---|
| 1.5 | | TRIAL HOLE TERMINATED | | | | |
