# HIGHWAYS/PUBLIC WALKWAYS SCHEDULE OF CONDITION

Kerswell Close - Development of a Tarmac carpark into 2  
blocks of residential flats

Prepared by: Tom Barker

Date: 06 October 2023

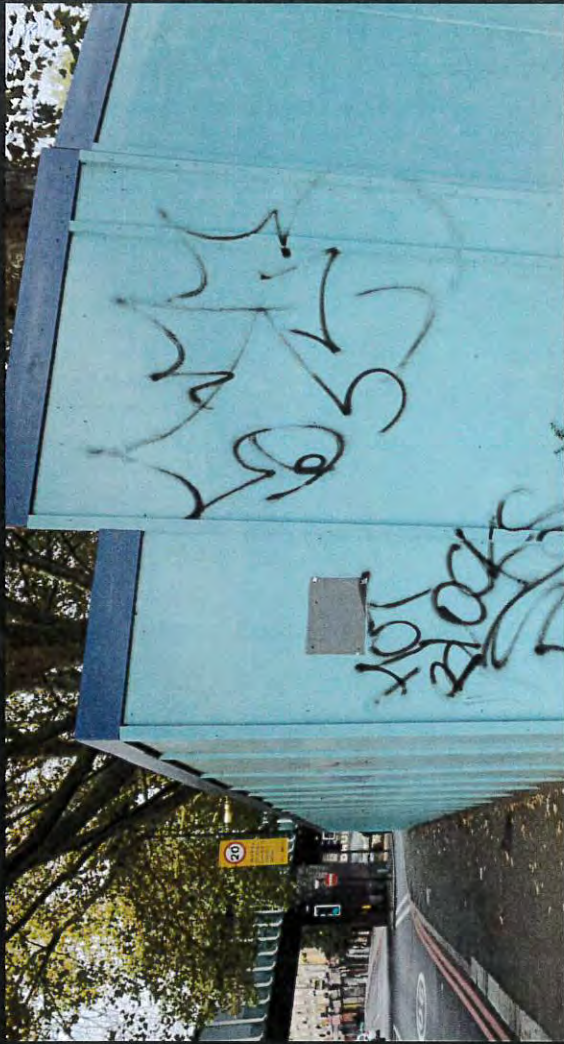
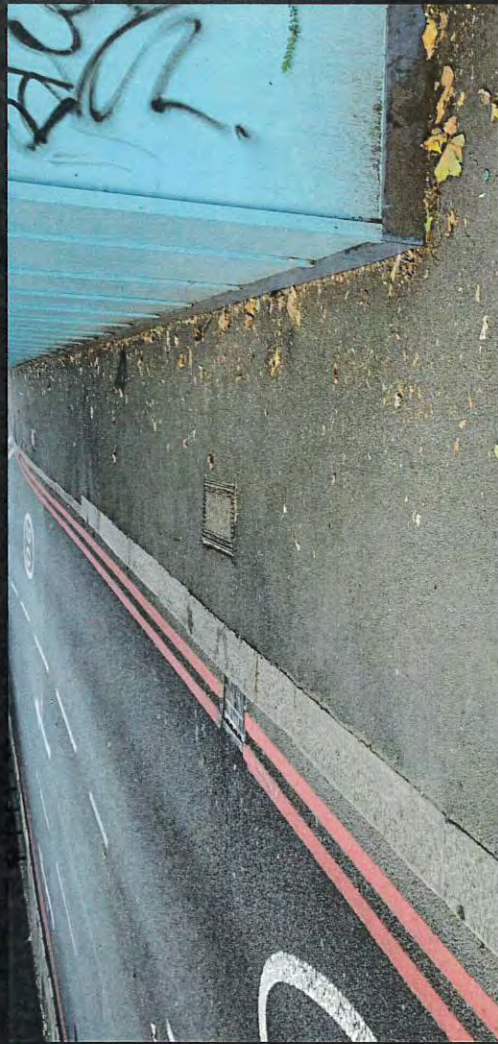
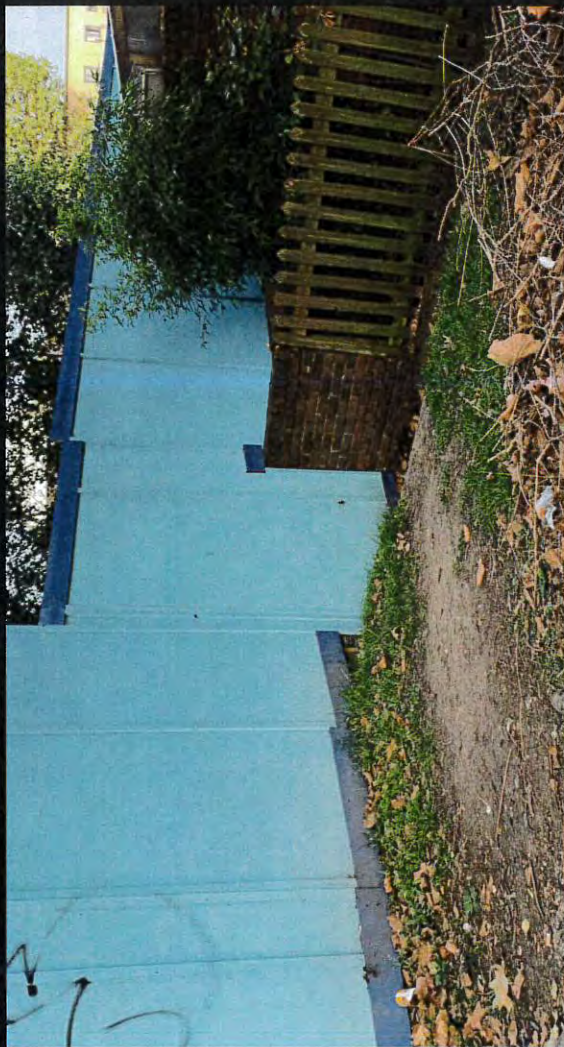
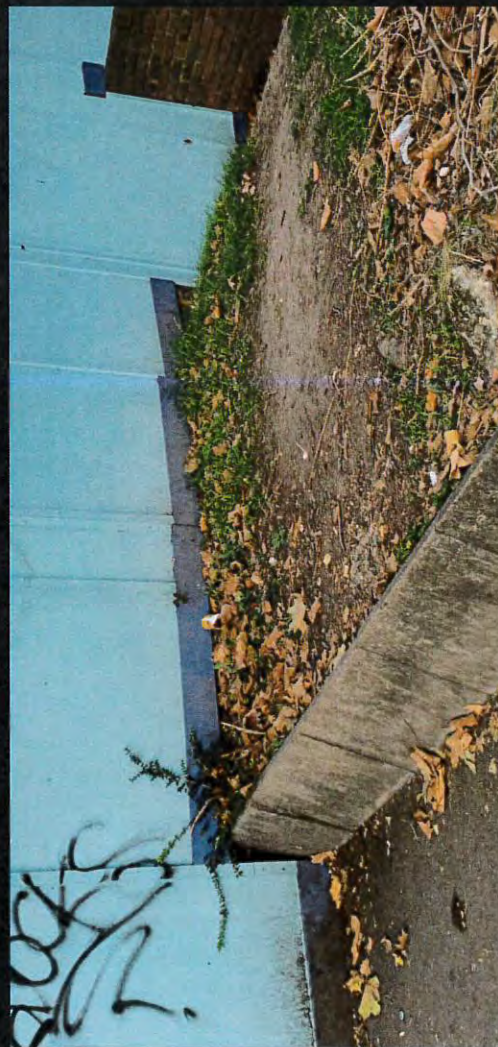
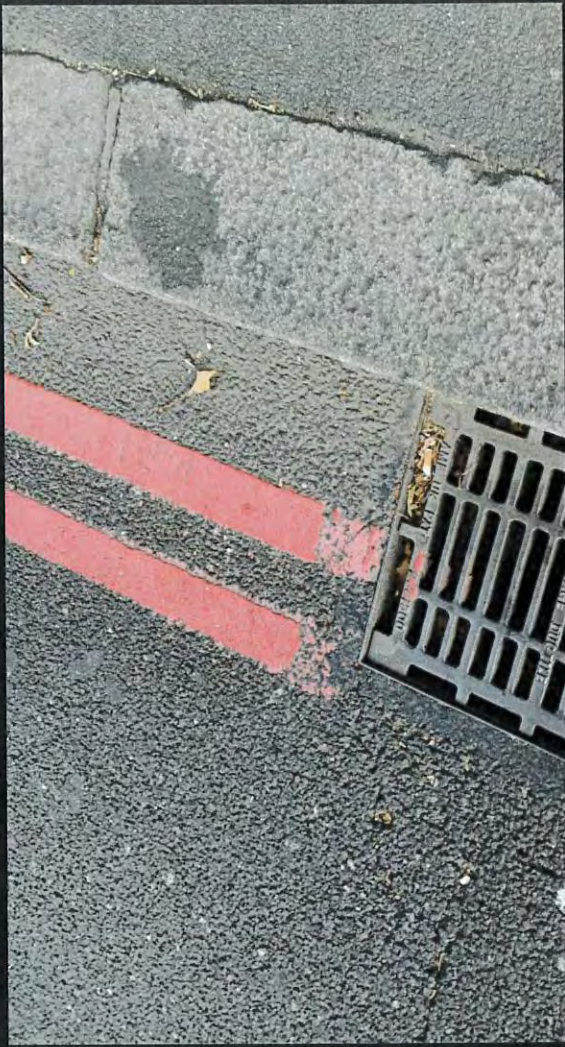
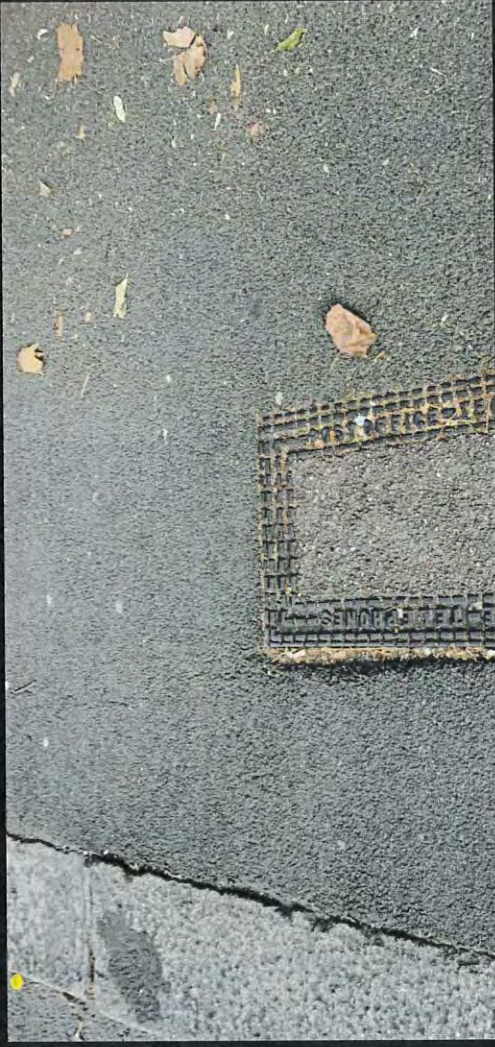
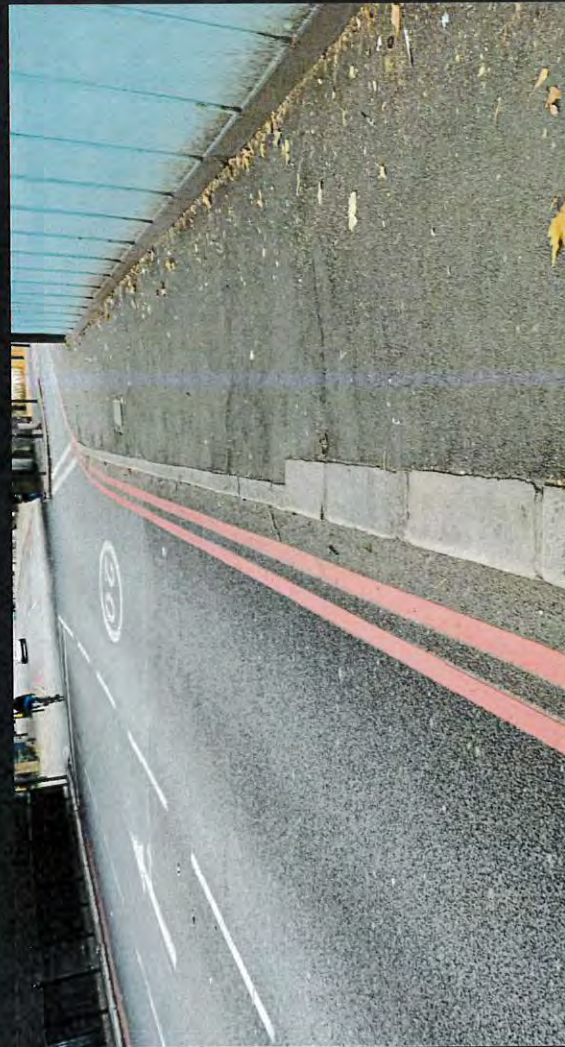
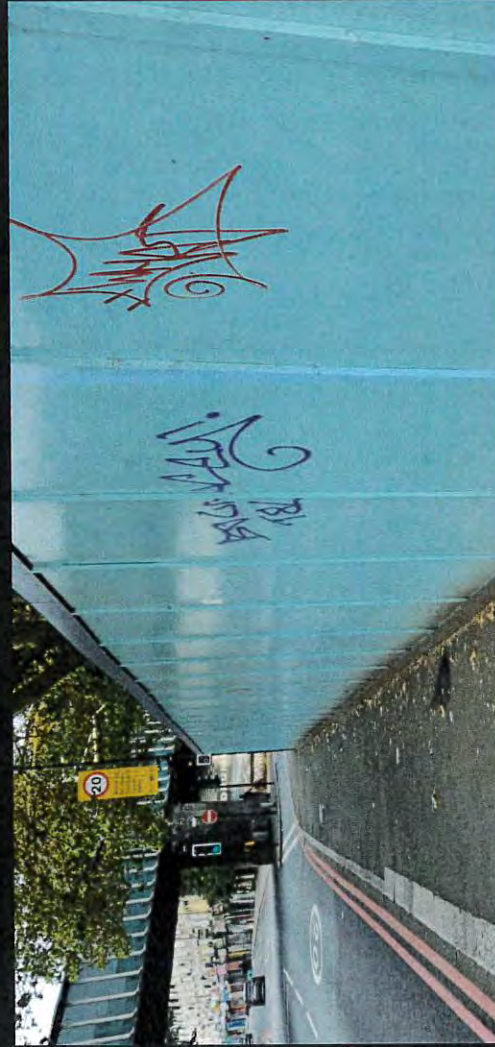
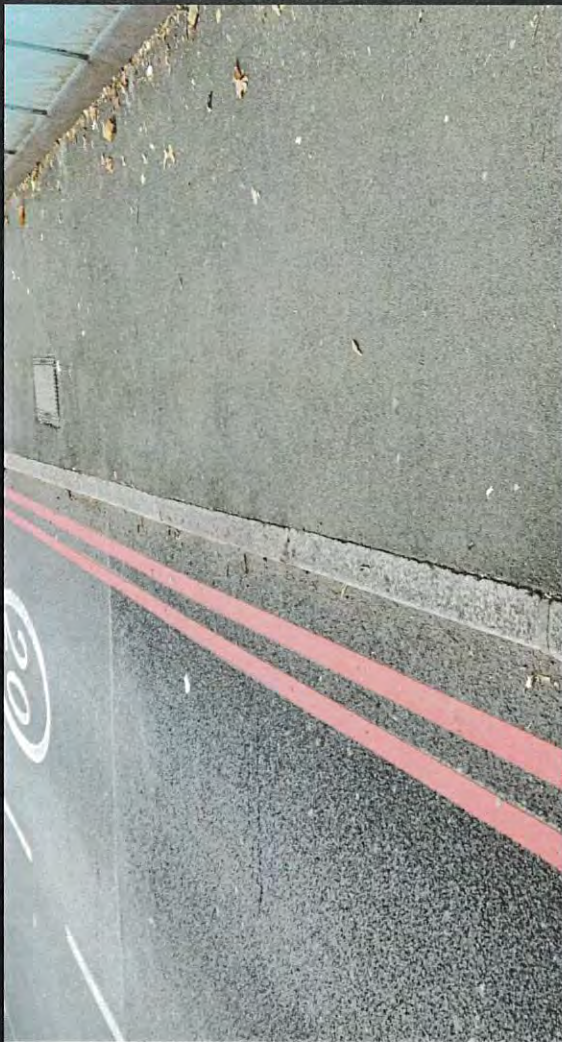
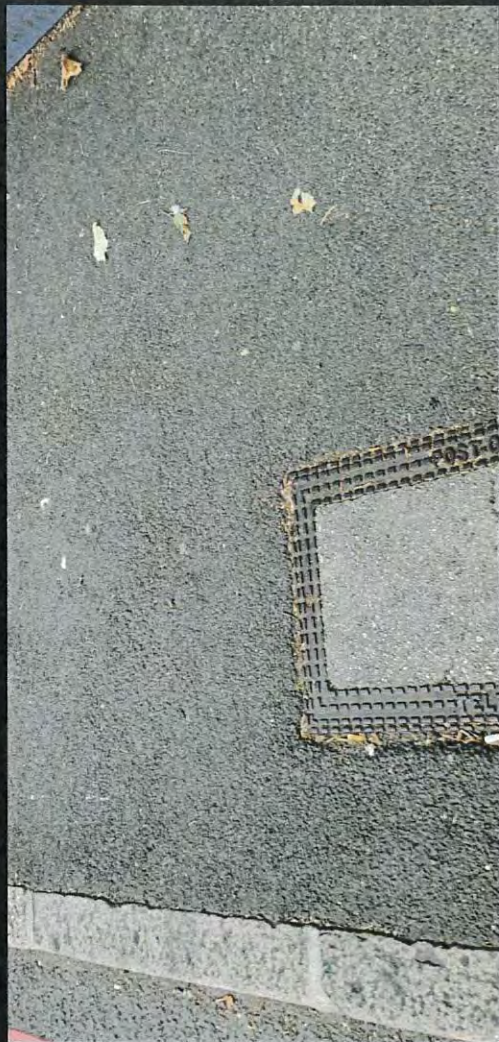
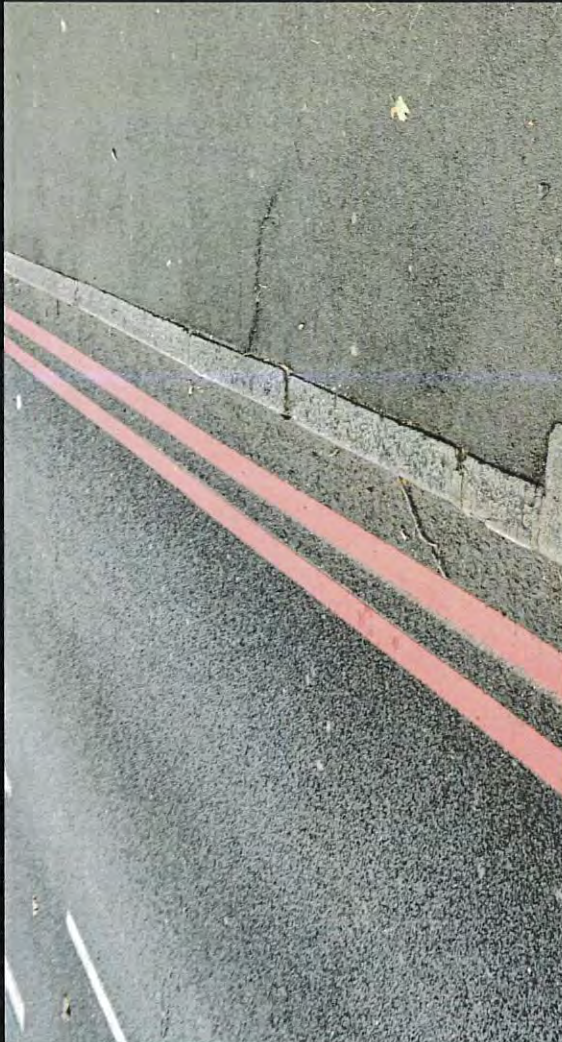
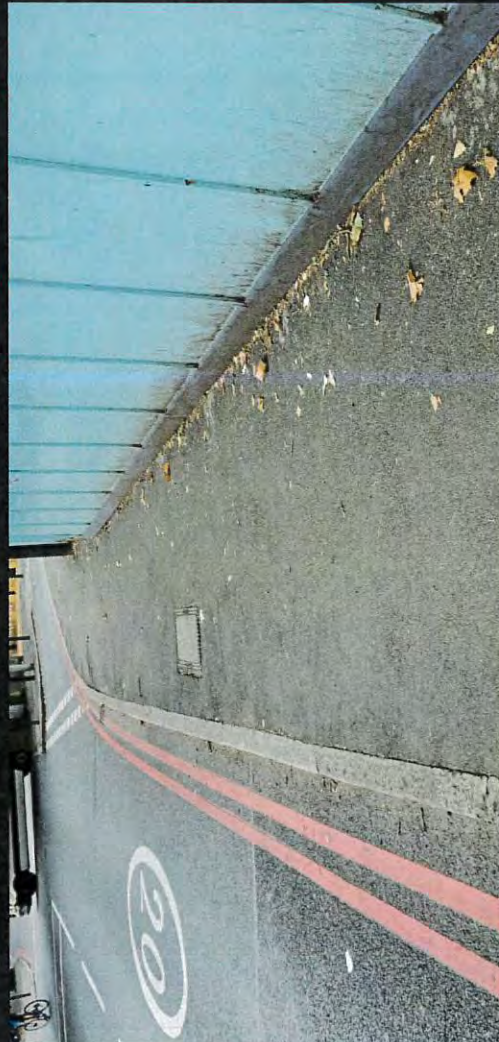
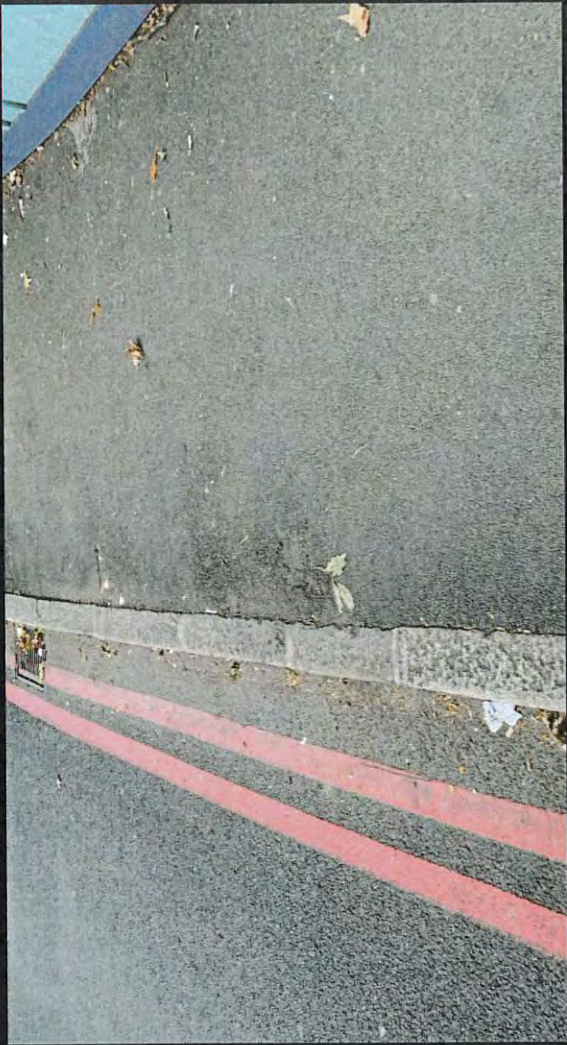
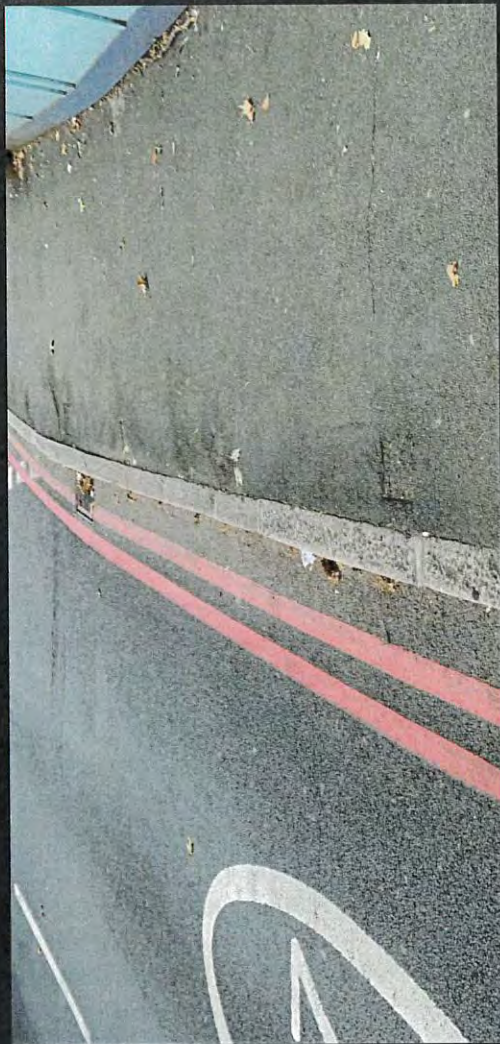
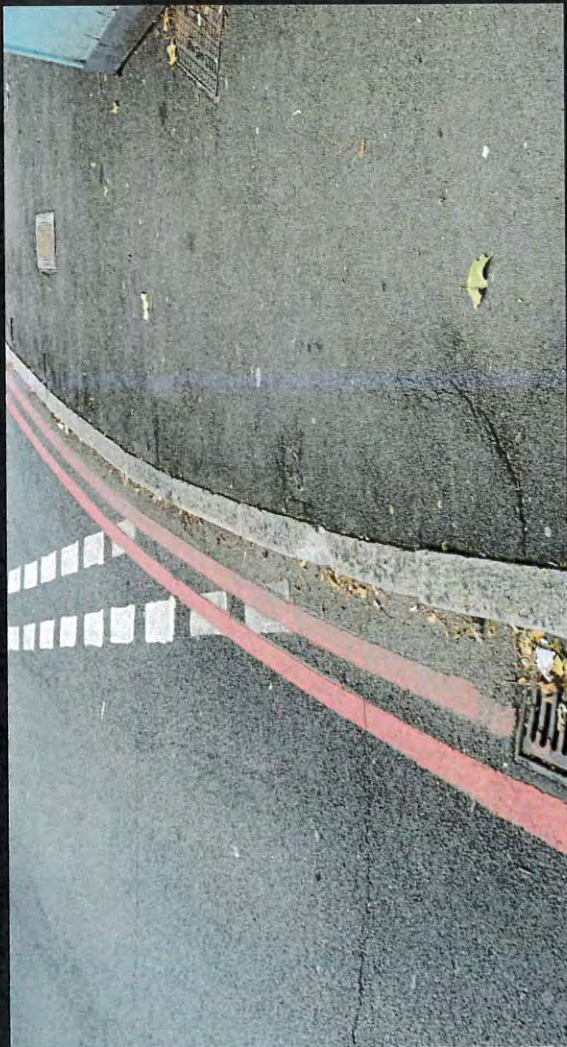
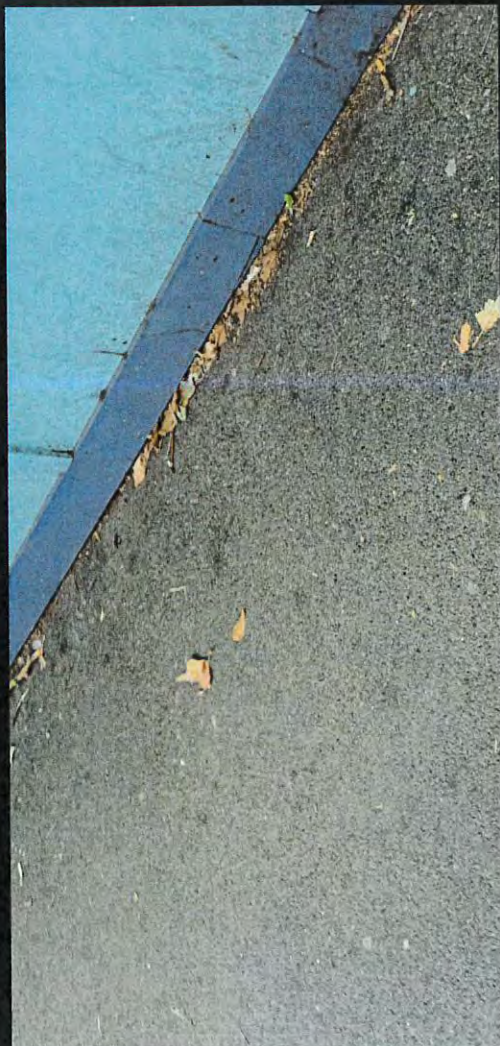
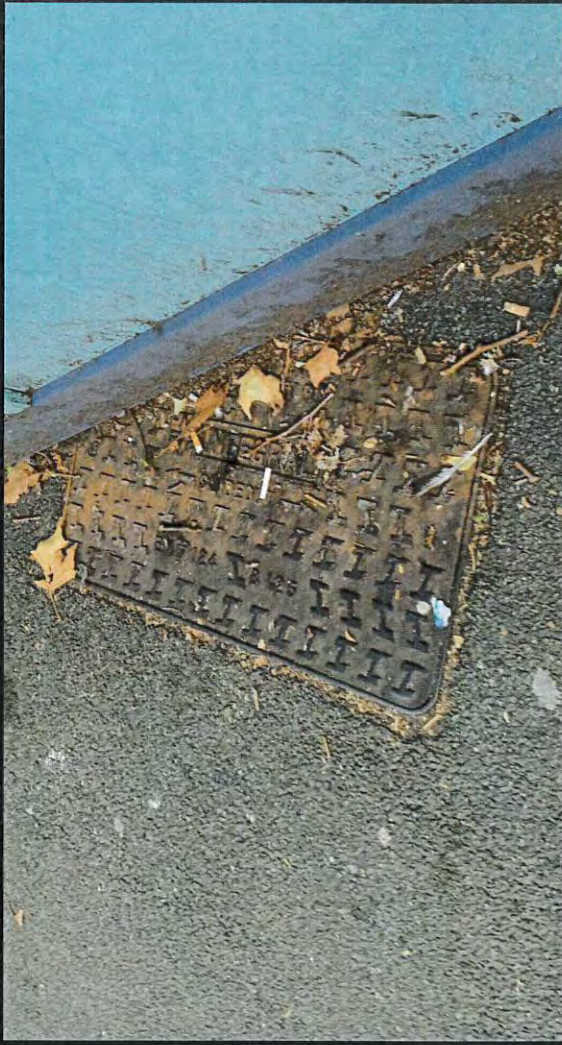
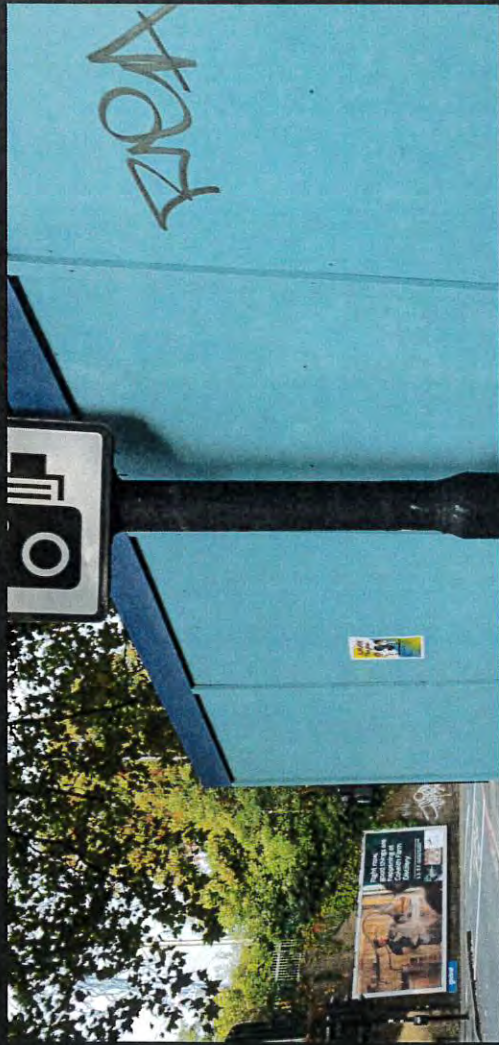
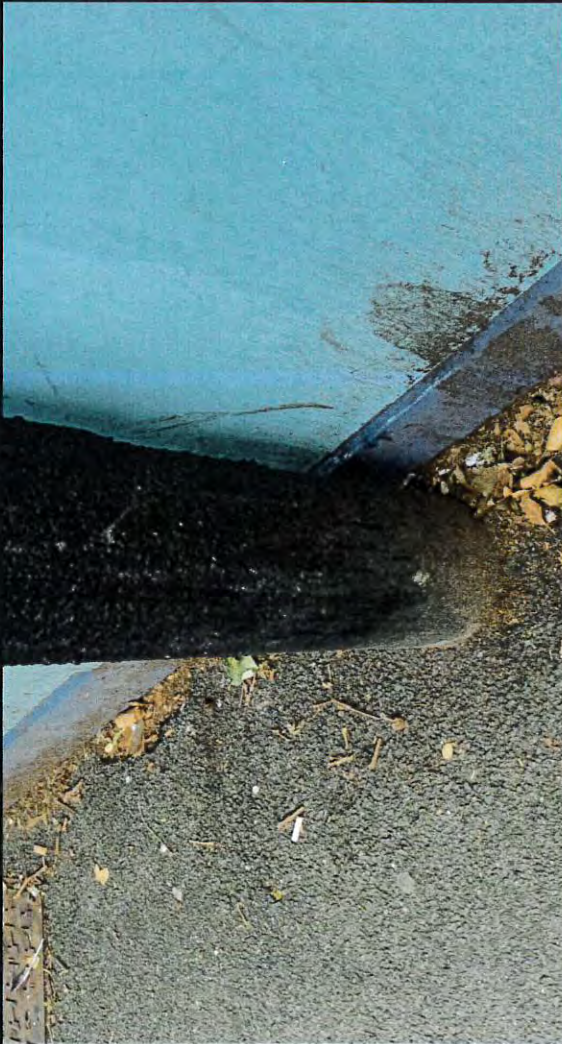
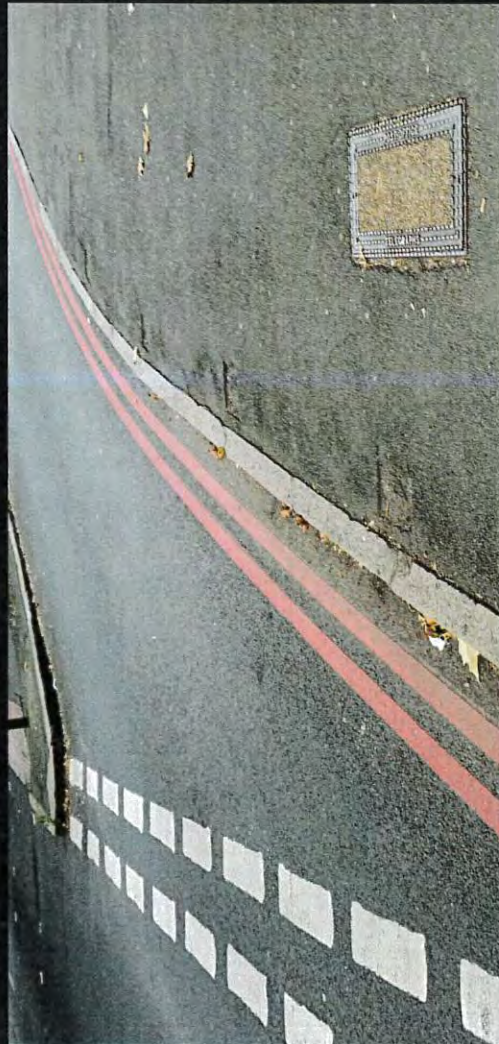
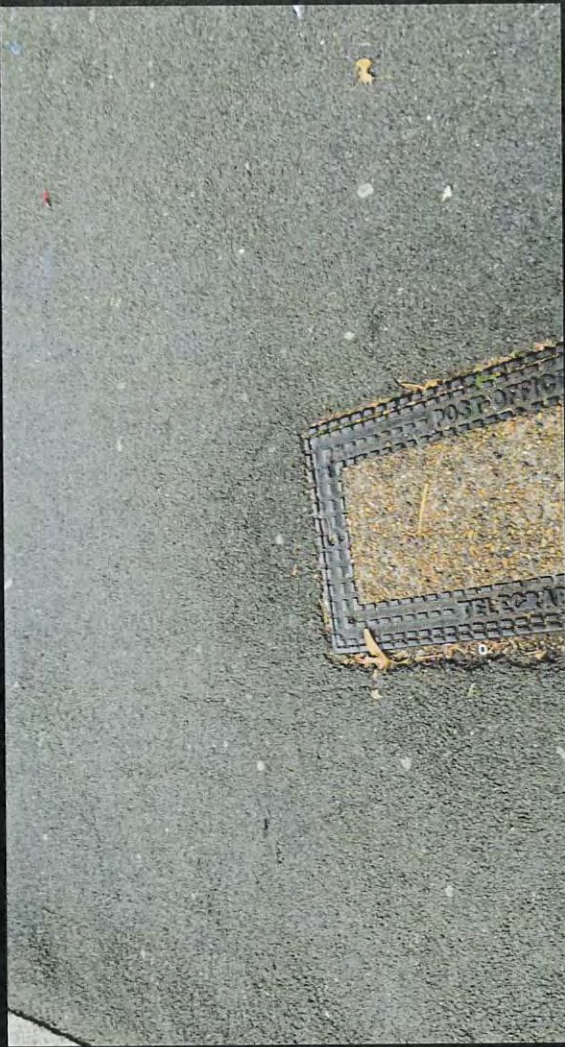
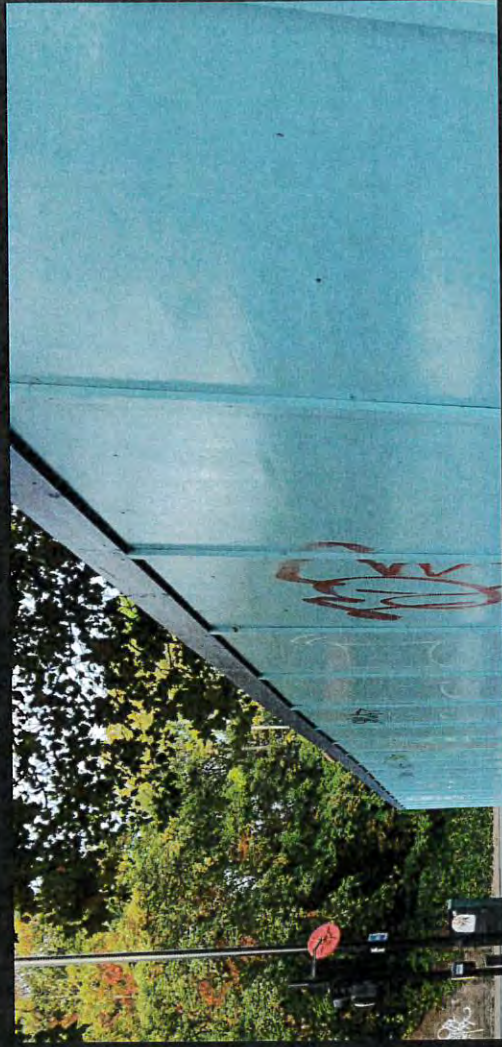
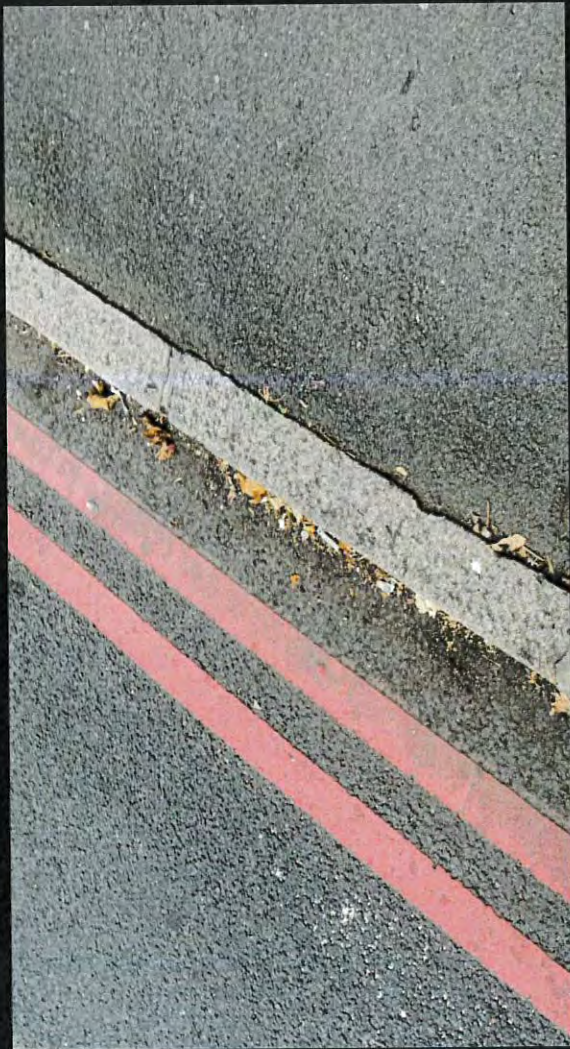
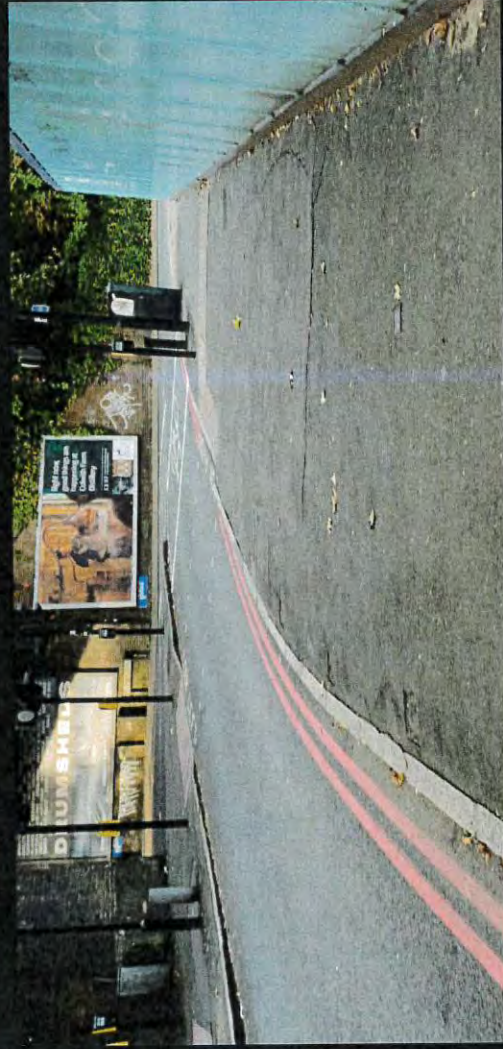
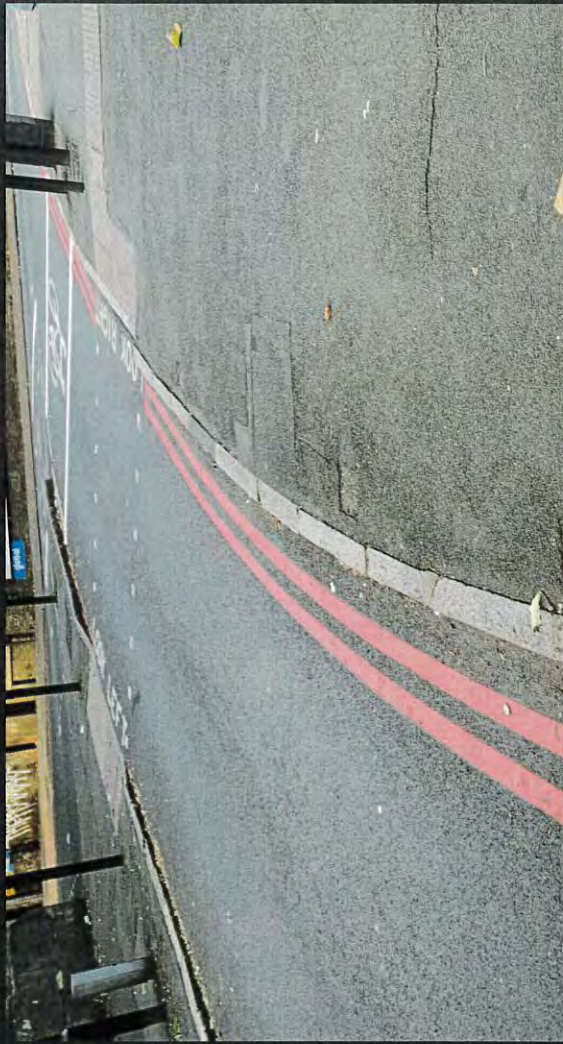
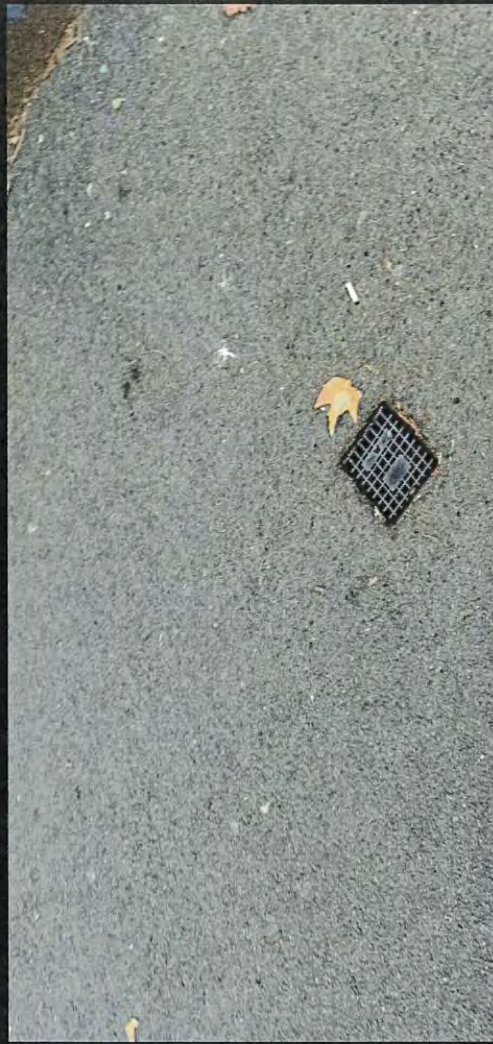
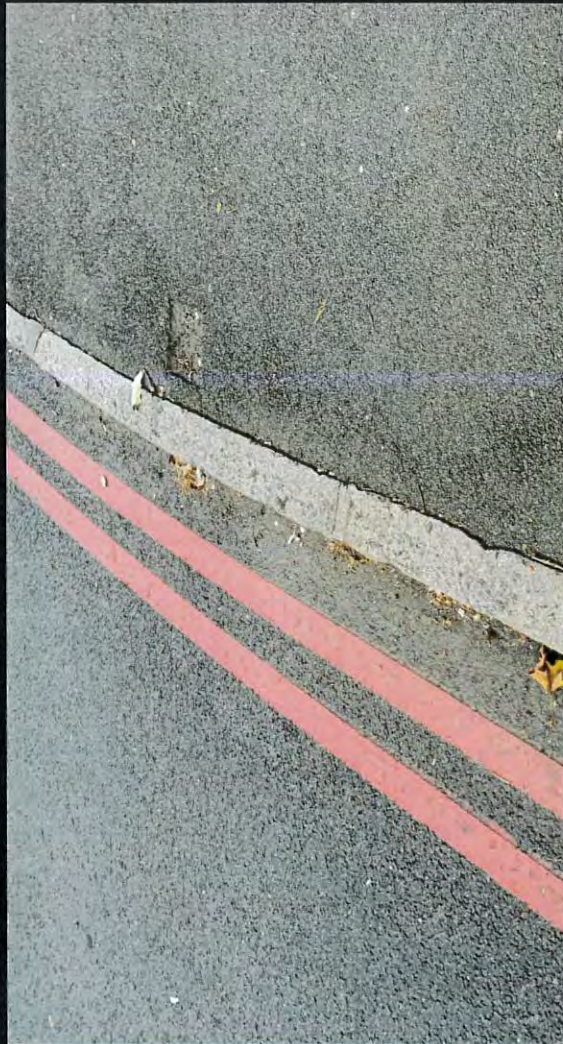
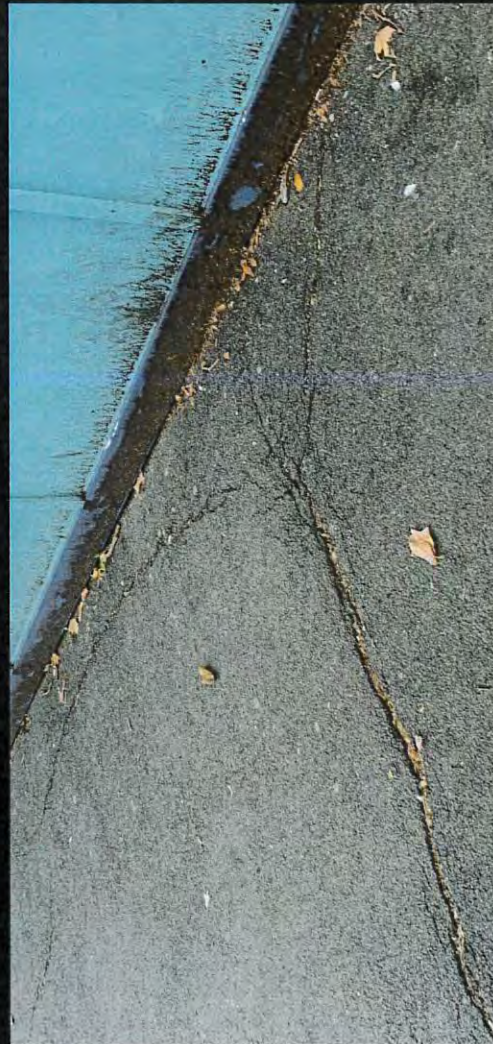
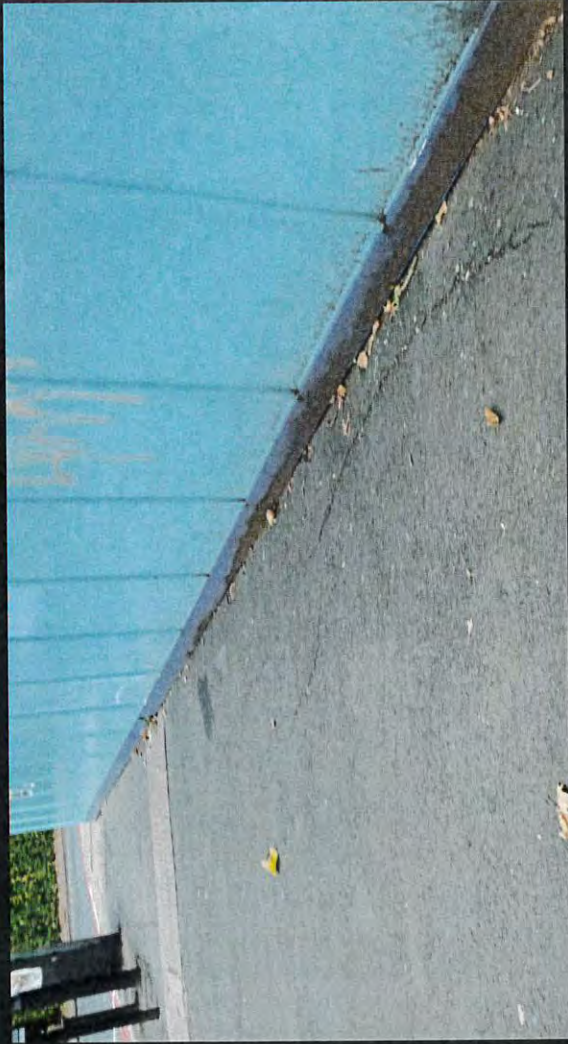
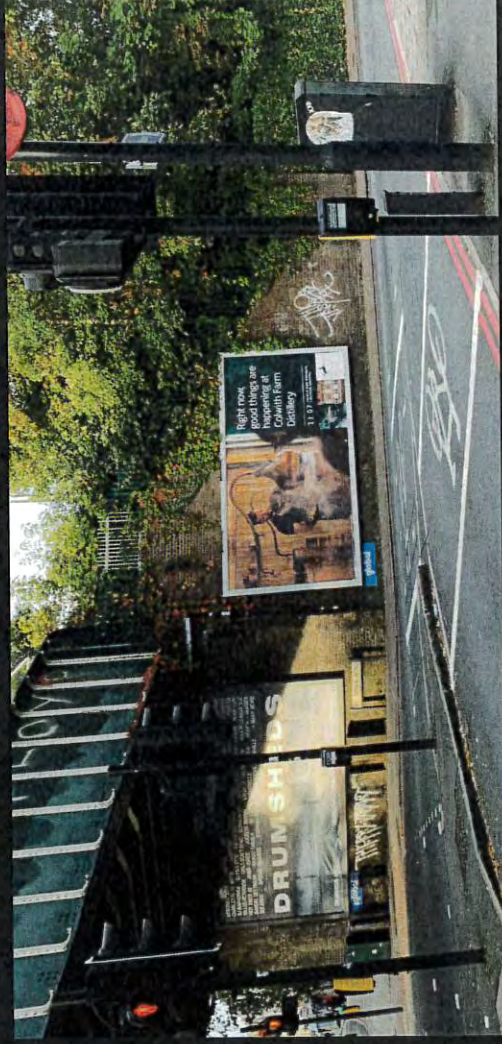
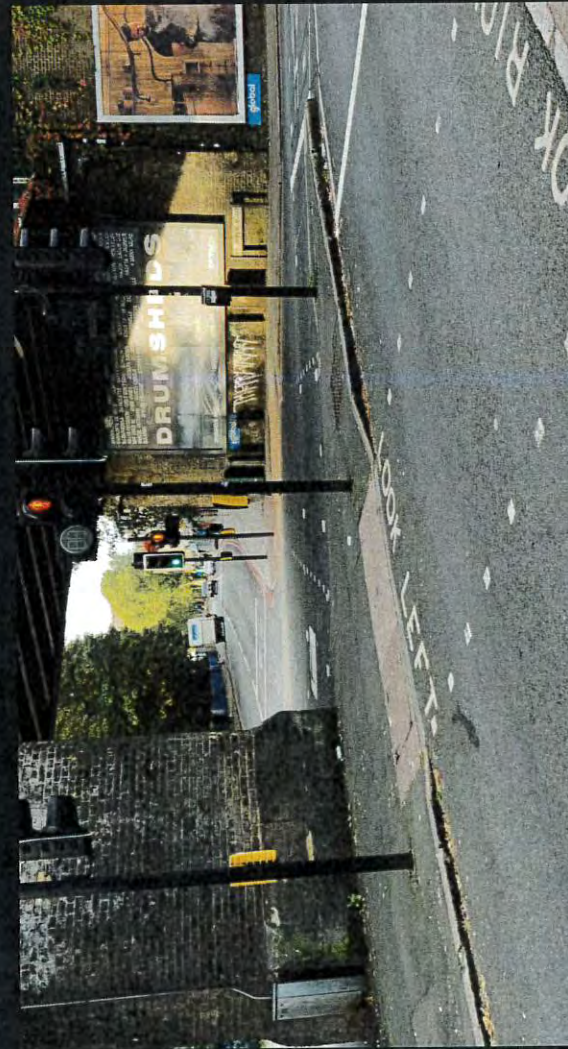
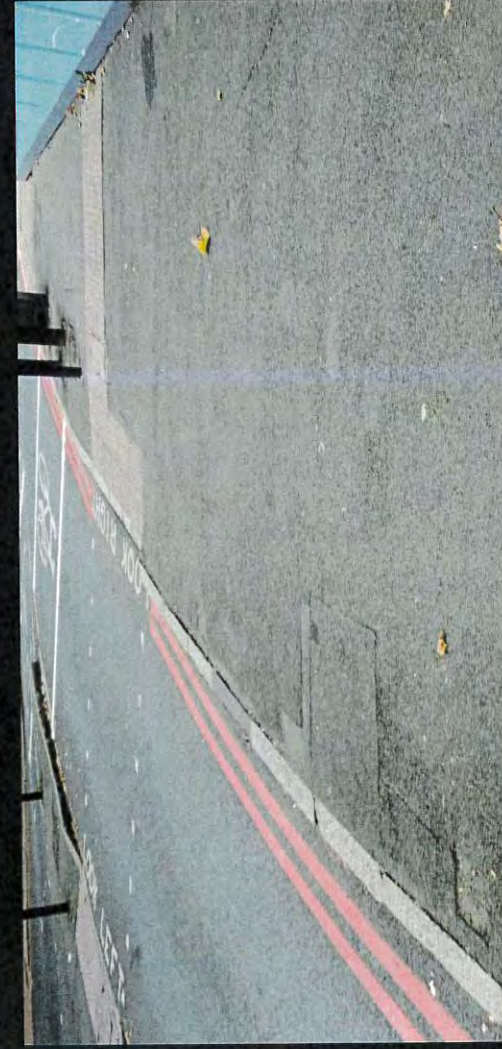
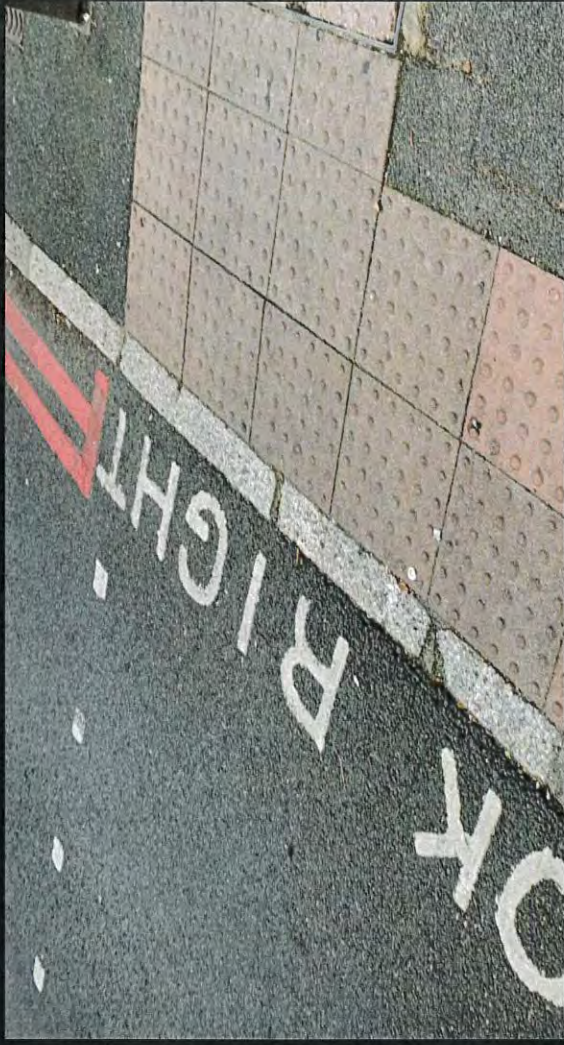
# Seven Sisters Road Photos 1 – 54

| Ref No | Location / Element | Description | Defects/Condition and Comments | Photo Ref No |
|---|---|---|---|---|
| 1.1.1 | Footpath | Footpath comprises of a combination of tarmacadam floor covering, block paving in a herringbone arrangement (to corner junction with Seven Sisters road), tactile paving to pedestrian crossing and corner junction connecting with ,Concrete paving slabs, plus stone kerb. | A heavily trafficked footpath showing general wear and tear on all elements. Some paving slabs loose and uneven with various areas being infilled with cement to repair. Kerbs well-worn and chipped | Photos 1 - 29 |
| 1.1.2 | Carriageway | Heavily trafficked main road comprising of tarmac covering with painted road markings and drains adjacent to kerb. Pedestrian crossing located centrally to surveyed section | Carriageway appears to be in an overall fair condition, with some sections of the carriageway appearing to be more recently resurfaced. Exhibits signs general surface wear, discolouration, and weathering. Road markings are faded in areas. Drain covers appear secure and intact and clear of debris. The following defect was noted. | |
| 1.1.3 | Street Furniture | Utility maintenance covers, Pedestrian crossing, cylindrical streetlamp, and street signage. | Overall fair condition, loose cover panels to some columns and numerous cable ties on one column | |
