# HIGHWAYS/PUBLIC WALKWAYS SCHEDULE OF CONDITION

Kerswell Close - Development of a Tarmac carpark into 2  
blocks of residential flats

Prepared by: Tom Barker

Date: 06 October 2023

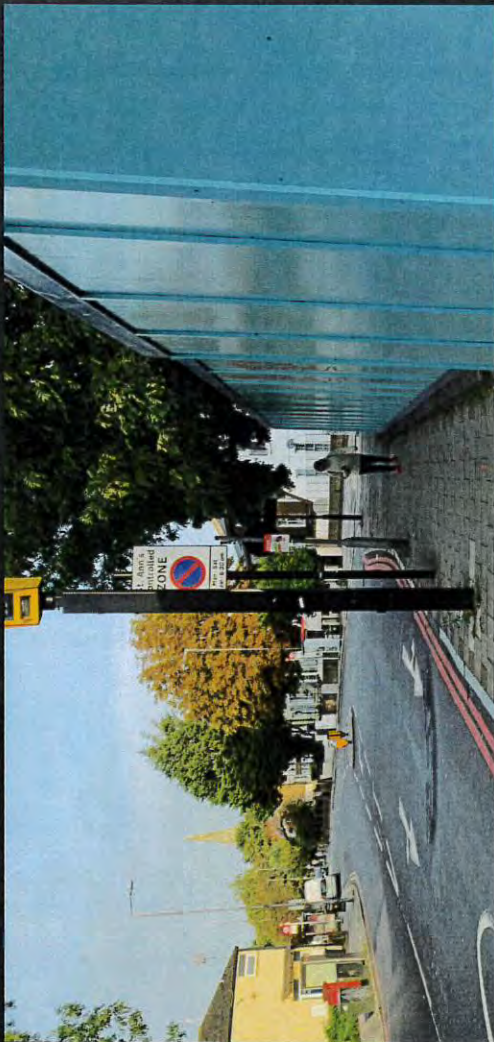
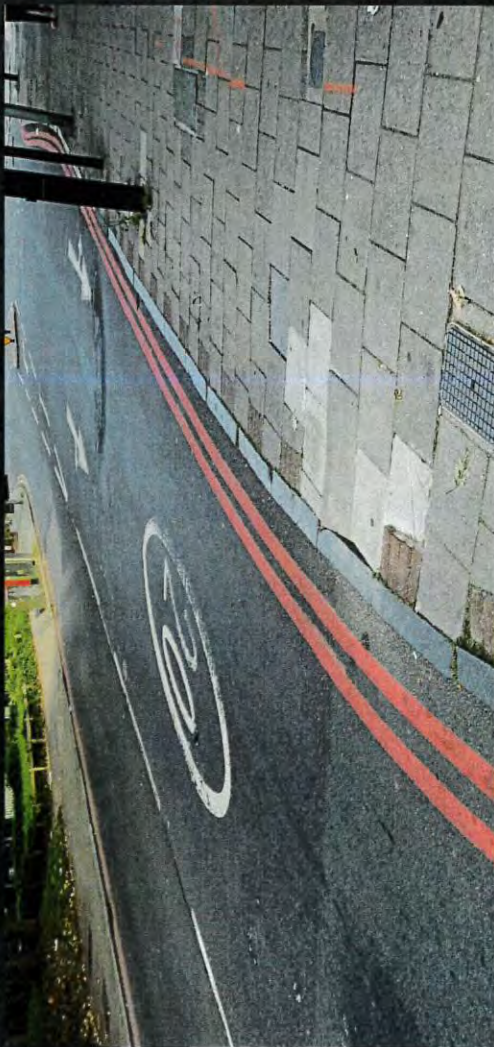
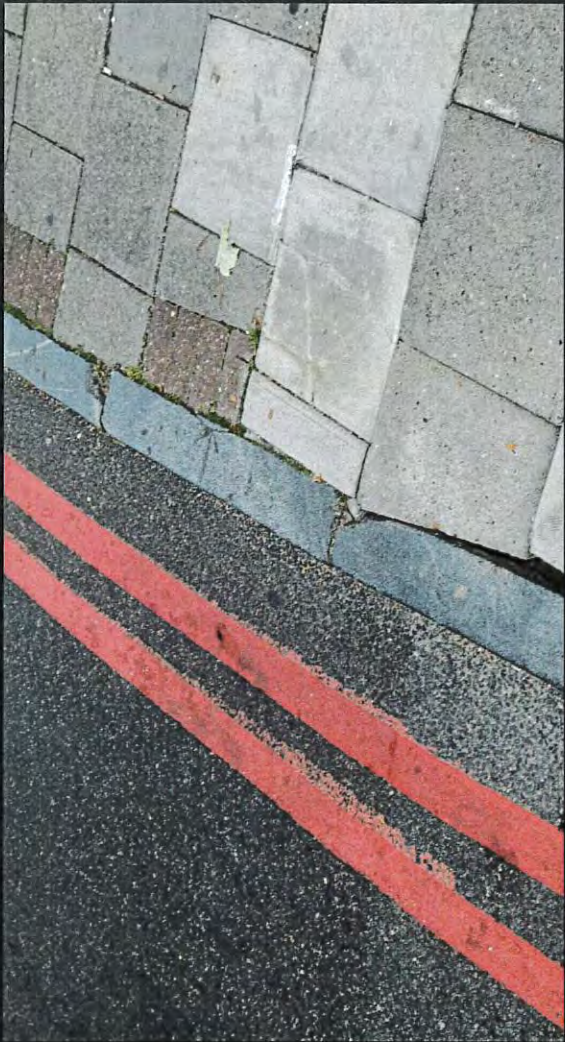
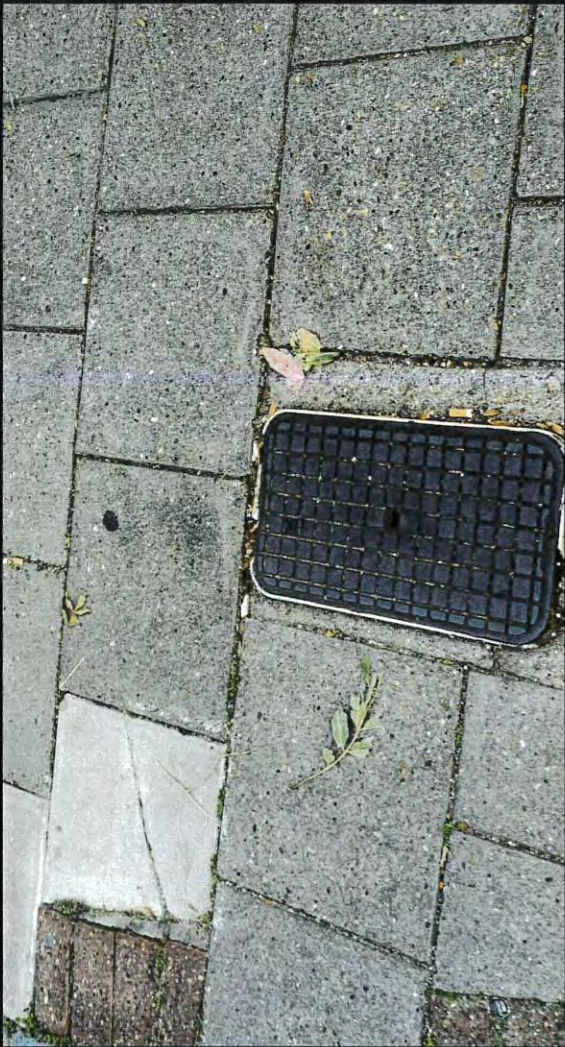
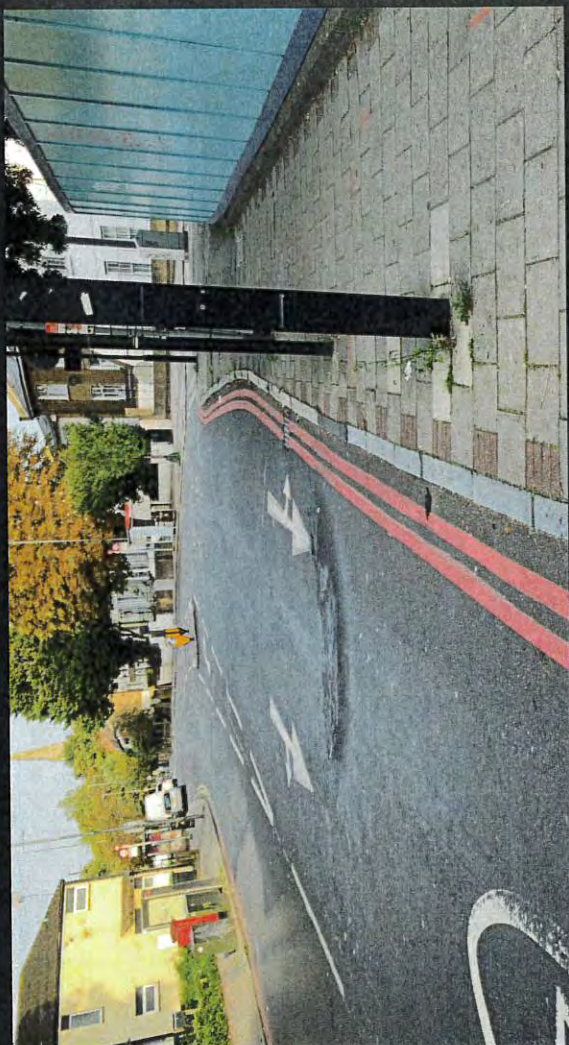
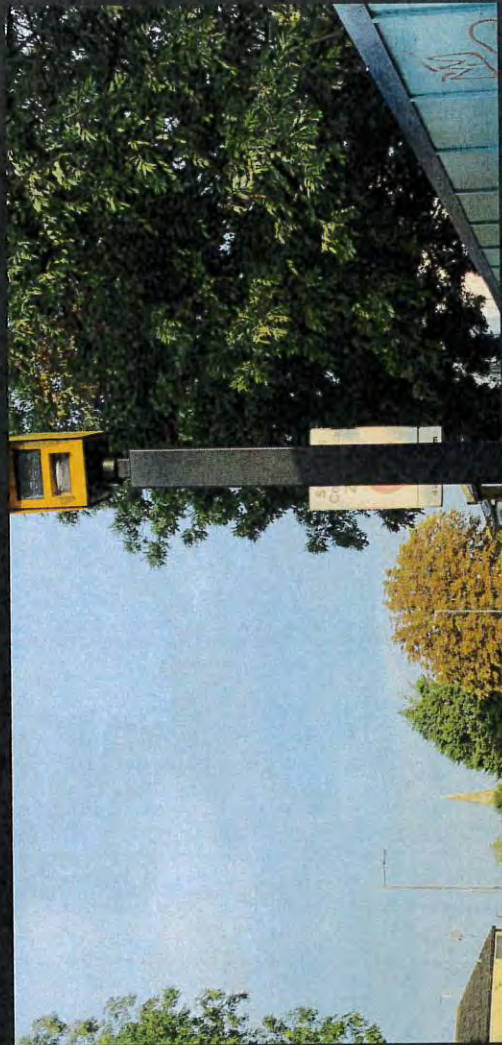
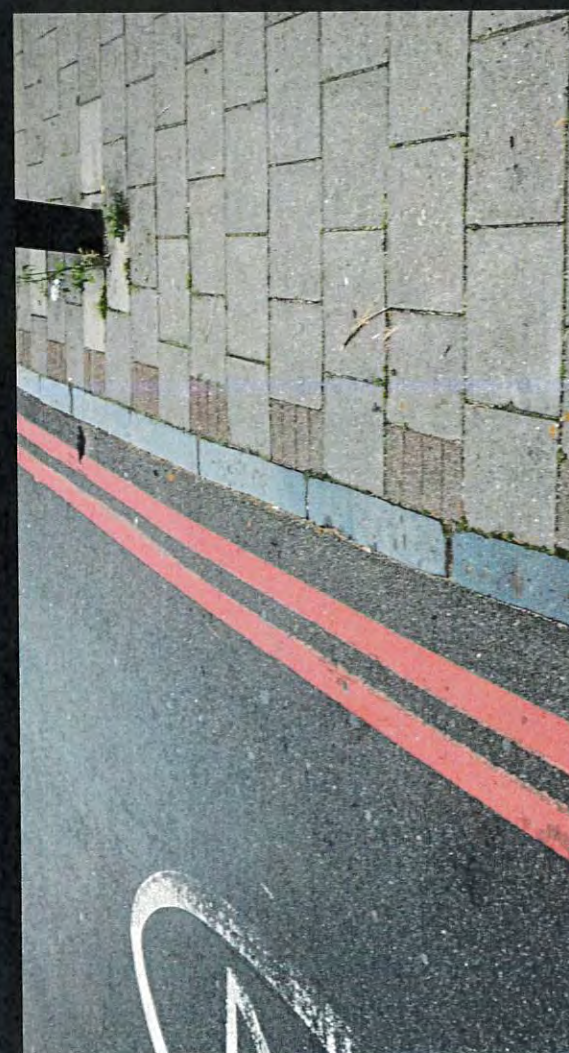
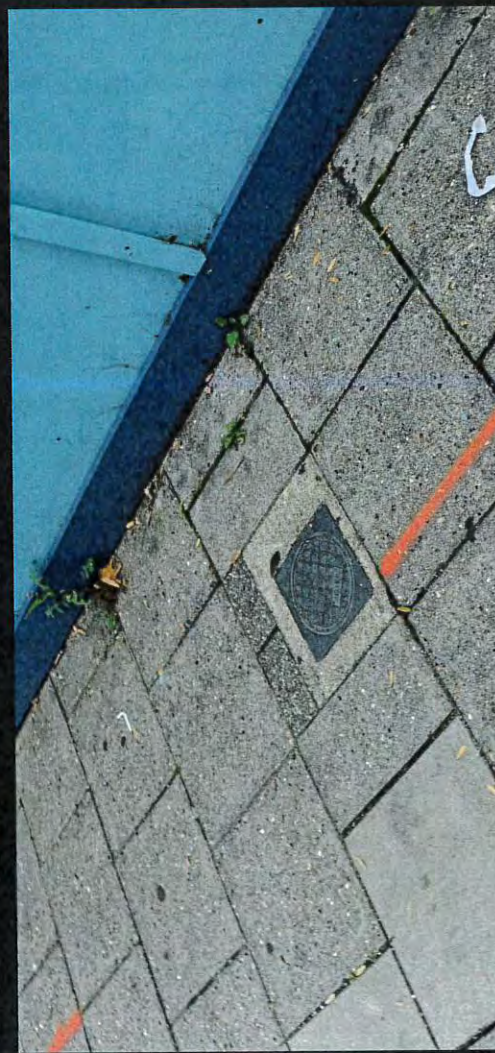
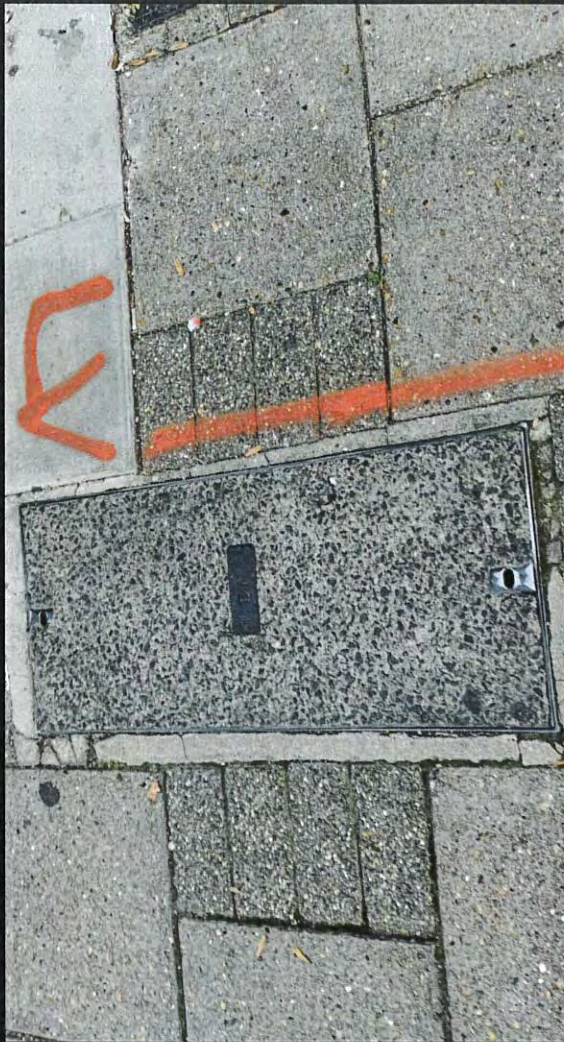
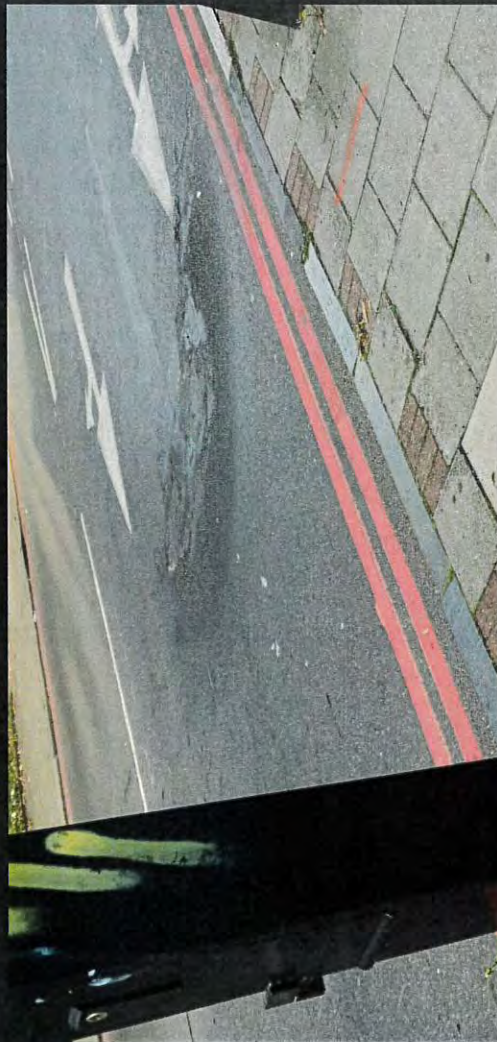
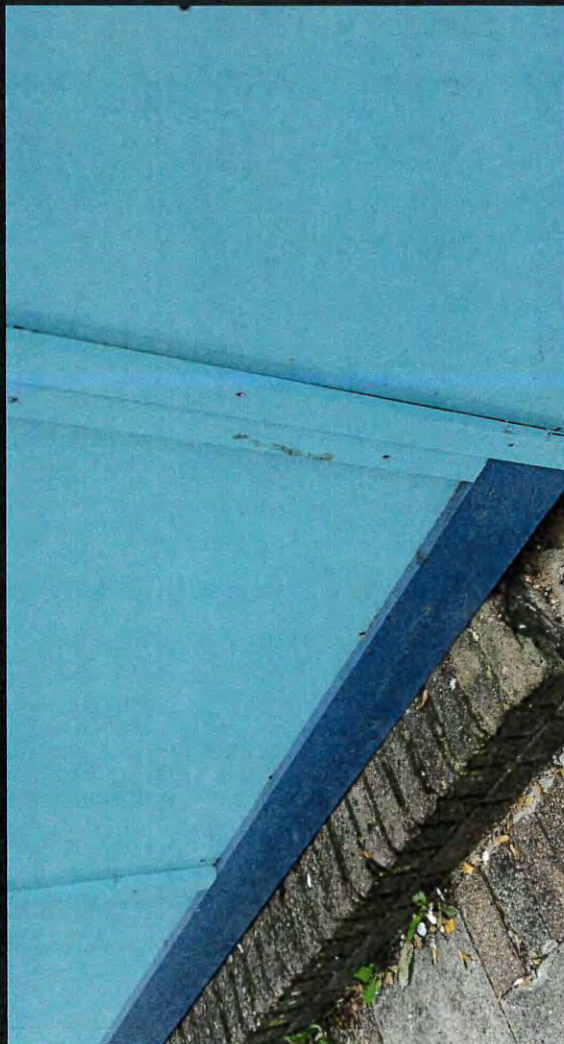
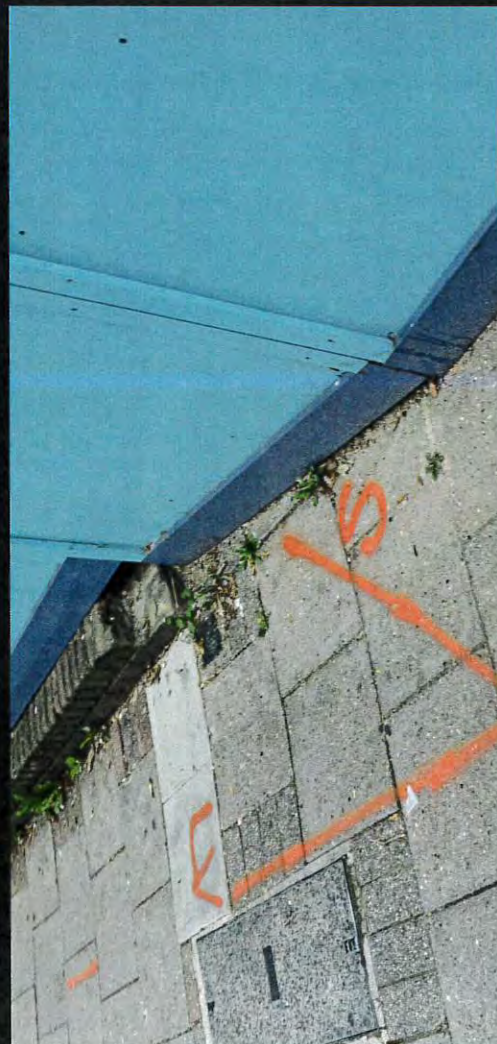
# St Annes Road Photos 55 – 82

| 1.2 | St Annes Road | | | Ref |
|---|---|---|---|---|
| 1.2.1 | Footpath | Foot path consists of paving flags and Concrete patch repair | Showing general wear and tear, uneven paving flags and broken concrete around BT covers | Photos 55 to 83 |
| 1.2.2 | Carriageway | Heavily used section of carriageway, made up of tarmac | Line marking worn but no pot holes or divots | |
| 1.2.3 | Street Furniture | Speed camera and road signs | Street camera looks new all other signs are fairly old but all in ok condition. | |
