# ARBORICULTURAL ASSESSMENT REPORT

46 Vallance Road, London, N22 7UB

**PRI Ref:** 252204

**Survey Date:** 21/02/2023

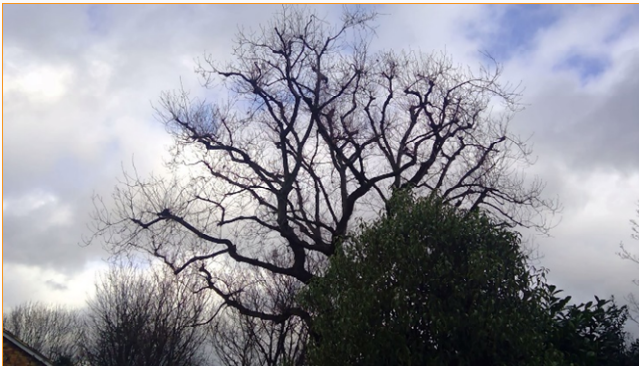
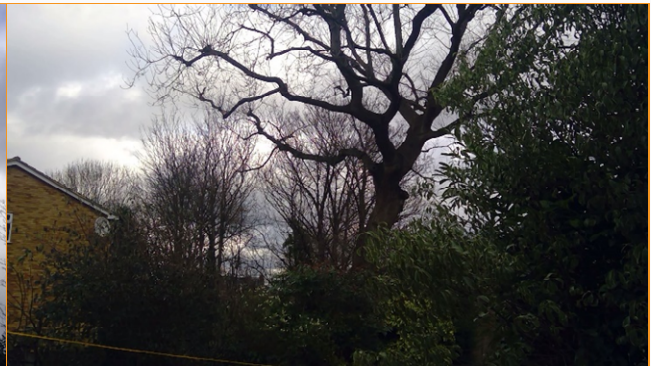
T1 - Oak (English)

| Tree No | Common Name | Age Class | Condition | Height (m) | Crown Spread (m) | Stem diam. (mm) | Dist to bldg. (m) | Roots Implicated | Pruning history | Recommendation | Tree work constraints | Notes | Owner address | Owner |
|---|---|---|---|---|---|---|---|---|---|---|---|---|---|---|
| T1 | Oak (English) | Mature | Good | 13 | 8 | 550* | 13 | Y | Subject to past reduction management (within last 3years). | A 4m height and width canopy reduction. | Access through building. | | 48 Vallance Road<br>London<br>N22 7UB | P3P |

| Tree No: | Species | Works Required |
|---|---|---|
| T1 | Oak (English) | A 4m height and width canopy reduction |

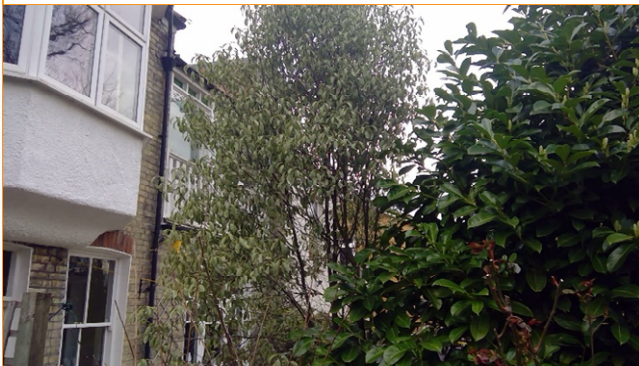
S1 - Pittosporum

| Tree No | Common Name | Age Class | Condition | Height (m) | Crown Spread (m) | Stem diam. (mm) | Dist to bldg. (m) | Roots Implicated | Pruning history | Recommendation | Tree work constraints | Notes | Owner address | Owner |
|---|---|---|---|---|---|---|---|---|---|---|---|---|---|---|
| S1 | Pittosporum | Mature | Good | 4 | 1.0 | 20 | 3.7 | N | Subject to past management. | No work required. | | | 48 Vallance Road<br>London<br>N22 7UB | P3P |

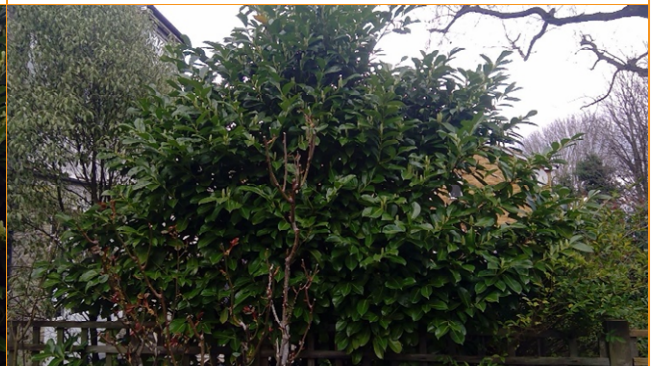
S2 - Laurel (Cherry)

| Tree No | Common Name | Age Class | Condition | Height (m) | Crown Spread (m) | Stem diam. (mm) | Dist to bldg. (m) | Roots Implicated | Pruning history | Recommendation | Tree work constraints | Notes | Owner address | Owner |
|---|---|---|---|---|---|---|---|---|---|---|---|---|---|---|
| S2 | Laurel (Cherry) | Mature | Good | 4 | 2 | 50* | 4.6 | N | Subject to past management. | No work required. | | | 48 Vallance Road<br>London<br>N22 7UB | P3P |

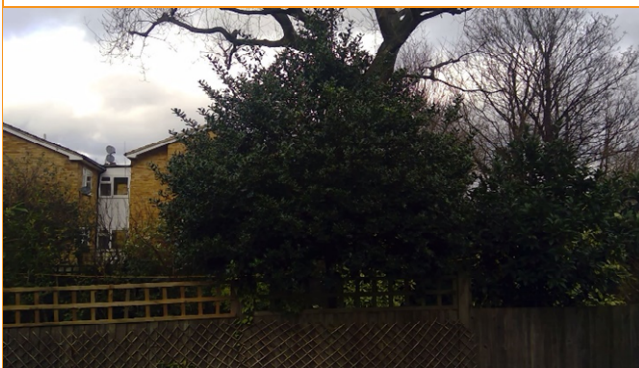
S3 - Holly

| Tree No | Common Name | Age Class | Condition | Height (m) | Crown Spread (m) | Stem diam. (mm) | Dist to bldg. (m) | Roots Implicated | Pruning history | Recommendation | Tree work constraints | Notes | Owner address | Owner |
|---|---|---|---|---|---|---|---|---|---|---|---|---|---|---|
| S3 | Holly | Mature | Good | 4 | 3.0 | 80* | 9.2 | N | Subject to past management. | No work required. | | | 48 Vallance Road<br>London<br>N22 7UB | P3P |

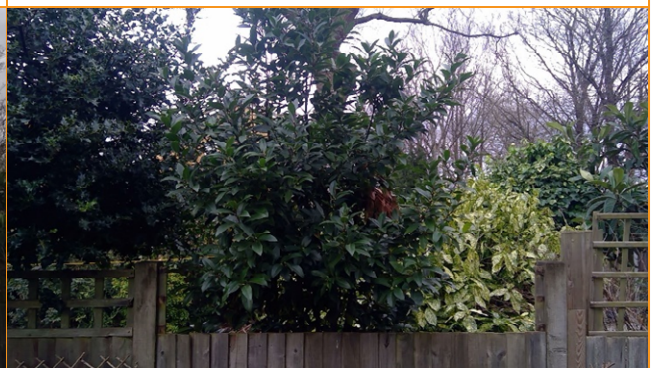
S4 - Laurel (Bay)

| Tree No | Common Name | Age Class | Condition | Height (m) | Crown Spread (m) | Stem diam. (mm) | Dist to bldg. (m) | Roots Implicated | Pruning history | Recommendation | Tree work constraints | Notes | Owner address | Owner |
|---|---|---|---|---|---|---|---|---|---|---|---|---|---|---|
| S4 | Laurel (Bay) | Semi-Mature | Good | 3 | 1.0 | 20* | 11 | N | No significant past tree works. | No work required. | | | 48 Vallance Road<br>London<br>N22 7UB | P3P |

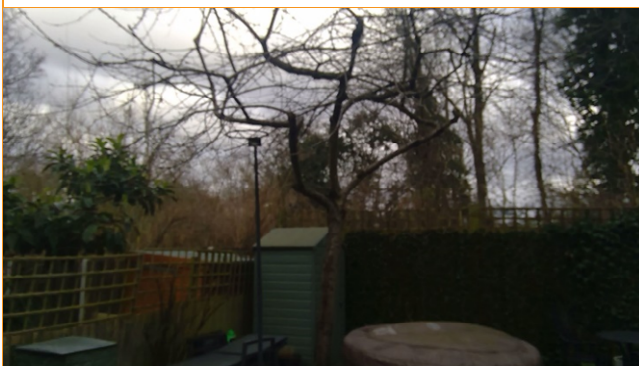
T2 - Cherry

| Tree No | Common Name | Age Class | Condition | Height (m) | Crown Spread (m) | Stem diam. (mm) | Dist to bldg. (m) | Roots Implicated | Pruning history | Recommendation | Tree work constraints | Notes | Owner address | Owner |
|---|---|---|---|---|---|---|---|---|---|---|---|---|---|---|
| T2 | Cherry | Early Mature | Good | 6 | 5.0 | 180 | 15.9 | N | Subject to past management. | No work required. | | | 46 Vallance Road<br>London<br>N22 7UB | PH |

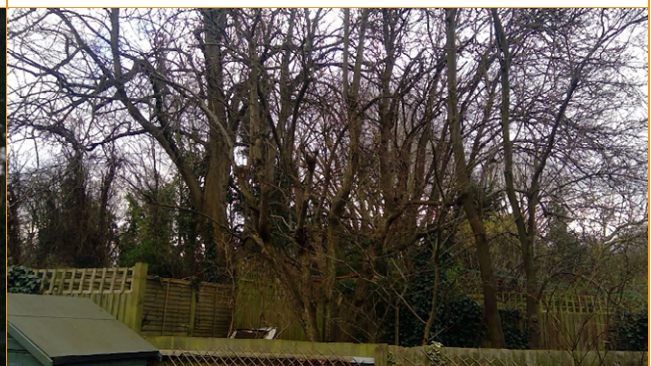
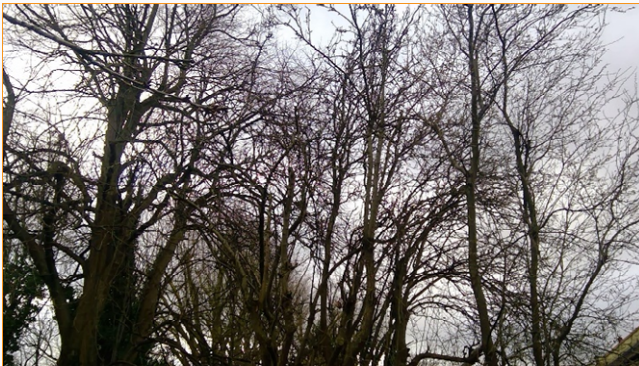
T3 - Pear

| Tree No | Common Name | Age Class | Condition | Height (m) | Crown Spread (m) | Stem diam. (mm) | Dist to bldg. (m) | Roots Implicated | Pruning history | Recommendation | Tree work constraints | Notes | Owner address | Owner |
|---|---|---|---|---|---|---|---|---|---|---|---|---|---|---|
| T3 | Pear | Mature | Fair | 9 | 6 | 340 | 13.6 | N | No significant past tree works. | No work required. | | | 44 Vallance Road<br>London<br>N22 7UB | P3P |

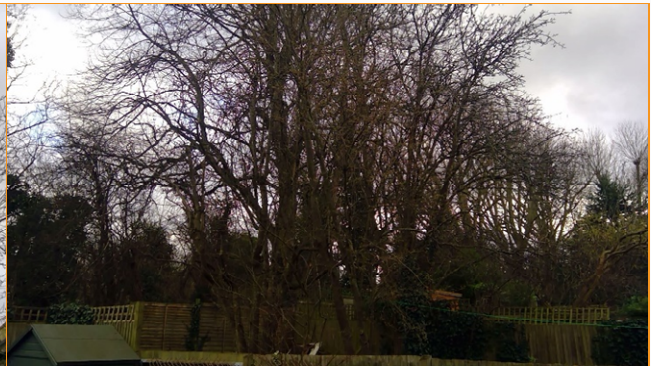
T4 - Plum

| Tree No | Common Name | Age Class | Condition | Height (m) | Crown Spread (m) | Stem diam. (mm) | Dist to bldg. (m) | Roots Implicated | Pruning history | Recommendation | Tree work constraints | Notes | Owner address | Owner |
|---|---|---|---|---|---|---|---|---|---|---|---|---|---|---|
| T4 | Plum | Semi-Mature | Good | 9 | 5.0 | 100 | 11.3 | N | No significant past tree works. | No work required. | | | 44 Vallance Road<br>London<br>N22 7UB | P3P |

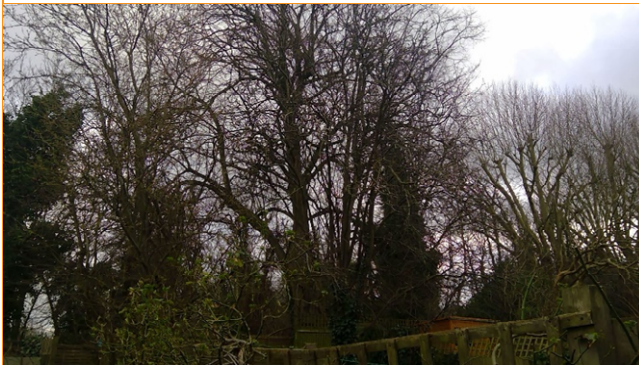
T5 - Pear

| Tree No | Common Name | Age Class | Condition | Height (m) | Crown Spread (m) | Stem diam. (mm) | Dist to bldg. (m) | Roots Implicated | Pruning history | Recommendation | Tree work constraints | Notes | Owner address | Owner |
|---|---|---|---|---|---|---|---|---|---|---|---|---|---|---|
| T5 | Pear | Mature | Fair | 10 | 6 | 400* | 15.3 | N | No significant past tree works. | No work required. | | | 44 Vallance Road<br>London<br>N22 7UB | P3P |

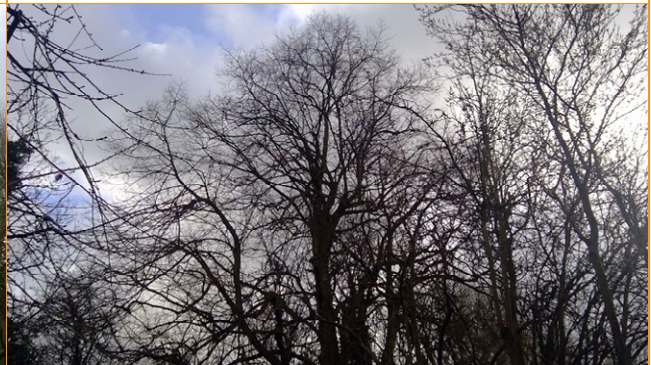
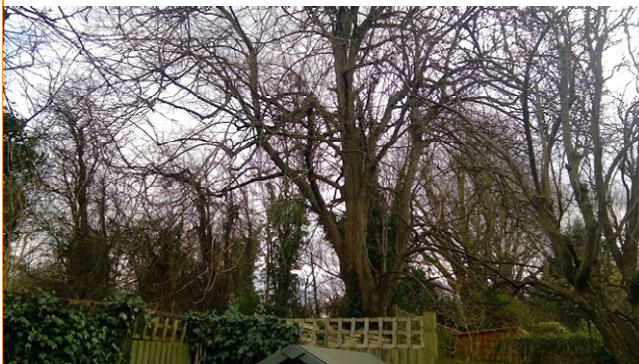
T6 - Lime

| Tree No | Common Name | Age Class | Condition | Height (m) | Crown Spread (m) | Stem diam. (mm) | Dist to bldg. (m) | Roots Implicated | Pruning history | Recommendation | Tree work constraints | Notes | Owner address | Owner |
|---|---|---|---|---|---|---|---|---|---|---|---|---|---|---|
| T6 | Lime | Mature | Good | 23 | 14 | 800* | 22.8 | N | No significant past tree works. | No work required. | | | Unknown Address | UKN |

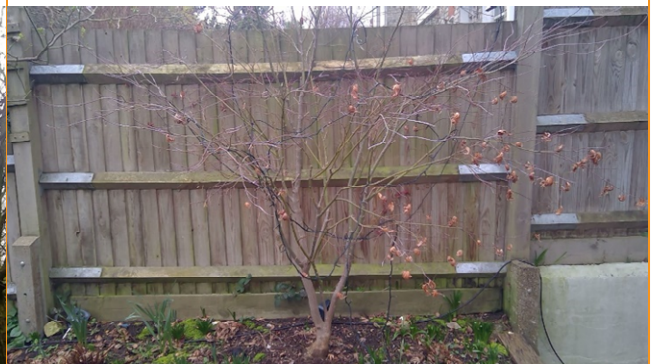
T7 - Acer

| Tree No | Common Name | Age Class | Condition | Height (m) | Crown Spread (m) | Stem diam. (mm) | Dist to bldg. (m) | Roots Implicated | Pruning history | Recommendation | Tree work constraints | Notes | Owner address | Owner |
|---|---|---|---|---|---|---|---|---|---|---|---|---|---|---|
| T7 | Acer | Semi-Mature | Fair | 2 | 1.0 | 40 | 2.6 | N | No significant past tree works. | No work required. | | | 46 Vallance Road<br>London<br>N22 7UB | PH |

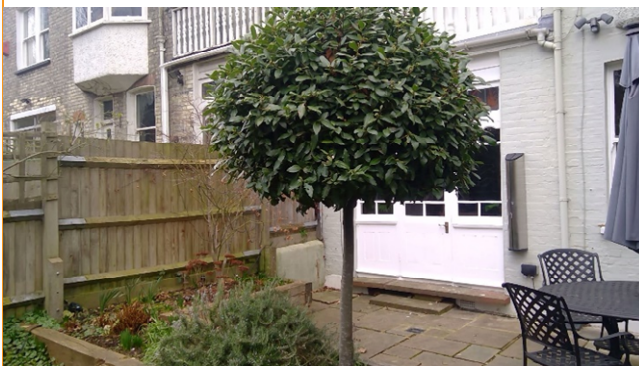
S5 - Laurel (Bay)

| Tree No | Common Name | Age Class | Condition | Height (m) | Crown Spread (m) | Stem diam. (mm) | Dist to bldg. (m) | Roots Implicated | Pruning history | Recommendation | Tree work constraints | Notes | Owner address | Owner |
|---|---|---|---|---|---|---|---|---|---|---|---|---|---|---|
| S5 | Laurel (Bay) | Young | Good | 2 | 1.0 | 40 | 3.8 | N | Subject to past management. | No work required. | | | 46 Vallance Road<br>London<br>N22 7UB | PH |

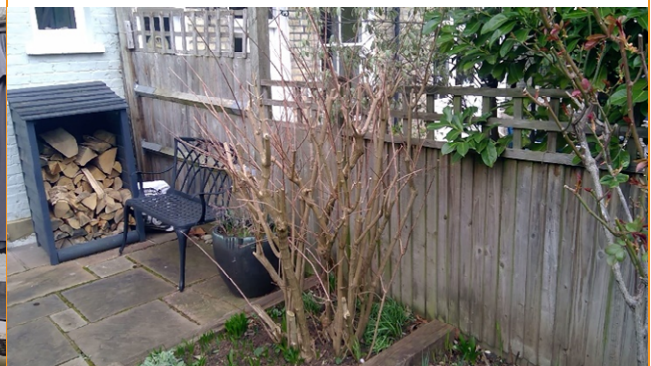
S6 - Weigela

| Tree No | Common Name | Age Class | Condition | Height (m) | Crown Spread (m) | Stem diam. (mm) | Dist to bldg. (m) | Roots Implicated | Pruning history | Recommendation | Tree work constraints | Notes | Owner address | Owner |
|---|---|---|---|---|---|---|---|---|---|---|---|---|---|---|
| S6 | Weigela | Mature | Fair | 2 | 1.0 | 20 | 3.8 | N | Subject to past management. | No work required. | | | 46 Vallance Road<br>London<br>N22 7UB | PH |

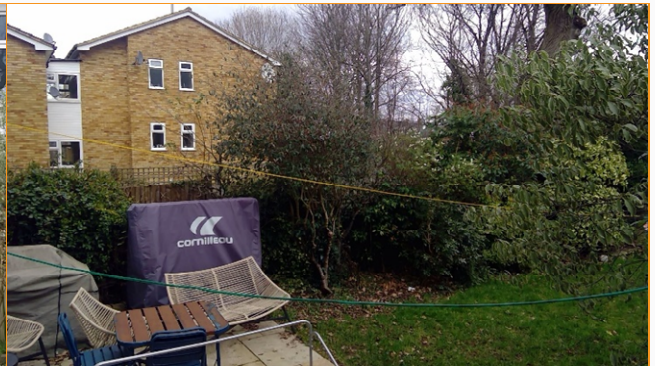
SG1 - Mixed species shrubs

| Tree No | Common Name | Age Class | Condition | Height (m) | Crown Spread (m) | Stem diam. (mm) | Dist to bldg. (m) | Roots Implicated | Pruning history | Recommendation | Tree work constraints | Notes | Owner address | Owner |
|---|---|---|---|---|---|---|---|---|---|---|---|---|---|---|
| SG1 | Mixed species shrubs | Mature | Good | 2 | 1.0 | 20 | 8 | N | Subject to past management. | No work required. | | | 48 Vallance Road<br>London<br>N22 7UB | P3P |
