Section Pictures - 17/10/2023 - RE

TSA-23-2537 Channing School for Girls CCTV Report\_303\_Issue01

Section Inspection - 17/10/2023 - MH21 X

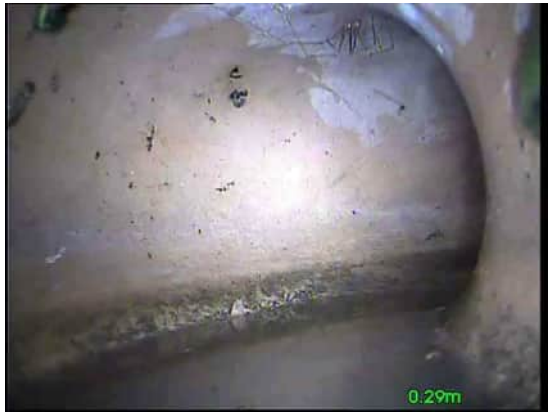
1, 00:00:06, 0.29 m  
Line deviates right

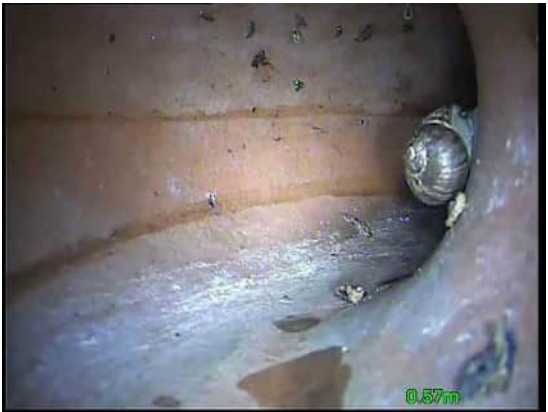
2, 00:00:14, 0.57 m  
Line deviates right

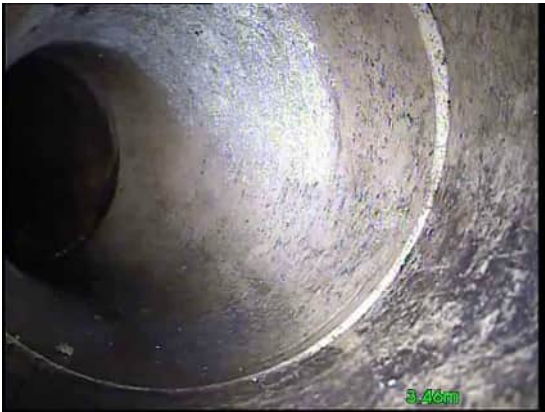
6, 00:00:30, 3.46 m  
Line deviates left

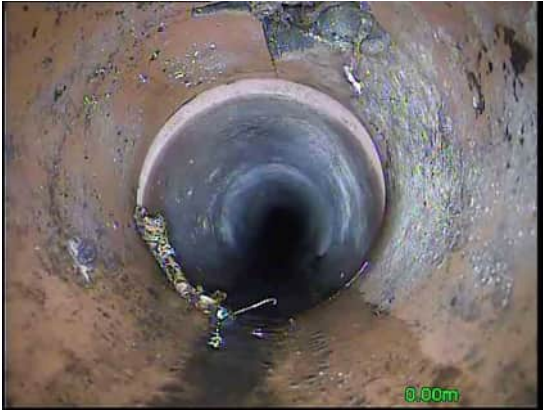
1, 00:00:01, 0.00 m  
Broken pipe from 11 o'clock to 1 o'clock

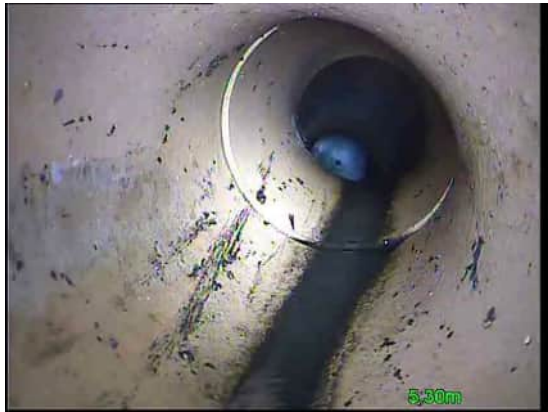
5, 00:00:33, 5.30 m  
Line deviates up

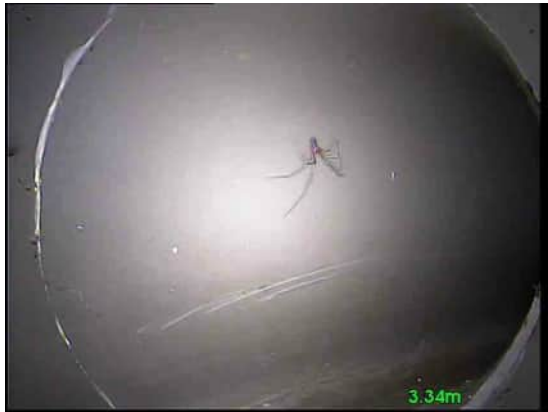
5, 00:00:25, 3.34 m  
Line deviates right

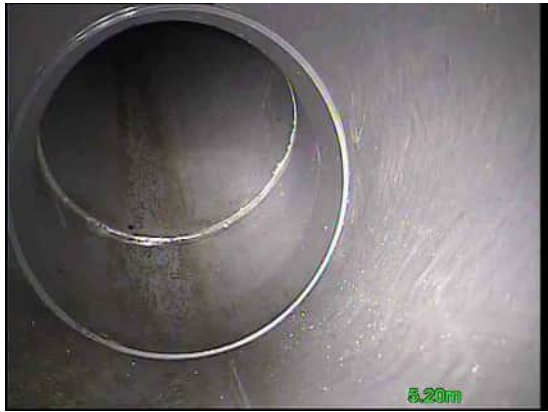
7, 00:00:46, 5.20 m  
Line deviates up

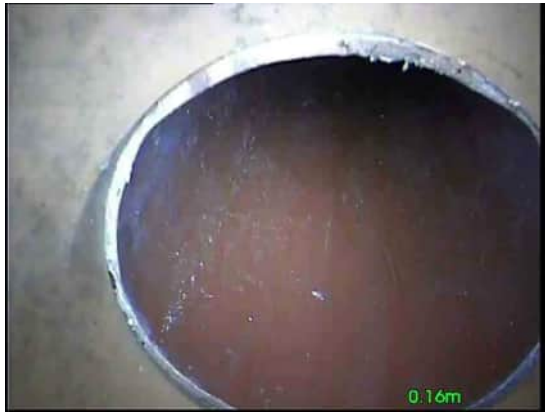
1, 00:00:04, 0.16 m  
Line deviates up

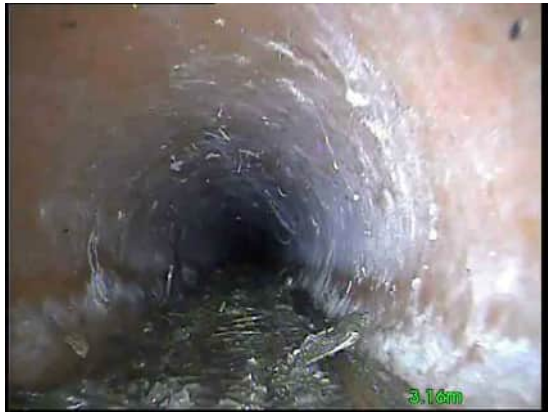
2, 00:00:14, 3.16 m  
Settled deposits, fine, 10% cross-sectional area loss, finish

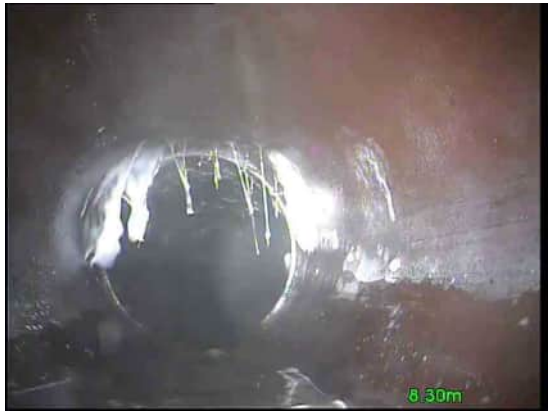
3, 00:02:23, 8.30 m  
Attached deposits, fouling at joint from 9 o'clock to 3 o'clock,  
5% cross-sectional area loss

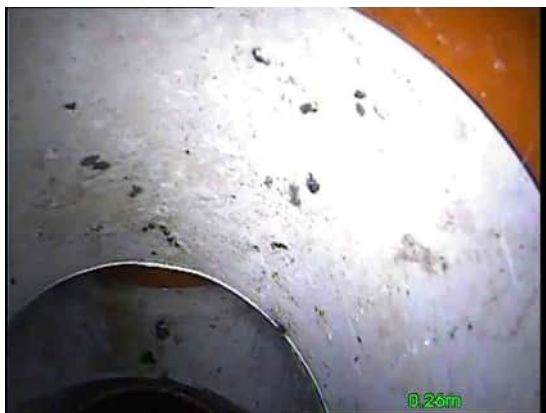
1, 00:00:05, 0.26 m  
Line deviates down

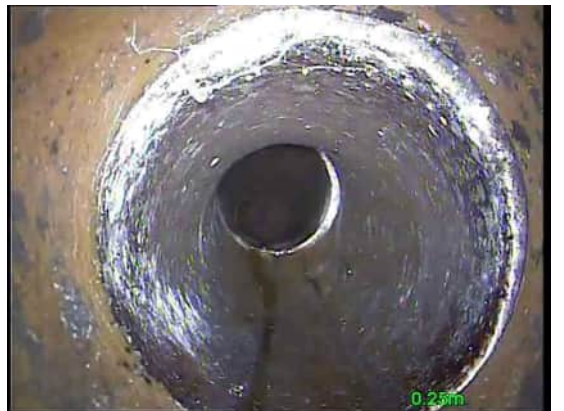
2, 00:00:06, 0.25 m  
Line deviates up

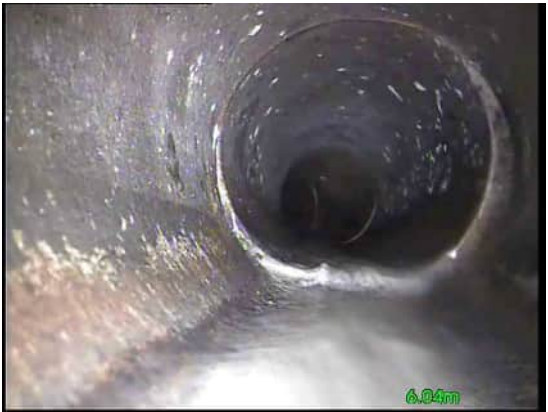
6, 00:00:41, 6.04 m  
Joint displaced, medium

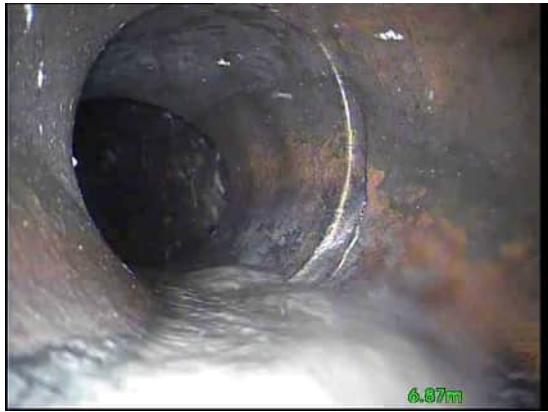
7, 00:00:45, 6.87 m  
Line deviates left

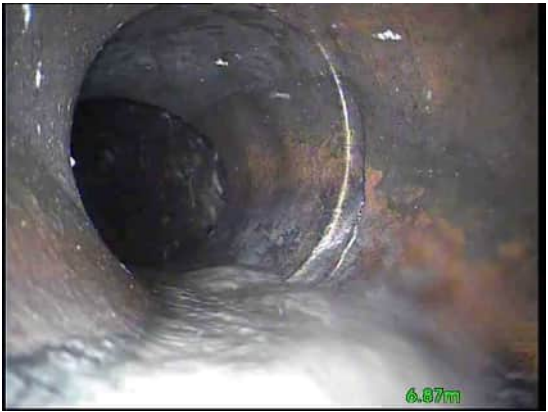
8, 00:00:45, 6.87 m  
Line deviates down

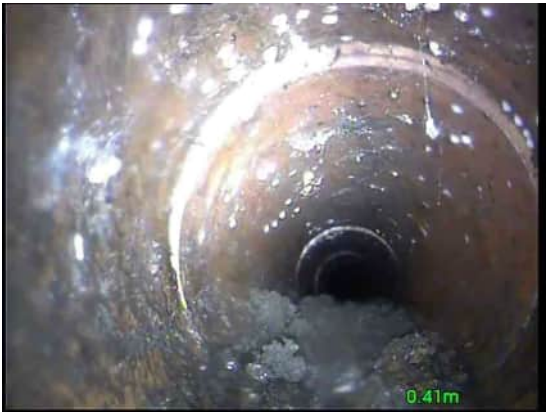
2, 00:00:05, 0.41 m  
Settled deposits, fine, 25% cross-sectional area loss, start

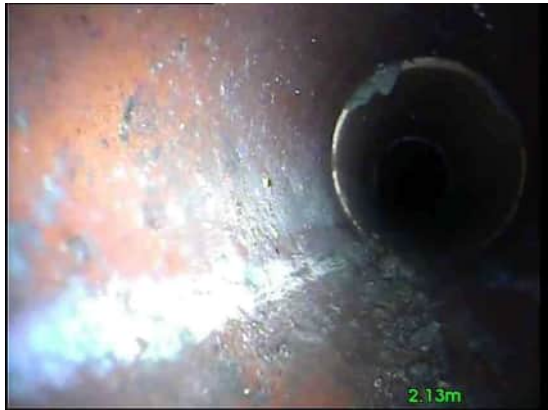
3, 00:00:15, 2.13 m  
Settled deposits, fine, 5% cross-sectional area loss, change

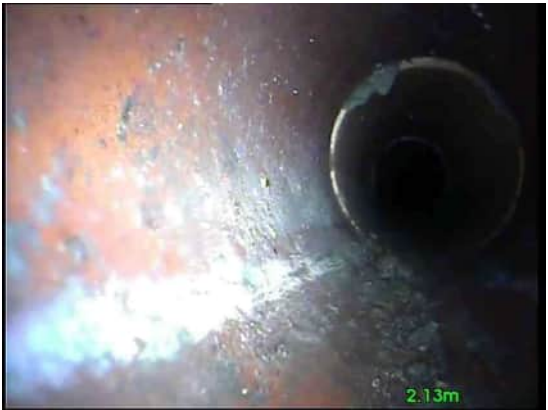
4, 00:00:15, 2.13 m  
Settled deposits, hard or compacted at joint, 5% cross-sectional area loss, start

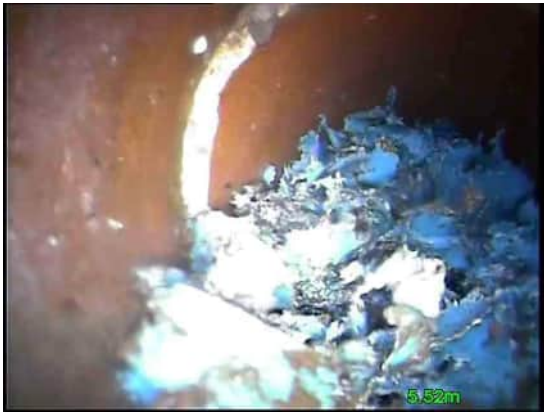
6, 00:00:39, 5.52 m  
Settled deposits, other, 100% cross-sectional area loss, Pipe full of loose plastic
