## Level 2 - Tree Survey, Condition and Management Report

The Priory  
Church Lane  
London  
N17 7AA

GD/230516/TCP

Tuesday 10<sup>th</sup> October 2023

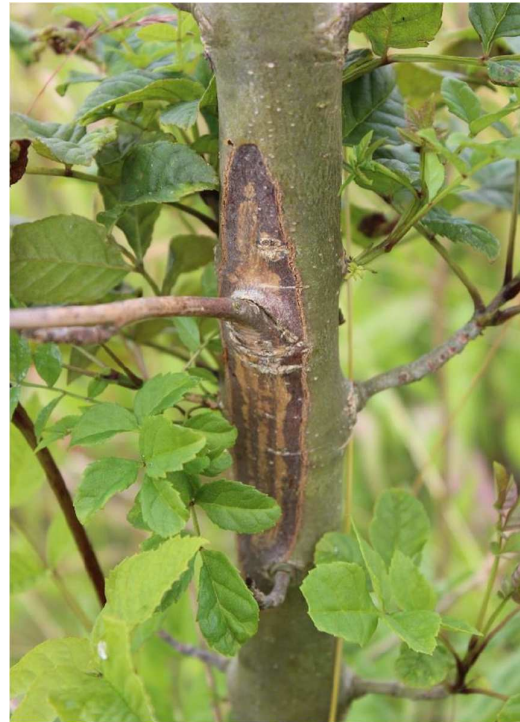
4.1.1 Ash Dieback is a highly destructive fungal disease affecting the United Kingdom's Ash trees. It causes leaf loss and crown decline and in some instances caused tree death.

4.1.4 Type of Decay: The disease affects the vascular tissues of the tree, blocking the supply of water and nutrients.

4.1.8 Consequence: Significant dieback throughout the crowns of affected trees, leading to brittle failures of branches and stem. Affected trees are also susceptible to secondary pathogens, such as Honey Fungus (*Armillaria mellea*) and subsequently prone to windthrow from root decay.

Figure 2: Example photograph of lesion caused by Ash Dieback.

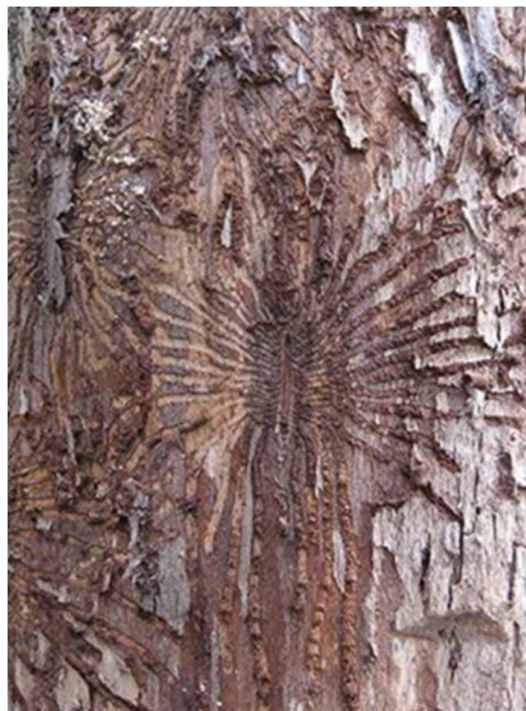
4.2.0 Many dead standing and declining English Elm specimens were found throughout the site. The death and decline are attributed to Dutch Elm Disease (*Ophiostoma novo-ulmi*).

4.2.3 Type of Decay: The beetles colonise the bark of host trees, carrying with them fungal spores. Infection leads to blockages of xylem (water transport vessels).

4.2.7 Consequences: Death of infected trees.

Figure 3: Example photograph of Elm Bark Beetle galleries within an Elm tree.
