21 Clarence Road  
LONDON  
N22 8PG

**INSURANCE CLAIM**

**CONCERNING SUSPECTED SUBSIDENCE**

**ENGINEERING APPRAISAL REPORT**

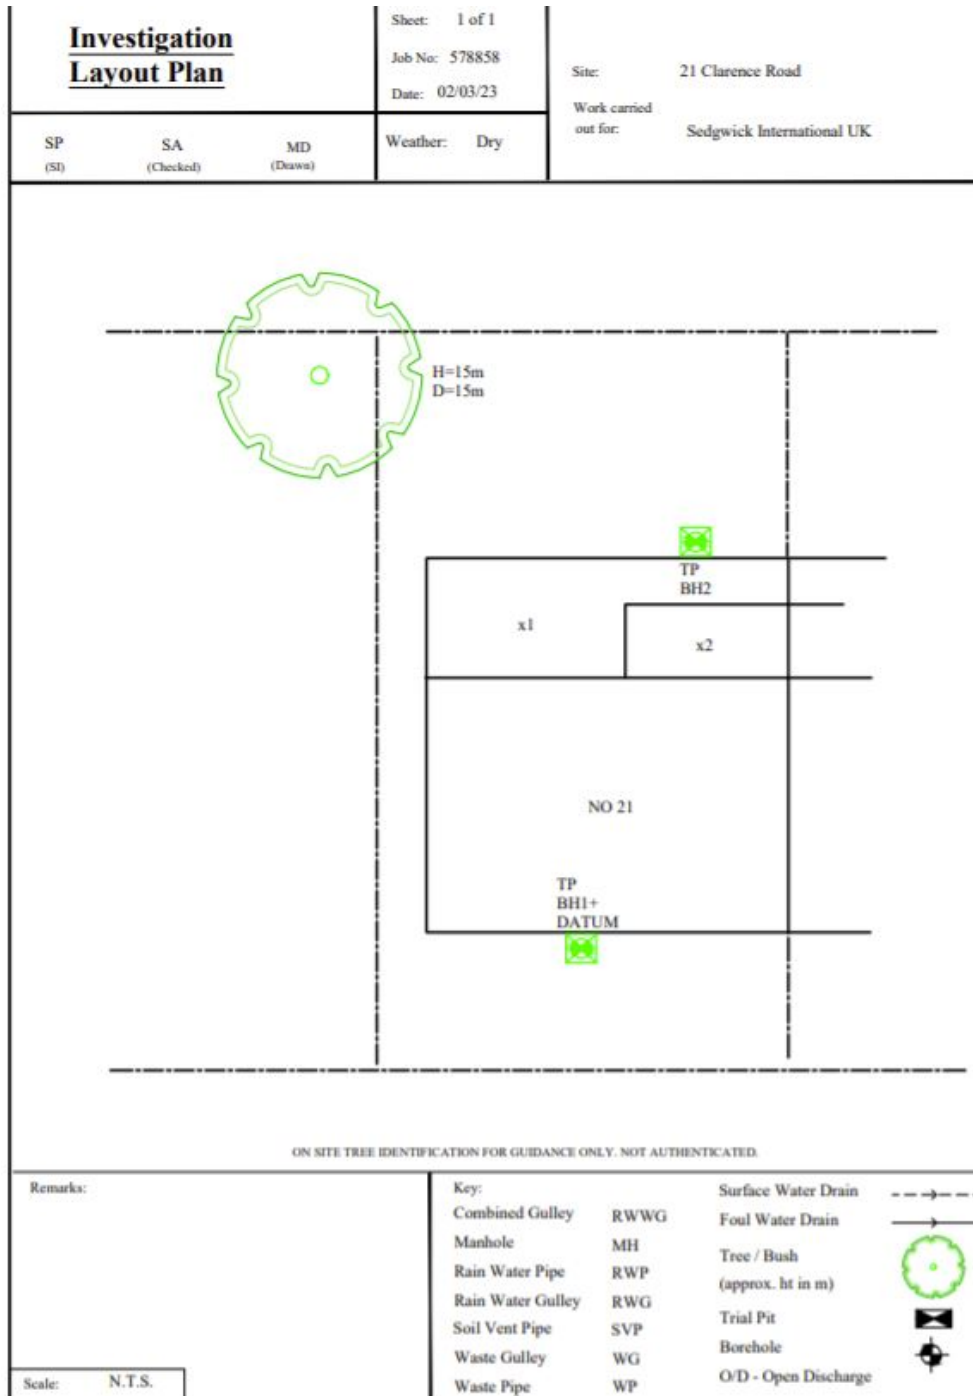
# ROOT IDENTIFICATION

Trial pit and borehole 1 were excavated to the front of the house. The foundations are 200mm thick brickwork at a depth of 750mm. The subsoil is stiff orange, brown clay. The clay has a very high shrinkage potential. Leguminosae roots were noted under the foundations to 1,800mm depth.

Trial pit and borehole 2 were excavated against the rear extension. The foundations are 200mm thick concrete at a depth of 950mm. The subsoil is stiff orange, brown clay. The clay has a high shrinkage potential. Eucalyptus roots were noted to a depth of 2,500mm.

| Sub Sample | Species Identified | Root Diameter | Starch |
|---|---|---|---|
| to 1.8m | Leguminosae spp. | 2 | <1 mm Abundant |
| to 2.5m | <i>Eucalyptus</i> spp. | 3 | <1 mm Low |

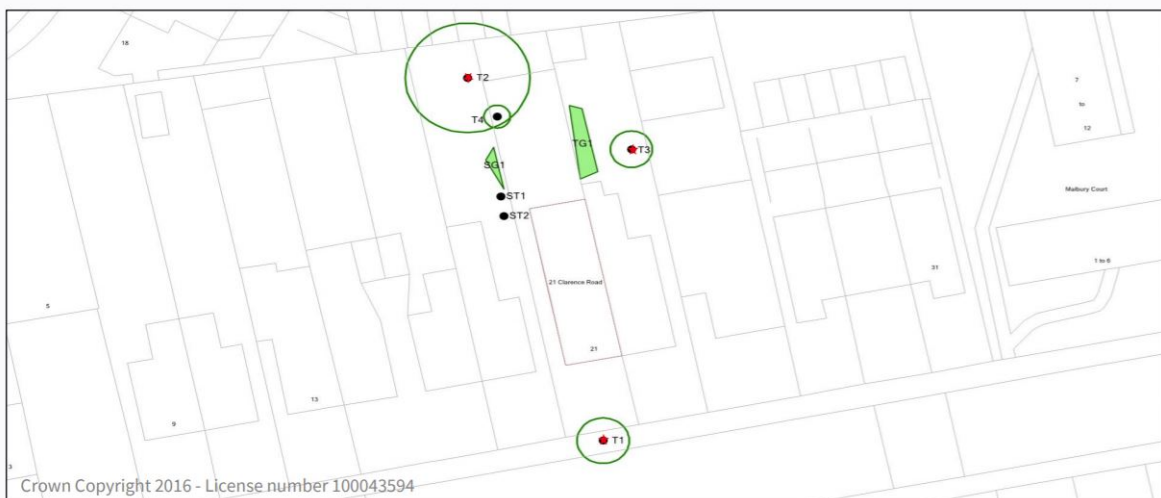
Location: 21 Clarence Road, London, N22 8PG

In relation to s96(6) of the Highway's Act 1980, we understand that highway tree T1 is under the ownership and control of London Borough of Haringey.

Our mitigation team will liaise with the Council to fell T1.

The eucalyptus trees in the grounds of No. 19 (T2) and No. 23 (T3) need to be felled. Our mitigation department will liaise with the Third Parties to fell those trees.
