# PROTECTED TREE REPORT (TREE WORKS)

| <b>Application number</b> | HGY/2023/3260 |
| <b>Site Address:</b> | Highgate Junior School, Bishopswood Road, London N6 4PL |
| <b>Proposal</b> | <p>Works to trees protected by TPOs.</p> <p>Works to trees, as detailed on Tree Survey Report attached, for specimens numbered T4262, T4263, T4264, T4265, T4267, T4268, T4269, T4270 and T4271. (**Amended description to include T4262**)</p> <p>Works to all other trees will be considered under application reference HGY/2023/3258, as those trees are not protected by TPOs but are located within a Conservation Area.</p> |

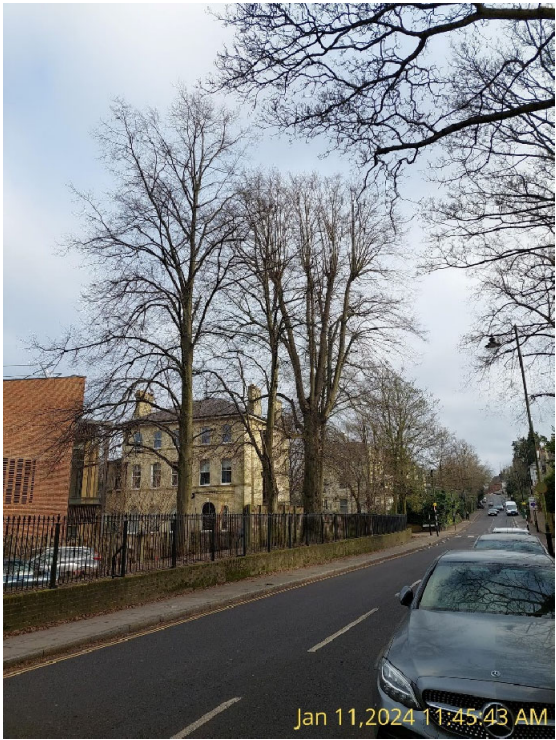
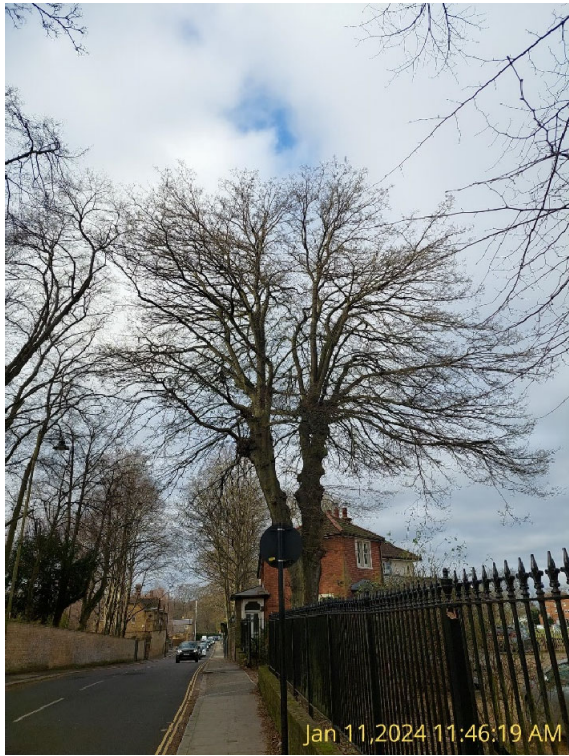
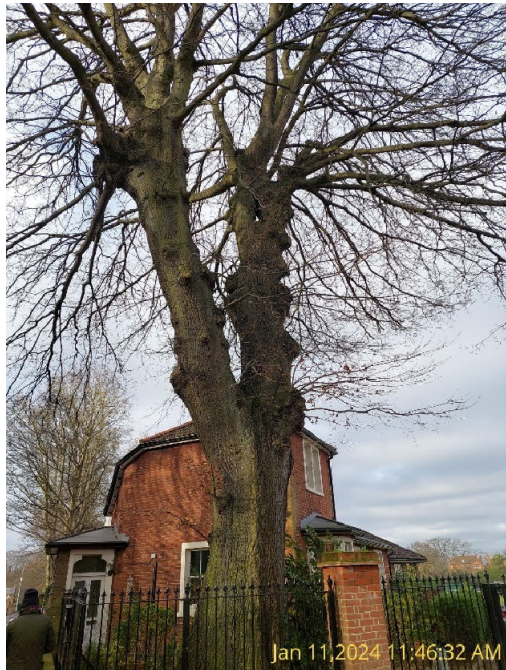
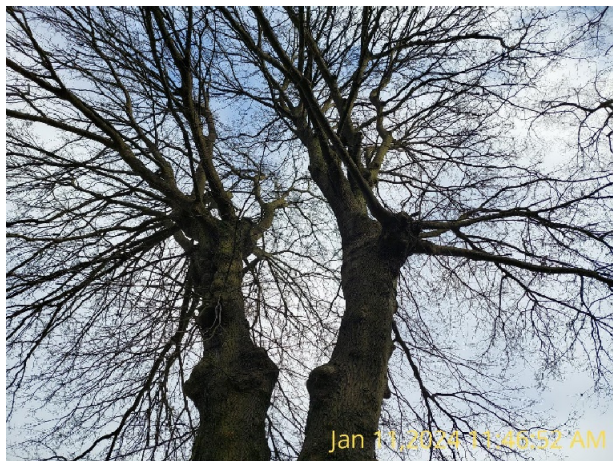
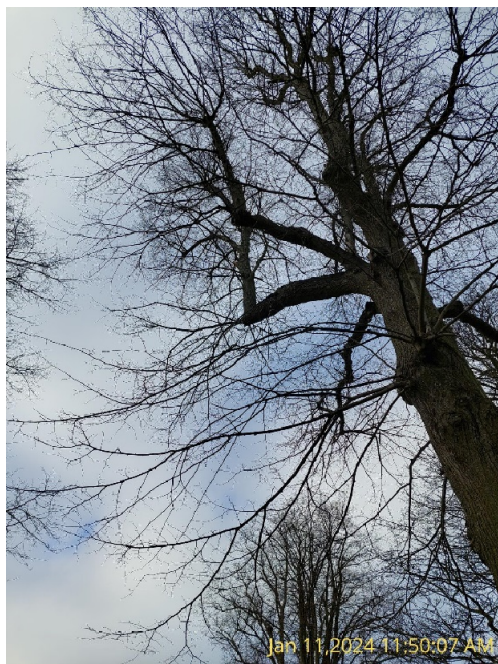
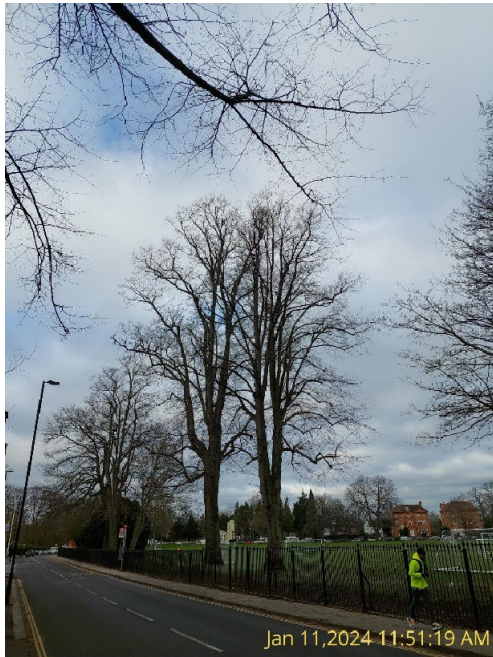
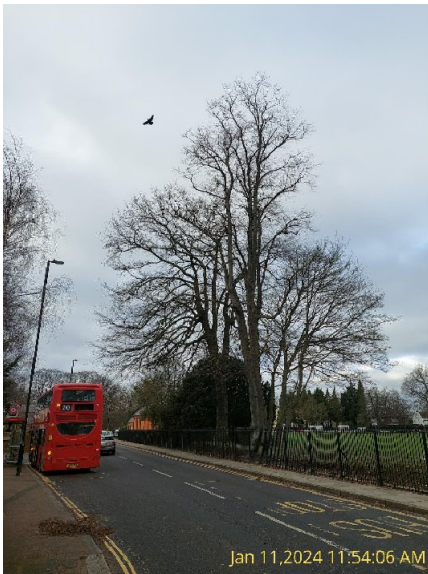
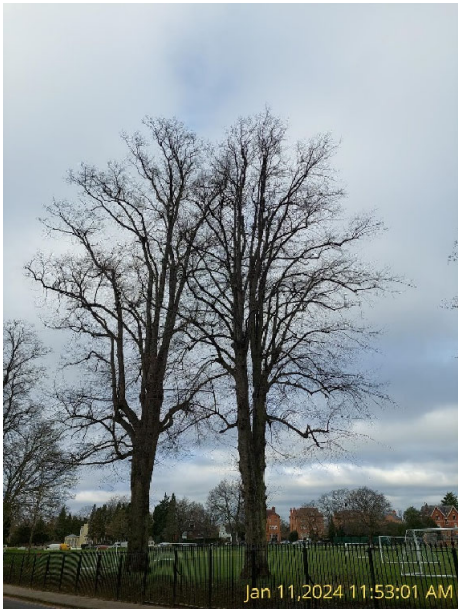
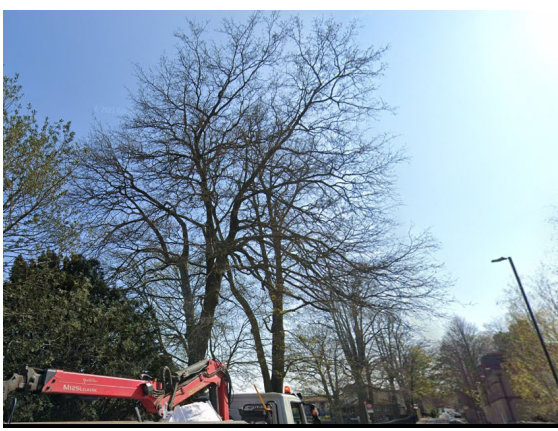
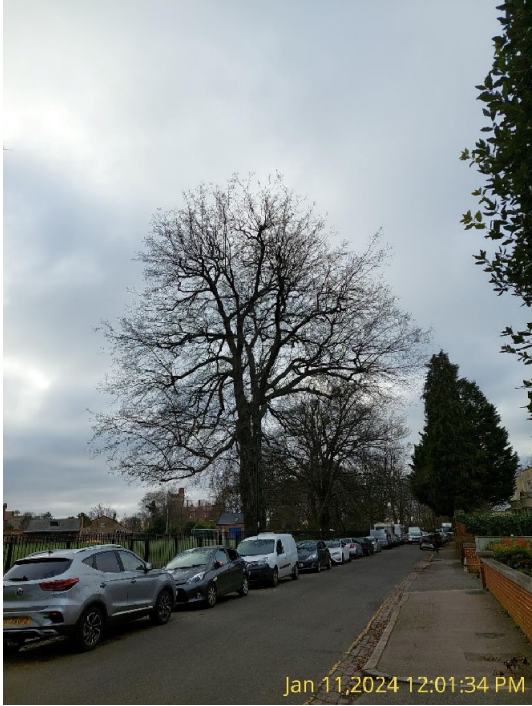
Many of the Limes and Turkey Oaks are past high pollards/ past reductions that have grown on and restored their full crowns. A few of the trees have been pollarded in the distant past just above the break.

Reductions form weak re growth attachments and often require reducing again. Collectively the Limes have cavities within the crown, cavities at the base, dog elbows, and which is often characteristic for the species tight forks.

Turkey Oaks wood strength and longevity is not as superior to the English Oak.

The poor condition Holly fell T4271 will require a re planting replacement.

The proposed individual proportionate reduction works (measured from the very tips of the crown) will bring the avenue of trees along Hampstead Lane into uniform sync and good present collective management. Works include pruning back to most recent previous pruning points.

**Conditions: 10-12cm girth *Taxus* spp.**
