## **REPORT 75190/S/1**

**51 JACKSONS LANE, LONDON N6**

## **BASEMENT SURVEY**

25 July 2023

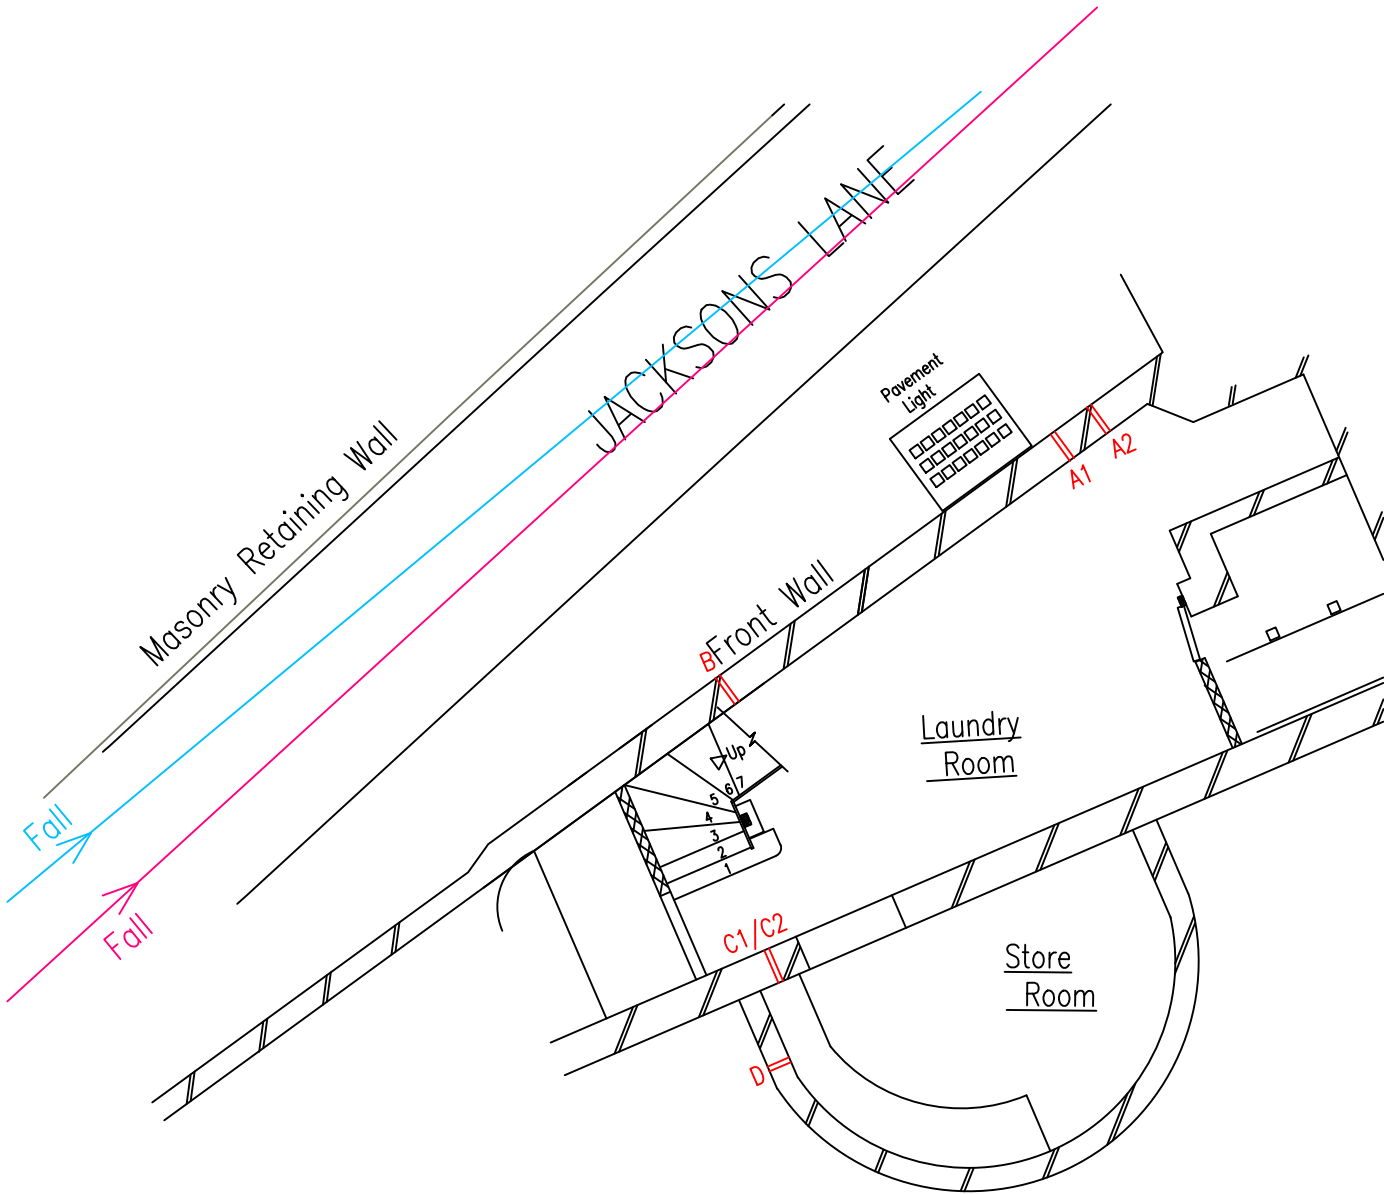
Figure 1 Plan of part of basement showing core locations

Four locations were nominated, these being identified as positions A to D. Two holes were cut at each of positions A and C as indicated on Figures 1 and 2. Photographs illustrate the findings.

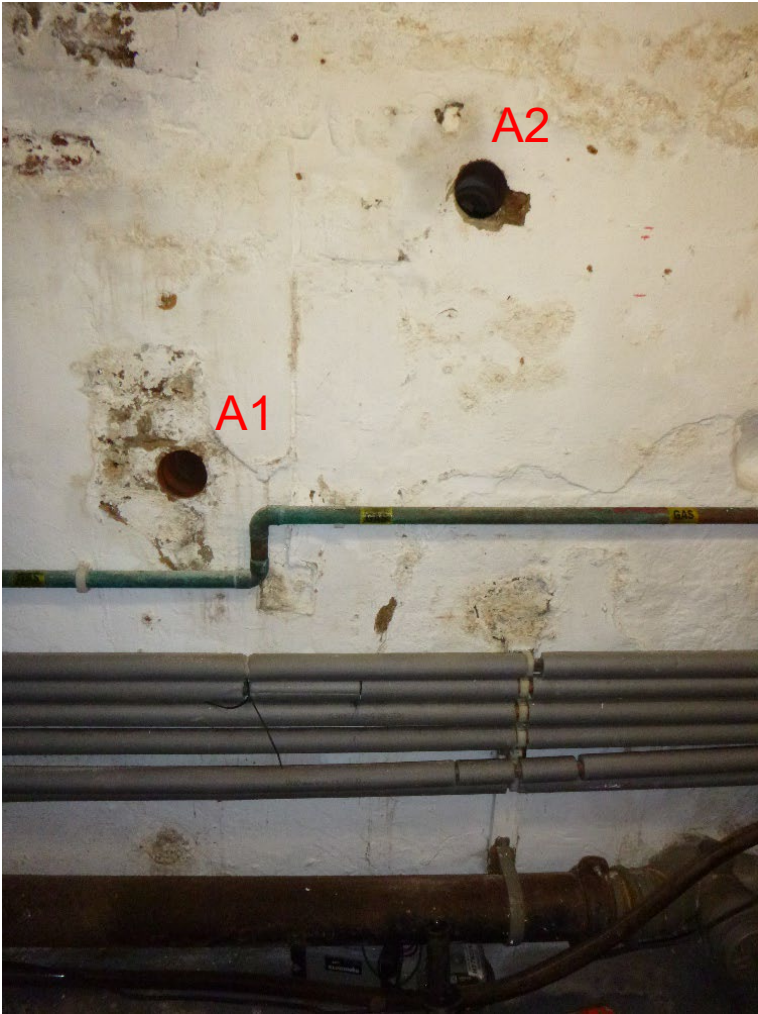
Two cores were cut at Position A. These are referenced A1 and A2.

**Photograph 1** Locations of Holes A1 and A2.

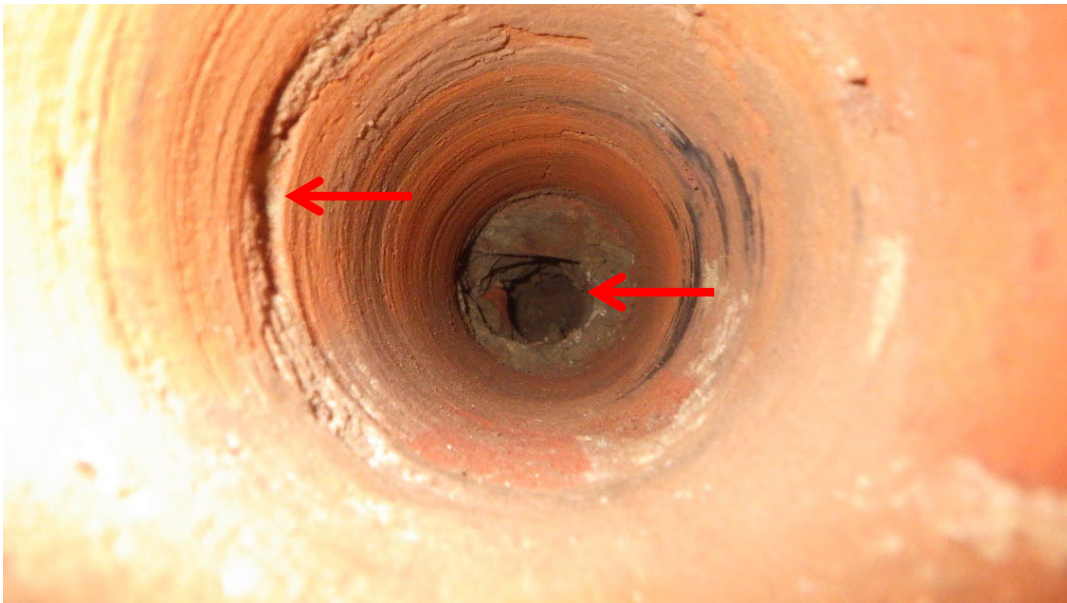
Core A1 was 1000mm above floor level. It was located at a position in which the white coating on the surface of the wall was severely disrupted seemingly by the passage of moisture, its evaporation and the consequent accumulation of salts. The wall was found to be 350mm thick with no evidence of any waterproofing on the back face. The brickwork was very damp throughout the thickness of the wall. The horizontal and vertical joints between bricks were found to be well filled with mortar. Drilling was in increments: a lump of clayey silt was encountered in the depth increment 100mm to 240mm but no further similar material was observed. The soil behind was probed to a depth of 600mm from the surface of the wall: this was found to be a fill material comprising a well compacted sandy, silty clay containing occasional brick fragments. This material was damp.

**Photograph 2** Location A1. View down hole. Slight voiding in vertical joint on left. Soil sample at back of hole.

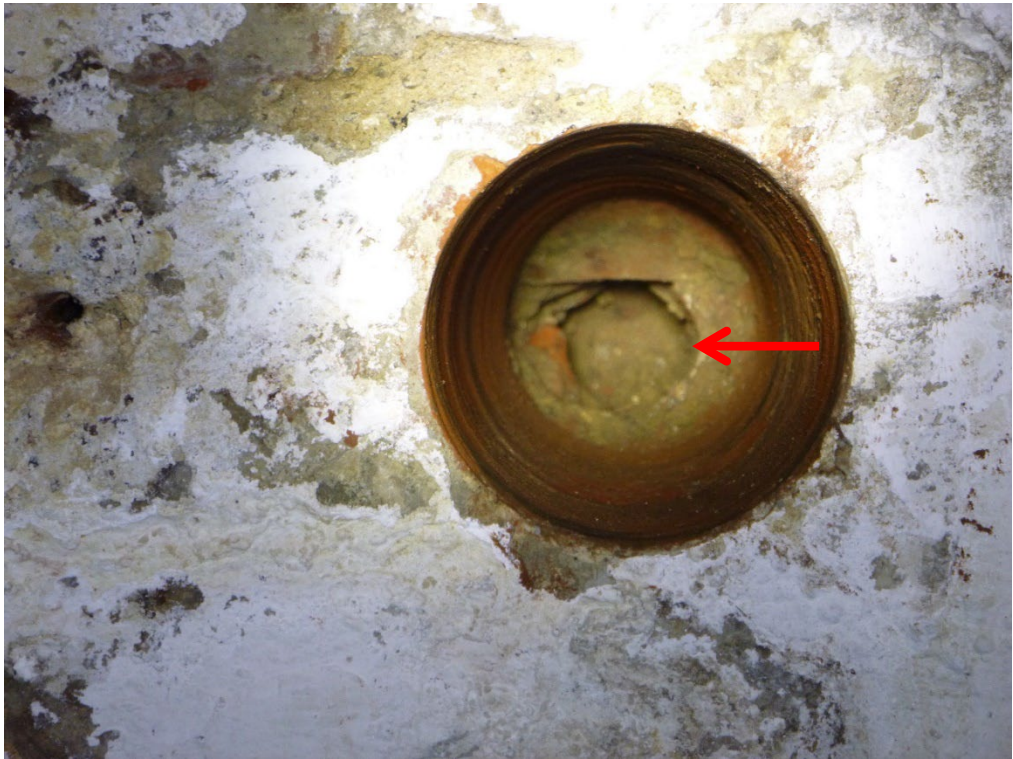
**Photograph 3** Location A1. Soil sample at back of hole.

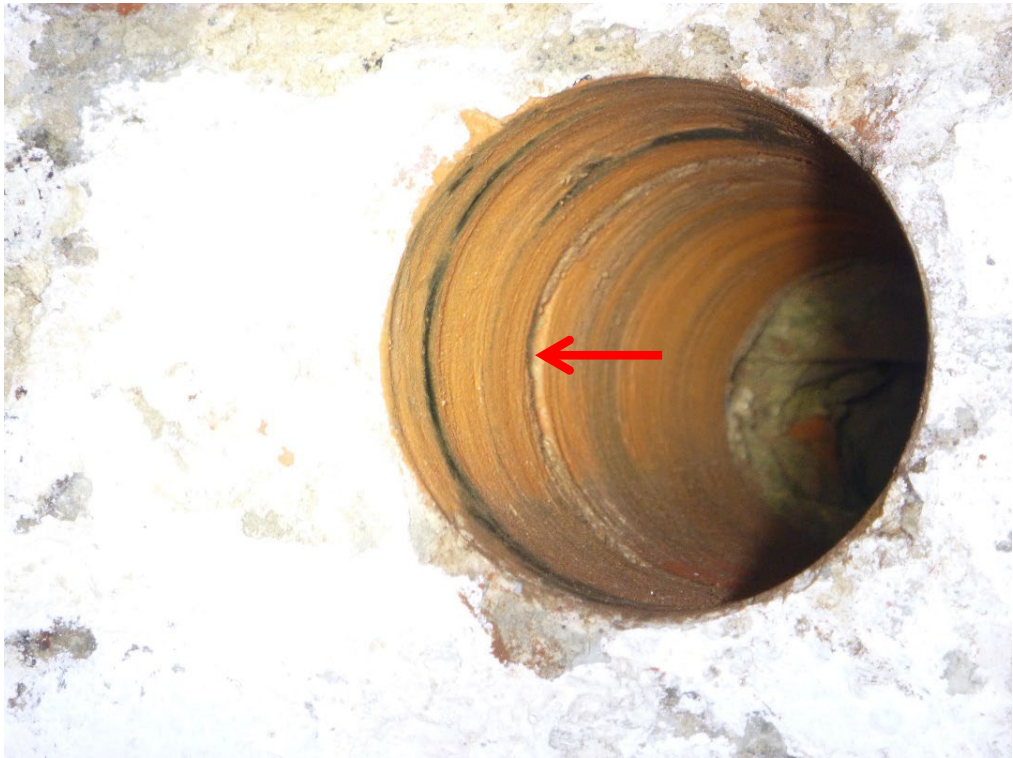
**Photograph 4** Location A1. View of slight void in joint on left side of hole.

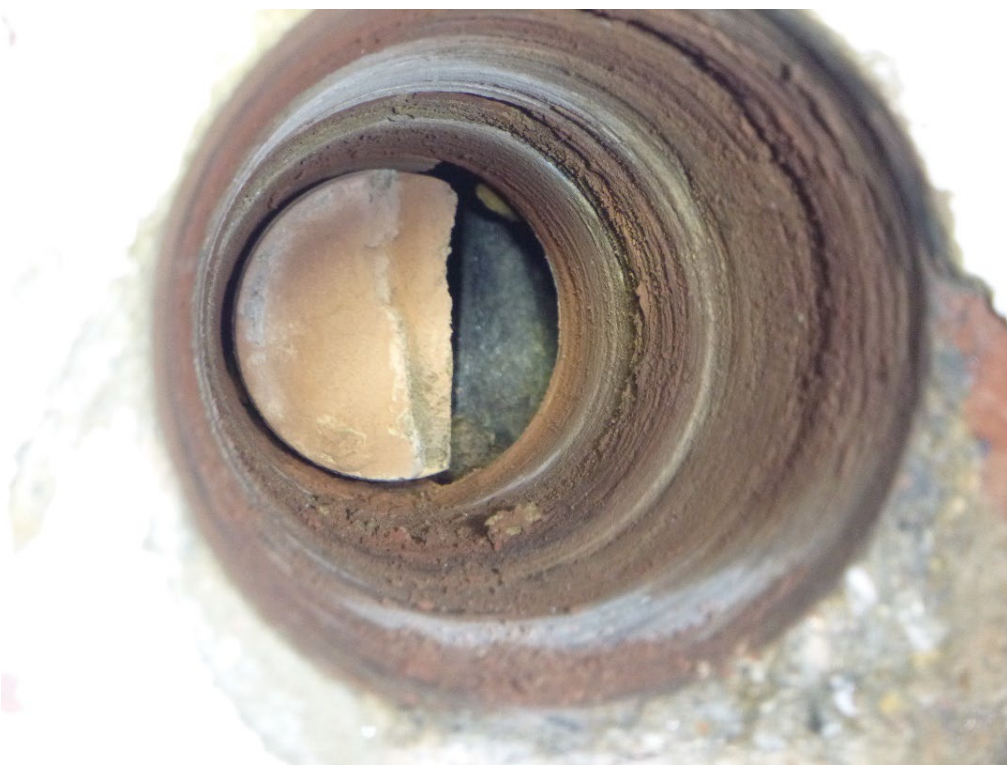
Core A2 was 1450mm above floor level in an area in which the white coating on the brickwork was in good condition. There was a tough cementitious render on the face of the wall behind the white coating; the render had a variable thickness in the range 5mm to 15mm. This render probably had fairly effective waterproofing properties. The core passed through 380mm of wall which backed directly onto a deep manhole where there was also a render coating. The vertical and horizontal joints in the brickwork appeared to be well filled with mortar. The brickwork was damp but seemingly less so than at location A1.

Behind the wall at location A2 is a deep manhole that uses the basement wall as one of its edges. The walls around the manhole are all render coated.

**Photograph 5** Location A2. No apparent voids in brickwork. Manhole behind.

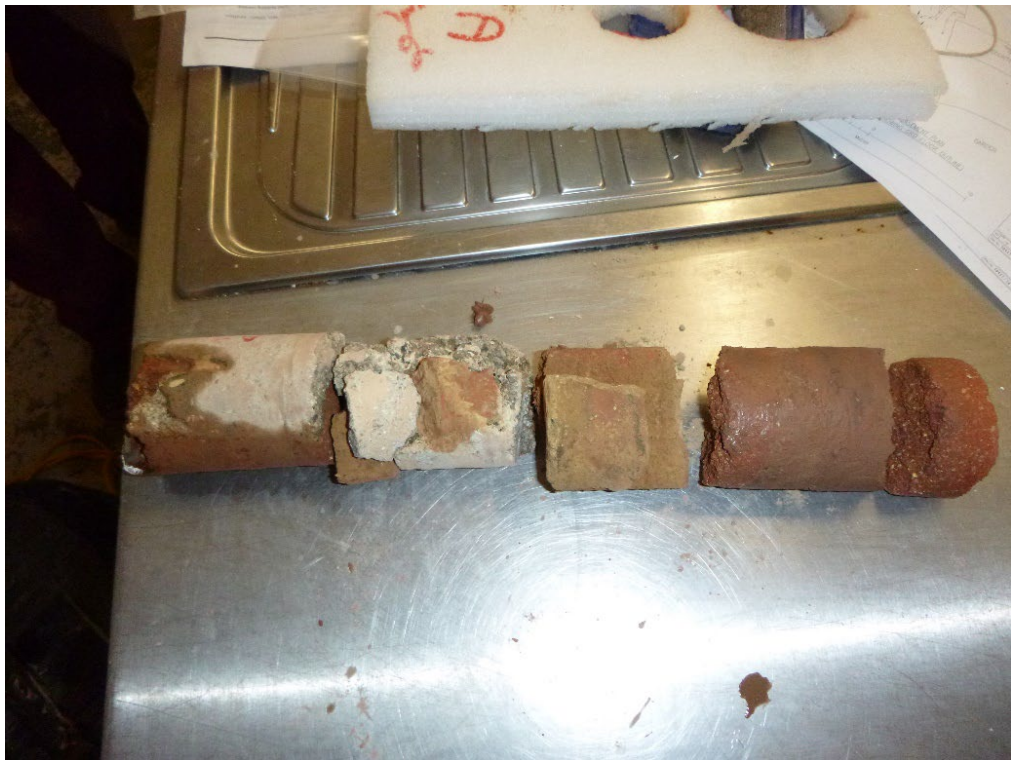
**Photograph 6** Location A2. Core sample. Well filled.

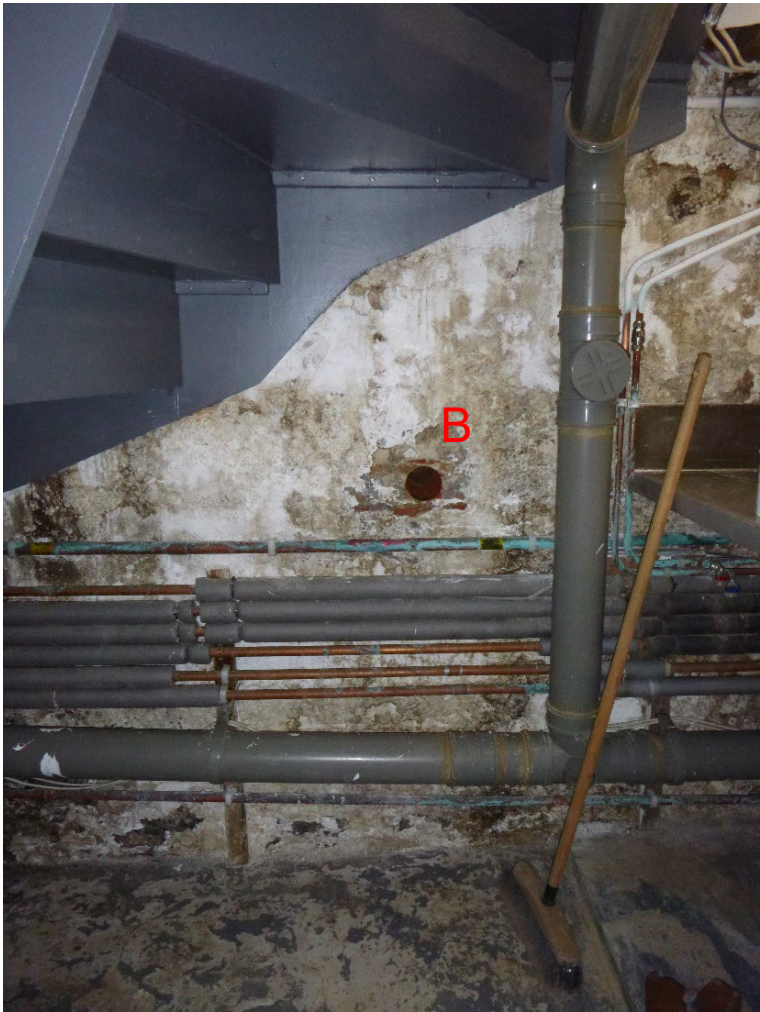
Photograph 7   Location B.

Core B. The location of Core B was moved to the left from the specified position which clashed with the sink. The revised location was under the flight of stairs at a height of 950mm above floor level. At the test location the coatings on the surface of the wall had been disrupted by the passage of moisture, evaporation and the accumulation of salts. The wall was 350mm thick. The bricks in the wall were very damp but most of the joints were passably well filled. A possible gap in a vertical joint was observed on the left side of the hole, however the mortar may have been lost during the coring operation. There was no damp-proof coating or layer on the back of the wall. The soil behind was a slightly sandy, silty clay fill containing occasional brick fragments. The soil was continuous and firm with no gap to the wall.

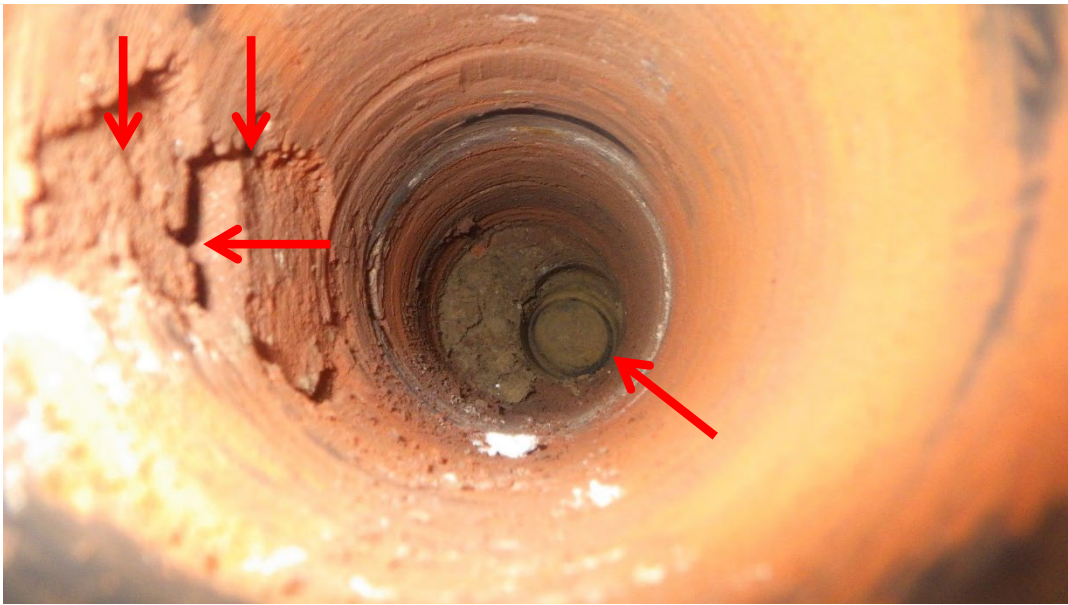
Photograph 8   Vertical voids on left side of Location B.   Soil sample at back of hole.

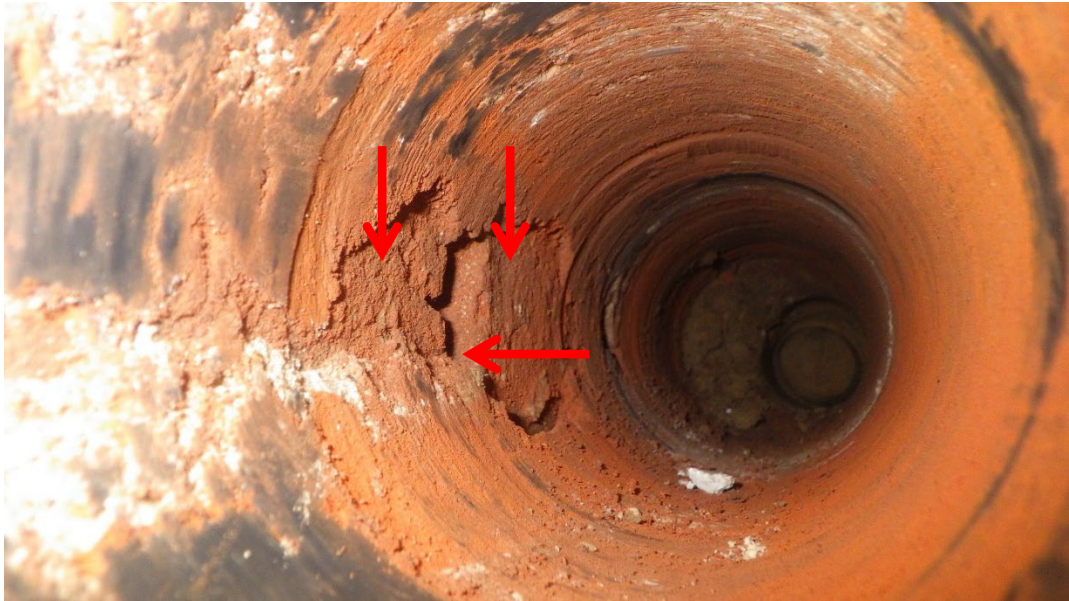
**Photograph 9** Location B. Further detail of voids on left of hole.

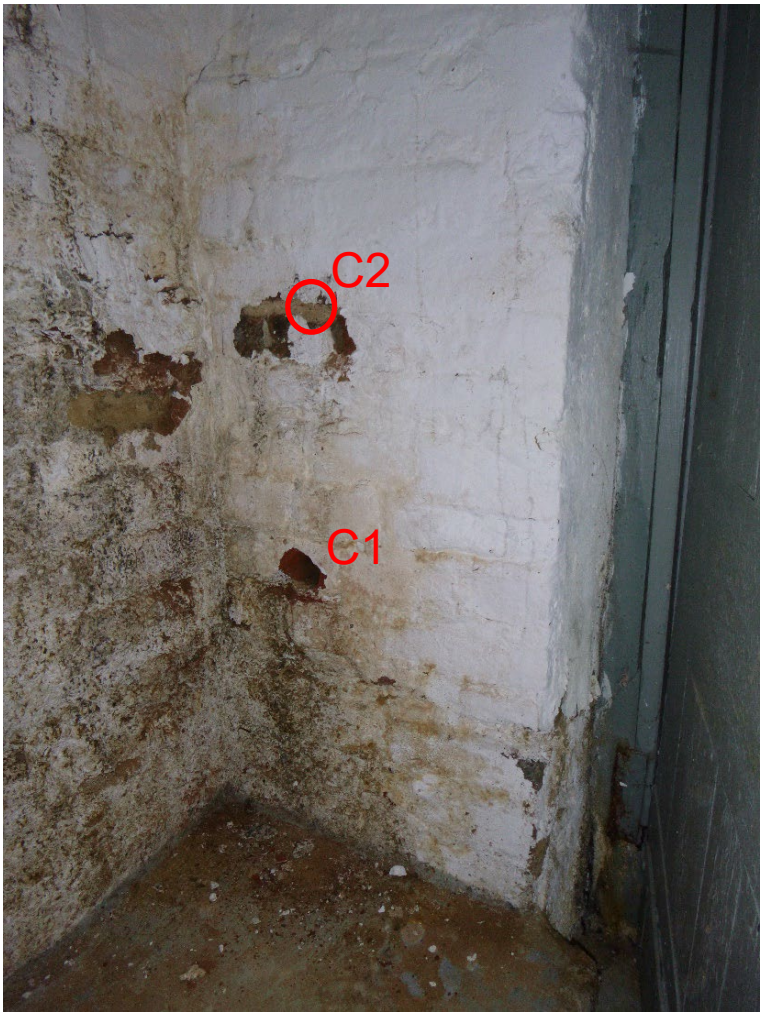
Two cores were cut at Position C. These are referenced C1 and C2.

**Photograph 10** Location C showing sample locations.

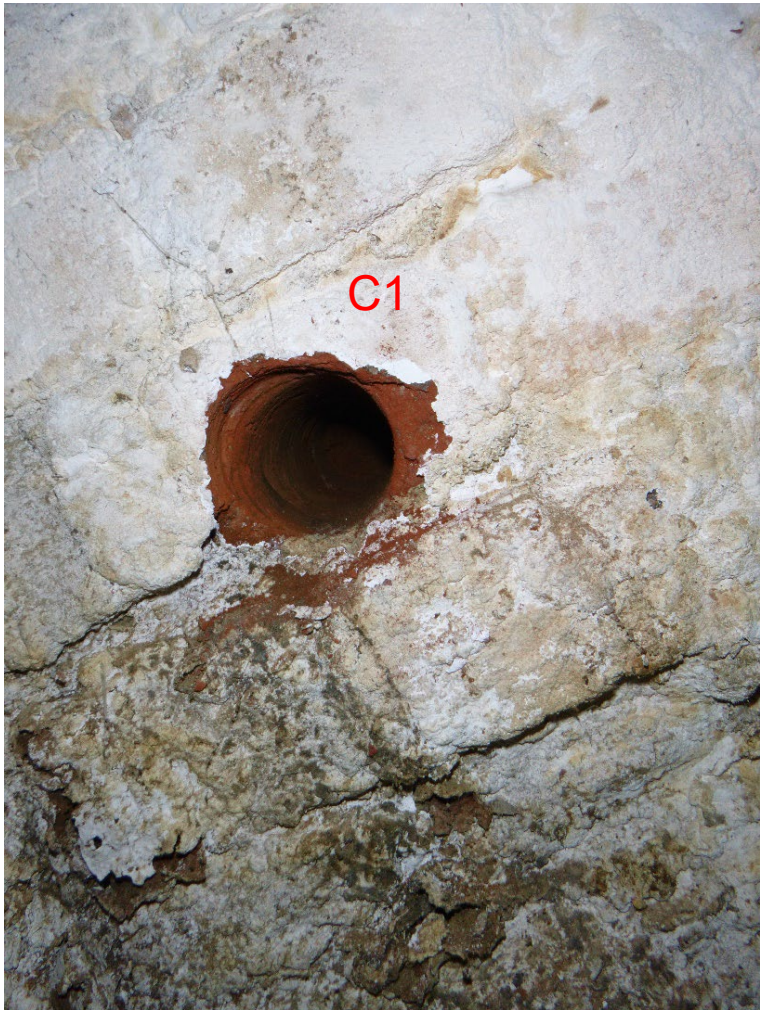
Core C1. Core C1 was the first to be cut; it was 50mm in diameter (the only core of this size) and was cut at a height of 620mm above floor level. The core was cut from the back store room extending towards the laundry room but terminating about 10mm before breakthrough so as not to cause unnecessary damage. The wall is some 350mm thick. Although water is reported to have gushed out of this wall the white coating was only slightly damaged by its passage and any subsequent evaporation. The brickwork was found to be very damp. The core hole revealed little even when inspected using an endoscope, in consequence other holes were cut with a 75mm diameter core barrel which facilitated better inspection of the interiors of the walls. No voids were identified.

**Photograph 11** Location C1 core hole.

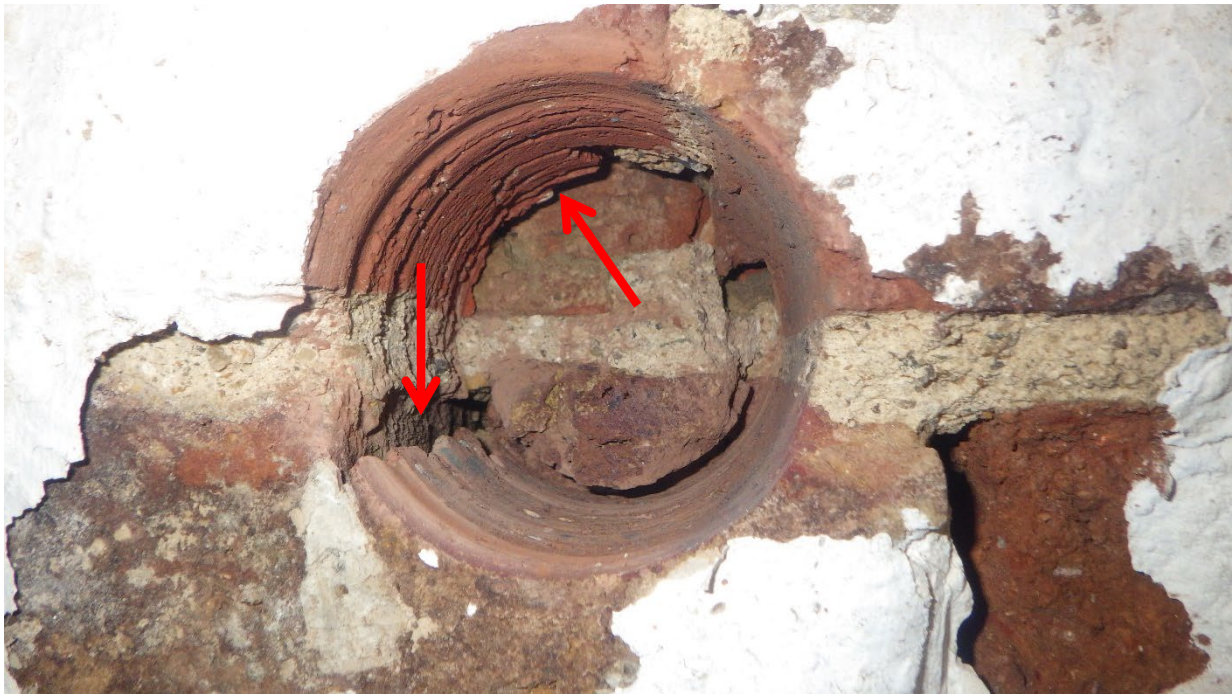
Core C2. Before Core C2 was cut a vertical mortar joint close to its location 1000mm above the floor, was probed using a knife. There was material in the joint but it had no strength whatsoever; it was probably material that had moved location during the flooding incident.

The core was cut to a depth of 330mm in the 350mm thick wall being drilled from the store room side. A vertical joint between bricks was found to be empty, never having been filled with mortar during construction; the horizontal joints were mortar filled. The bricks were damp but perhaps less moist than lower down.

In general the walls had been well constructed with both horizontal and vertical joints being mortar filled. Filling of vertical joints was notably incomplete in the internal section of wall between the Store Room and Laundry where water had reportedly ingressed. Our opinion is that the joints at this location had never been filled properly rather than the potential alternative of the material being eroded by the incoming water.

**Photograph 12** Location C2. Vertical voids in joints to left and at towards back of hole.

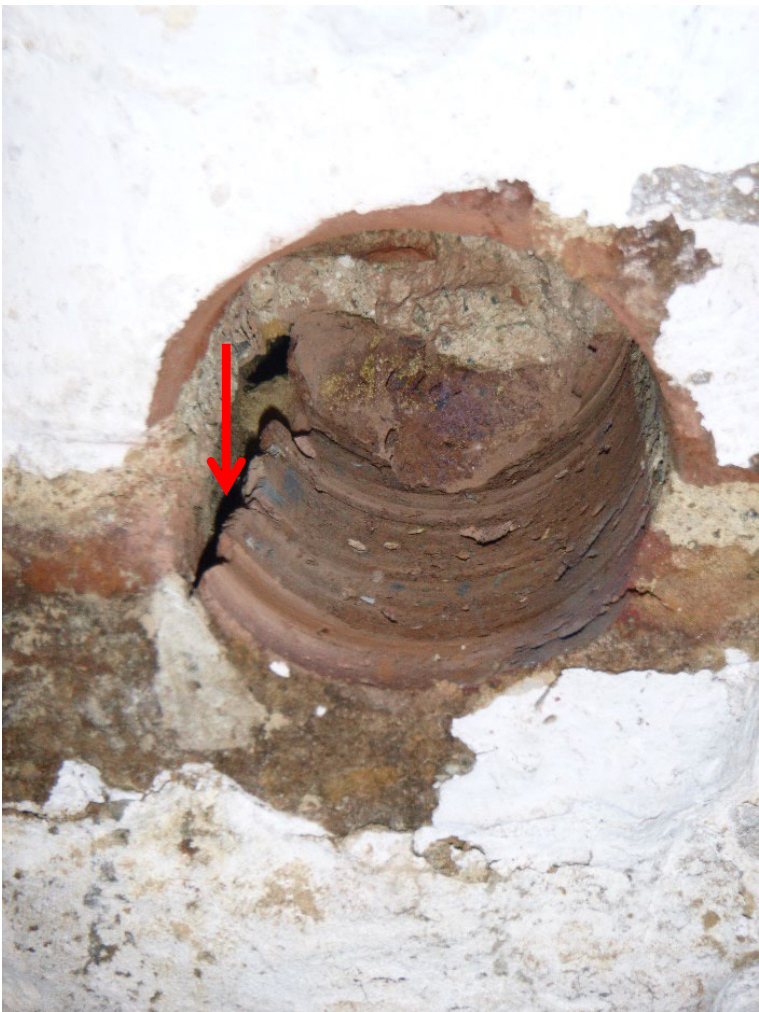
**Photograph 13** Location C2. Vertical void between bricks on left.

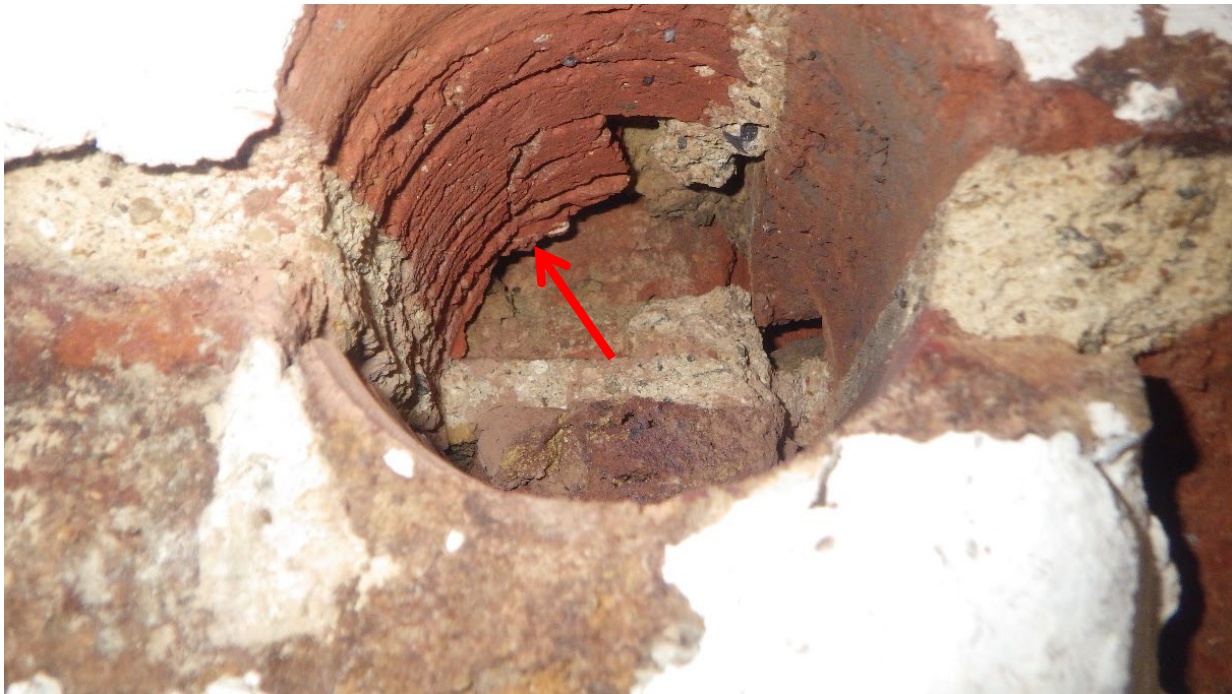
**Photograph 14** Location C2. Vertical voids between bricks towards back of hole.

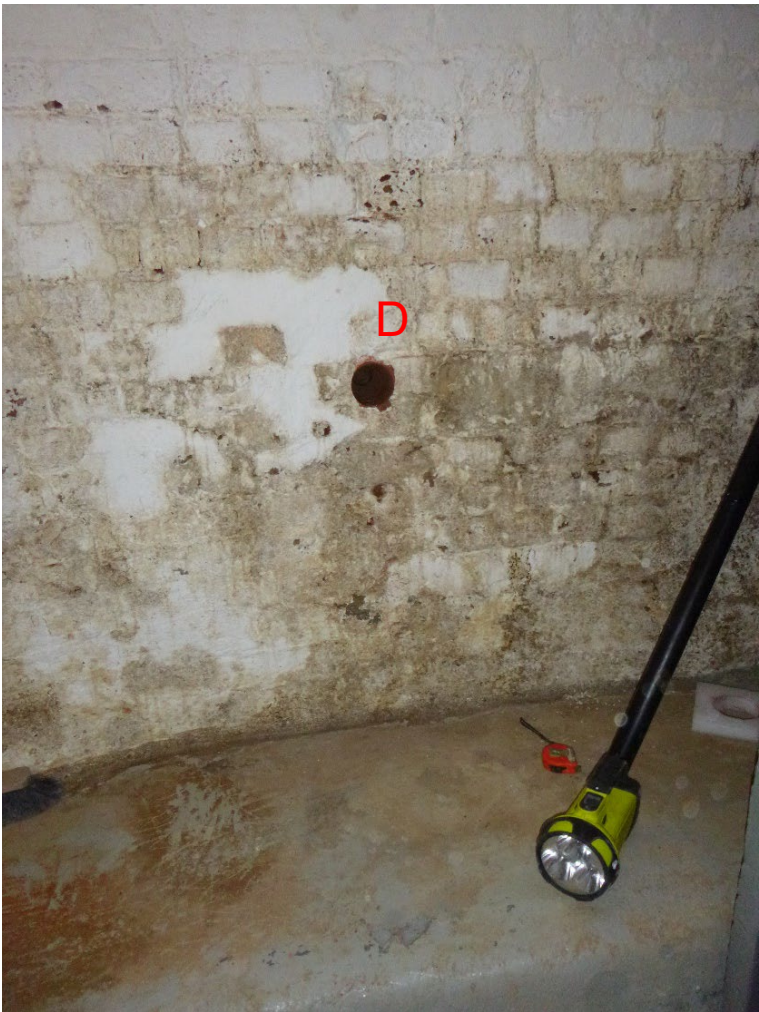
**Photograph 15** Location D.

Core D. Core D was cut into the Store Room wall where it backs onto fill. The surface of the wall had been painted white, this layer was in a middling condition showing some disruption from the passage and evaporation of moisture. The wall was 350mm thick. The brick proved to be damp and very soft while the mortar joints (vertical and horizontal) were well filled with mortar. There was no waterproof coating on the back of the wall. The fill was a slightly sandy, silty clay that was well compacted with no evident voids.

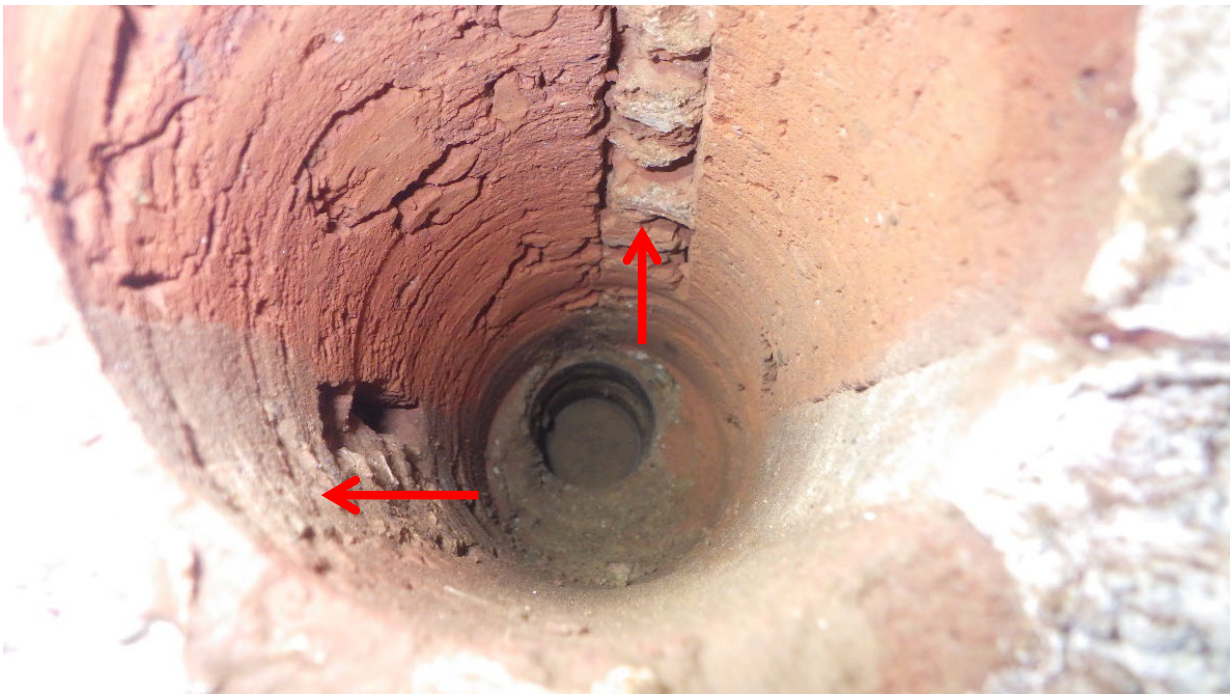
**Photograph 16** Location D. Vertical and horizontal joints reasonably well filled with mortar.

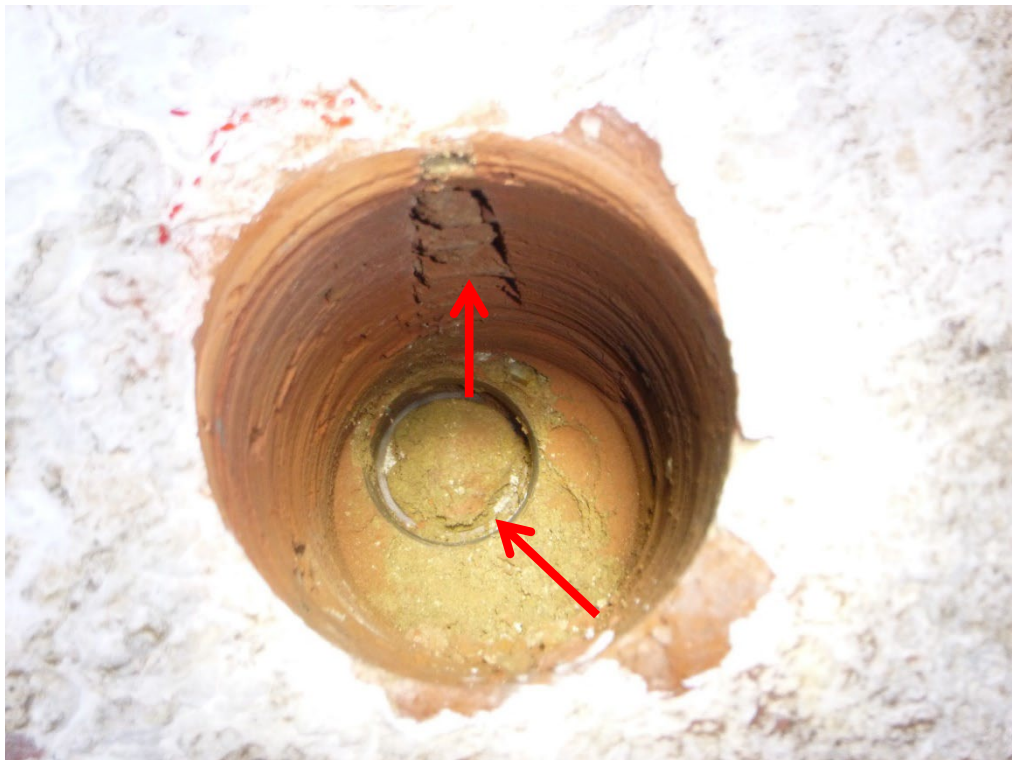
**Photograph 17** Location D showing mortar filled vertical joint between bricks and soil sample.
