Project ref: **383**

Site address: **139 Fortis Green Road, London, N10 3LX**

# HERITAGE STATEMENT & ASSESSMENT

Revision: **A 09.11.2023 (first issue)**  
**B 22.01.2024**

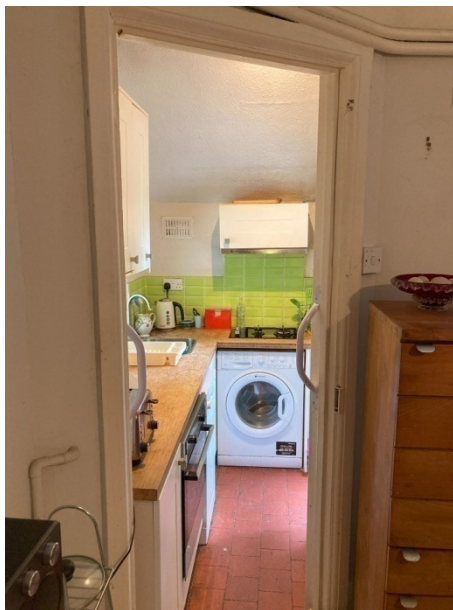
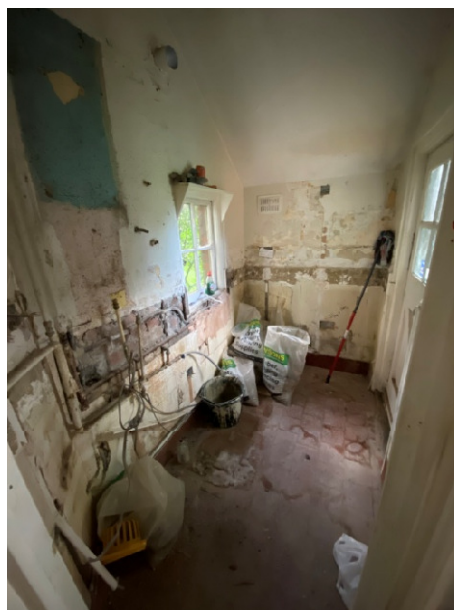
- 4.1 The property was inspected on 26<sup>th</sup> October 2023. Stripping-out works have been undertaken in the property.
- 4.2 At the rear of the property, where a small kitchen was located [ROOM A], this has been stripped-out exposing pipework that has been altered over the years as well as a mix of plaster finishes, tile adhesive and paints on the wall. As this space is located within a lean-to structure with a low lying vaulted ceiling there are no plaster details observed. We understand that the vaulted ceiling and small window are to be retained in their original form. The garden door providing access into the rear garden is proposed to be replaced with a 'like-for-like' replacement in timber with double glazing and matching timber profiles/details.

Non-original kitchen prior to strip-out

Current status

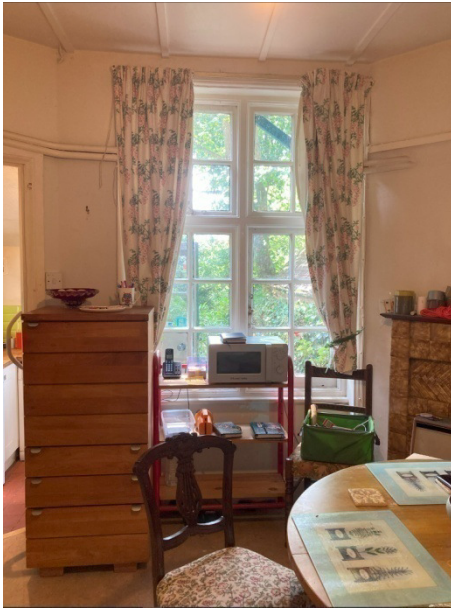
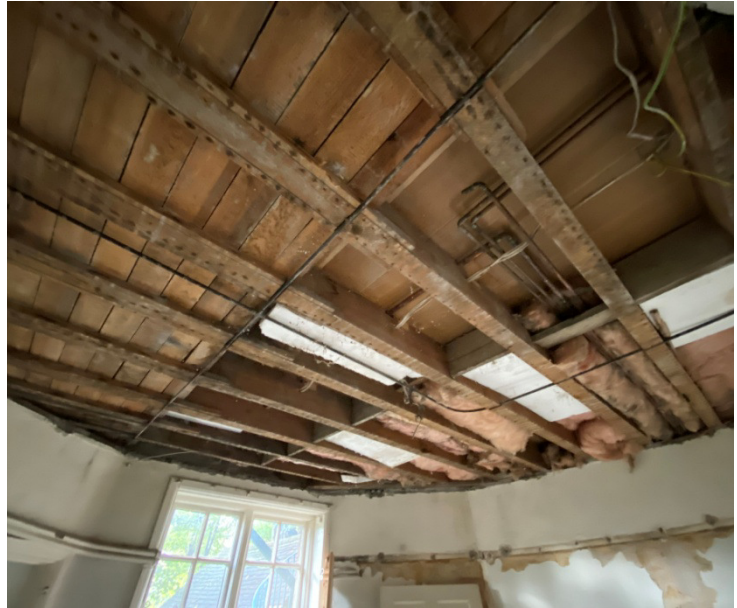
- 4.3 Given the alterations that have previously been made to this room and the existing condition we do not consider the proposed alterations to be detrimental to the Listing.
- 4.4 In the original dining room [ROOM B] previous photos show a timber paneled ceiling and a partial picture rail. Section of the picture rail appear to have been removed to allow for the installation of service pipework.

Dining room prior to strip-out

Current status

- 4.5 Following the removal of the ceiling there are clear indications that historic alterations have been made to the ceiling structure through the presence of polystyrene and fiberglass type insulation.

**We would recommend that these materials are removed as they do not reflect the building's heritage and present a fire hazard. We would suggest these are replaced with a more natural acoustic insulation such as a sheep's wool or hemp based insulation.**

**Removed skirting boards should be replaced with a solid natural wood skirting, ie: not an MDF or other similar composite material.**

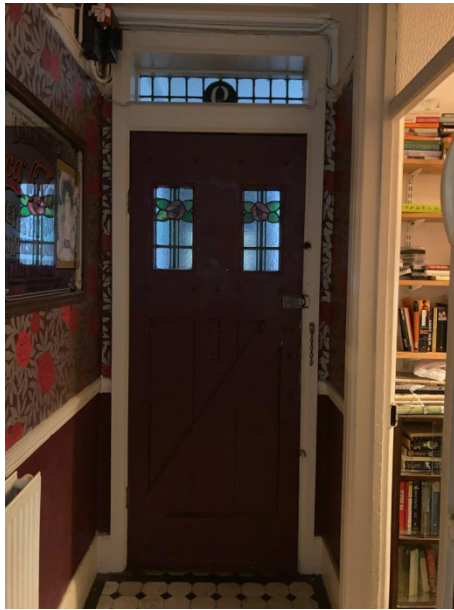
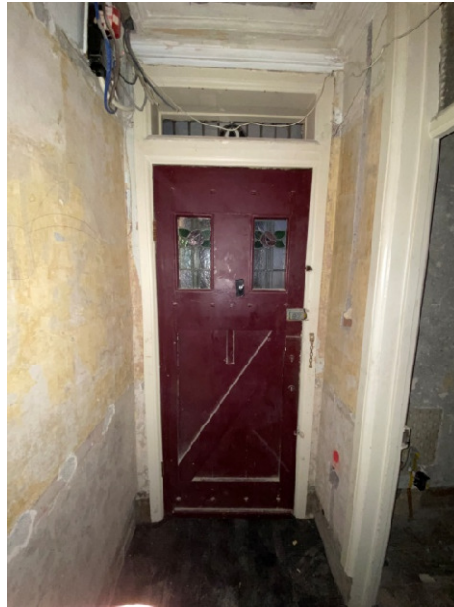
Flat front door and hallway prior to strip-out

Current status

- 4.9 Our assessment of the hallway is that the key aspects that are of considerable historic and architectural interest are the partition walls that denote the circulation space and separate the front (road facing) and the back (garden facing) rooms ending with the two internal oblique doors positioned at around 45 degrees. The original floor tiles also feature a simple decorative boarder that aligns with the original wall partitions. Internal clear storey panes of glass above the doors also allow for natural light to enter the otherwise windowless hallway and while the glass in these openings does not appear to be original the opening itself and design feature is an aspect that we would deem of interest and worth preserving. Original door openings, doors and architraves all remain in situ and we understand are to be preserved.

**We would suggest that the skirting and dado rail is replaced with a design in keeping with the period in a traditional material such as solid timber.**

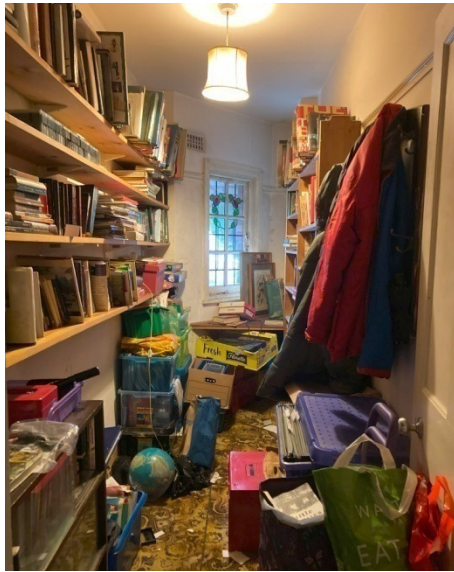
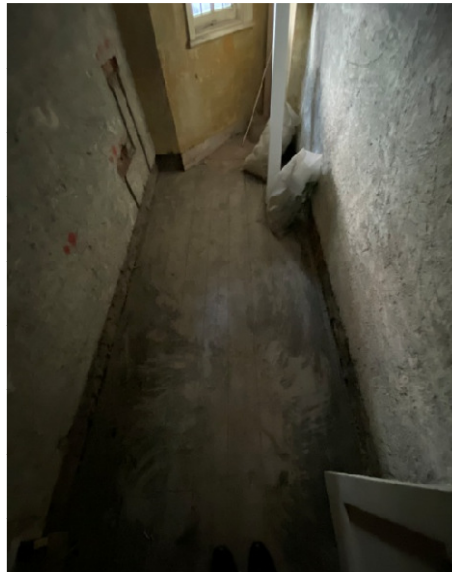
4.10 Adjacent to the flat front door is [ROOM D]. A non-original carpet has been stripped-out, as well as the plaster top coat to the walls and a dado rail that may not have been original. An original timber window facing the main roadside common entrance remains with the original lead lined glazing and an original monkey-tail window handle and window stay.

Room D prior to strip-out

Current status

**We deem the window, window ironmongery and internal architrave to be of significant interest and should be preserved. The plaster skim to the walls and ceiling should be re-instated.**

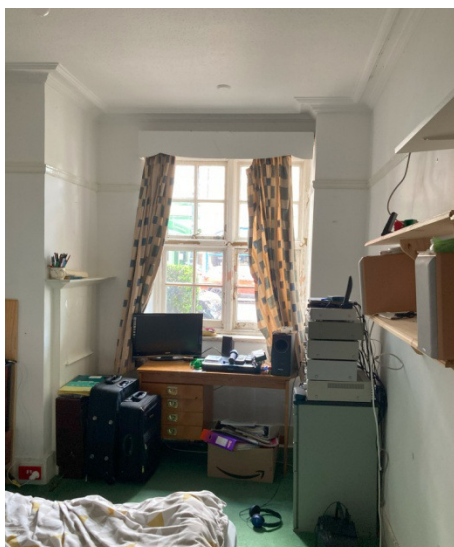
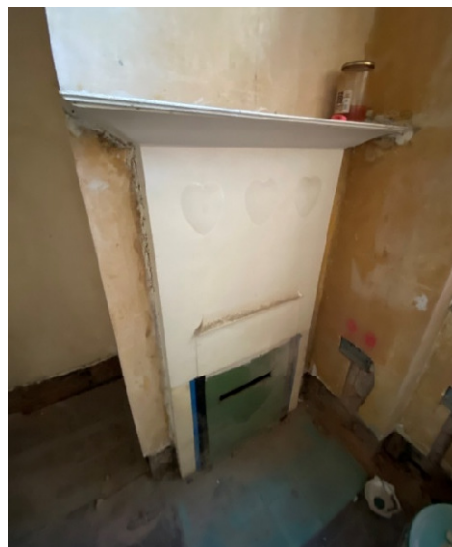
- 4.11 In the smaller spare room / study [ROOM E] finishes have been stripped-out including the picture rail and skirting boards. Looking at photos prior to the strip out the skirting boards appear to be plain square edge either modern or not of any particular merit or interest. The picture rail that has been removed can be replaced however again within the context of the building we do not feel that this is of significance in this small room.

Room E prior to strip-out

Cast iron fireplace

**The key aspects of merit that must be retained and preserved are the original windows and ironmongery that mostly appear in adequate order. As well as the simple plaster cornice and of most significance the small cast iron fireplace with simple heart motifs which is very likely to be a Thomas Elsley design.**

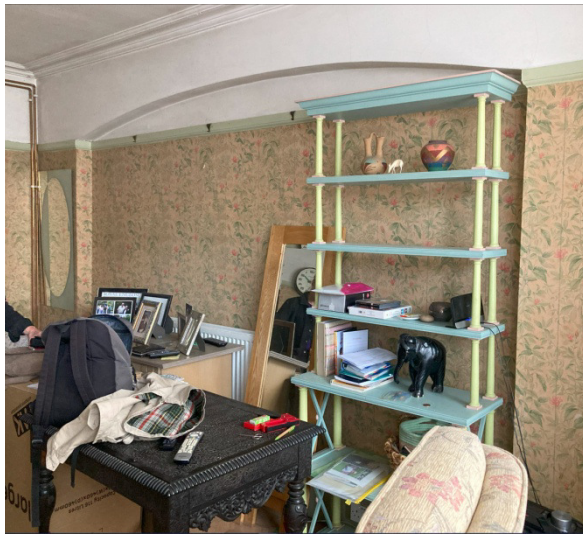
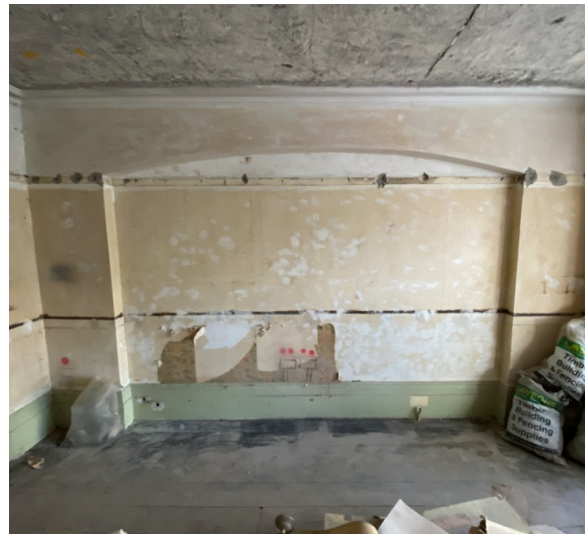
- 4.12 In the principle room of the flat [ROOM F], which faces the road side, photos prior to the strip out do not show a dado rail present, however there is clear horizontal 'ghost' line in the current photo indicating that a dado rail did originally exist. This confirms that the wallpaper that has been removed, while appears faded and in the Arts & Crafts style is not original. While this previous wallpaper did appear to have charm we understand that the owners intend to re-instate similarly appropriate William Morris wallpaper. However, in the context of the Listed building whether the walls are papered/lined or not we do not feel that this detrimentally impacts the significance of the structure.

Room F prior to strip out

Current status

**We deem the arched recess in the wall, the windows and window ironmongery to be of interest and should be preserved. The plaster skim to the ceiling should be re-instated.**

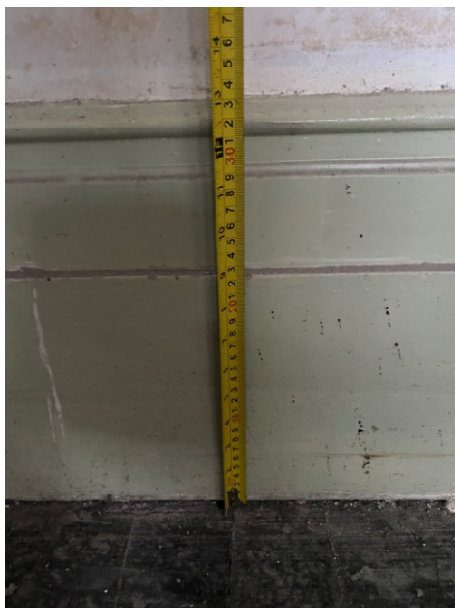
- 4.13 An original skirting board (at 330mm/13 inches high), that is not particularly decorative and appears to have been over-boarded at some point in history to create an additional square profile remains in situ and is worth preserving.

Skirting board detail with likely 220mm high add on

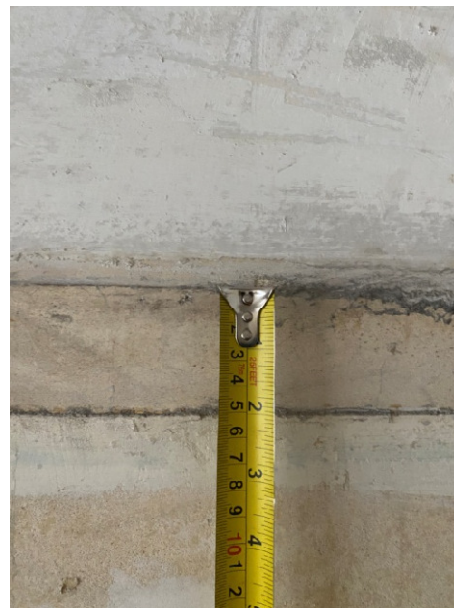
50mm / 2 inch picture rail

- 4.14 The 2 inch picture rail that has been removed offered a pleasing addition to the skirting board, however we do not feel that this is essential to preserve the heritage of the overall Listing. We understand that the owners intend to re-instate the picture rail.
- 4.15 A significant architectural and historic feature of this room is the shallow arched recess. Being located within the principle room and referencing the three external brick arches that can be observed on the front elevation this feature should not be permanently altered.

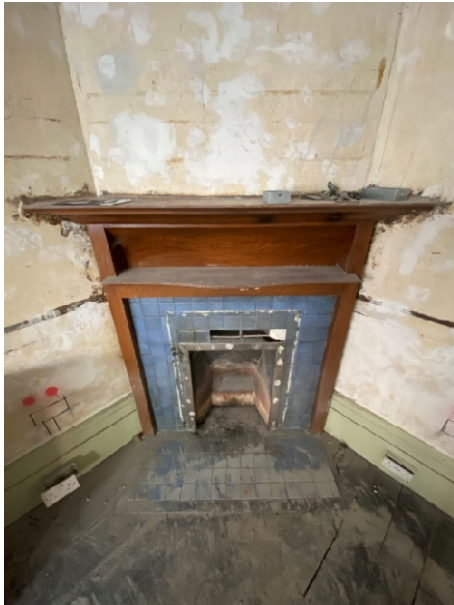
- 4.16 The final aspect that requires preservation is the simple hardwood fire place surround located in the corner of the room and obliquely orientated to reflect the oblique room door. This orientation and simple timber surround should be retained as its removal would have a detrimental impact on the room and Listing.

Room F fire place surround

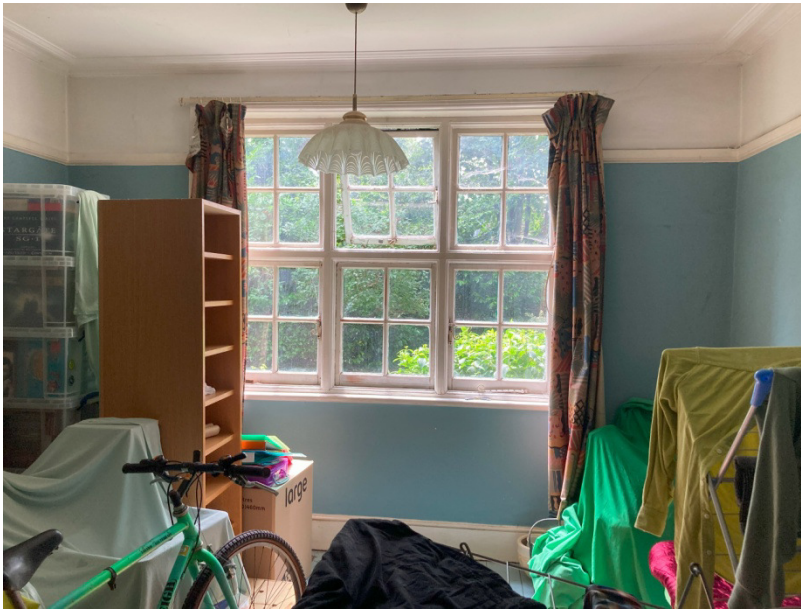
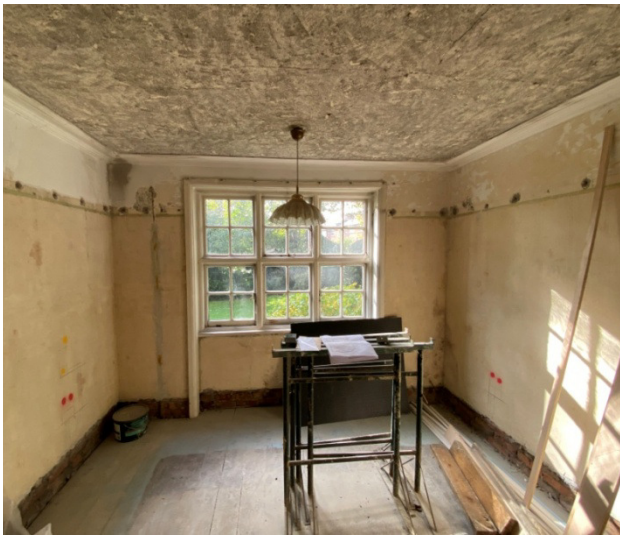
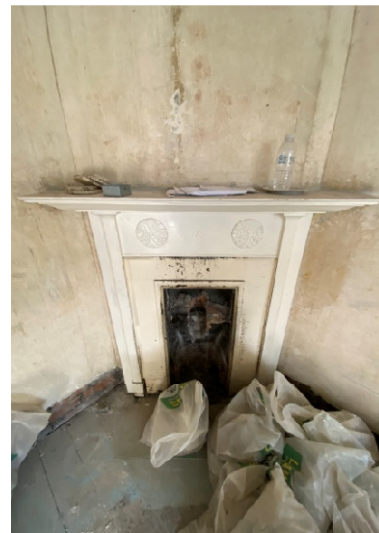
- 4.17 In the rear garden facing bedroom [ROOM G] the level of strip out is similar to the adjacent room F. This room benefits from a feature window recess framed by an architrave. This along with the windows should be retained as it is a distinctive feature of the property. Similarly, an original fireplace installed on an oblique wall should be retained as it mirrors the fireplace in room F as well as the oblique room door entrance.

Room G prior to strip-out

Current status

Room G fireplace surround

**The plaster skim to the ceiling should be re-instated.**

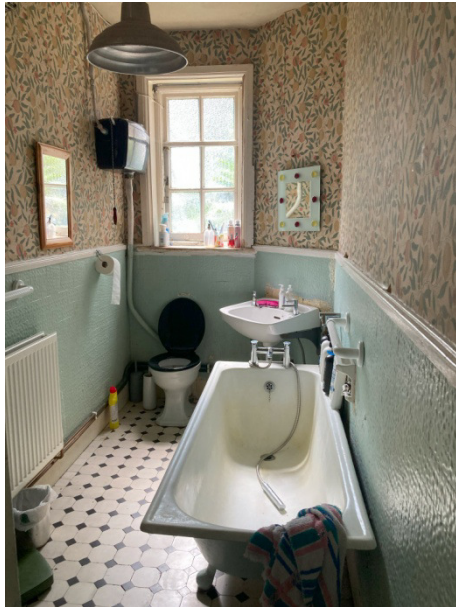
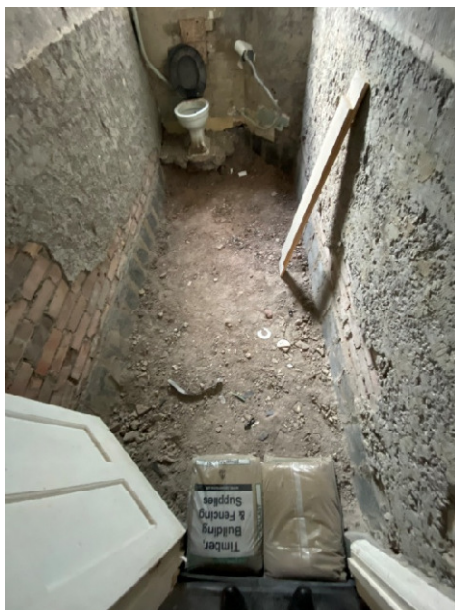
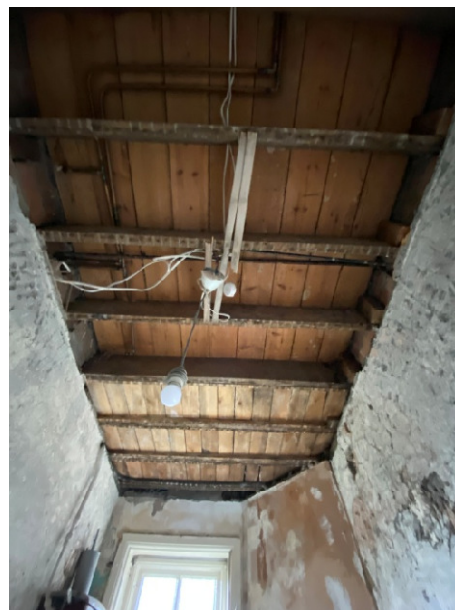
- 4.18 The bathroom [ROOM H] has had the most significant strip-out including the removal of the floor structure. We understand that the floor tiles have been stored on site and can be re-instated. Prior to the strip-out works there also appears to have been a dado rail, wall paper and painted tiles. There was no ceiling details or plaster cornice. The dado rail appeared to be quite poorly installed and likely suffered from moisture ingress from the bathroom

use. Given the flats continued operation as a private dwelling we do not feel that upgrading this small room to meet modern standards to have an impact on the Listing. As with the other rooms, the window should be retained and restored.

Room H prior to strip-out

Current status

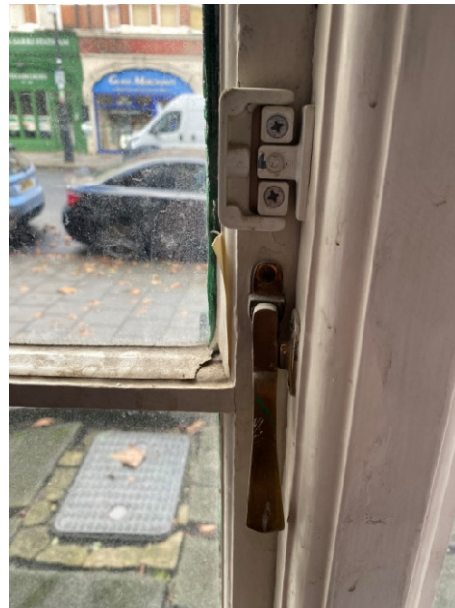
Poor quality historic alteration that will be replaced

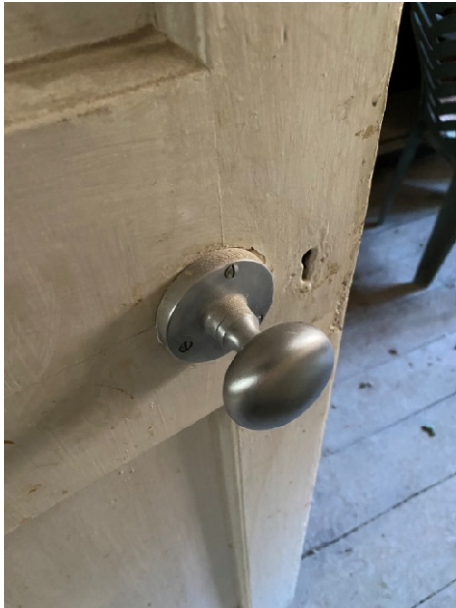
Poor quality internal door ironmongery to be replaced
