Appendix A  
Phlorum, Arboriculturist  
Letter and tree survey

Our ref: RS/10408/PD

Land at Hornsey Town Hall: Arboricultural Survey

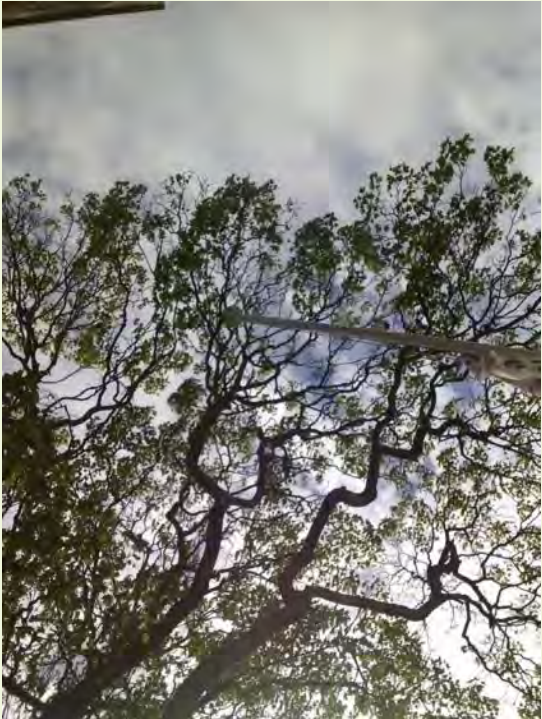
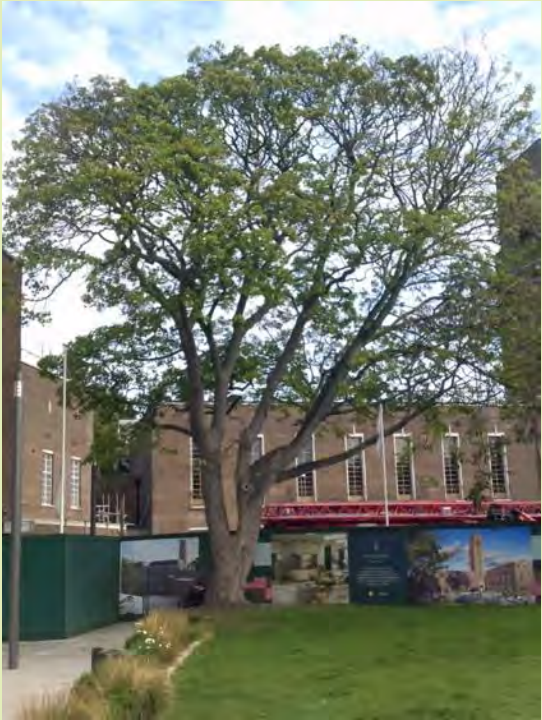
| Photo No. | Photograph |
|---|---|
| 1 | <p data-bbox="831 1144 986 1171">T2 – Sycamore</p> |

**T2 – Sycamore:** The construction works around T2 have been completed. This primarily involved the installation of replacement hard standing within the root protection area, although it appears the area to the north of the tree has been used as a contractor compound during the development as well. T2 is exhibiting some dieback in the upper crown. As the tree had a full and healthy crown prior to the development, it is likely that this loss of vitality is a result of the development. As the majority of the rooting area of the tree is located under hard standing, and the retained grass area does not appear to have been compacted or contaminated during the construction period, there is very limited scope to ameliorate the rooting area. Instead, the tree should be monitored and have the dead wood removed as required in the future.

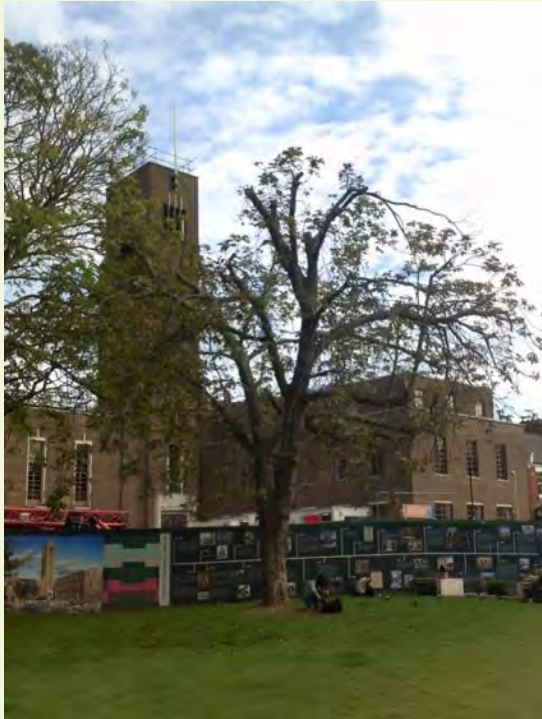
| Photo No. | Photograph |
|---|---|
| 3 | <p data-bbox="836 1140 979 1167">T3 - Chestnut</p> |

**T3 – Chestnut:** T3 has been reduced in accordance with the previous recommendations from Phlorum as a result of a limb snapping out in the crown during the course of the development. The tree is in a state of decline but this is not the result of the HTH development and there does not appear to have been any direct damage to the rooting medium or tree as a result of the construction works.

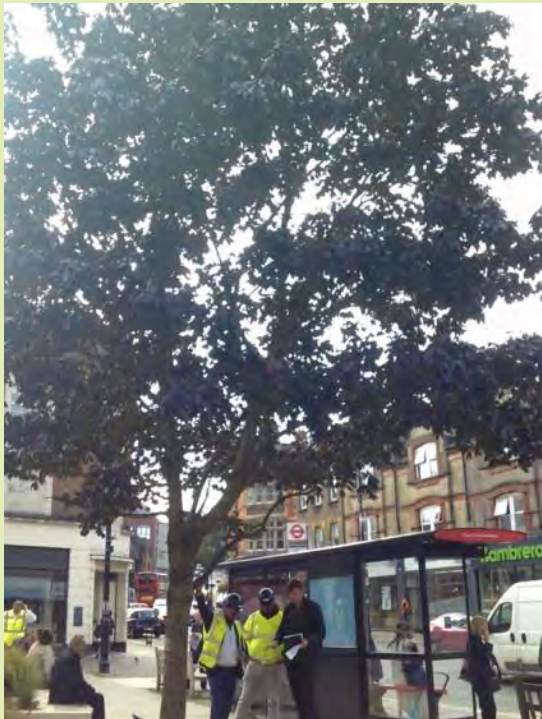
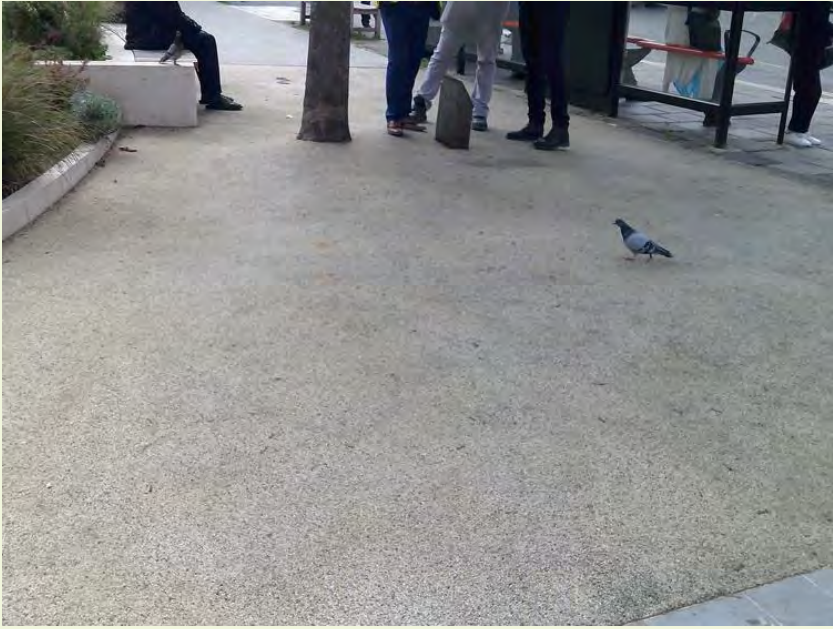
| Photo No. | Photograph |
|---|---|
| 4 | <p data-bbox="812 1924 1003 1951">T4- Norway maple</p> |

T4 – Norway maple: T4 has a full and healthy crown. It is now surrounded by permeable hard standing on what used to be half grass and half tarmac. Concerns have been raised regarding this type of surface in terms of durability and aesthetics. It is my opinion that this is the most suitable surface type to surround the tree. The hard standing needs to be permeable and flush with level of the existing pavement. Use of block paving or permeable tarmac would likely require a greater sub-base than the bonded gravel that has been used. Additionally, any hard standing around the base of the tree is likely to be subject to cracking as the tree matures, however the bonded gravel will be the easiest to repair in the future.

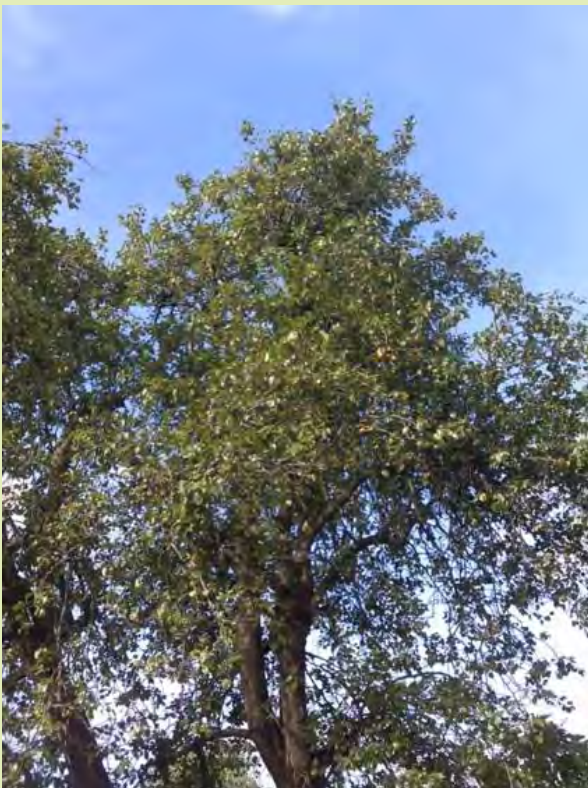
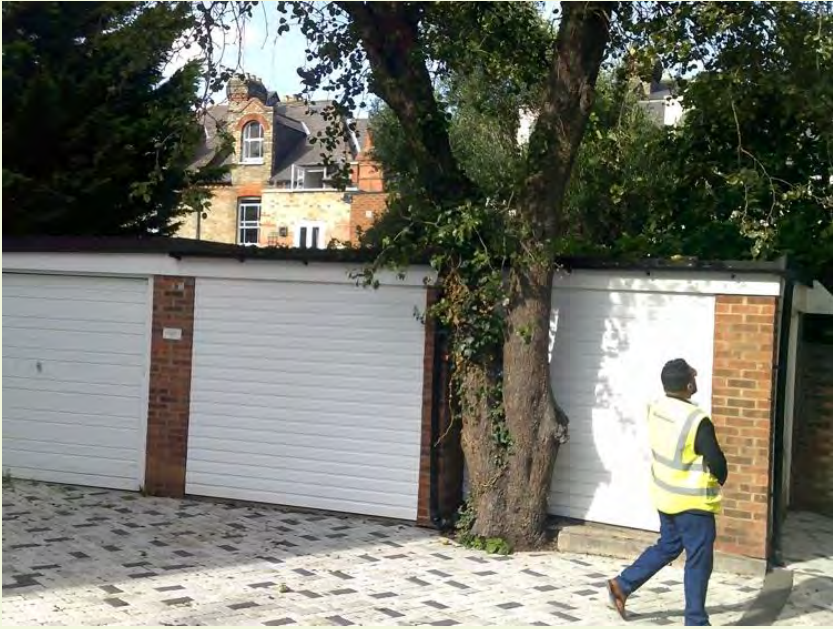
| Photo No. | Photograph |
|---|---|
| 6 | <p data-bbox="853 1892 965 1924">T13 – Pear</p> |

T13 – Pear: The construction works surrounding T13 (installation of permeable paving) have been completed. These works do not appear to have impacted on the tree as it has a full and healthy crown and no visible physical damage resulting from the construction works.

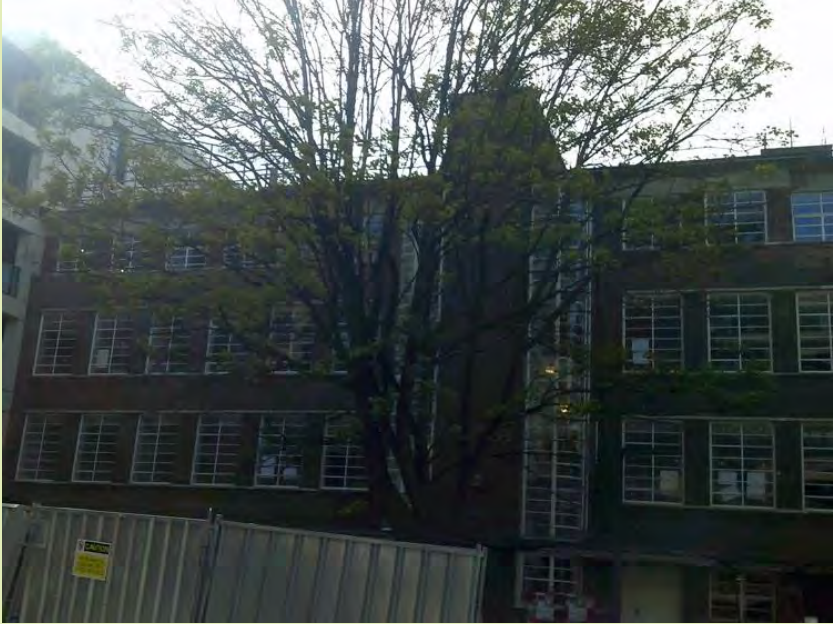
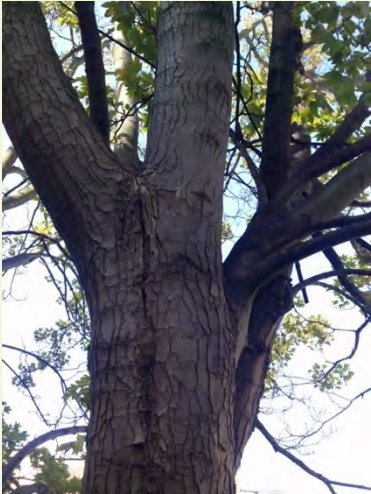
| Photo No. | Photograph |
|---|---|
| 8 | <p>T14 - Sycamore</p> |

T14 – Sycamore: T14 is exhibiting significant crown dieback (estimated to be about 30-40% density now whereas it had a full and healthy crown prior to the development). It is highly likely that this is the result of the construction activities that have occurred around the tree. A weak branch union was also observed on the north side of the tree. Ameliorating the rooting area of T14 will now be very difficult as it is surrounded by hard standing. Instead, it is recommended that the crown be reduced to approximately 10m height and monitored.

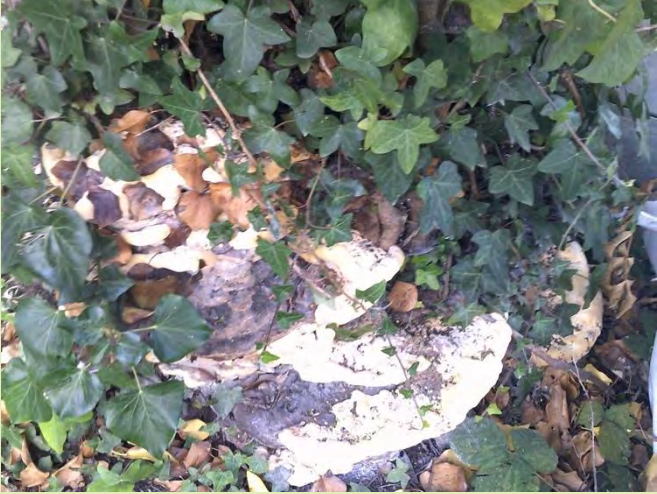
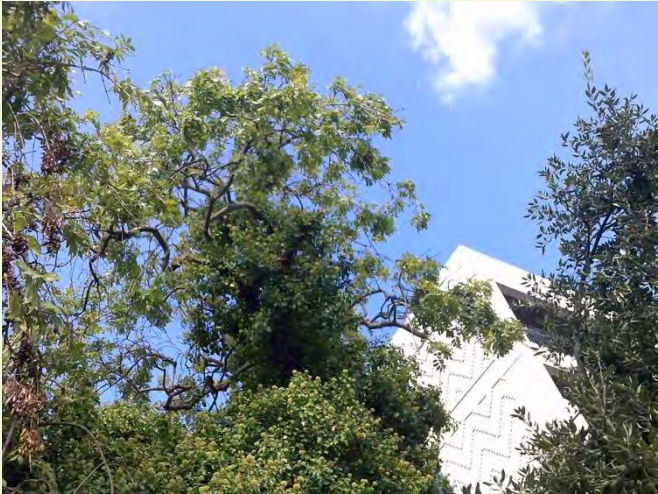
| Photo No. | Photograph |
|---|---|
| 10 | <p data-bbox="810 1473 1010 1507">T27 – Weeping ash</p> |

T27 – Weeping ash: The existing retaining wall to the south of the stem has been demolished and is to be rebuilt. Additionally, further works to the wall on the east side of the buttress is still to occur and will likely result in further root damage. Currently T27 has a healthy crown, however during the updated site visit, numerous *Perenniporia fraxinea* brackets were observed on multiple sides of the buttress. Given the high risk target zone of this tree in the completed development and the likelihood of further root disturbance during the course of the remaining construction works which will further weaken the trees natural defence against the decay, it is my opinion that this tree should be felled and replaced during the soft landscaping phase of development.

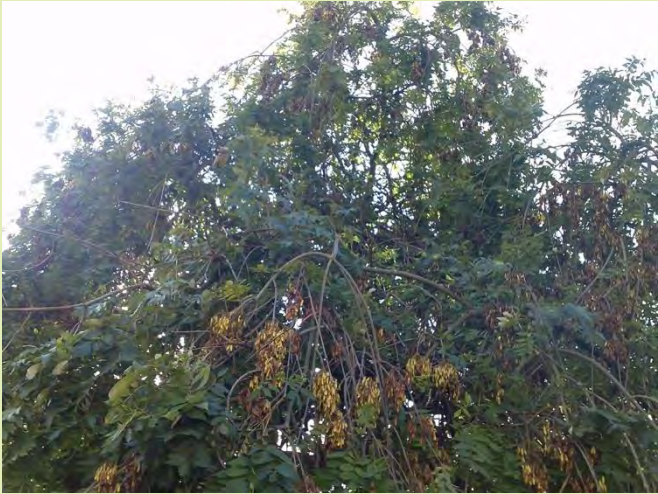
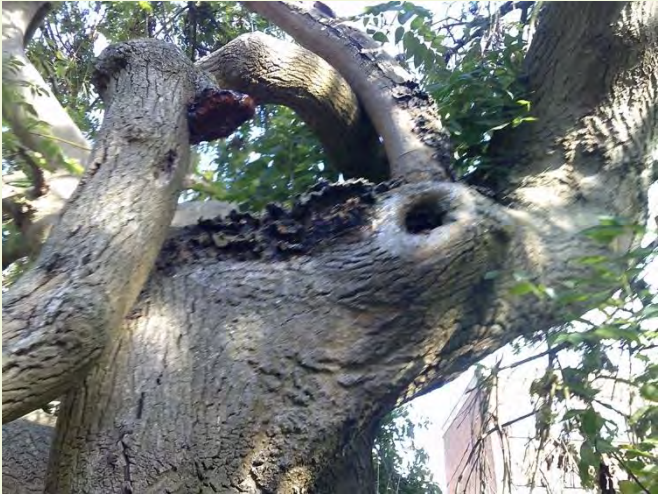
| Photo No. | Photograph |
|---|---|
| 12 | <p data-bbox="810 1473 1008 1505">T28 – Weeping ash</p> |

T28 – Weeping ash: T28 has a healthy crown. There are multiple cavities in primary limbs of the crown, however given the form of the tree it is not considered that any pruning works are needed/viable to mitigate these defects. The construction works directly around T28 are yet to commence and must occur sensitively to ensure no damage occurs to the roots or rooting medium.
