# HIGHWAYS/PUBLIC WALKWAYS SCHEDULE OF CONDITION

Brunel Walk – Regeneration scheme – Replacing old  
Residential blocks for new Residential blocks

Prepared by: Tom Barker

Date: 08 January 2024

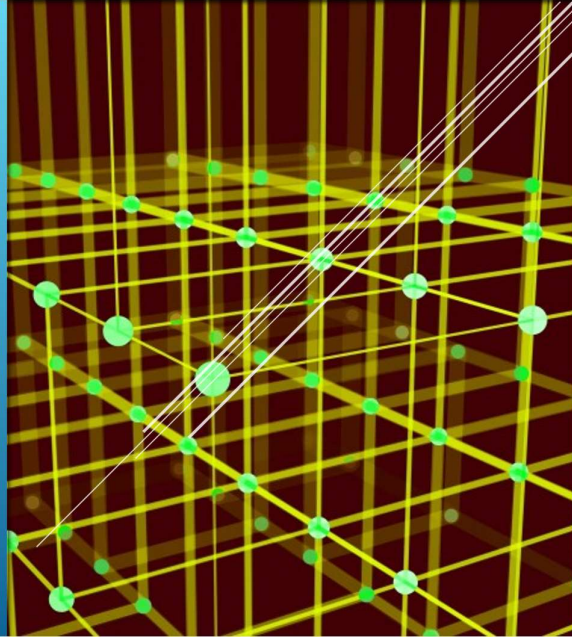
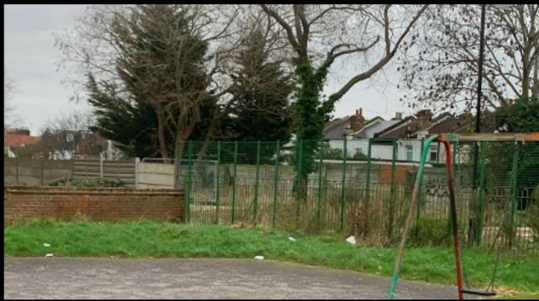
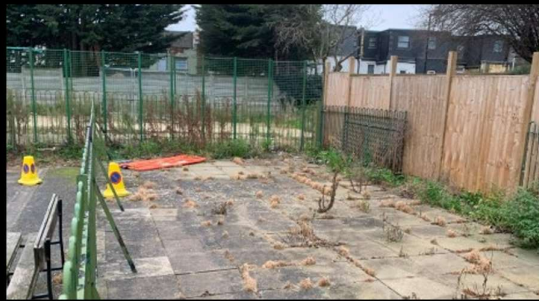
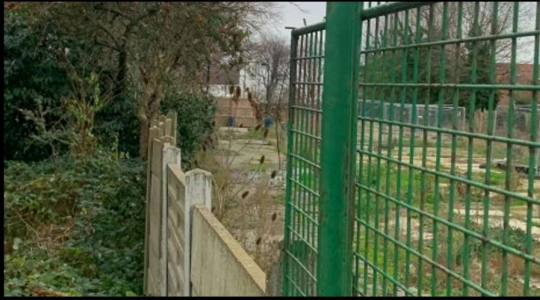
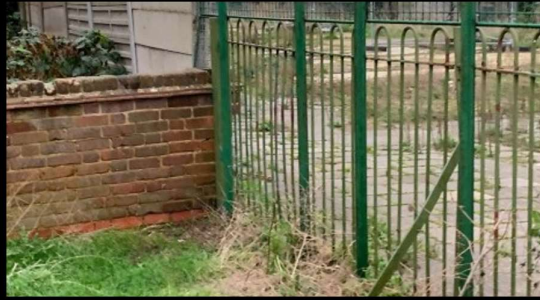
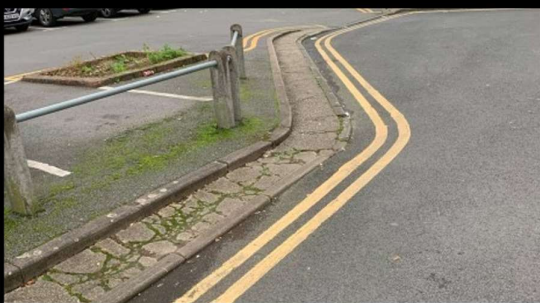
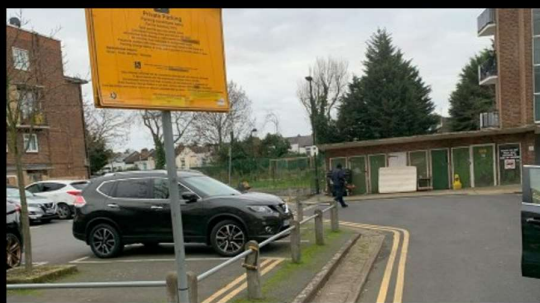
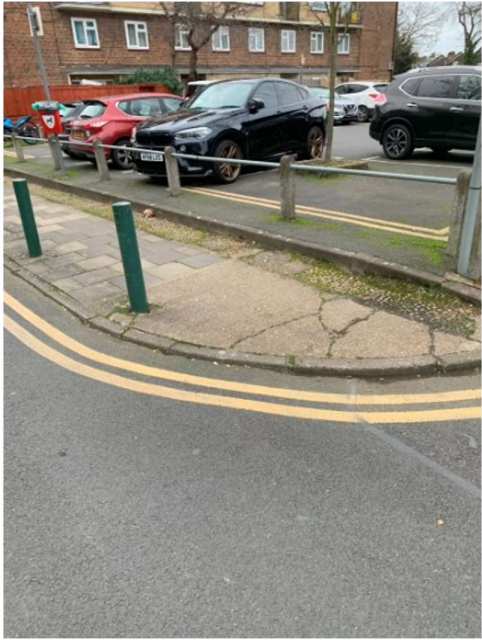
# SECTION 1

| Ref No | Location / Element | Decription | Defects/Condition and Comments | Photo Ref No |
|---|---|---|---|---|
| 1.1.1 | Footpath | Footpath comprises of a combination of Tarmac, concrete paving and concrete patching. | A heavily trafficked footpath showing general wear and tear on all elements. Some paving slabs loose and uneven with various araes being infilled with cement to repair. Kirbs well worn and chipped | Photos 1 - 13 |

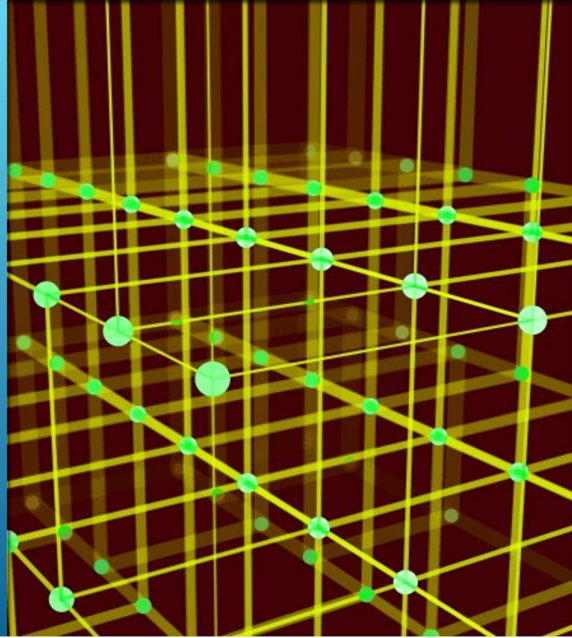
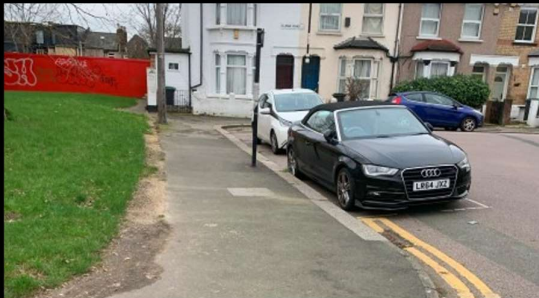
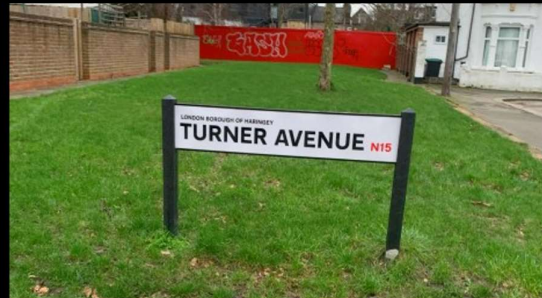
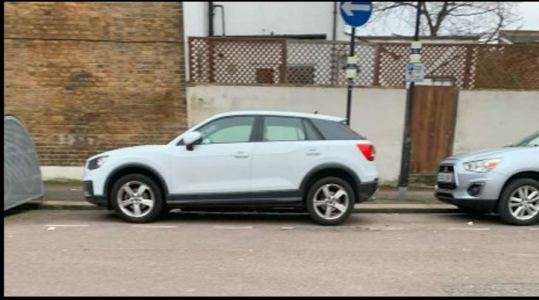
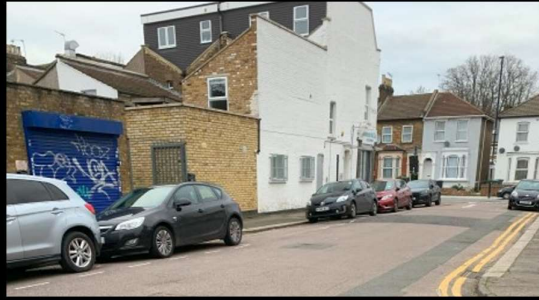
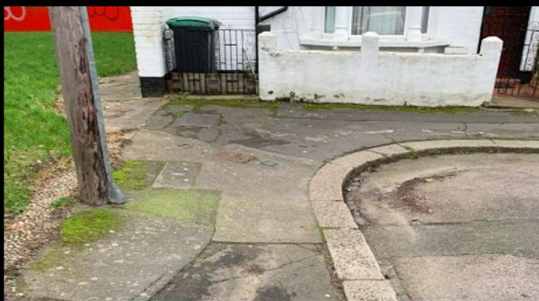
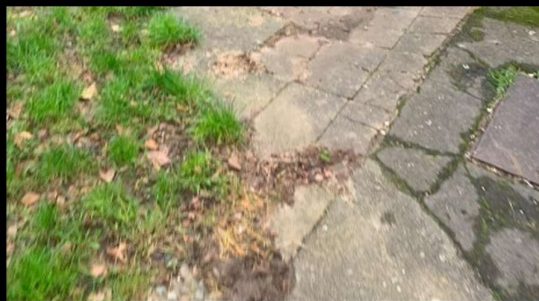
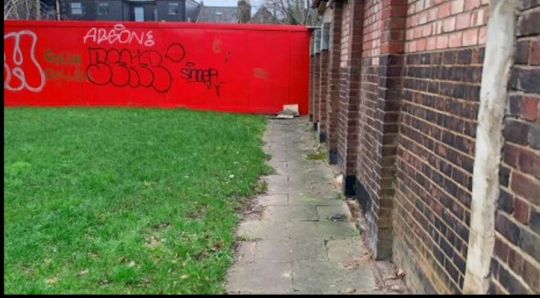
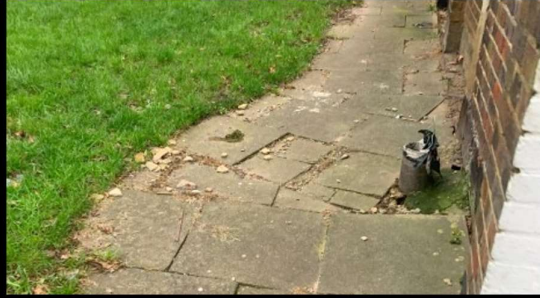
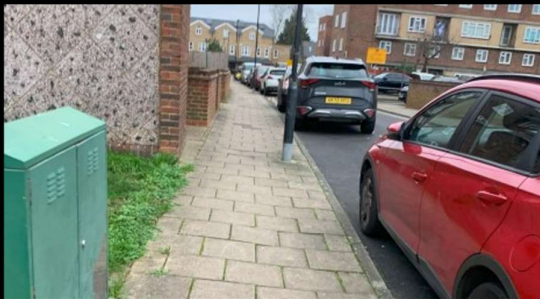
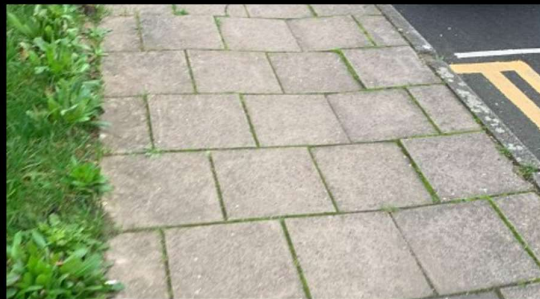
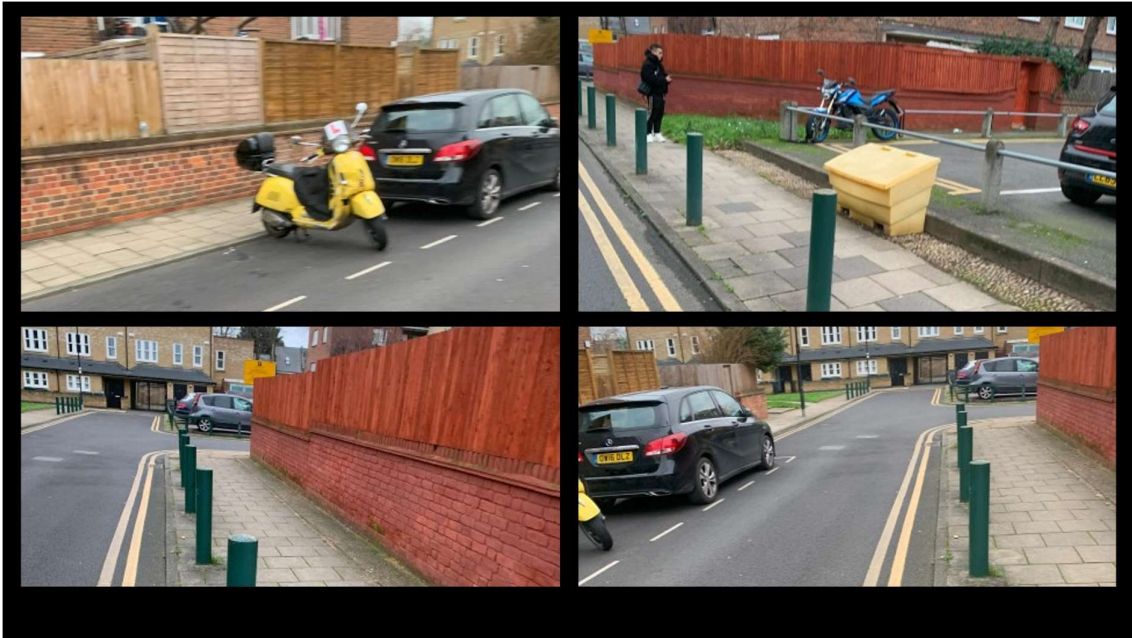
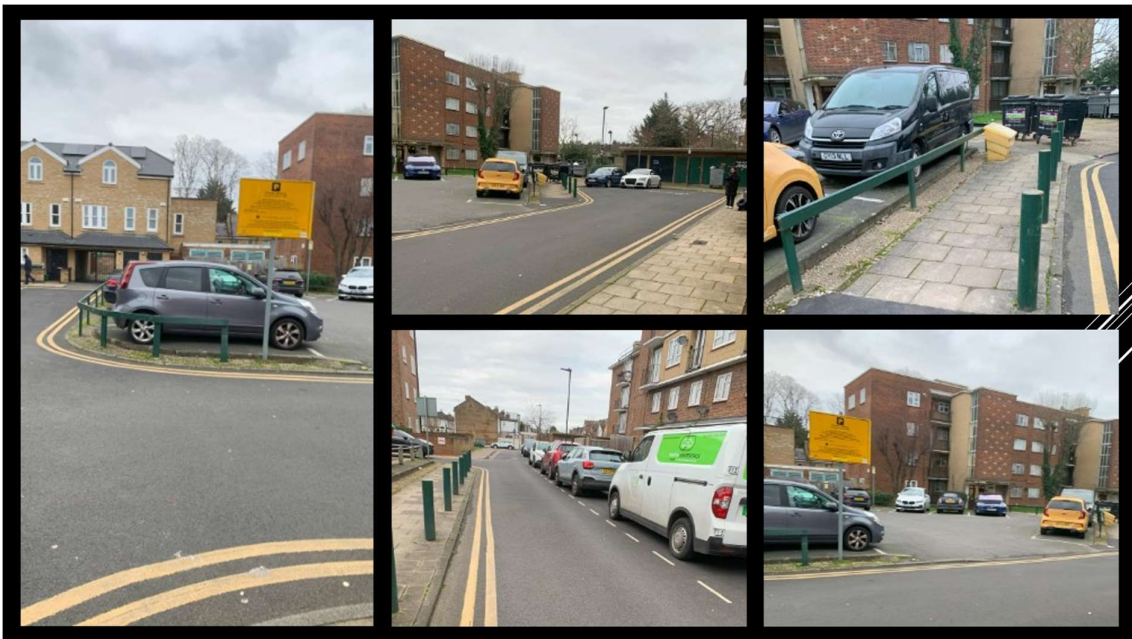
## SECTION 2

| Ref No | Location / Element | Decription | Defects/Condition and Comments | Photo Ref No |
|---|---|---|---|---|
| 1.2.1 | Footpath | Foot path consists of paving flags and Concrete patch repair | Showing general wear and tear, uneven paving flags and brocken contrete around BT covers | Photos 13 to 42 |

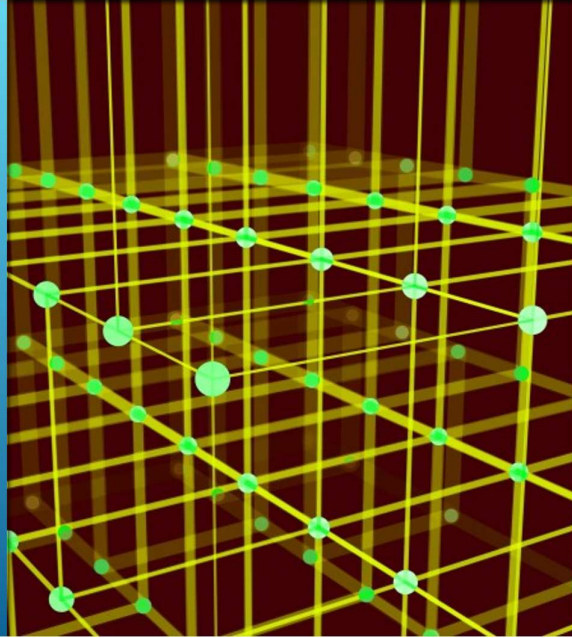
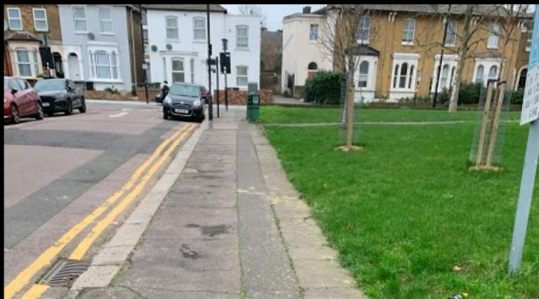
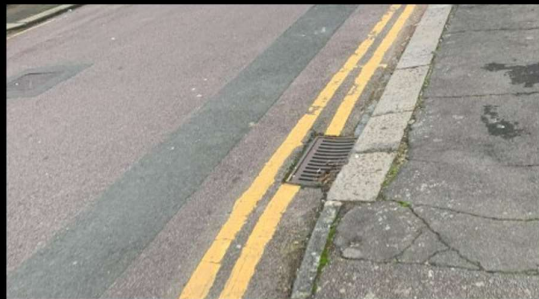
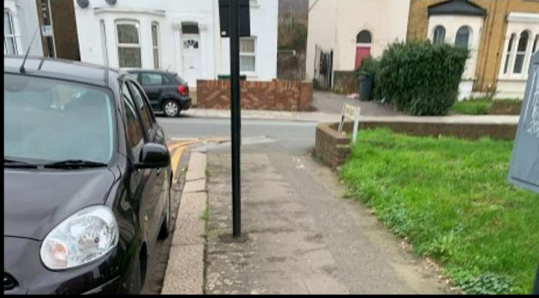
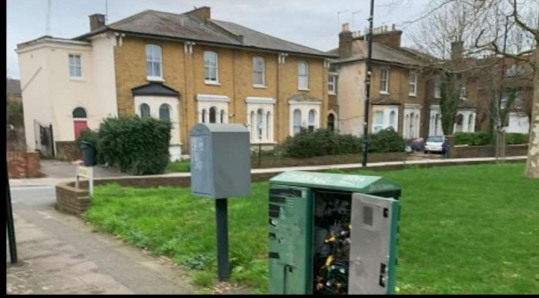
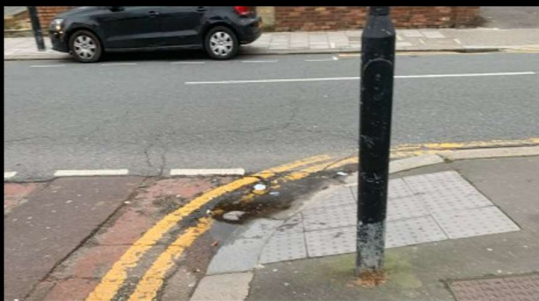
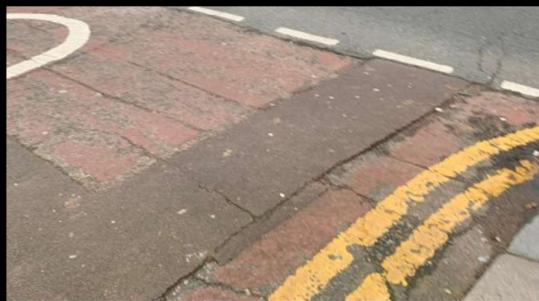
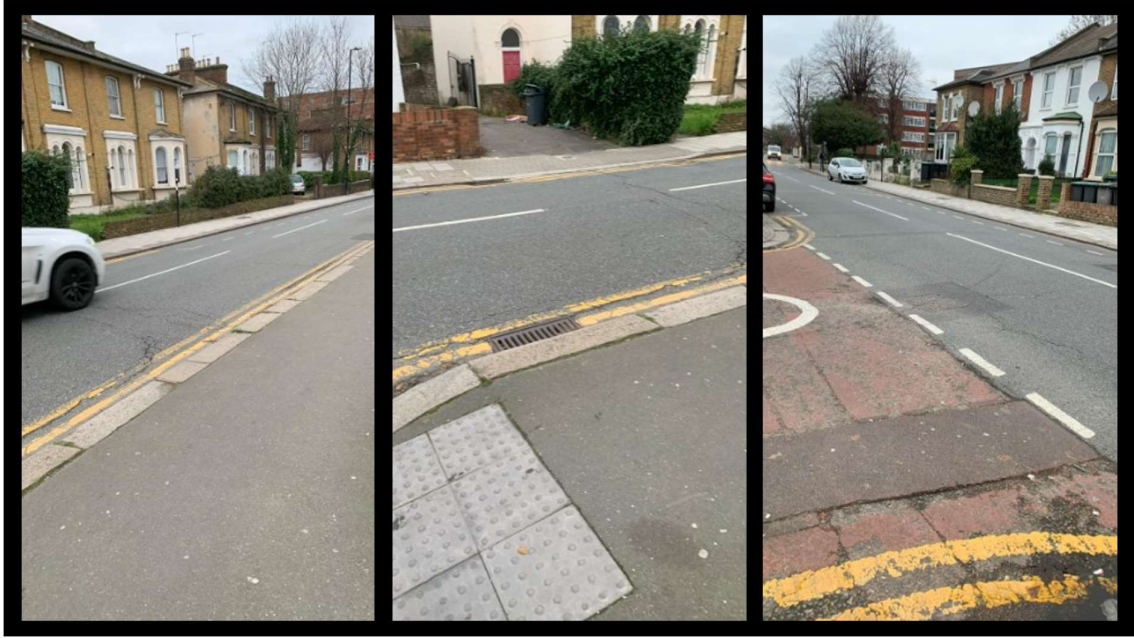
## SECTION 3

| Ref No | Location / Element | Decription | Defects/Condition and Comments | Photo Ref No |
|---|---|---|---|---|
| 1.3.1 | Footpath | Consisting of Tarmac and concrete paving flags and tactile paving | Some flags area cracked / Brocken. Tarmac has new and old sections showing ware and cracking. Tacktile paving flags are uneven and worn. | Photos 42 to 57 |

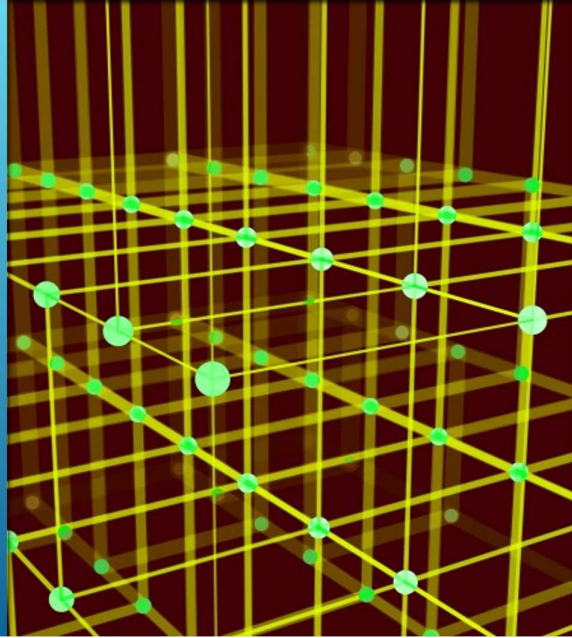
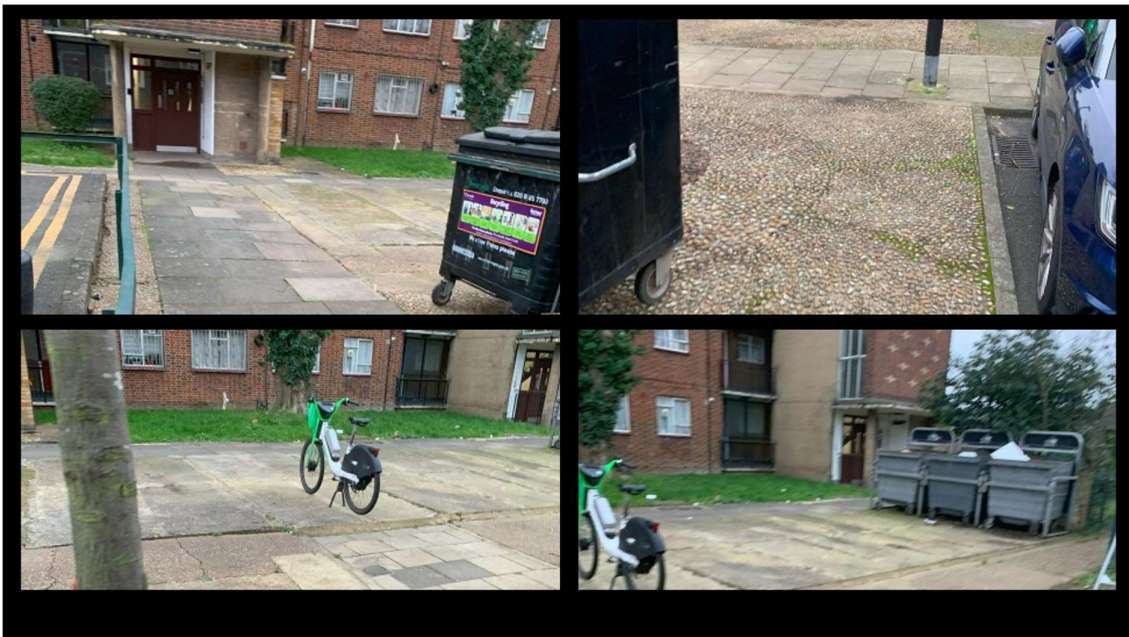
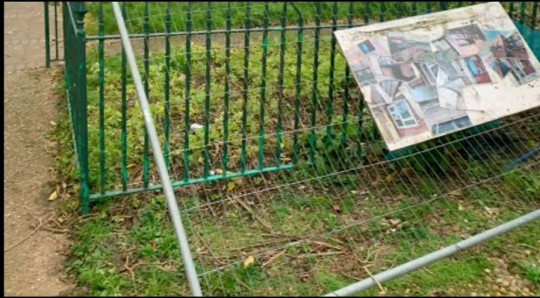
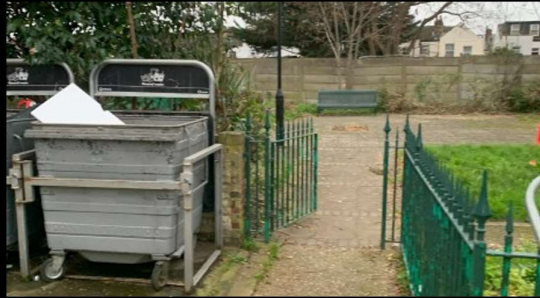
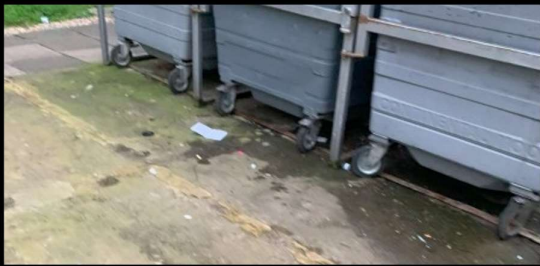
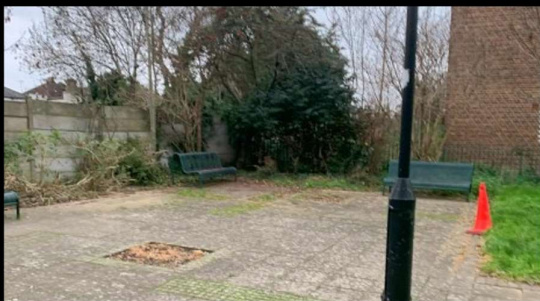
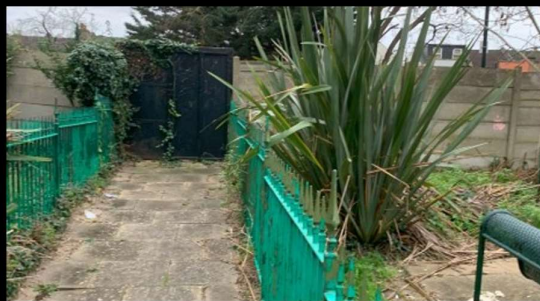
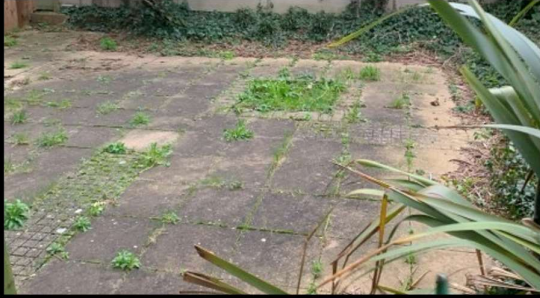
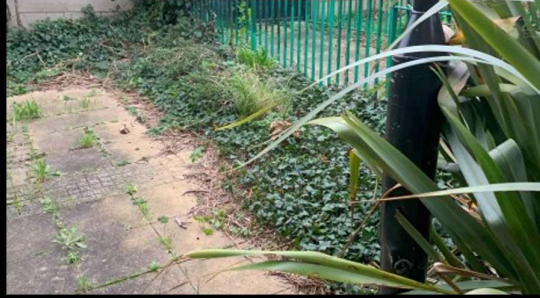
## SECTION 4

| 1.4.1 | Footpath | Consisting of Tarmac and concrete paving flags and pebble dash paving | Some flags area cracked / Brocken. Tarmac has new and old sections showing ware and cracking. | Photos 57 to 73 |

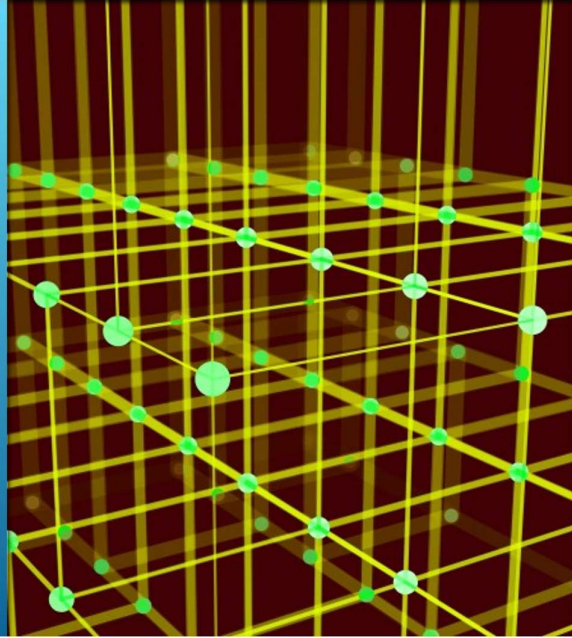
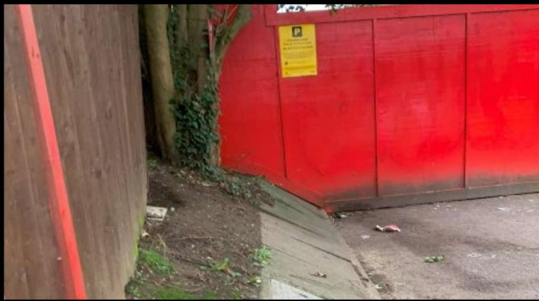
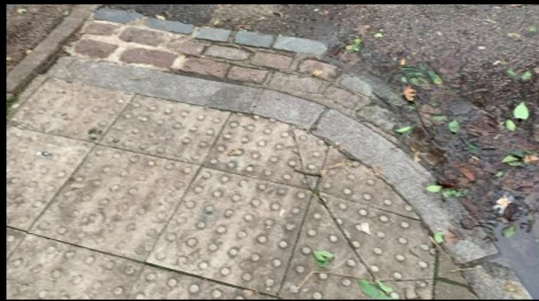
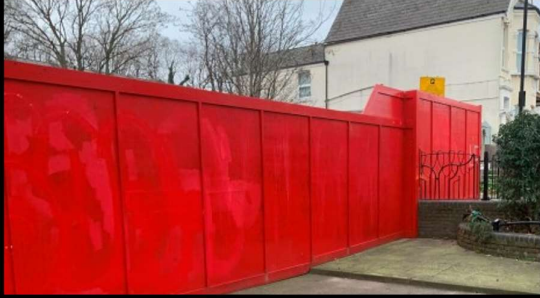
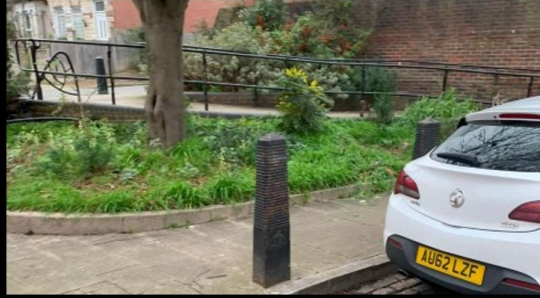
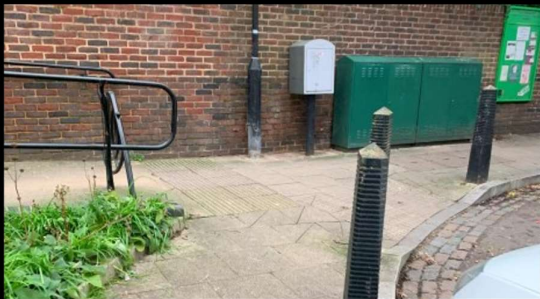
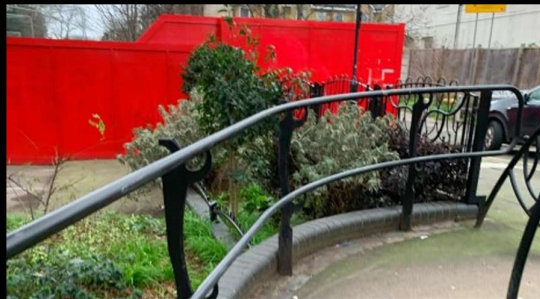
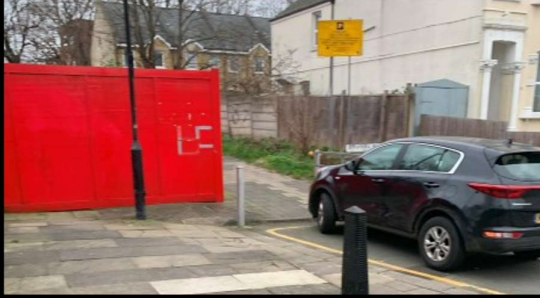
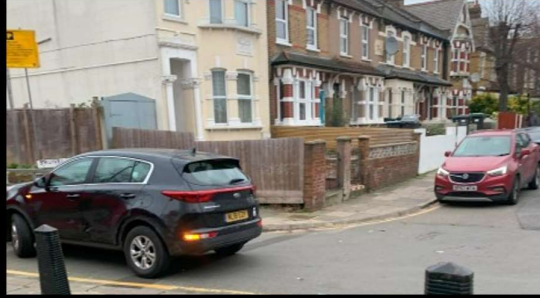
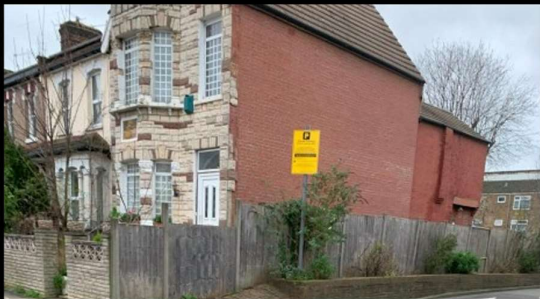
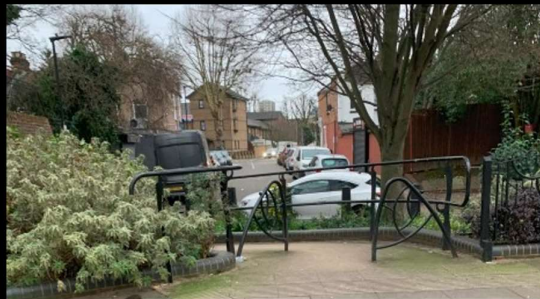
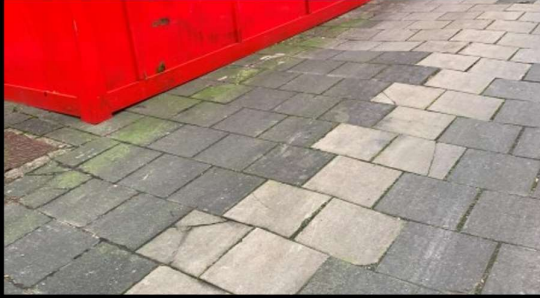
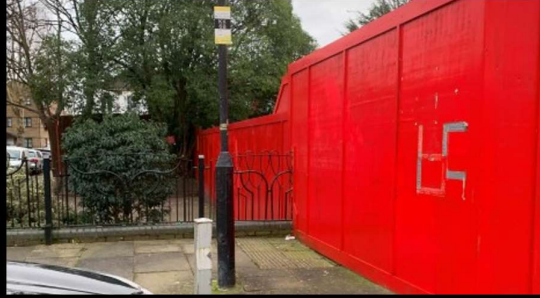
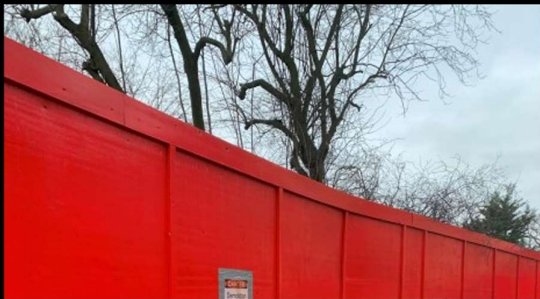
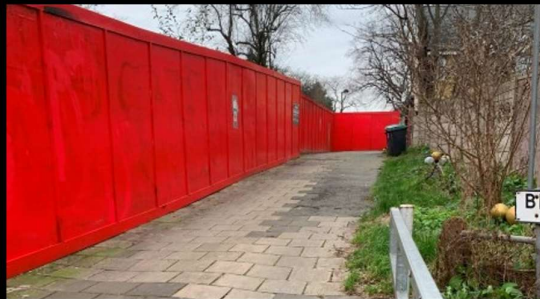
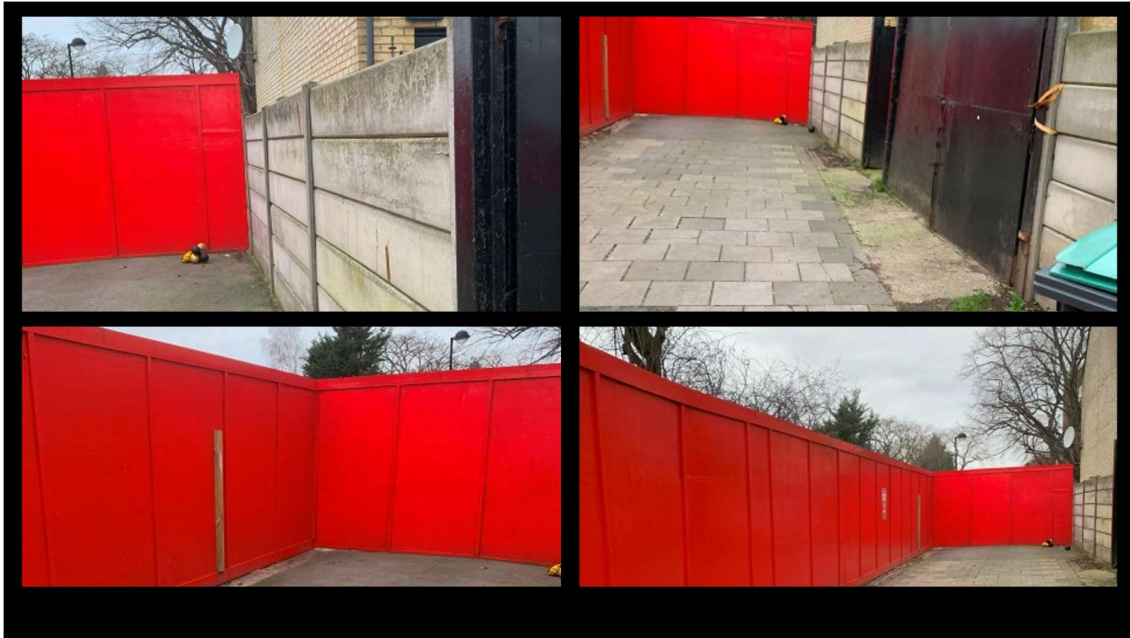
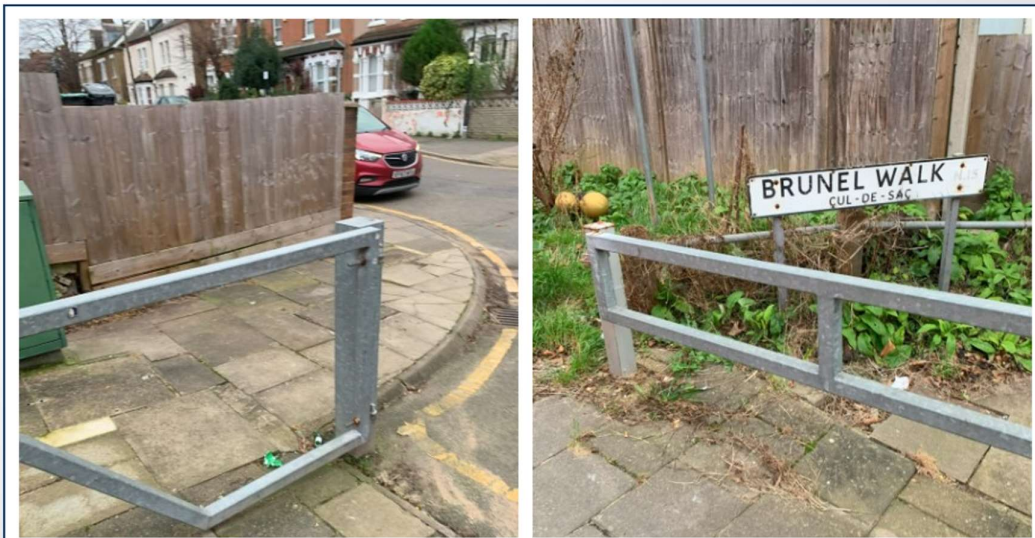
## SECTION 5

| 1.5.1 | Footpath | Consisting of Tarmac and concrete paving flags and tactile paving | Some flags area cracked / Brocken. Tarmac has new and old sections showing ware and cracking. Tacktile paving flags are uneven and worn. Tarmac patching where paving flags have been removed | Photos 73 to 107 |

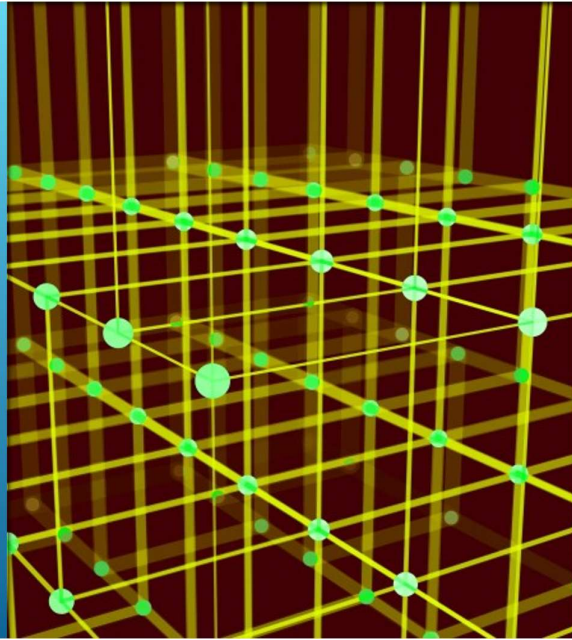
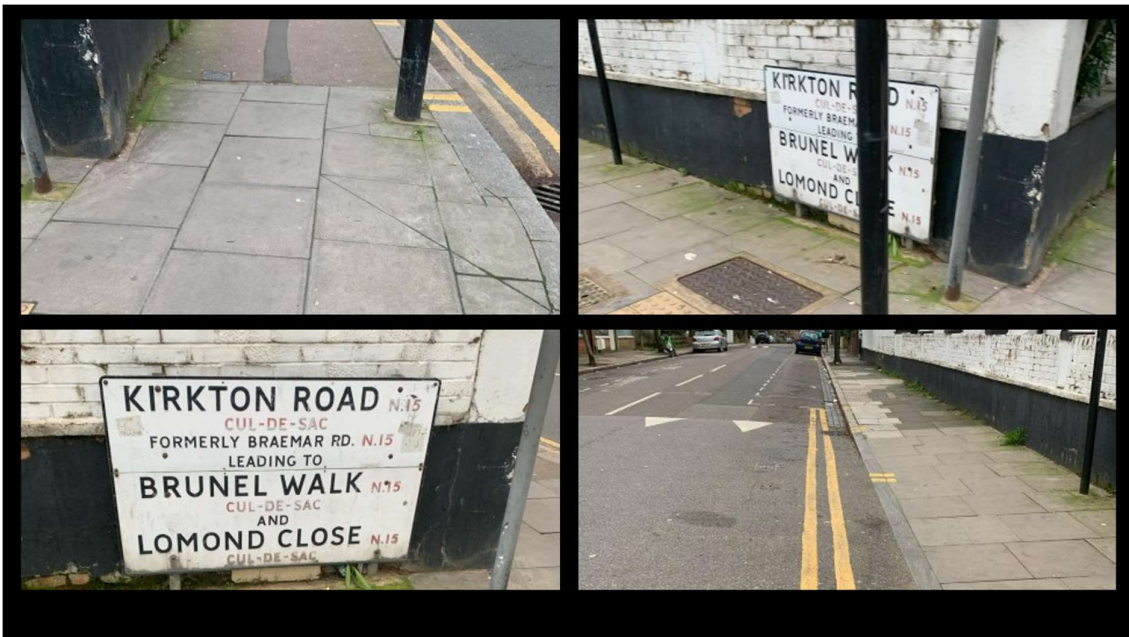
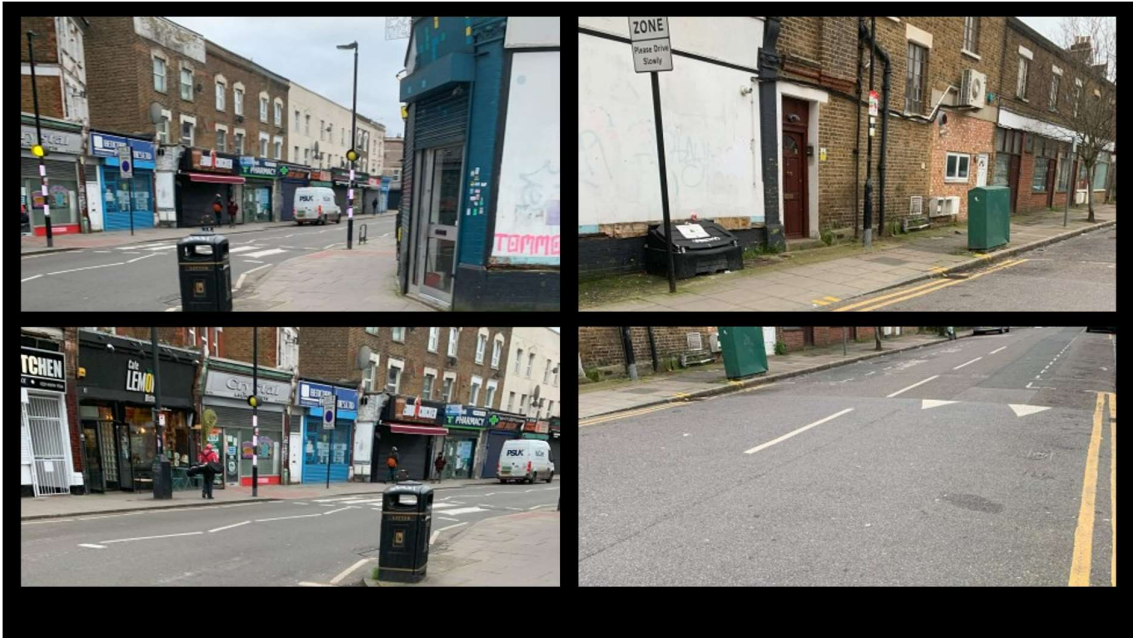
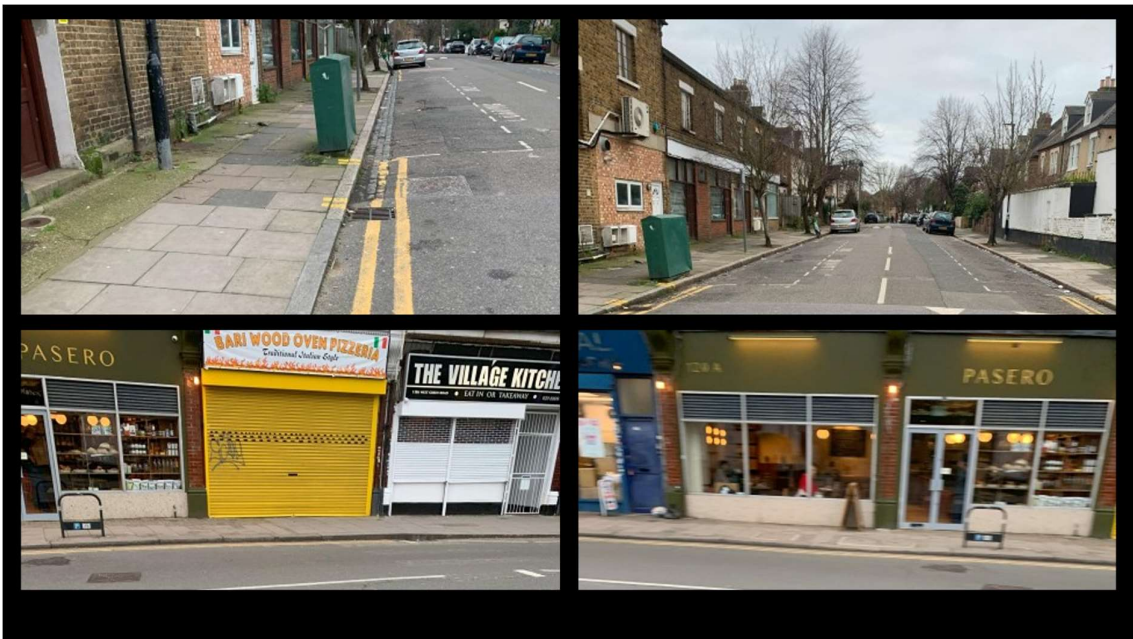
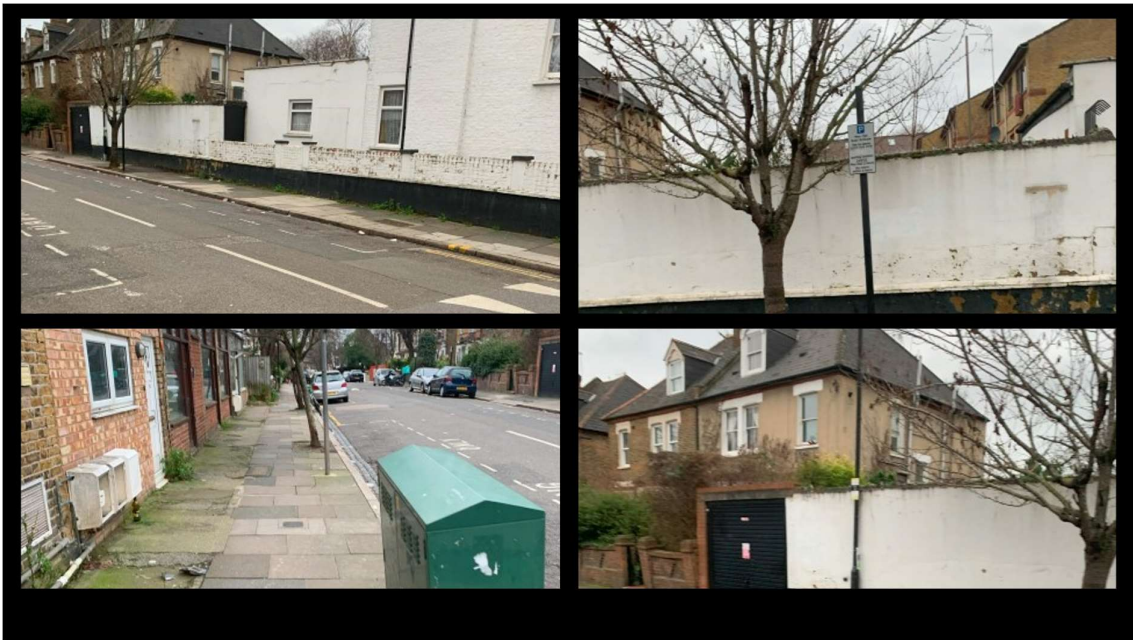
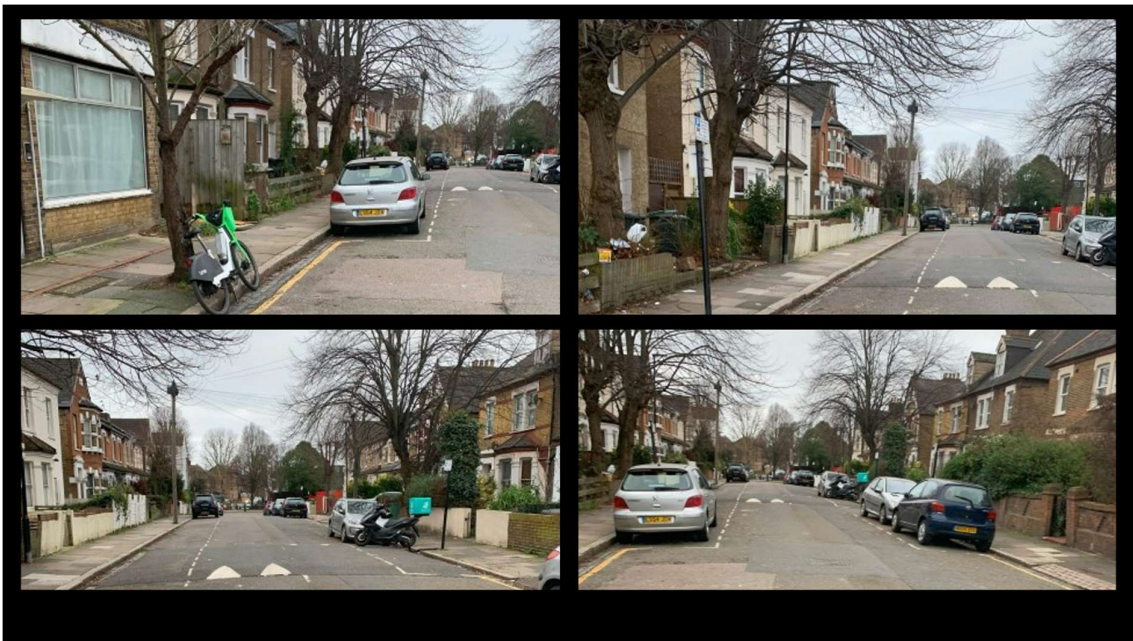
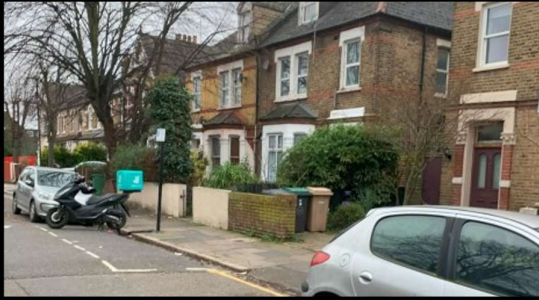
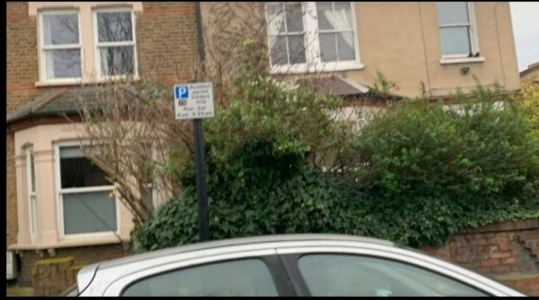
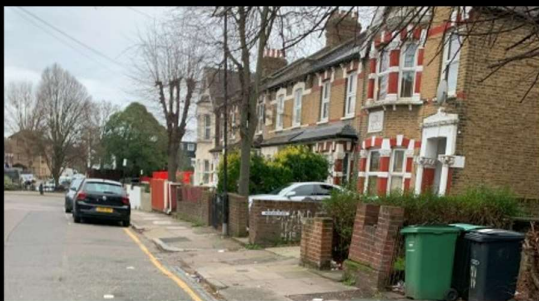
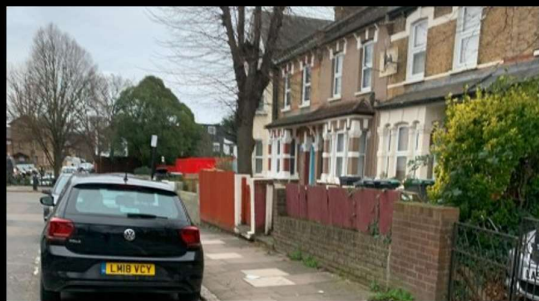
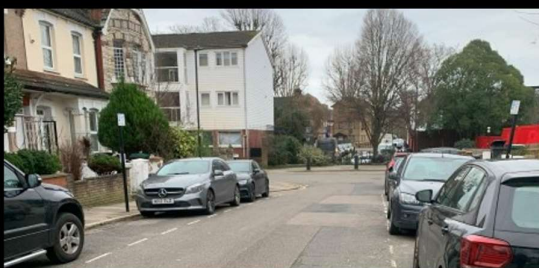
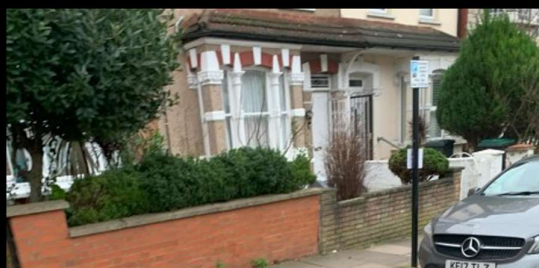
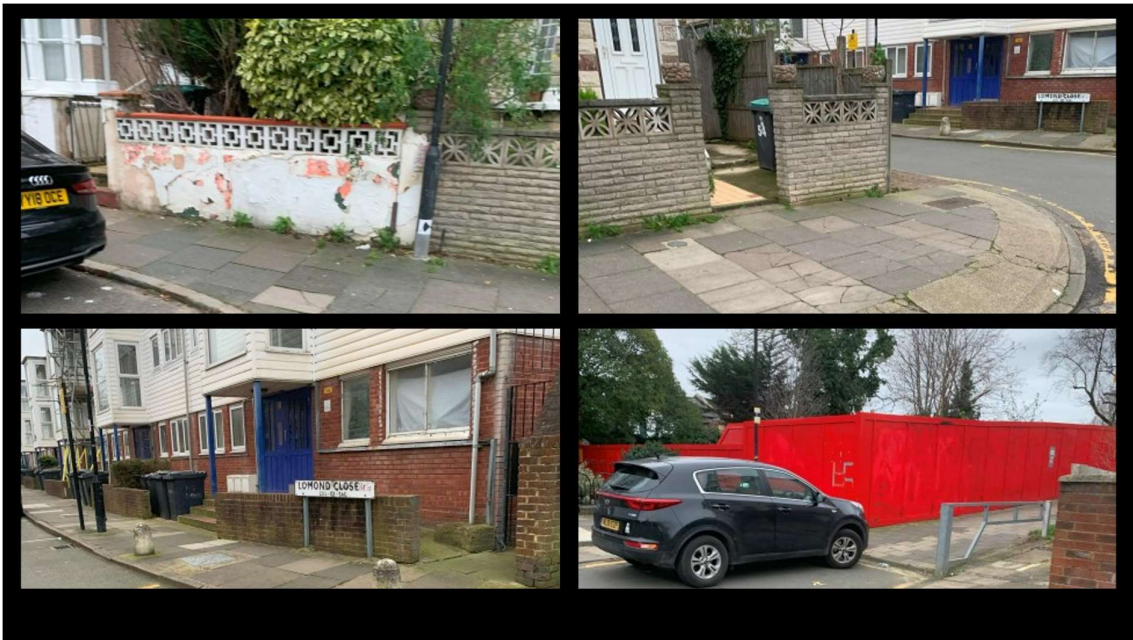
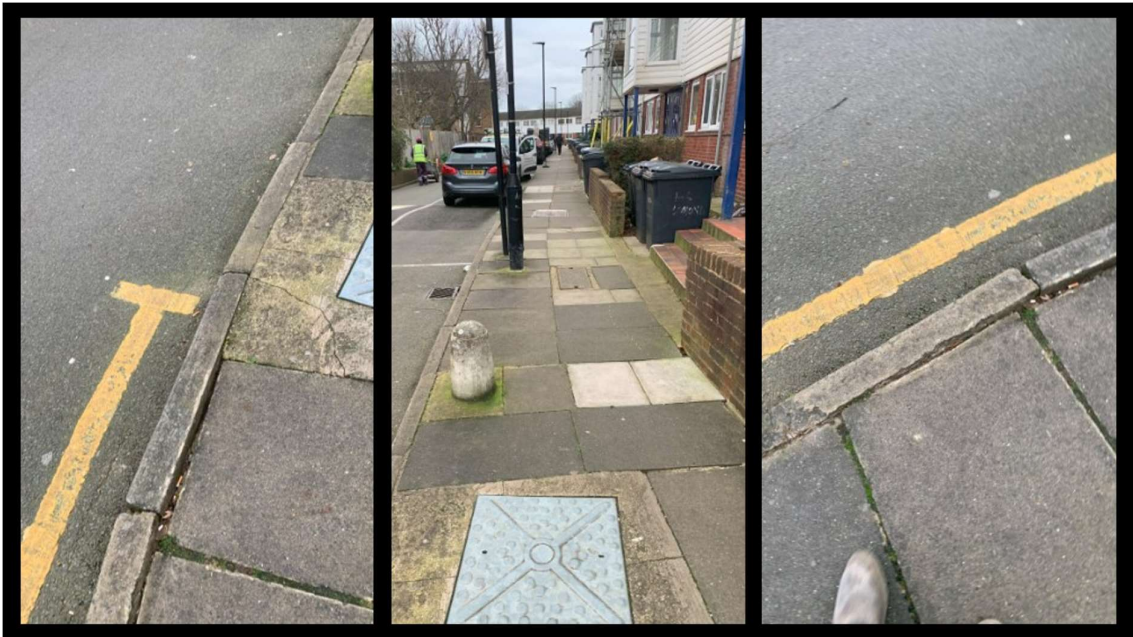
## SECTION 6

| 1.6.1 | Footpath | Consisting of Tarmac and concrete paving flags and tactile paving | Some flags area cracked / Brocken. Tarmac has new and old sections showing ware and cracking. Tacktile paving flags are uneven and worn. Manhole lids been cut into the foot path with cement infill around edges | Photos 107 to 142 |
