## SITE INVESTIGATION FACTUAL REPORT

Client: Quest gates

Our Reference Number: HH/22/69374

| Site Address & Postcode | 2 Ringwood Avenue, London, N2 9NS |

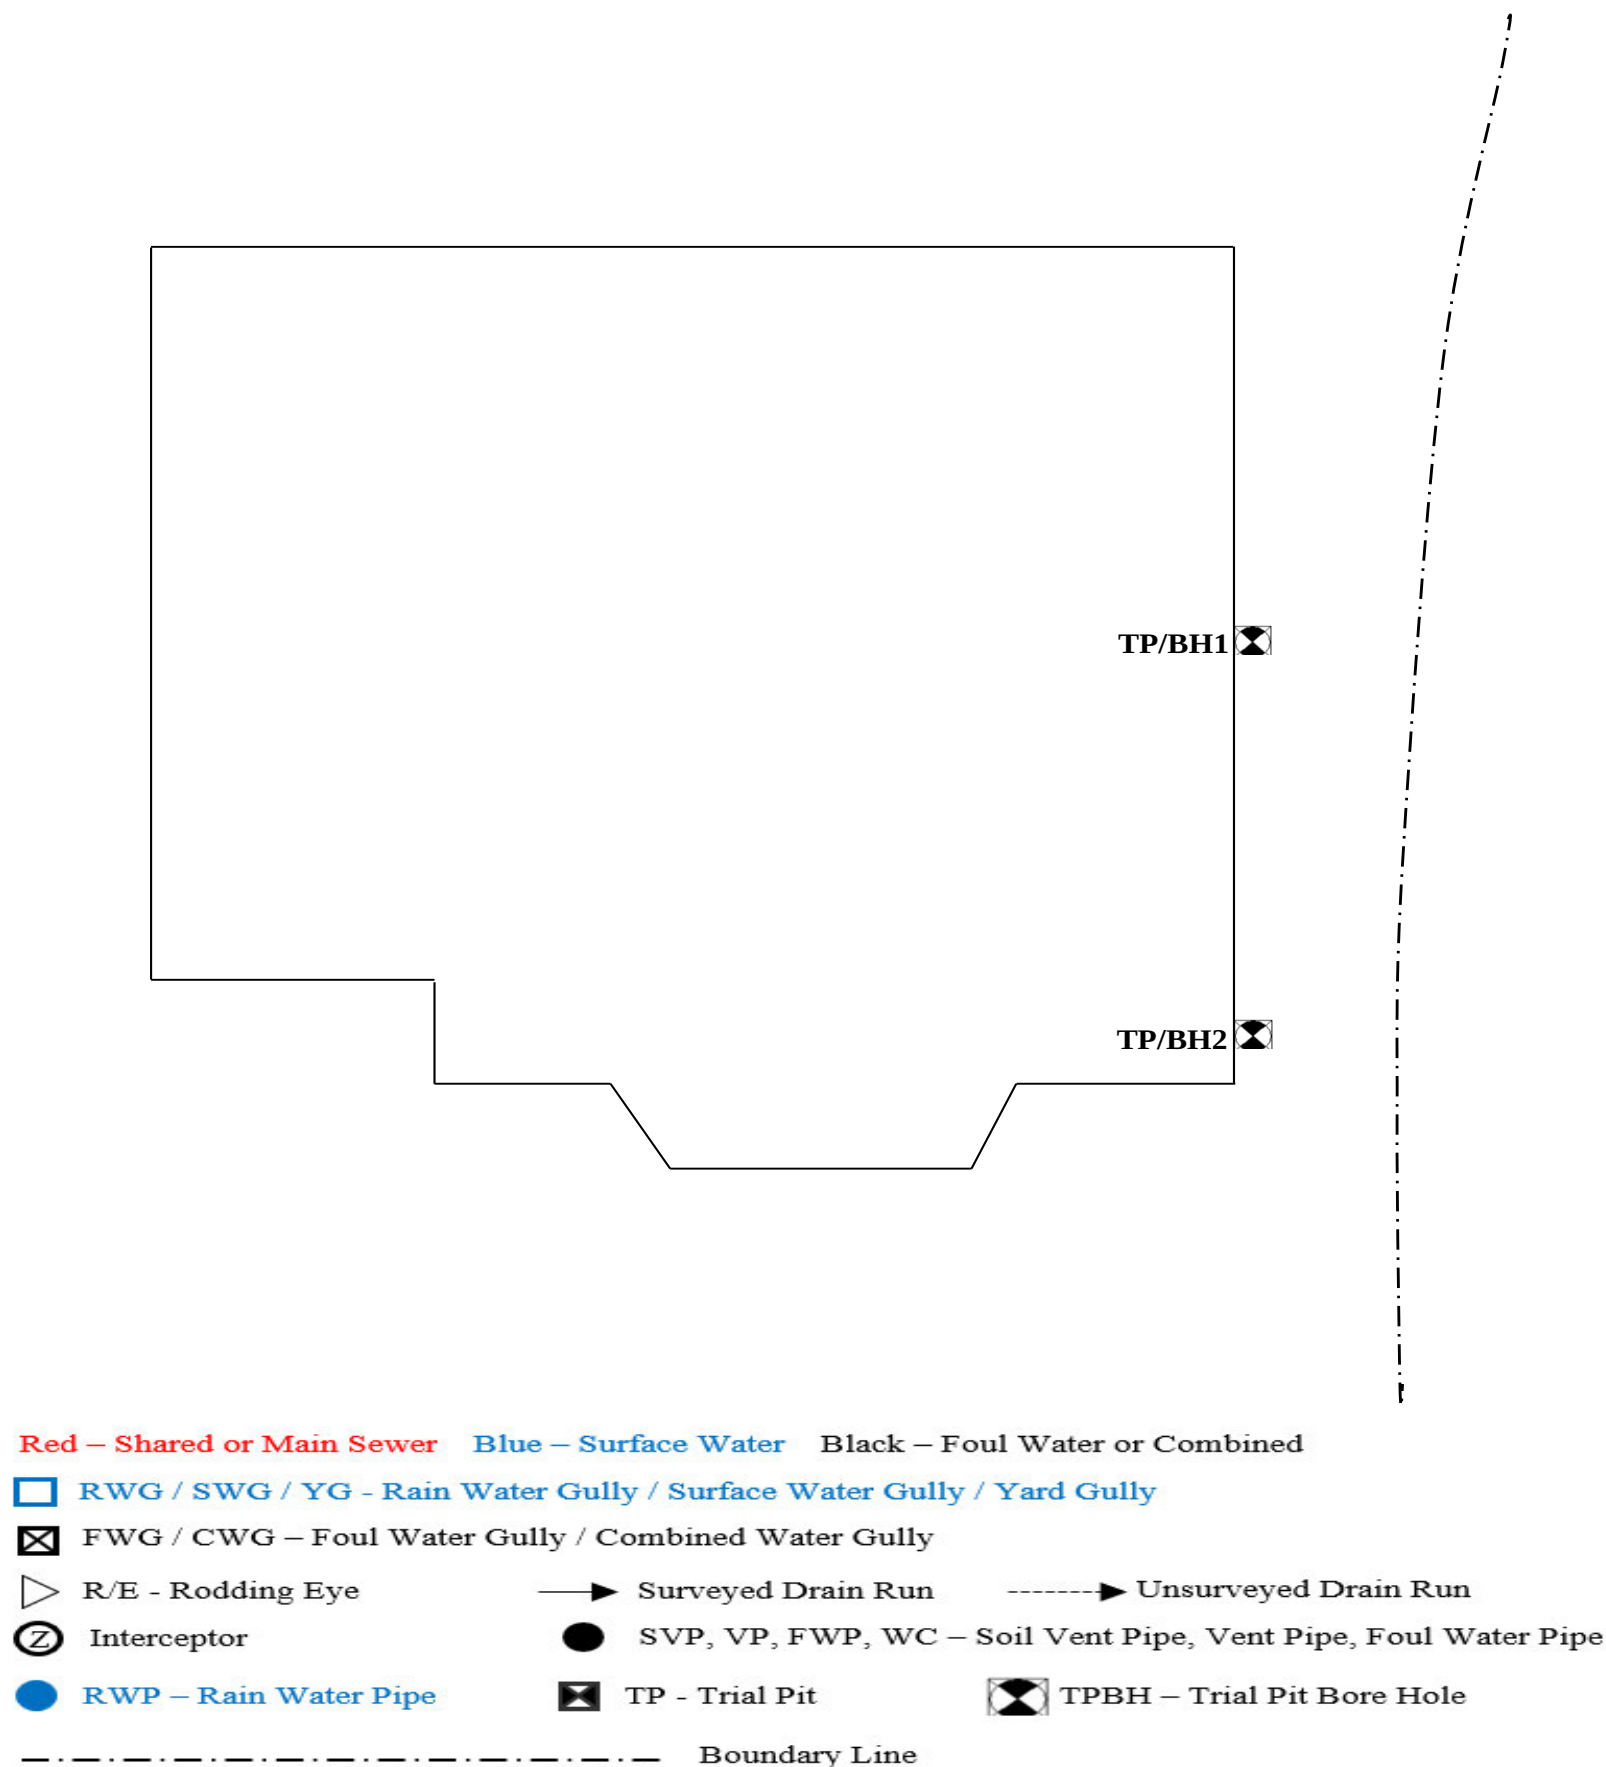
### Figure 1: Site & Drainage Layout

The operatives on site found that the property is served by a separate foul and surface water system. There are two manholes on site which serve the foul system but there is no visible manholes for the surface water system.

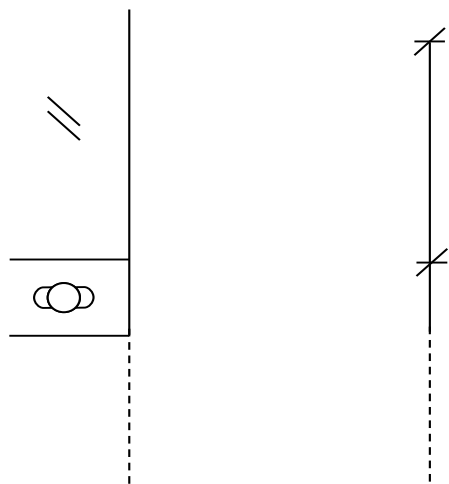
TP/BH2 FOUNDATION DETAIL

For strata information, please refer to borehole log TPBH2

Unable to determine depth of foundations due to buried services. No other appropriate location for TP/BH2
