# Arboricultural Appraisal Report

## Subsidence Damage Investigation at:

2 Ringwood Avenue  
London  
N2 9NS

| REPORT DATE: | 06/06/2023 |

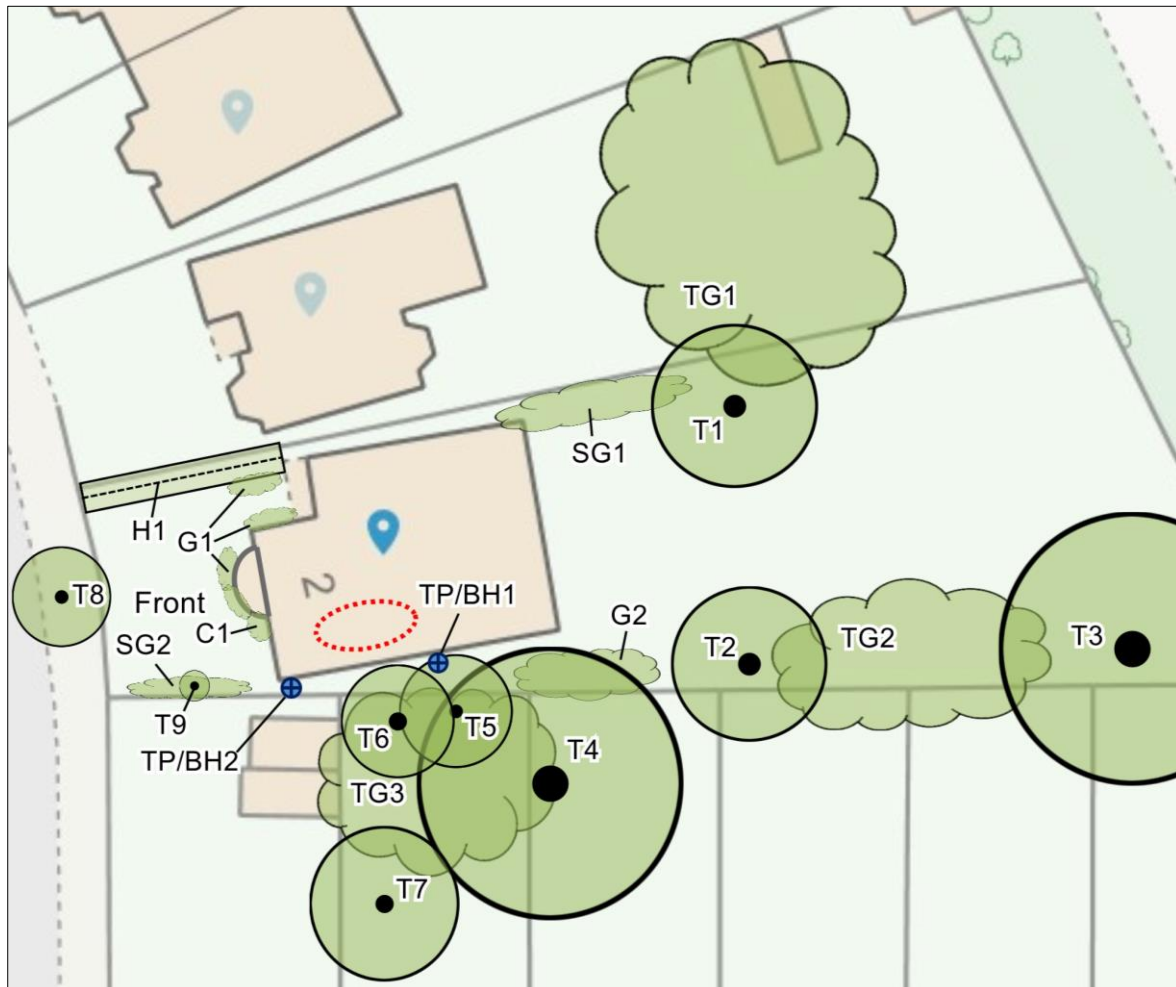
Approximate areas of damage
