**639 High Road, Tottenham**  
Design & Access & Heritage Statement  
Facade Remediation

**Application for facade remediation**

This document has been prepared by Freehaus for and on behalf of our client, The GLA, for the purpose of a Listed building consent application to Haringey Council. Heritage specialist architects Purcell have provided review of the Heritage Statement, review and commentary of the 2022 facade condition survey by PAYE, and produced an Outline Specification.

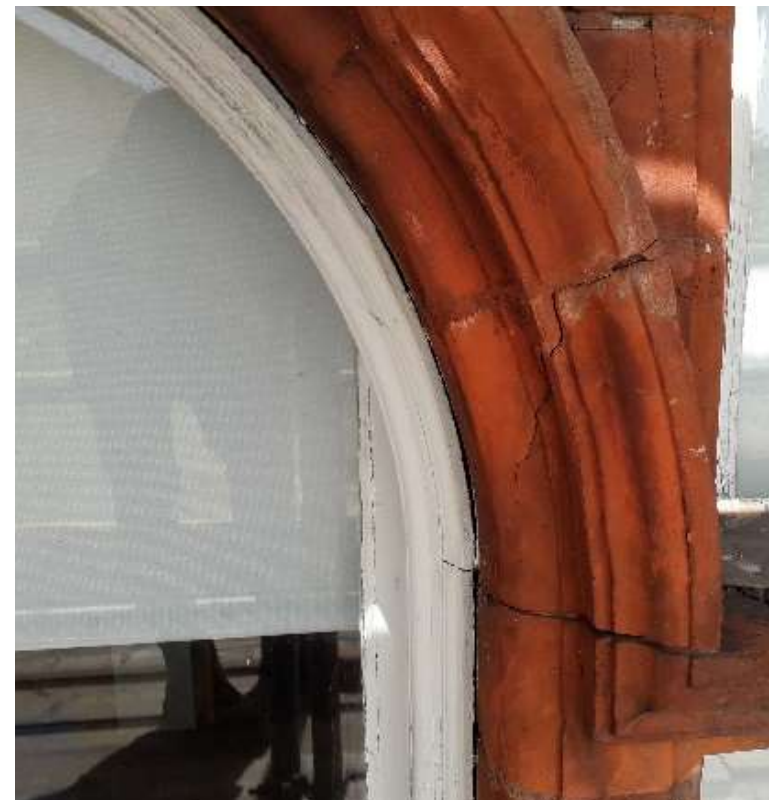
**Displacement and fractures of terracotta**

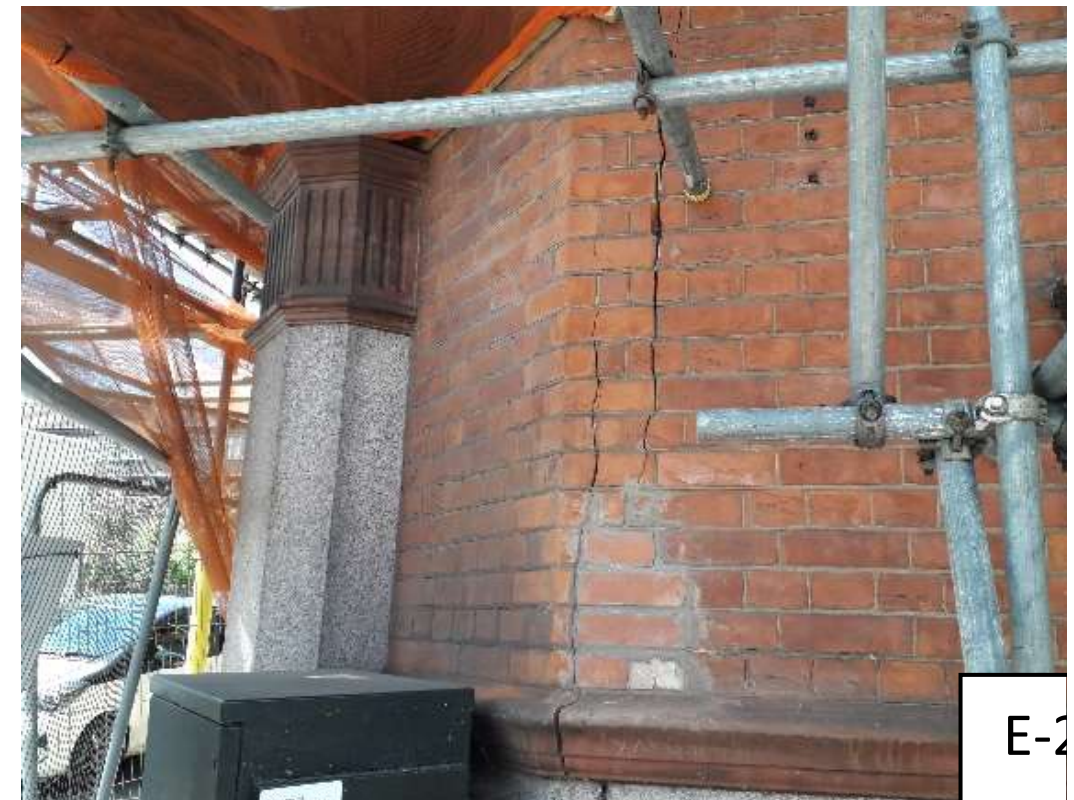
**East facade crack- repairs already granted permission under HGY/2019/1968**

15mm wide continuous crack observed through the facade. The cause for the cracking could potentially be settlement / building movement which may have been a result of historic tunnelling (e.g., tube line extension).

Strongly recommend consultation with a structural engineer.

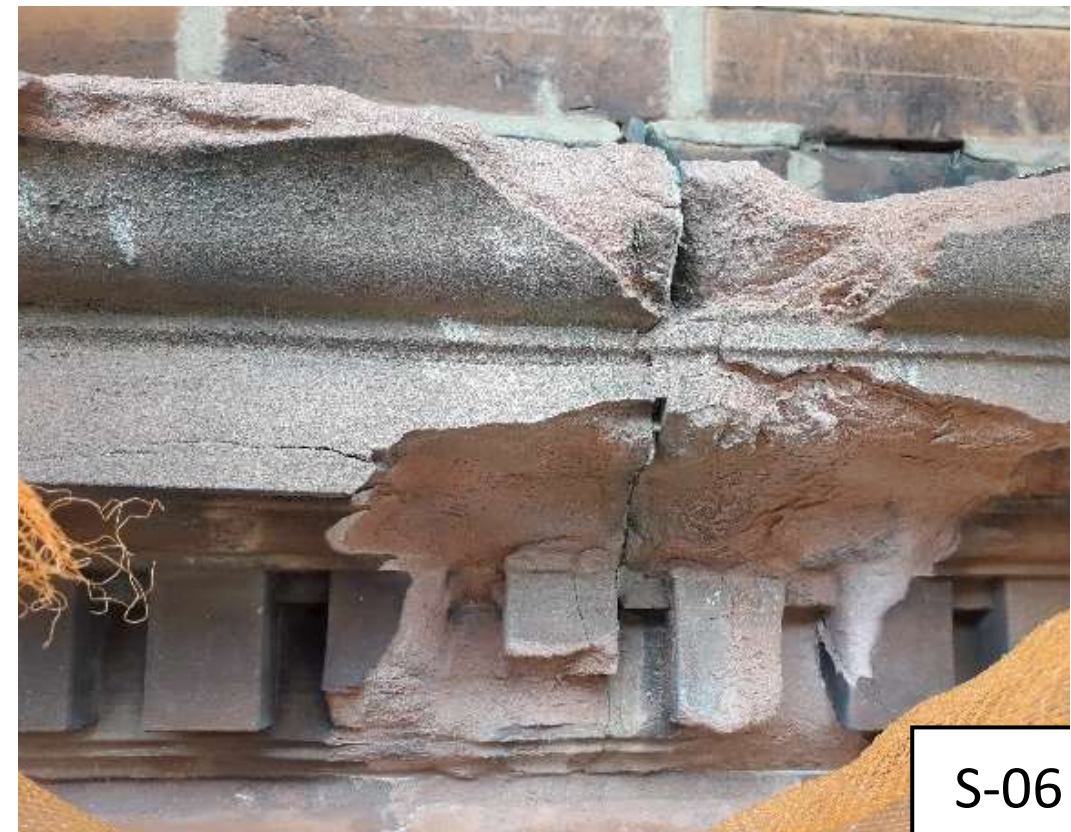
Example of decorative masonry deterioration

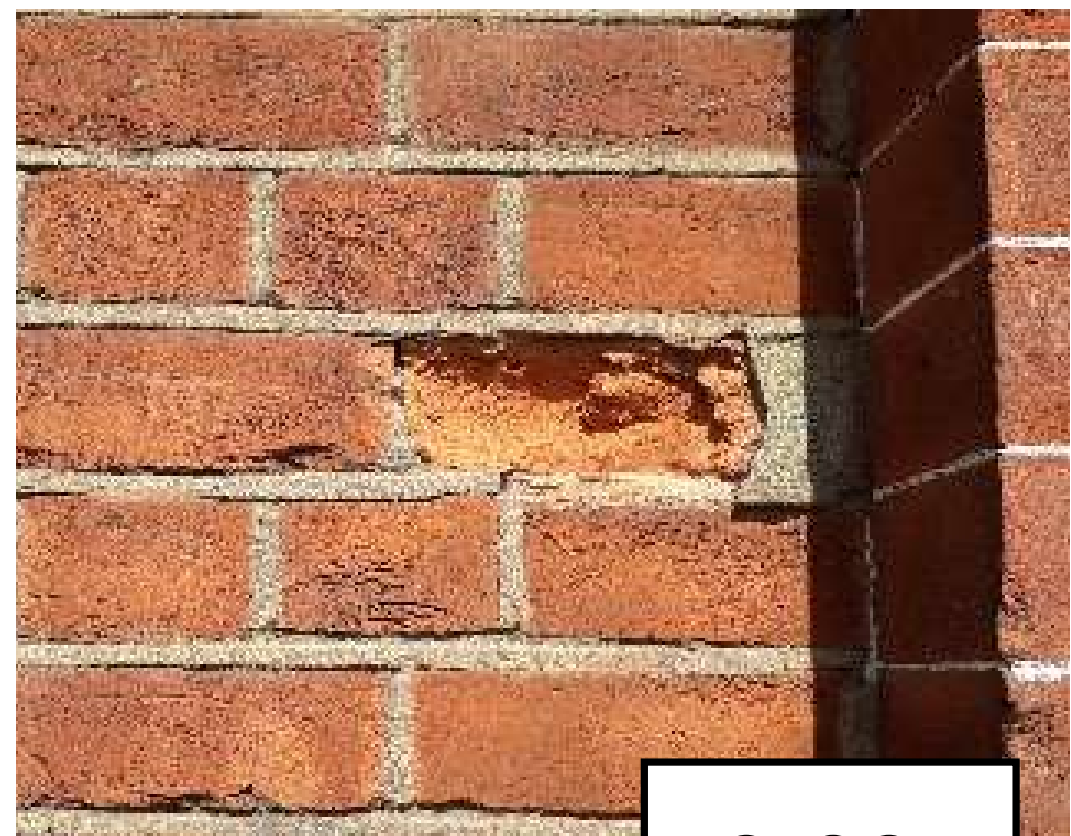
Spalling brickwork caused by cement-rich repointing

A rich cementitious mortar has been used to repoint the facade. At high level the cementitious mortar is causing damage to the soft red bricks. Cement is impervious resulting in any moisture within the facade not able to escape through the joints. This has caused the soft red bricks to become saturate and de-laminate, losing their fired face.

Recommend mechanically cutting out all cement rich mortar joints at high level and replacing with a lime based mortar.

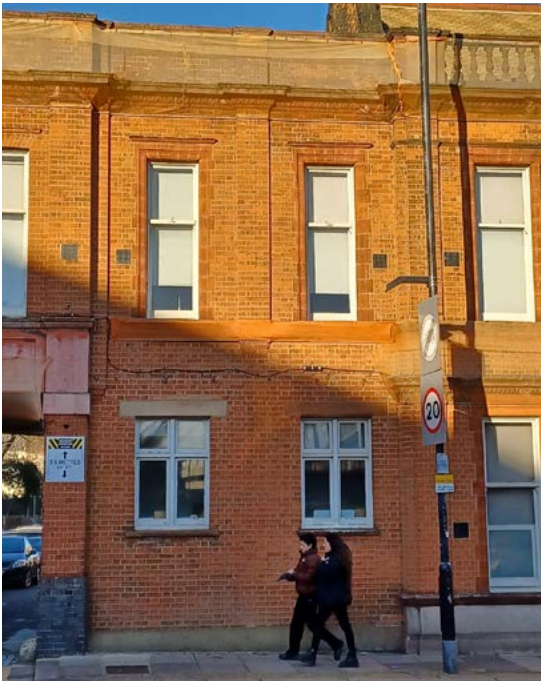
To the south elevation the window cills are damaged and causing water staining and damage to the brickwork below.

Damage to window cills and inappropriate lintel replacement

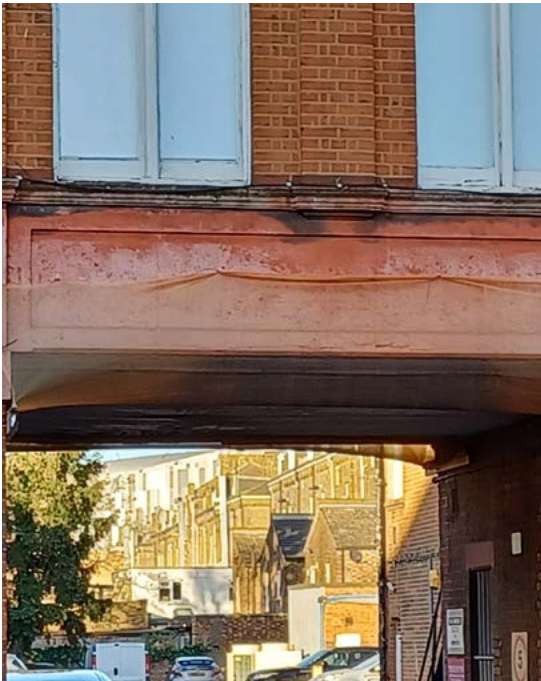
Cracked and loose render - netted for protection

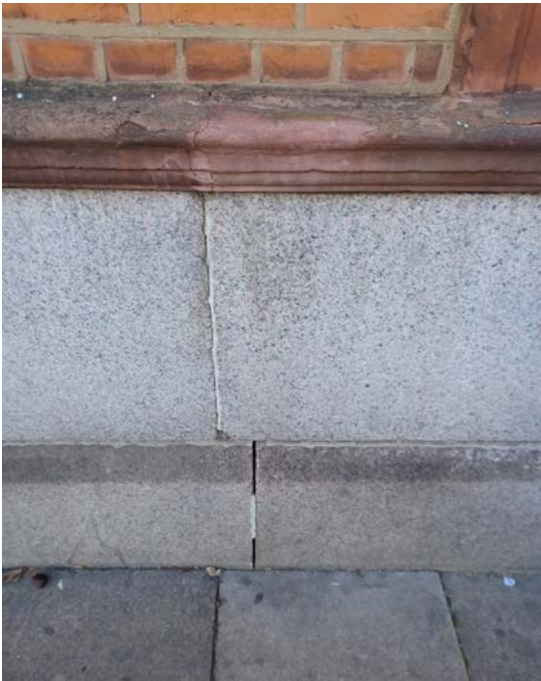
To the length of the building there are large cracks and open joints to the granite plinth.

Open Joints and cracks to plinth and cement pointing

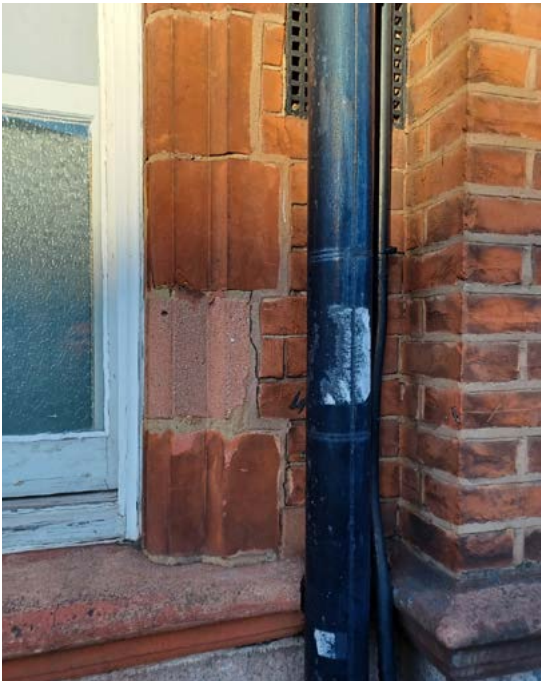
Inappropriate repairs

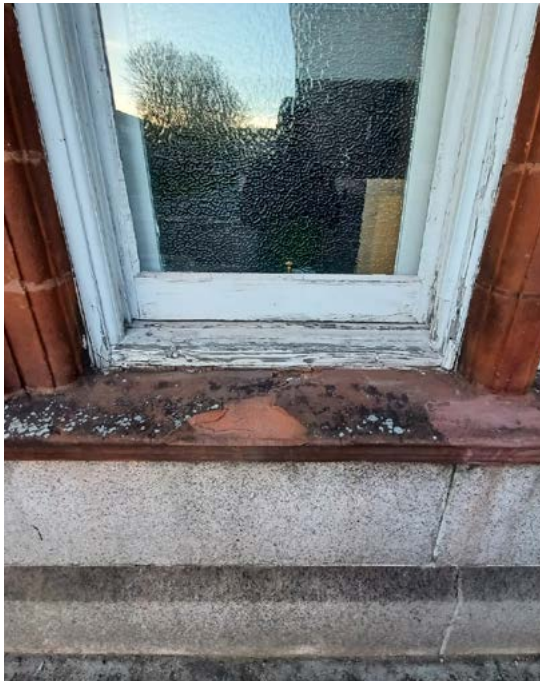
Damage to window cills and poor decoration of window frames

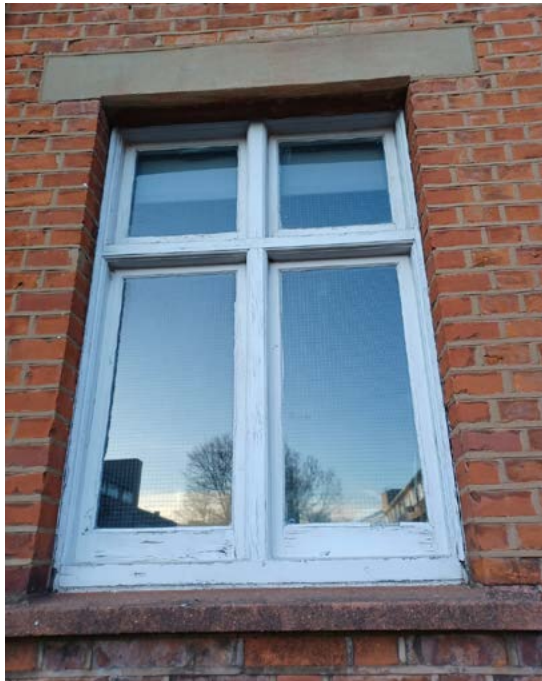
Inappropriate lintel replacement and open joints around the window

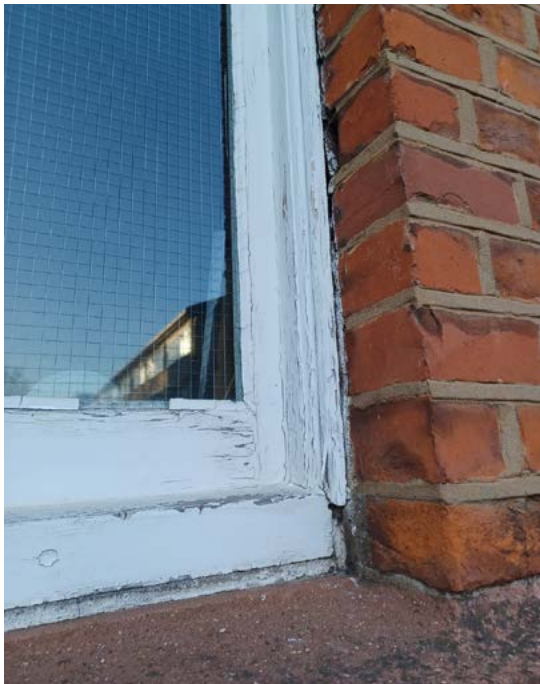
Damage to timber frame and open joints to window surround

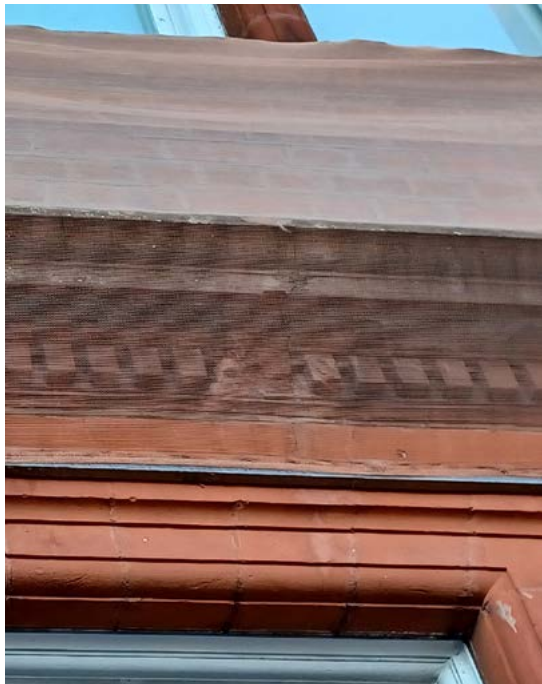
Deterioration of details to cornice dentils and profiling

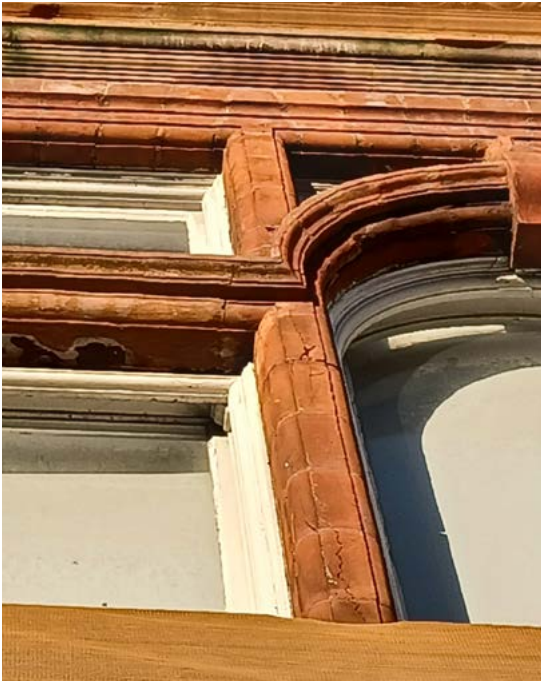
The window jambs and transoms are constructed from terracotta. There are many fissures and cracks to the terracotta sections.

Damage to terracotta window jambs and transoms

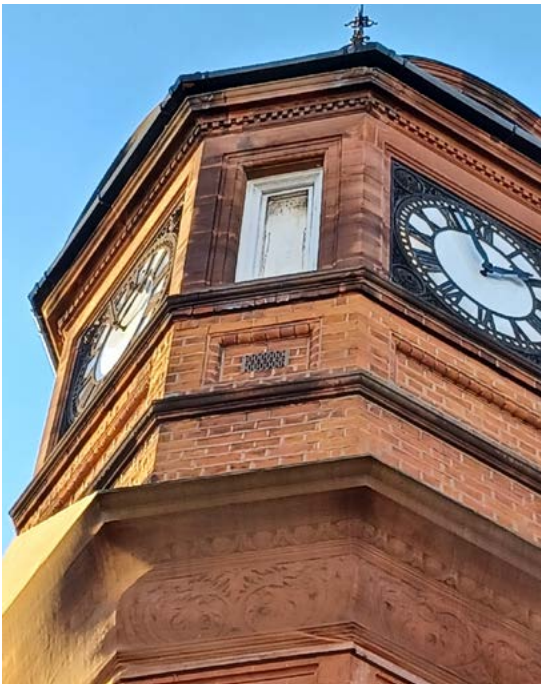
Deteriorating and rotten timber to clock tower

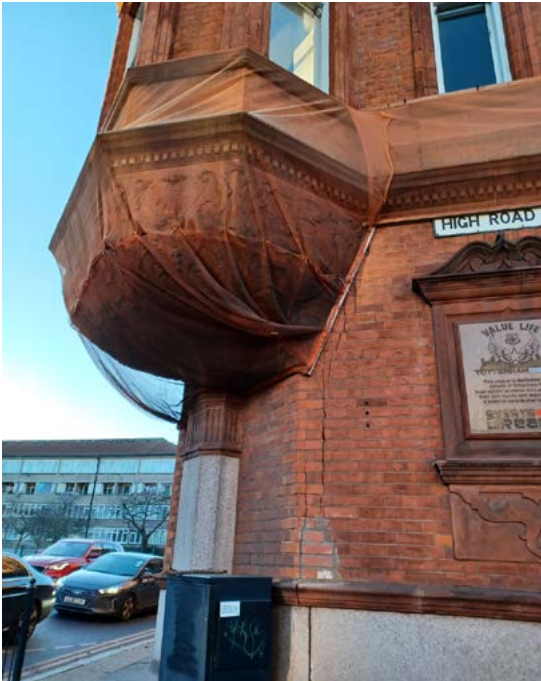
Large cracks through masonry to corner of building

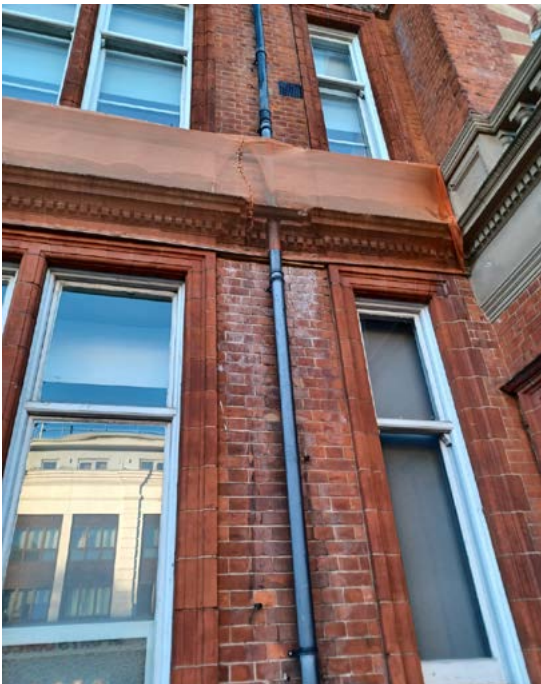
Heavy staining and deterioration of brickwork behind downpipe

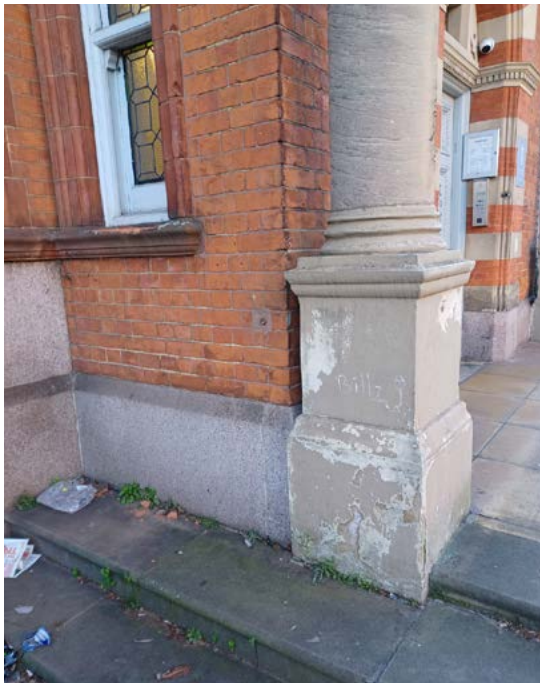
Damage to shelter coatings on stone

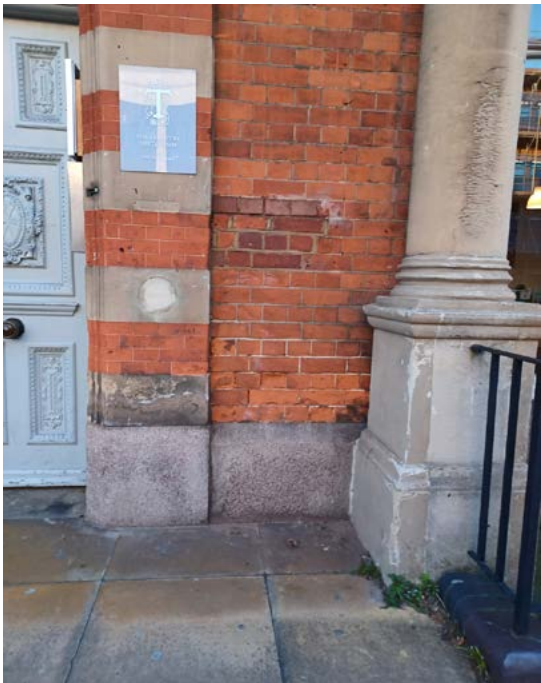
Damage to brickwork and loose mortar with cement repairs

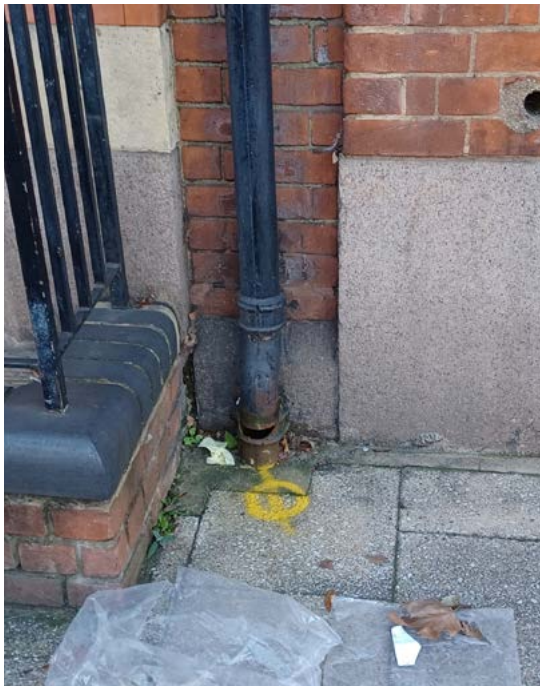
The downpipes are comprised of elements of cast iron and plastic. Many cast iron elements are damaged and corroding and require replacement, repair or redecoration. The plastic elements should be replaced with cast iron.

Damage to downpipe at ground level with corroding cast iron

It is recommended that the rain water goods undergo repair and redecoration with the plastic sections being replaced with cast iron to match the existing.

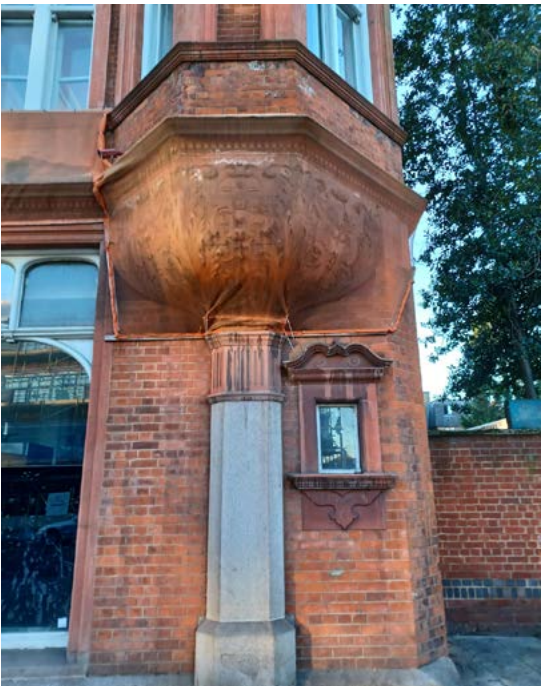
Water staining and damage to masonry

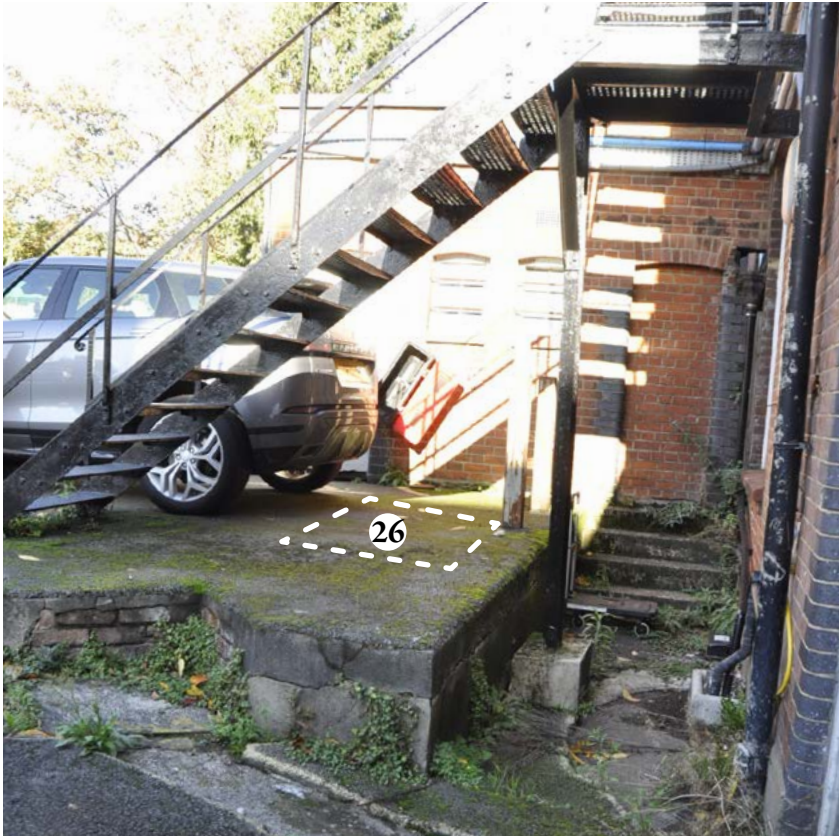
Approximate location of MH 26 to be exposed

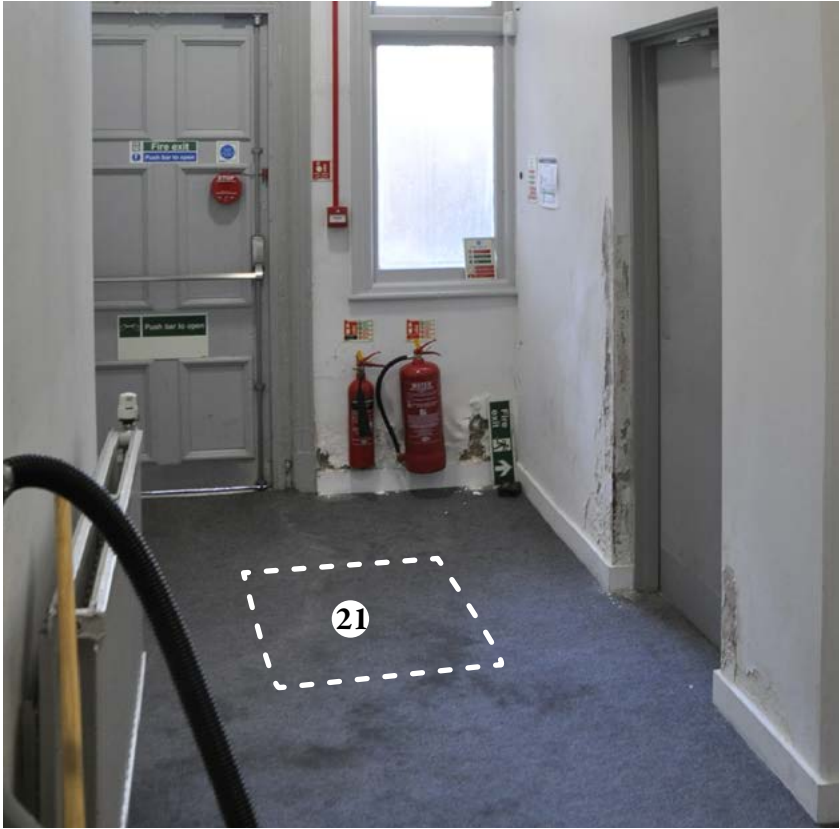
Approximate location of MH 21 to be exposed & evident water damage to walls
