# Heritage Statement

Heritage Statement  
Facade Remediation

639 TOTTENHAM HIGH ROAD - FACADE CONDITION SURVEY

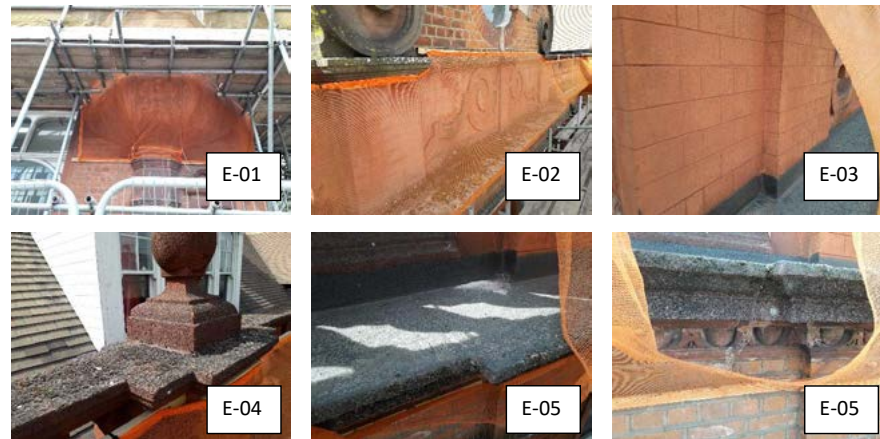
Netting installed by LPM to the façade (E-01-02, Historic render repairs (E-03), A historic cement render resurfacing repairs have been undertaken to the balustrade, copings, and cornice to half of the east elevation. The sky surface of the grand cornice has been covered in a bitumen paint system (E-04-05)

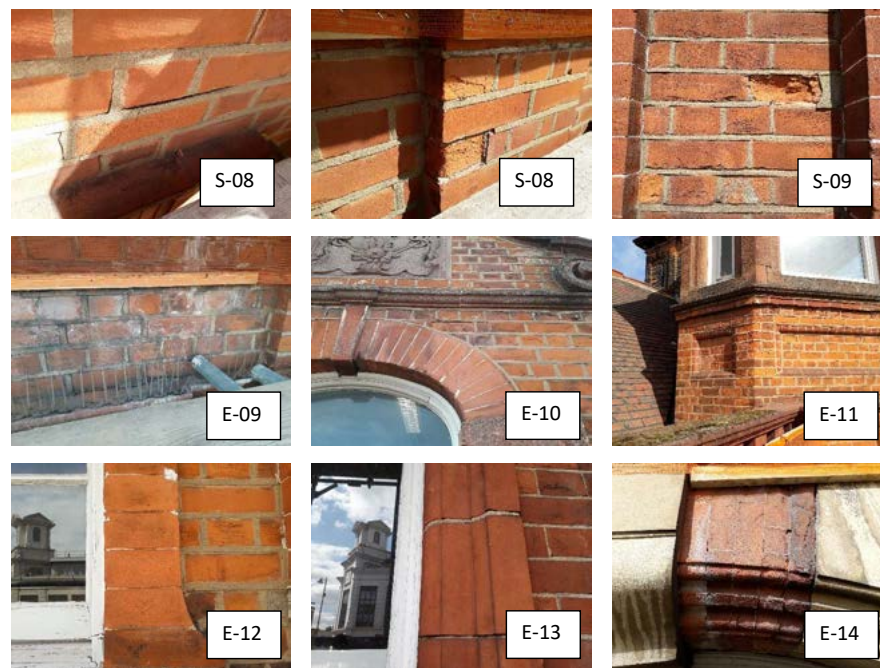
A rich cementitious mortar has been used to repoint the façade in the past. At high level (gables and below the grand cornice) the cementitious mortar is causing damage to the soft red bricks. Cement is impervious and therefore any moisture is not able to escape through the joints. This has caused the soft red bricks to become saturated and de-laminate, losing their fired face. As the bricks have lost their fired face this form of deterioration will continue until the defective bricks are replaced.

Cement rich repointing causing defects to the soft red brickwork at high level (parapet and gabled). Missing and friable pointing (including lime putty pointing). Defective bricks to be cut out.

At high level we recommend mechanically cutting out all the cement-rich mortar joints and replacing with a suitable lime-based mortar. This is because the rich cementitious mortar is causing damage to the soft red bricks. At higher level – where the building is more exposed to the elements – this has resulted in many defective bricks which are now at risk of delaminating and falling to the pavement below.

All defective bricks which have lost their fired face should be carefully stitch drilled out and replaced with a new soft red brick to match.

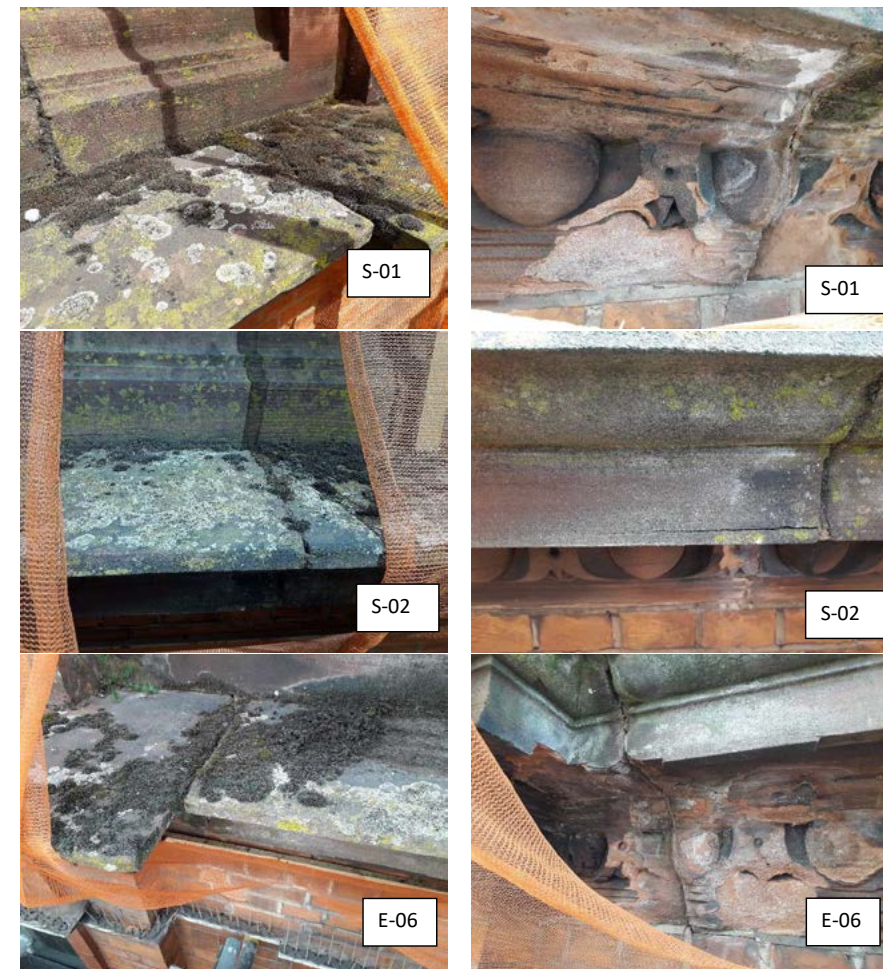
The missing pointing to the grand cornice is causing notable erosion to the Egg and Dart detail to the sandstone cornice. To areas of missing pointing there is a loss of material or de-laminating stone observed. There is a risk of loose or delaminated stone falling.

Missing pointing to grand cornice which has caused erosion or delamination of the stone. Risk of further deterioration and sections of stone falling.

To the areas of the grand cornice and L01 cornice and string courses, we recommend that all areas of hollow masonry are removed and made safe. Options for repair include de-frassing and installation of a lead flashing or undertaking an indent repair to defective masonry and installation of a lead flashing. Installation of a code 6 lead weathering flashing will likely require planning permission but will provide long term protection to the stone below.

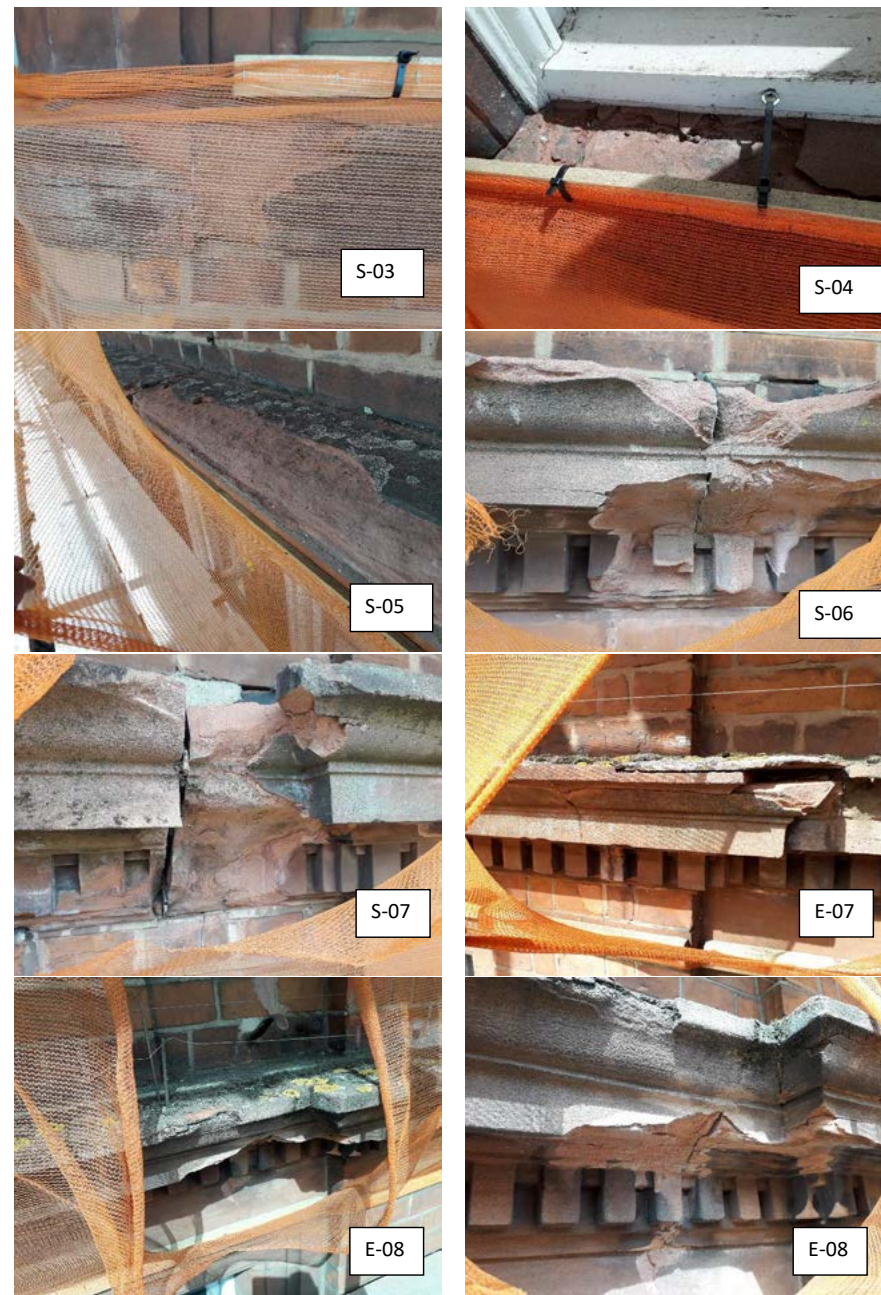
Missing pointing to L01 cornice and string course which has caused erosion or delamination of the stone. Risk of further deterioration and sections of stone falling. Note the failure of the windowsill flaunching (S-04)

To all L01 windowsills where historic flaunching is loose, remove all loose sections of masonry and re-flaunch the sky surfaces of windowsill.

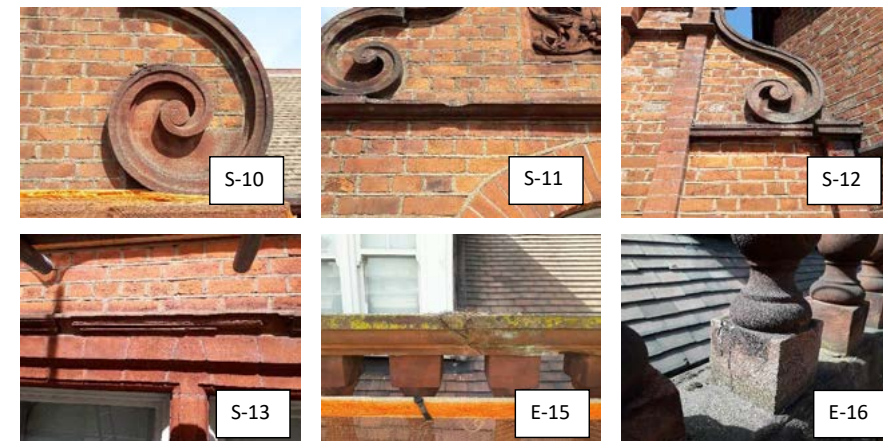
Defects (e.g., delamination, cracking) to sandstone masonry requiring repairs (e.g., pinning or indent repairs).

Where there has been observed loss of masonry or delamination to the sandstone, loose sections of masonry should be removed and made safe and pin or indent repairs undertaken. It should be noted that Red Mansfield stone is no longer available. Any repairs will be undertaken with Course Hill, Red Lazenby, or St. Bees which will likely require sampling and planning approval.

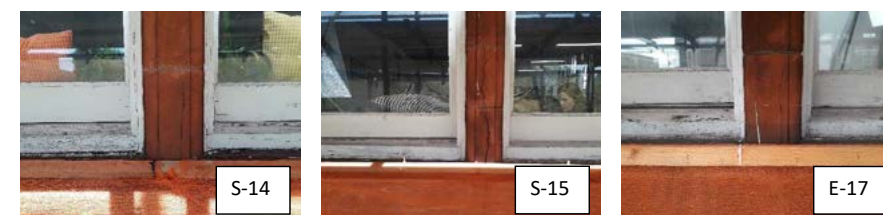
Vertical fractures were observed to the terracotta window mullions on both elevations. The cause for the fractures is likely building settlement. Recommend repointing to ensure the building is weathertight and continued monitoring of fractures as part of the Pre-Planned Maintenance. Replace defective unit with new if fractures deteriorate.

Vertical fractures observed to terracotta window mullions.

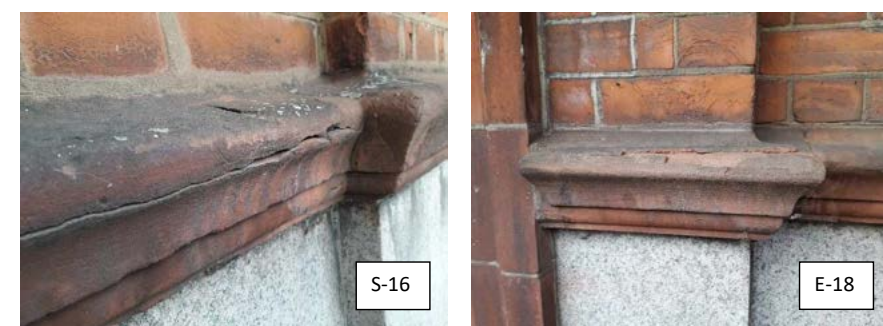
Missing pointing to L01 cornice and string course which has caused erosion or delamination of the stone. Risk of further deterioration and sections of stone falling. Note the failure of the windowsill flaunching (S-04)

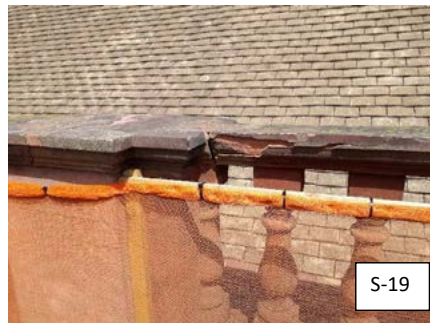
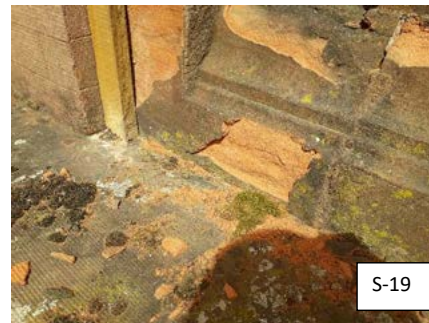
S-19

To one bay the bottled balustrade is loose with two delaminated coping units and one damaged base unit. Recommend dismantling and rebuilding parapet with replacement stone for the damaged units

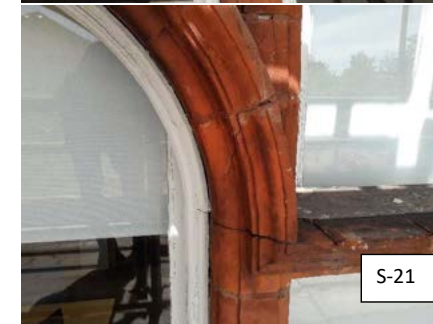
S-21

Fractures were observed to the arched terracotta window jambs and transoms. The cause for the fractures is likely due to settlement / building movement which may have been a result of historic tunnelling (e.g., tube line extension). Strongly recommend consultation with a structural engineer.

Fractures were observed to the arched terracotta window jambs and transoms. The cause for the fractures is likely due to settlement / building movement which may have been a result of historic tunnelling (e.g., tube line extension).

To the fractured terracotta L01 arched window jamb to the south elevation locally prop window and carefully remove fractured terracotta. Replace with new terracotta unit to match. It should be noted that terracotta has a 24-week lead in.

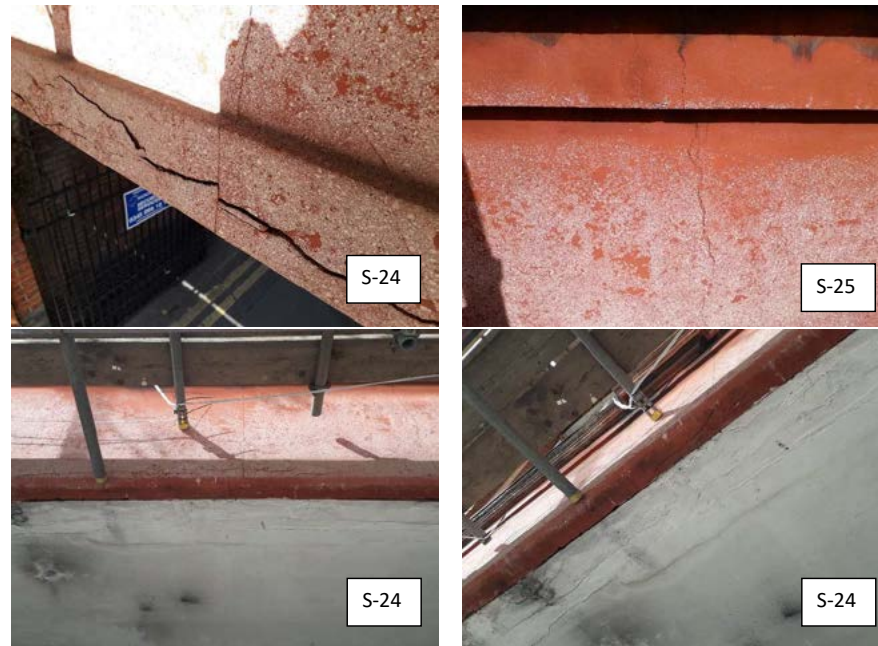
Fractures were observed to cement render over the vehicle entrance. The area was tap tested by LPM with loose sections removed at the time of the survey. Recommend cutting back areas of loose mortar and reinstate with a new render to match existing. To areas of sound render where fractures are observed undertake continued monitoring for future defect as part of the Pre-Planned Maintenance.

Fractures were observed to cement render over the vehicle entrance. The area was tap tested by LPM with loose sections removed at the time of the survey.

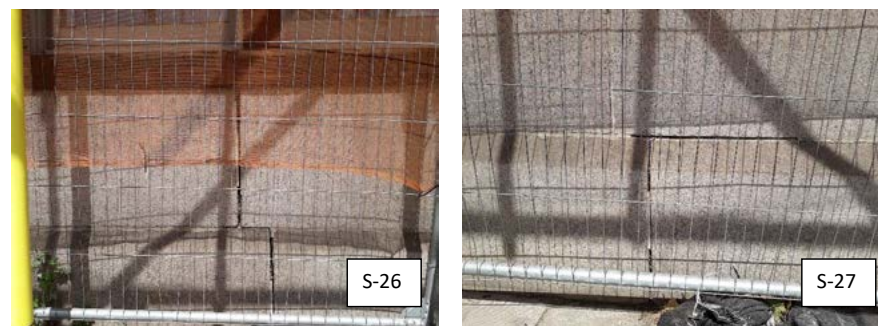
5mm to 15mm wide cracks were observed through the joints to the granite plinth course. The cause for the cracking could potentially be settlement / building movement which may have been a result of historic tunnelling (e.g., tube line extension). Strongly recommend consultation with a structural engineer.

5mm to 15mm wide cracks were observed through the joints to the granite plinth course

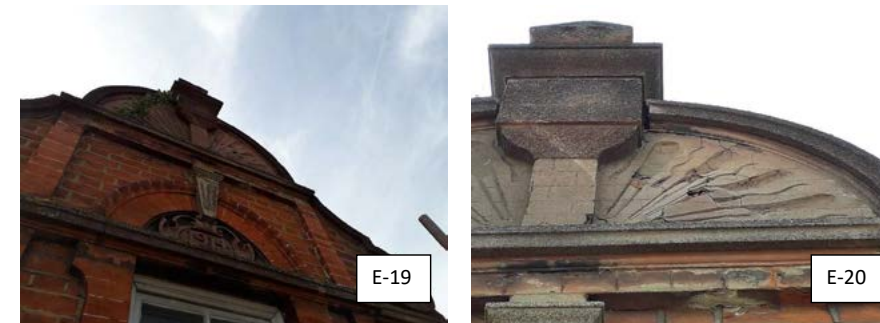
Render repairs have been historically undertaken to the gable pediments. This suggests a historic issue with the original building fabric. The render repair to two of the gables has blown and is at risk of falling. Recommend removing all buddleia, loose and de-bonded render and reinstating the original brick detail with half skin gauged brick specials with a lime putty mortar.

The render repair to two of the gables has blown and is at risk of falling.

To all other gables, we recommend that the scaffold access is extended and the areas tap tested to confirm their integrity.

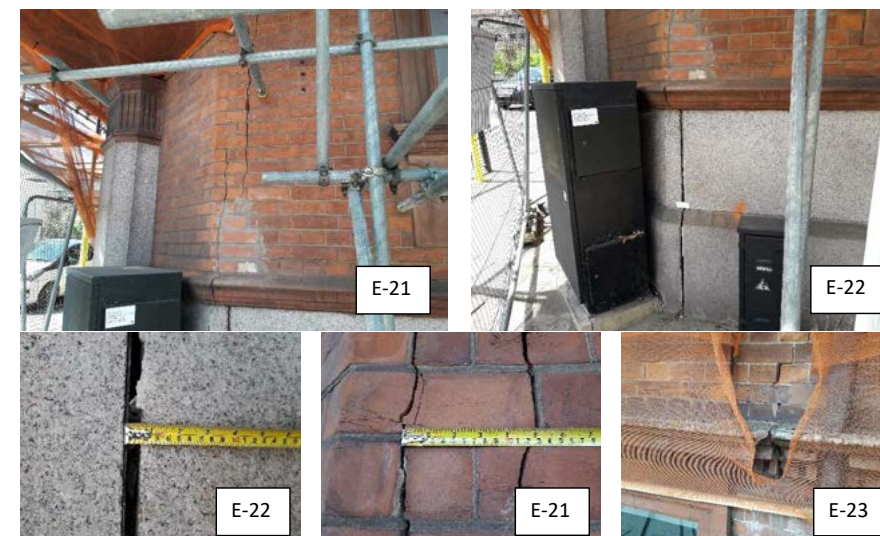
A 15mm wide continuous crack was observed through the façade at the southern end. Further localised cracking is observed through nearby brickwork. The cause for the cracking could potentially be settlement / building movement which may have been a result of historic tunnelling (e.g., tube line extension). Strongly recommend consultation with a structural engineer.

Fractures observed through brickwork to the SE corner

It is strongly recommended that a structural engineer is consulted regarding all the structural defects and extensive cracking observed to the granite plinths, brickwork, and terracotta window mullion to the South-East corner. Paye also recommend consulting a structural engineer with regards to the condition of the steel beam and bearing brickwork observed within the vehicle entrances passageway on the south elevation. The steel is showing signs of corrosion, there is no obvious bearing padstone, and the bearing brickwork is in a poor condition.

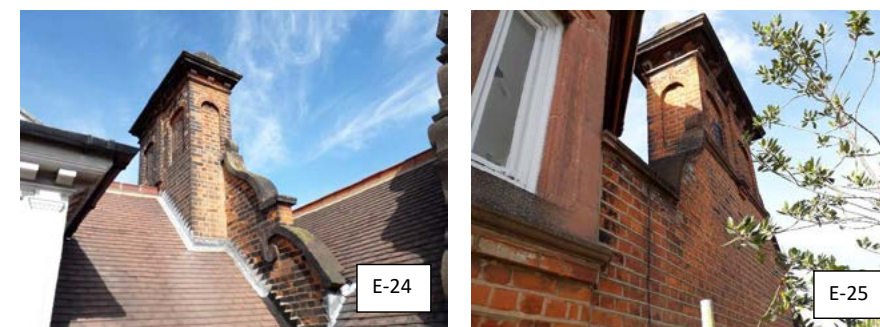
It was not possible to inspect the chimneys up close, however, the pointing is likely cementitious and appeared friable with defects to numerous bricks. For each chimney stack, provisionally allow to mechanically rake out and repoint 100%, allow for 100nr replacement bricks, and 100% replacement of the chimney flaunching.

Loose and friable pointing to chimney stacks, defective bricks.
