# Site Investigation Report

152016.2.BSI

| Overview | |
|---|---|
| Brief | Auger were commissioned by Sedgwick to undertake a site investigation within the area of concern at the property. |

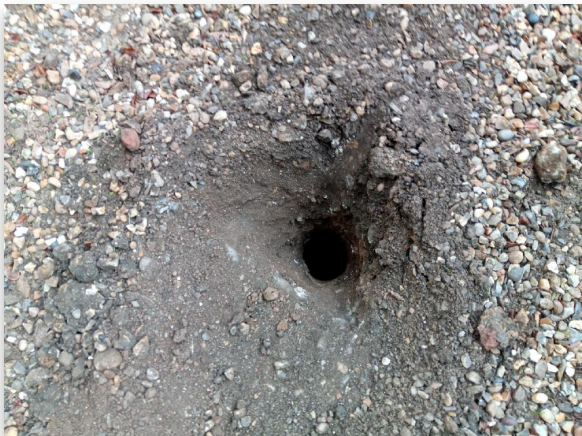
Fig 2.2: Bore Hole 2

| Overview | |
|---|---|
| Bore Hole Findings | Within BH2 we were unable to reach the required depth in BH2 because we encountered desiccated clay which our engineer could not auger through at 1.5m. The Bore Hole was carried out in the proposed location. We took root samples. These measurements are shown in Bore Hole Log 2 below. |

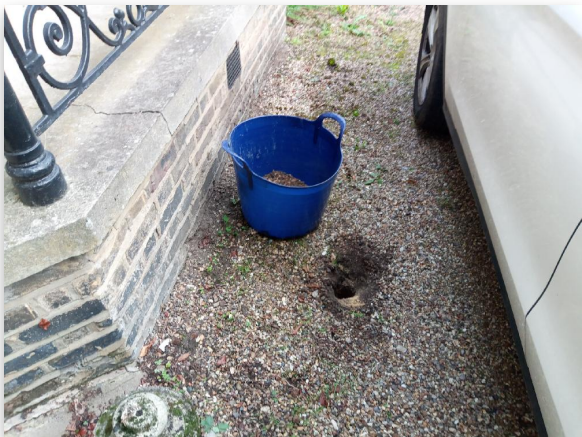
Fig 3.2: Bore Hole 3

| Overview | |
|---|---|
| | Within BH3 we were unable to reach the required depth in BH3 because we encountered desiccated clay which our engineer could not auger through at 1.8m. The Bore Hole was carried out in the proposed location. We took root samples. These measurements are shown in Bore Hole Log 3 below. |

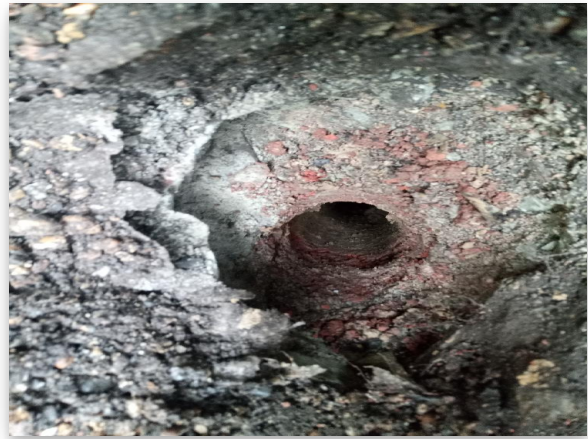
Fig 4.2: Bore Hole 4

| Overview | |
|---|---|
| | Within BH4 we augered to the required depth (3m) in the proposed location. We were unable to collect root samples from BH4 because no roots were present during the bore hole, hence no samples were retrieved. These measurements are shown in Bore Hole Log 4 below. |

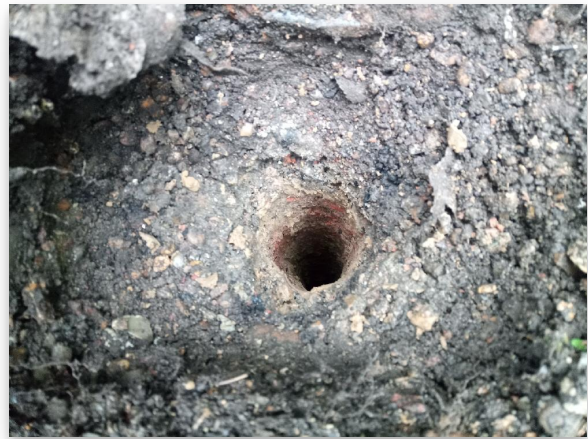
Fig 4.4: Bore Hole 5

| Overview | |
|---|---|
| | Within BH5 we augered to the required depth (3m) in the proposed location. We were unable to collect root samples from BH5 because no roots were present during the bore hole, hence no samples were retrieved. These measurements are shown in Bore Hole Log 5 below. |

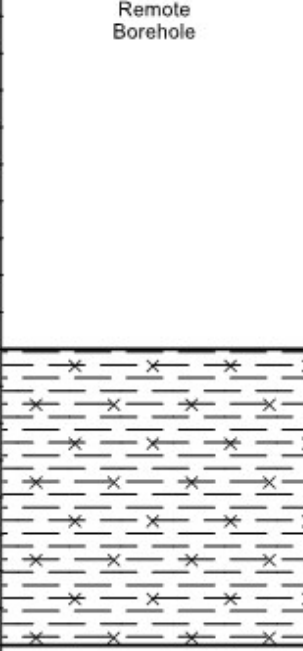
## Bore Hole Log No.3

| Depth<br>(m) | Symbolic Log | Strata Description | Insitu Tests | | Soil<br>Sample | Root<br>Sample |
|---|---|---|---|--|---|---|
| 1.5 | | Very dry very stiff brown silty<br>CLAY | 140kpa | | | |
| 2.0 | | BORE HOLE TERMINATED | | | | |

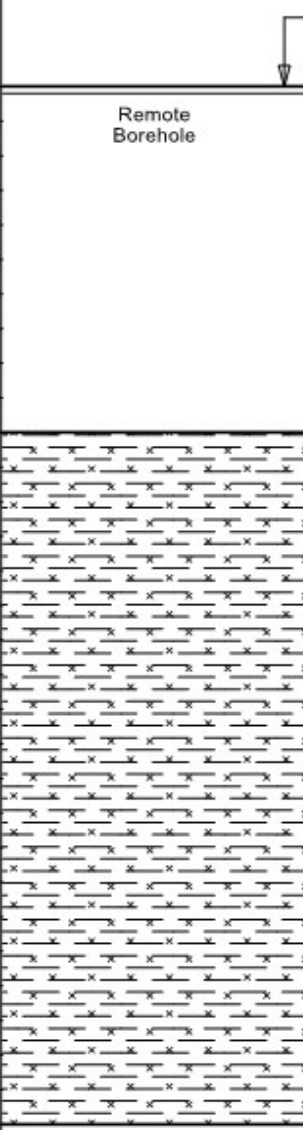
## Bore Hole Log No.5

| Depth<br>(m) | Symbolic Log | Strata Description | Insitu Tests | | Soil<br>Sample | Root<br>Sample |
|---|---|---|---|--|---|---|
| 2.0 | | Damp firm brown very silty<br>CLAY | 38kpa | | | |
| 3.0 | | BORE HOLE TERMINATED | 54kpa | | | |
