# Air Quality and Dust Management Plan (AQDMP)

**Client:** Base Contracts

**Project:** Printworks 819-829 Tottenham High Road

**Ref:** 15013

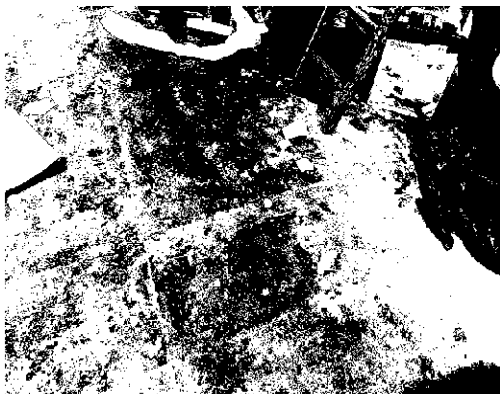
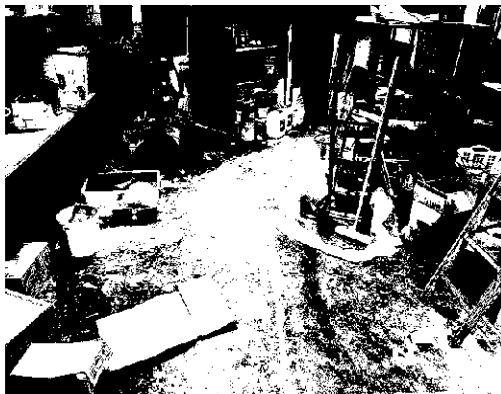
| Next Inspection | Unit 825 (La Royale Office) | | Sample No | Floor - Bituminous | |
| Bituminous Product | 1 | Fair | 2 | COM @OSitÆ | 0 |
