Project Number: 23002

Project: 41 Sheldon Avenue, N6

The information provided is relevant at the time of survey. The coding system in this report is based on the Manual of Sewer Condition Classification, 5th edition (MSCC5) domestic codes ( BS EN 13508-1:2003 ). This is the official standard for the water industry.

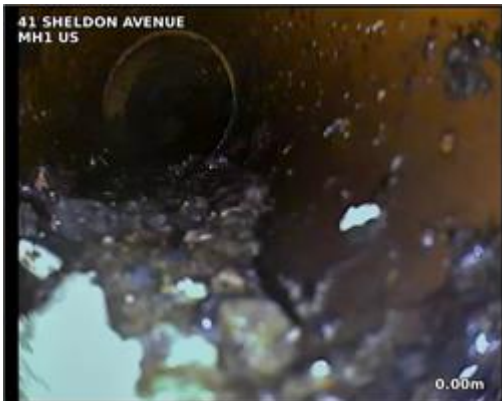
| Pos | Video Ref | Code | Description | Image |
|---|---|---|---|---|
| 00.00m | 0:00:00 | S1 DES | Settled deposits fine 0m - 1.1m: 30% Cross sectional area loss - Severity 3 | Image Provided - Ref: 0_2<br> |

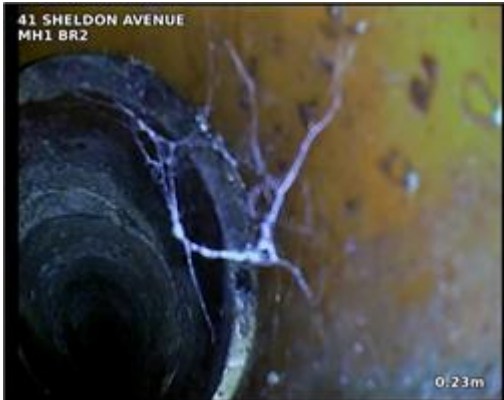
| Pos | Video Ref | Code | Description | Image |
|---|---|---|---|---|
| 00.30m | 0:00:03 | JDM | Joint displaced medium - Severity 3 | Image Provided - Ref: 2_3<br> |

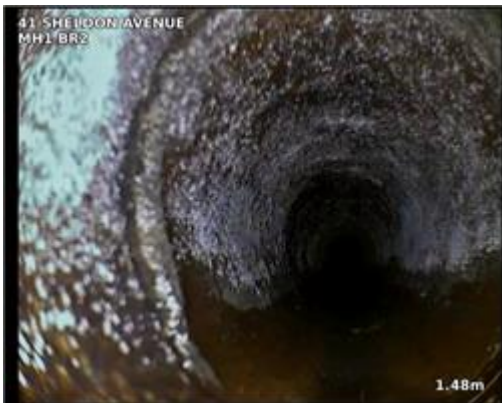
| Pos | Video Ref | Code | Description | Image |
|---|---|---|---|---|
| 01.50m | 0:00:47 | JDM | Joint displaced medium -<br>Severity 3 | Image Provided - Ref: 2_5<br> |

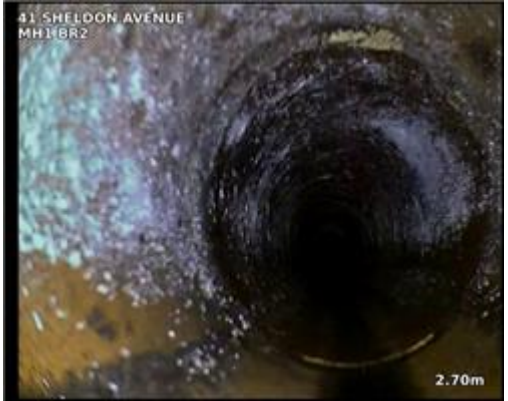
| Pos | Video Ref | Code | Description | Image |
|---|---|---|---|---|
| 02.70m | 0:01:00 | JDM | Joint displaced medium - Severity 3 | <p>Image Provided - Ref: 2_7</p> |

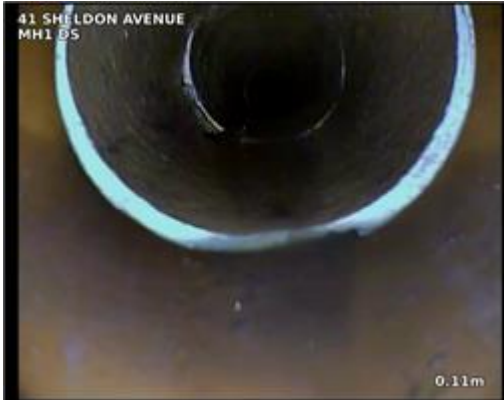
| Pos | Video Ref | Code | Description | Image |
|---|---|---|---|---|
| 00.20m | 0:00:08 | JDM | Joint displaced medium - Severity 3 | Image Provided - Ref: 4_2<br> |

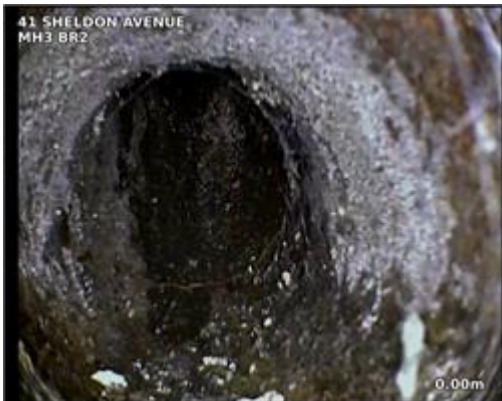
| Pos | Video Ref | Code | Description | Image |
|---|---|---|---|---|
| 00.00m | 0:00:00 | DES | Settled deposits fine: 10% Cross sectional area loss - Severity 3 | Image Provided - Ref: 6_2<br> |

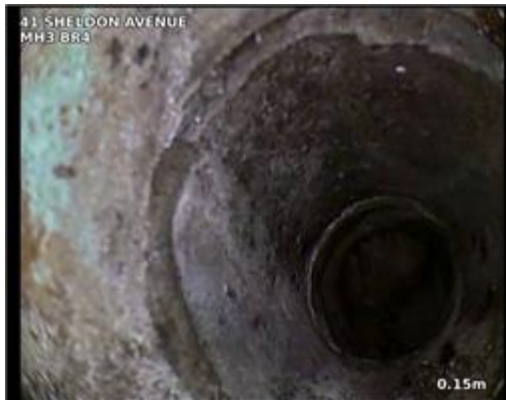
| Pos | Video Ref | Code | Description | Image |
|---|---|---|---|---|
| 00.20m | 0:00:01 | JDM | Joint displaced medium - Severity 3 | Image Provided - Ref: 8_3<br> A view looking down into the manhole, showing a joint displacement. The concrete walls are visible, and the pipe continues downwards. Text in the top left corner reads '41 SHELDON AVENUE MH3 BR4'. A scale marker '0.15m' is in the bottom right corner. |

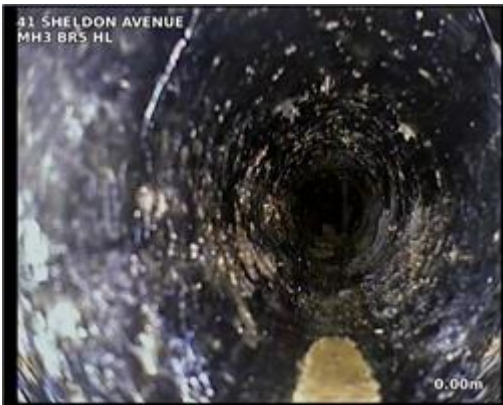
| Pos | Video Ref | Code | Description | Image |
|---|---|---|---|---|
| 00.00m | 0:00:02 | S1 DES | Settled deposits fine 0m - 1.2m: 10% Cross sectional area loss - Severity 3 | Image Provided - Ref: 9_2<br> |

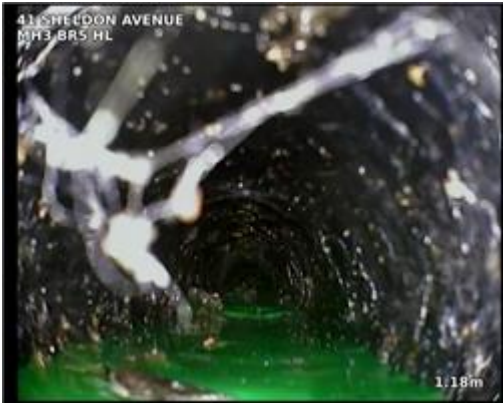
| Pos | Video Ref | Code | Description | Image |
|---|---|---|---|---|
| 01.20m | | SA | Survey abandoned camera unable to pass | Image Provided - Ref: 9_9999<br> |

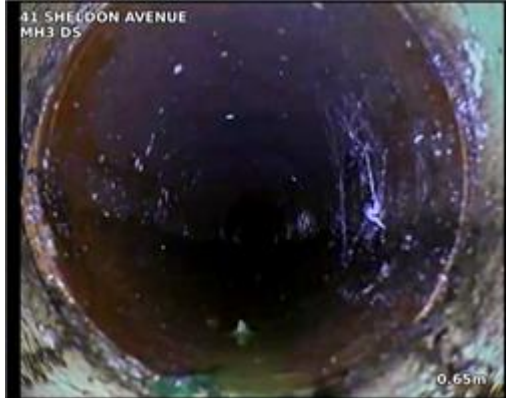
| Pos | Video Ref | Code | Description | Image |
|---|---|---|---|---|
| 00.70m | 0:00:05 | JDM | Joint displaced medium - Severity 3 | Image Provided - Ref: 10_2<br> |

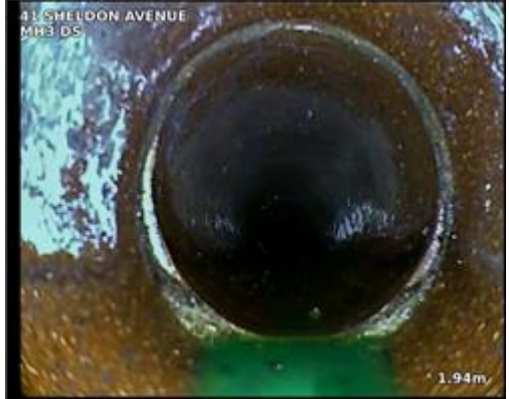
| Pos | Video Ref | Code | Description | Image |
|---|---|---|---|---|
| 02.00m | 0:00:19 | JDM | Joint displaced medium - Severity 3 | Image Provided - Ref: 10_3<br> |

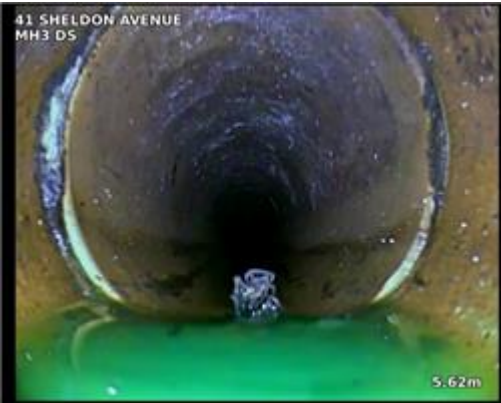
| Pos | Video Ref | Code | Description | Image |
|---|---|---|---|---|
| 05.60m | 0:00:59 | JDM | Joint displaced medium - Severity 3 | <p>Image Provided - Ref: 10_7</p> |

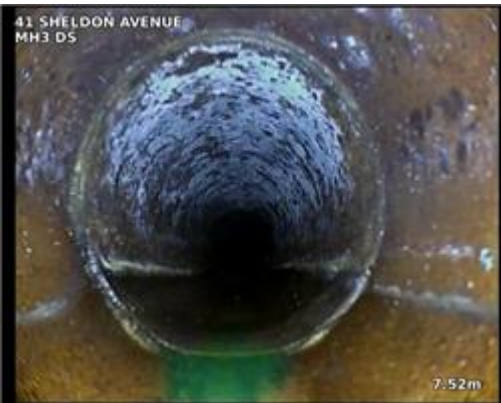
| Pos | Video Ref | Code | Description | Image |
|---|---|---|---|---|
| 07.60m | 0:01:22 | JDM | Joint displaced medium - Severity 3 | <p>Image Provided - Ref: 10_9</p> |

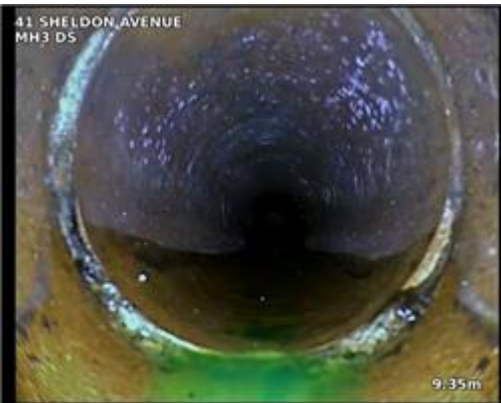
| Pos | Video Ref | Code | Description | Image |
|---|---|---|---|---|
| 09.40m | 0:01:41 | JDM | Joint displaced medium - Severity 3 | <p>Image Provided - Ref: 10_12</p> |

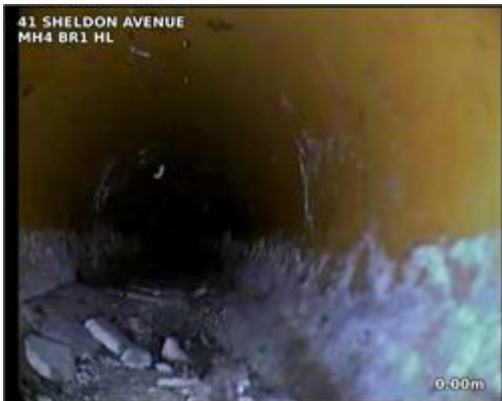
| Pos | Video Ref | Code | Description | Image |
|---|---|---|---|---|
| 00.00m | 0:00:00 | S1 DER | Settled deposits coarse 0m - 1.5m: 20% Cross sectional area loss - Severity 3 | Image Provided - Ref: 12_2<br> |

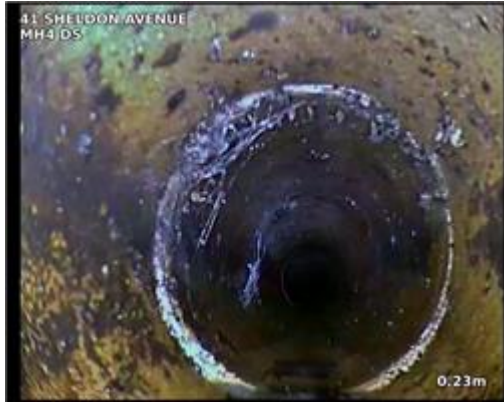
| Pos | Video Ref | Code | Description | Image |
|---|---|---|---|---|
| 00.30m | 0:00:07 | JDM | Joint displaced medium - Severity 3 | Image Provided - Ref: 13_2<br> |

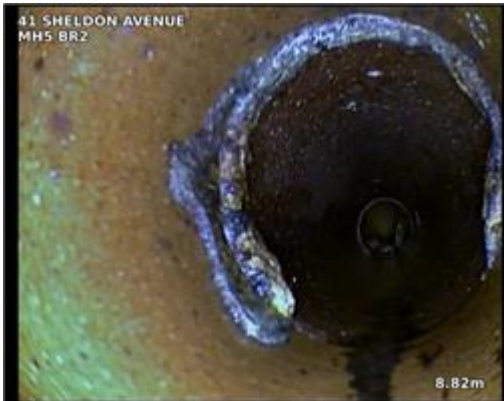
| Pos | Video Ref | Code | Description | Image |
|---|---|---|---|---|
| 08.90m | 0:02:15 | JDM | Joint displaced medium - Severity 3 | <p>Image Provided - Ref: 14_14</p> |

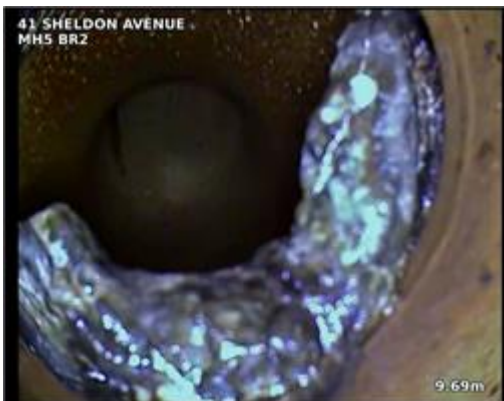
| Pos | Video Ref | Code | Description | Image |
|---|---|---|---|---|
| 09.70m | 0:02:25 | DEE | Attached deposits, encrustation from 02 o'clock to 08 o'clock: 30% Cross sectional area loss - Severity 3 | <p>Image Provided - Ref: 14_15</p> |

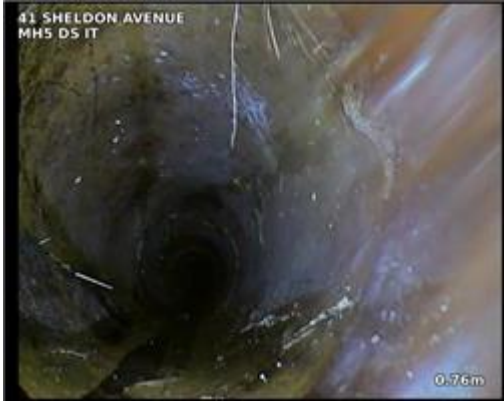
| Pos | Video Ref | Code | Description | Image |
|---|---|---|---|---|
| 00.80m | 0:00:13 | FL | Fracture longitudinal at 04 o'clock - Severity 3 | <p>Image Provided - Ref: 15_9</p> |

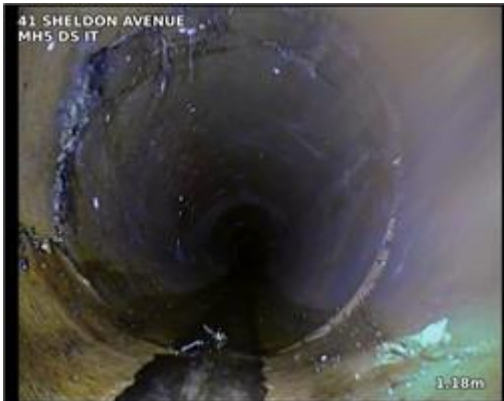
| Pos | Video Ref | Code | Description | Image |
|---|---|---|---|---|
| 01.20m | 0:00:16 | R | Roots - Severity 3 | <p>Image Provided - Ref: 15_3</p> |

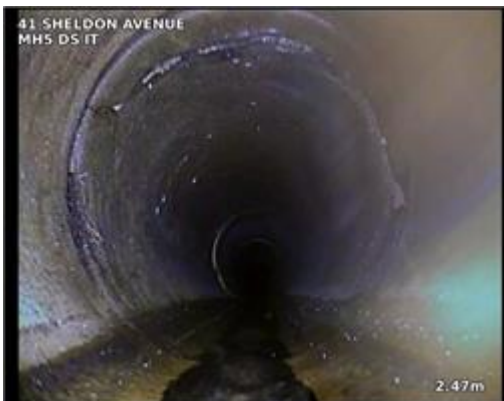
| Pos | Video Ref | Code | Description | Image |
|---|---|---|---|---|
| 02.50m | 0:00:30 | CC | Crack, circumferential from 10 o'clock to 03 o'clock - Severity 1 | <p>Image Provided - Ref: 15_4</p> |

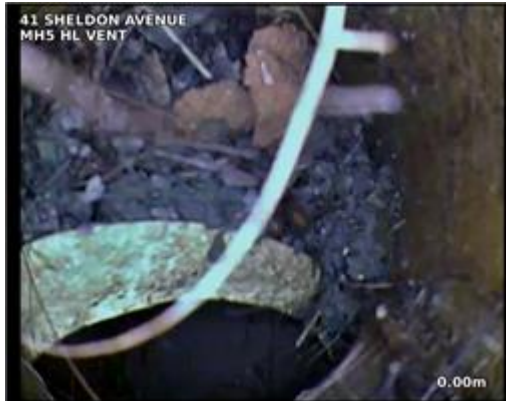
| Pos | Video Ref | Code | Description | Image |
|---|---|---|---|---|
| 00.00m | 0:00:02 | DER | Settled deposits coarse: 100% Cross sectional area loss - Severity 3 | |
| 00.00m | | SA | Survey abandoned camera unable to pass | Image Provided - Ref: 16_9999<br> 0.00m |

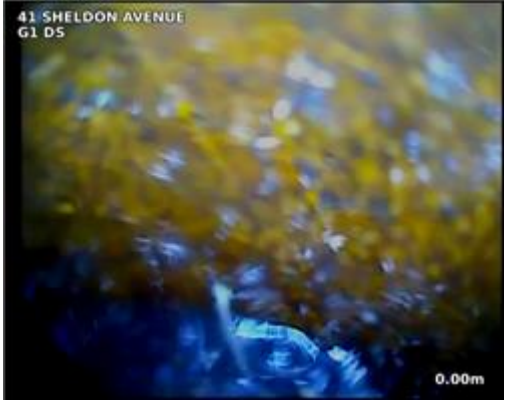
| Pos | Video Ref | Code | Description | Image |
|---|---|---|---|---|
| 00.00m | | SA | Survey abandoned camera unable to pass gully | <p>Image Provided - Ref: 17_9999</p> |
