## FLOOD RISK ASSESSMENT

41 SHELDON AVENUE  
LONDON  
N6 4JP

23135-SYM-XX-XX-RP-C-0001

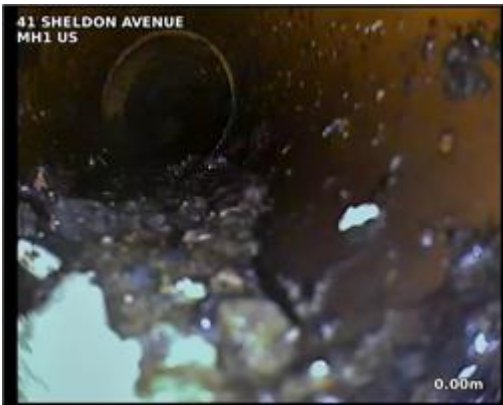
| Pos | Video Ref | Code | Description | Image |
|---|---|---|---|---|
| 00.00m | 0:00:00 | S1 DES | Settled deposits fine 0m - 1.1m: 30% Cross sectional area loss - Severity 3 | Image Provided - Ref: 0_2<br> |

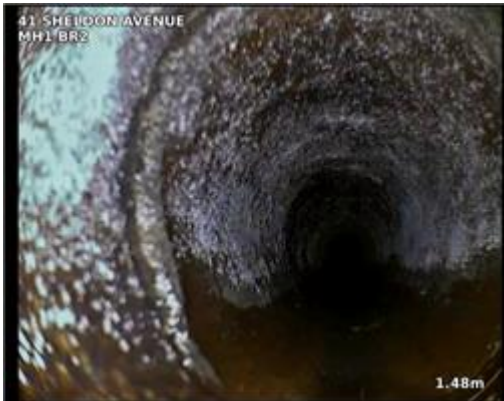
| Pos | Video Ref | Code | Description | Image |
|---|---|---|---|---|
| 01.50m | 0:00:47 | JDM | Joint displaced medium -<br>Severity 3 | Image Provided - Ref: 2_5<br> |

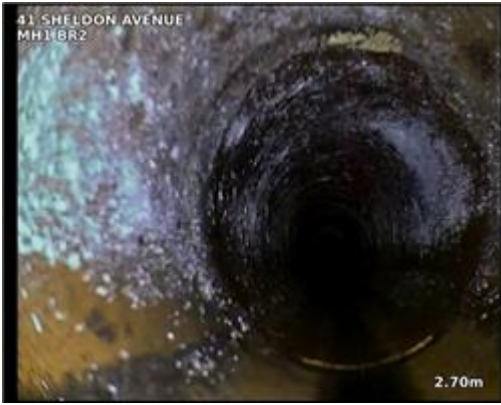
| Pos | Video Ref | Code | Description | Image |
|---|---|---|---|---|
| 02.70m | 0:01:00 | JDM | Joint displaced medium - Severity 3 | <p>Image Provided - Ref: 2_7</p> |

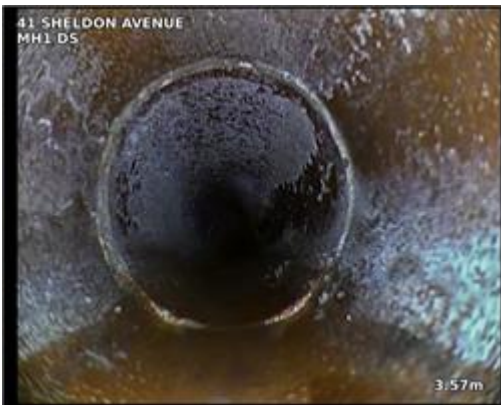
| Pos | Video Ref | Code | Description | Image |
|---|---|---|---|---|
| 03.60m | 0:00:54 | JDM | Joint displaced medium -<br>Severity 3 | Image Provided - Ref: 4_8<br> |

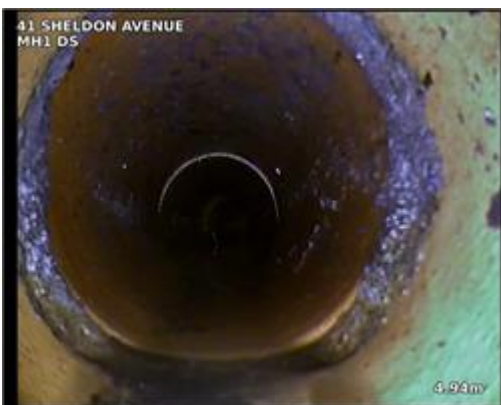
| Pos | Video Ref | Code | Description | Image |
|---|---|---|---|---|
| 05.00m | 0:01:12 | JDM | Joint displaced medium -<br>Severity 3 | Image Provided - Ref: 4_9<br> |

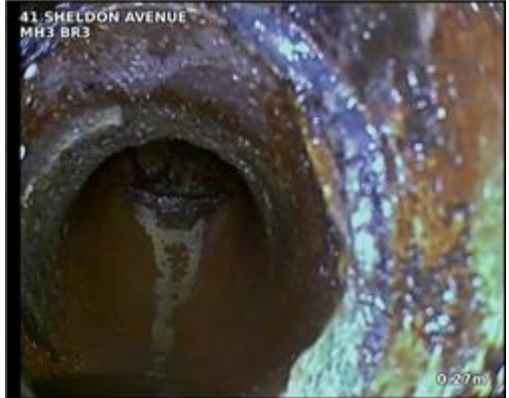
| Pos | Video Ref | Code | Description | Image |
|---|---|---|---|---|
| 00.30m | 0:00:08 | JDM | Joint displaced medium - Severity 3 | Image Provided - Ref: 7_2<br> |

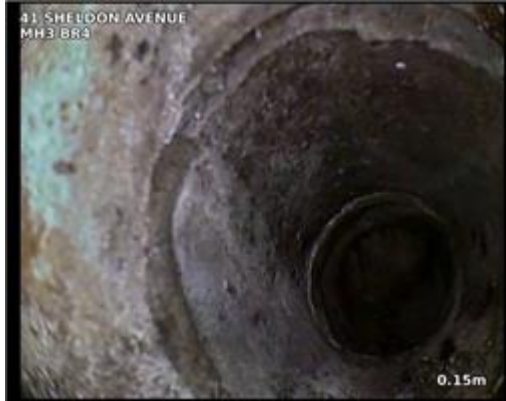
| Pos | Video Ref | Code | Description | Image |
|---|---|---|---|---|
| 00.20m | 0:00:01 | JDM | Joint displaced medium - Severity 3 | Image Provided - Ref: 8_3<br> A top-down view of a manhole opening, showing a joint displacement. Text in the top left corner reads '41 SHELDON AVENUE MH3 BR4'. A scale marker '0.15m' is in the bottom right corner. |

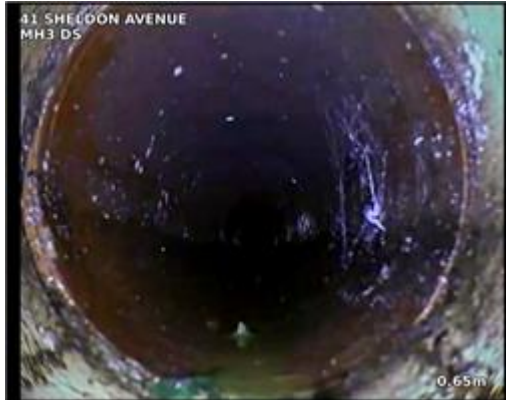
| Pos | Video Ref | Code | Description | Image |
|---|---|---|---|---|
| 00.70m | 0:00:05 | JDM | Joint displaced medium - Severity 3 | Image Provided - Ref: 10_2<br> |

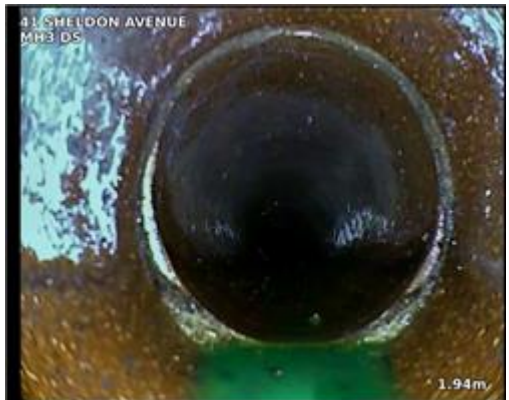
| Pos | Video Ref | Code | Description | Image |
|---|---|---|---|---|
| 02.00m | 0:00:19 | JDM | Joint displaced medium - Severity 3 | Image Provided - Ref: 10_3<br> |

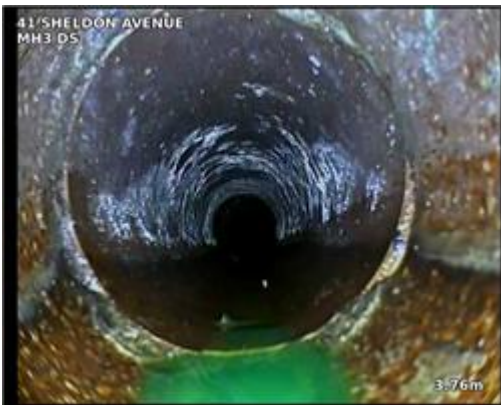
| Pos | Video Ref | Code | Description | Image |
|---|---|---|---|---|
| 03.80m | 0:00:36 | JDM | Joint displaced medium -<br>Severity 3 | <p>Image Provided - Ref: 10_5</p> |

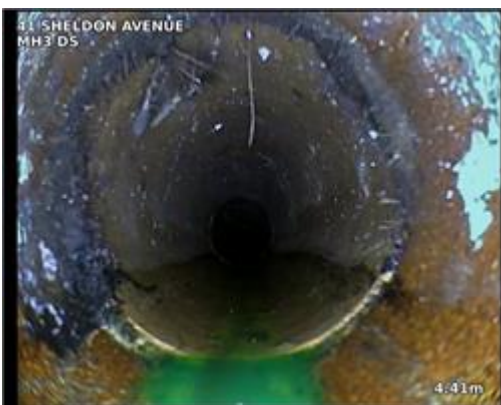
| Pos | Video Ref | Code | Description | Image |
|---|---|---|---|---|
| 04.40m | 0:00:46 | JDM | Joint displaced medium -<br>Severity 3 | <p>Image Provided - Ref: 10_6</p> |

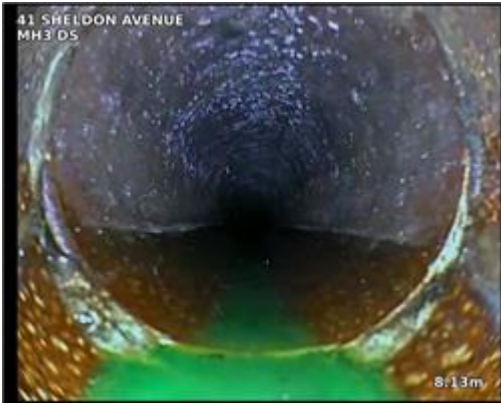
| Pos | Video Ref | Code | Description | Image |
|---|---|---|---|---|
| 08.20m | 0:01:28 | JDM | Joint displaced medium - Severity 3 | <p>Image Provided - Ref: 10_10</p> |

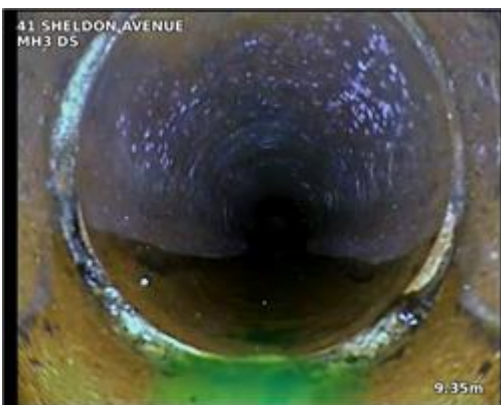
| Pos | Video Ref | Code | Description | Image |
|---|---|---|---|---|
| 09.40m | 0:01:41 | JDM | Joint displaced medium - Severity 3 | <p>Image Provided - Ref: 10_12</p> |

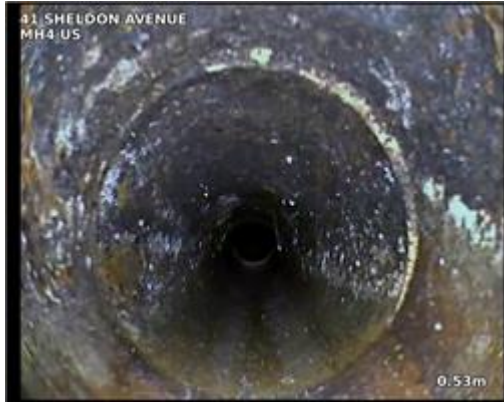
| Pos | Video Ref | Code | Description | Image |
|---|---|---|---|---|
| 00.60m | 0:00:08 | JDM | Joint displaced medium - Severity 3 | Image Provided - Ref: 11_2<br> |

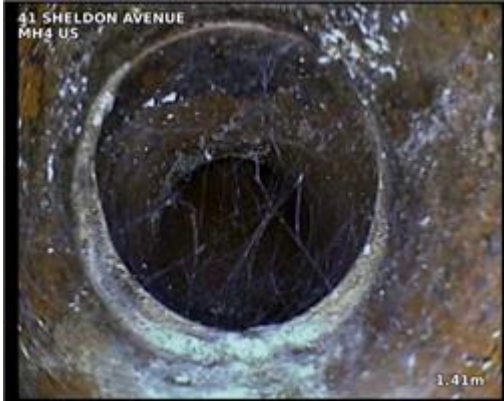
| Pos | Video Ref | Code | Description | Image |
|---|---|---|---|---|
| 01.50m | 0:00:20 | JDM | Joint displaced medium - Severity 3 | <p>Image Provided - Ref: 11_3</p> |

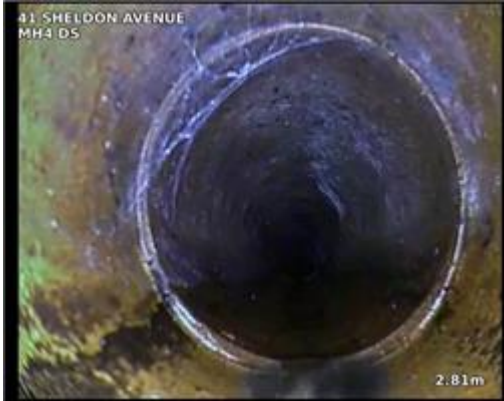
| Pos | Video Ref | Code | Description | Image |
|---|---|---|---|---|
| 02.90m | 0:00:43 | JDM | Joint displaced medium - Severity 3 | <p>Image Provided - Ref: 13_4</p> |

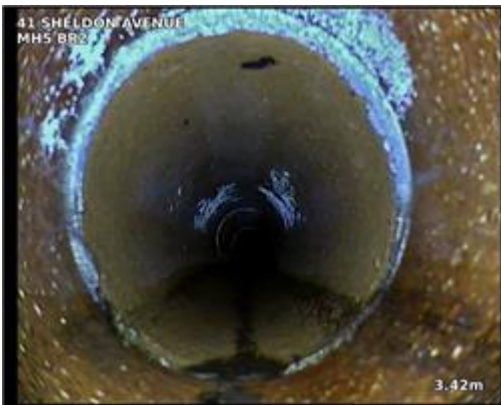
| Pos | Video Ref | Code | Description | Image |
|---|---|---|---|---|
| 03.50m | 0:00:43 | JDM | Joint displaced medium -<br>Severity 3 | <p>Image Provided - Ref: 14_5</p> |

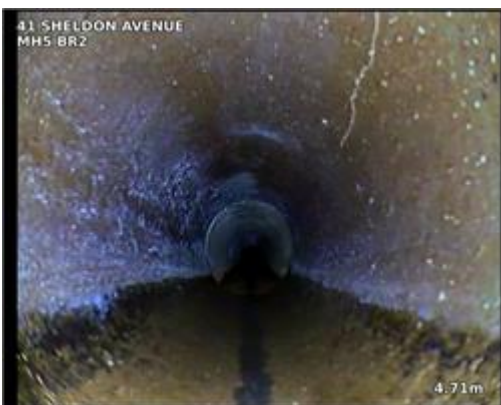
| Pos | Video Ref | Code | Description | Image |
|---|---|---|---|---|
| 04.70m | 0:00:57 | CL | Crack, longitudinal at 02<br>o'clock - Severity 1 | <p>Image Provided - Ref: 14_6</p> |

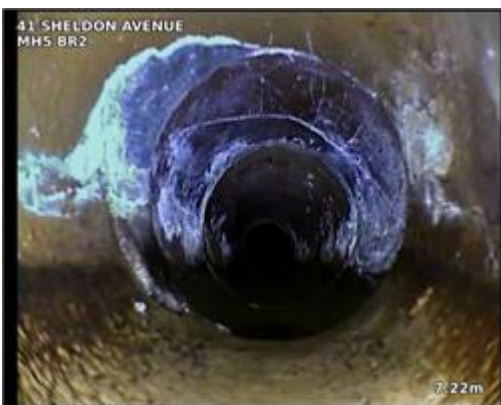
| Pos | Video Ref | Code | Description | Image |
|---|---|---|---|---|
| 07.30m | 0:01:36 | CC | Crack, circumferential from 07<br>o'clock to 12 o'clock - Severity<br>1 | <p>Image Provided - Ref: 14_9</p> |

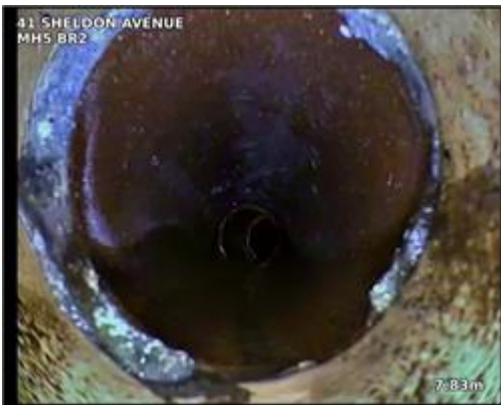
| Pos | Video Ref | Code | Description | Image |
|---|---|---|---|---|
| 07.90m | 0:02:03 | JDM | Joint displaced medium - Severity 3 | <p>Image Provided - Ref: 14_11</p> |

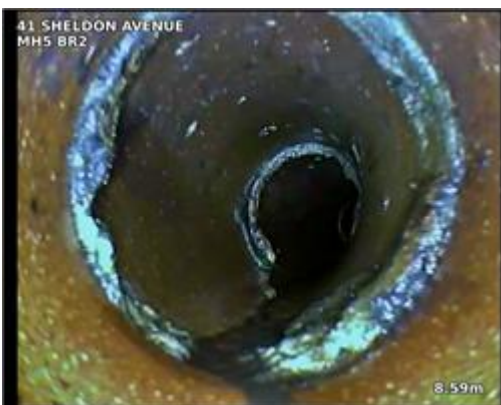
| Pos | Video Ref | Code | Description | Image |
|---|---|---|---|---|
| 08.60m | 0:02:09 | JDM | Joint displaced medium - Severity 3 | <p>Image Provided - Ref: 14_12</p> |

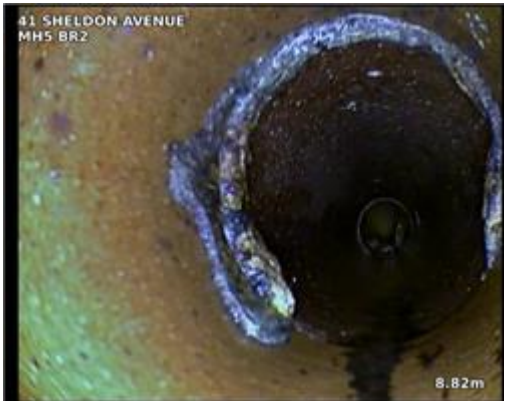
| Pos | Video Ref | Code | Description | Image |
|---|---|---|---|---|
| 08.90m | 0:02:15 | JDM | Joint displaced medium - Severity 3 | <p>Image Provided - Ref: 14_14</p> |

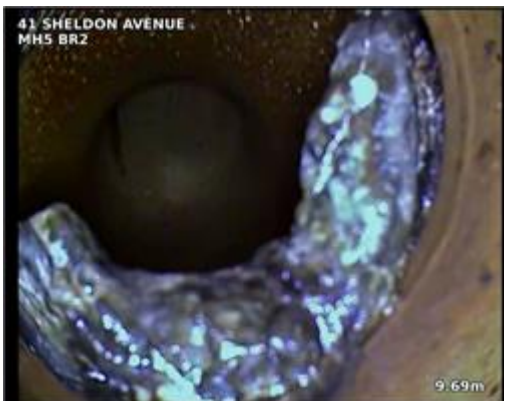
| Pos | Video Ref | Code | Description | Image |
|---|---|---|---|---|
| 09.70m | 0:02:25 | DEE | Attached deposits, encrustation from 02 o'clock to 08 o'clock: 30% Cross sectional area loss - Severity 3 | <p>Image Provided - Ref: 14_15</p> |

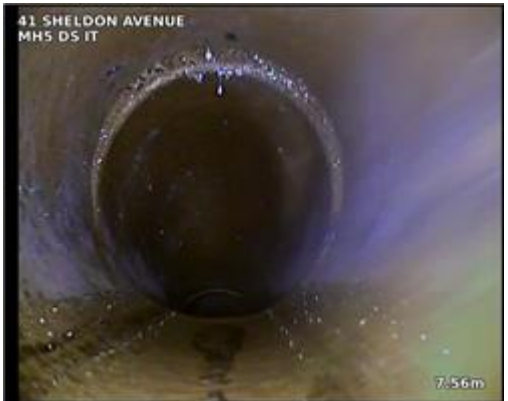
| Pos | Video Ref | Code | Description | Image |
|---|---|---|---|---|
| 07.60m | 0:01:01 | JDM | Joint displaced medium -<br>Severity 3 | <p>Image Provided - Ref: 15_6</p> |

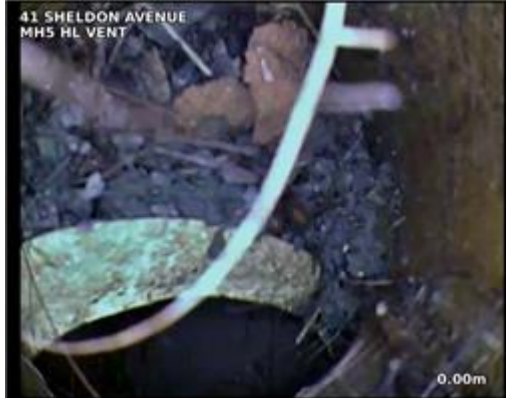
| Pos | Video Ref | Code | Description | Image |
|---|---|---|---|---|
| 00.00m | 0:00:02 | DER | Settled deposits coarse: 100% Cross sectional area loss - Severity 3 | |
| 00.00m | | SA | Survey abandoned camera unable to pass | Image Provided - Ref: 16_9999<br> 0.00m |

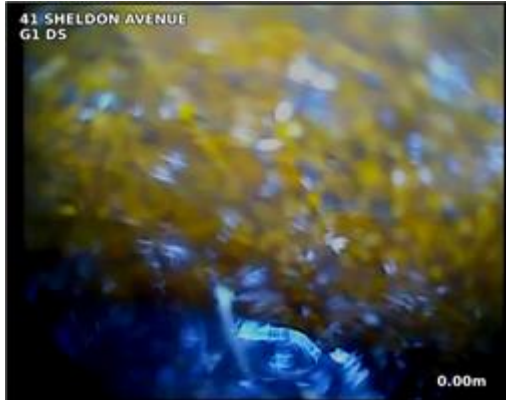
| Pos | Video Ref | Code | Description | Image |
|---|---|---|---|---|
| 00.00m | | SA | Survey abandoned camera unable to pass gully | <p>Image Provided - Ref: 17_9999</p> |

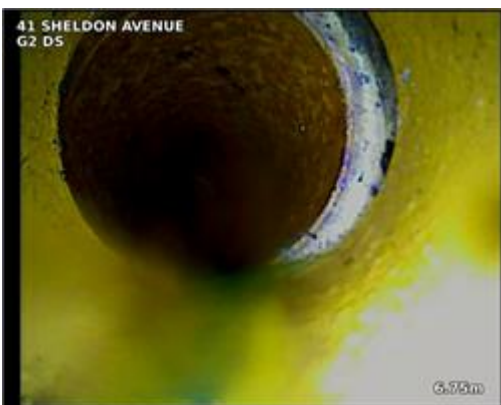
| Pos | Video Ref | Code | Description | Image |
|---|---|---|---|---|
| 06.80m | 0:01:55 | JDM | Joint displaced medium - Severity 3 | Image Provided - Ref: 18_6<br> |

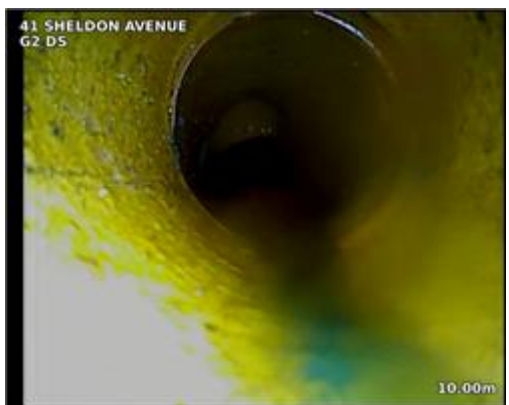
| Pos | Video Ref | Code | Description | Image |
|---|---|---|---|---|
| 10.00m | 0:02:54 | JDM | Joint displaced medium -<br>Severity 3 | <p>Image Provided - Ref: 18_12</p> |

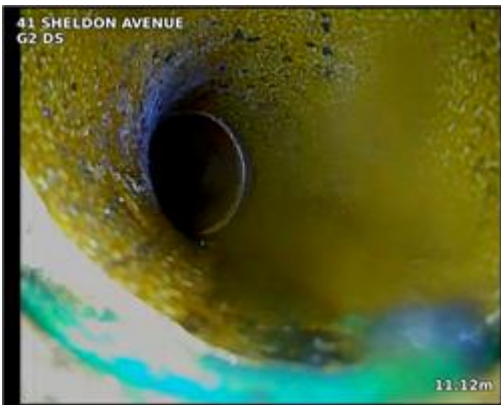
| Pos | Video Ref | Code | Description | Image |
|---|---|---|---|---|
| 11.20m | 0:03:24 | JDM | Joint displaced medium - Severity 3 | <p>Image Provided - Ref: 18_14</p> |

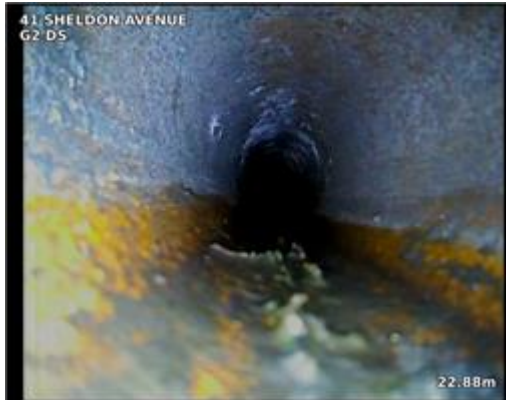
| Pos | Video Ref | Code | Description | Image |
|---|---|---|---|---|
| 22.90m | | SA | Survey abandoned<br>camera unable to continue | <p>Image Provided - Ref: 18_9999</p> |

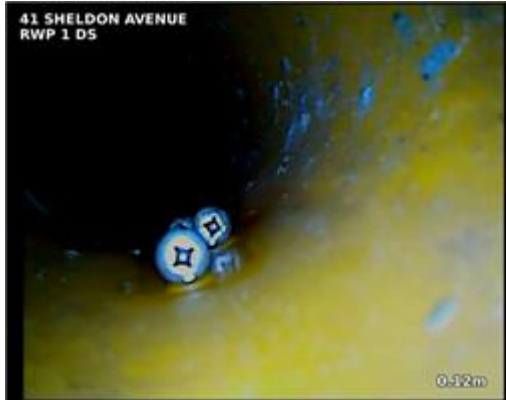
| Pos | Video Ref | Code | Description | Image |
|---|---|---|---|---|
| 00.20m | 0:00:03 | OB | Other obstacles: 10% Cross sectional area loss - Severity 3 screws | Image Provided - Ref: 19_2<br> |
