**INSURANCE CLAIM: ENGINEERING APPRAISAL REPORT**

Situation of Damage: Flats A&B, 103 Upper Tollington Park, Stroud Green, Stoke Newington, LONDON, N4 4ND

Date: 29/02/2024

Out Ref: 10017158

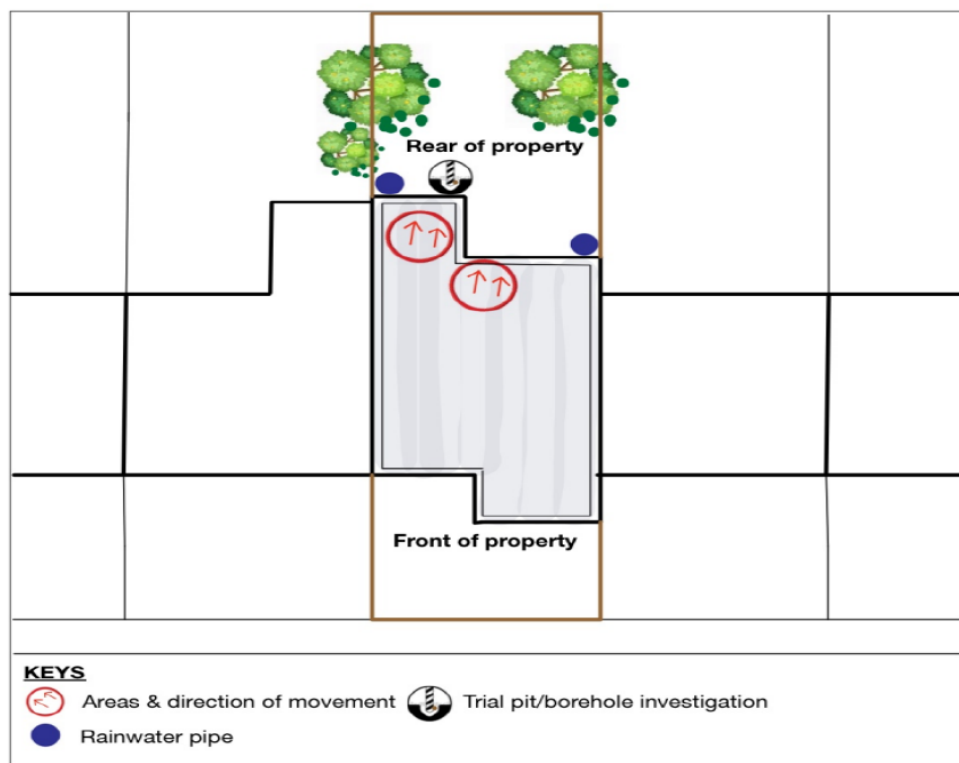
Some vegetations noted to rear of property as shown on site plan.
