## SITE INVESTIGATION FACTUAL REPORT

Report No: SI-759198  
Client: Sedgwick International UK - Maidstone  
Site: Flat A&B, 103 Upper Tollington Park  
Haringey  
Client Ref: 10017158  
Date of Visit: 14/12/2023

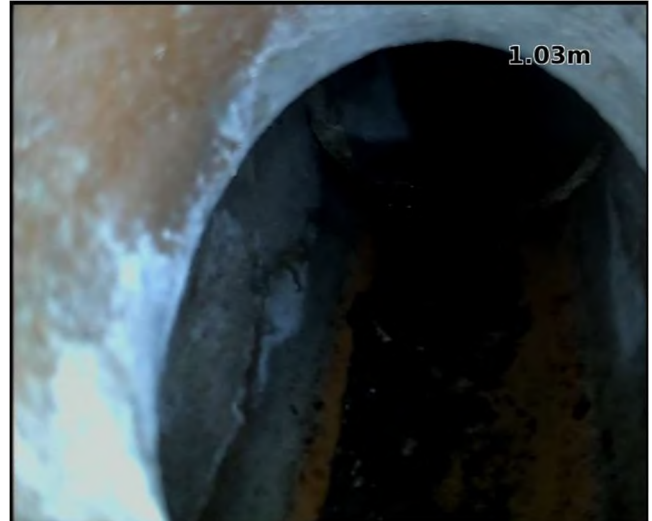
Run 1 – this run was surveyed downstream from the Rodding Eye to the Internal Manhole. The connection to the main is poor and appears to have no mechanical coupling. The RWP run connects to the run at 12 o'clock in the poor connection and could not be surveyed. There are structural defects on the run under the property. The run is believed to be shared and therefore the responsibility of the LWA.

Defective Connection

| <i>Rate code</i> | <i>Description</i> | <i>Unit</i> | <i>Qty</i> | <i>Rate</i> | <i>Amount</i> |
|---|---|---|---|---|---|
| Run 1 excavate defective connection; Install 3x1500mm patches. | | | | | |

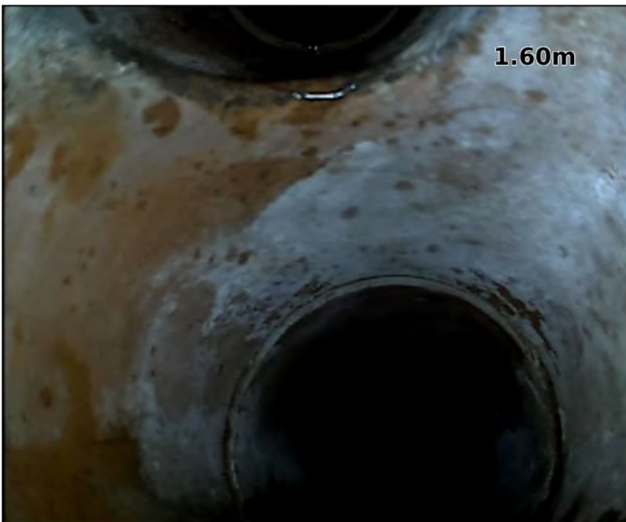
RWP junction

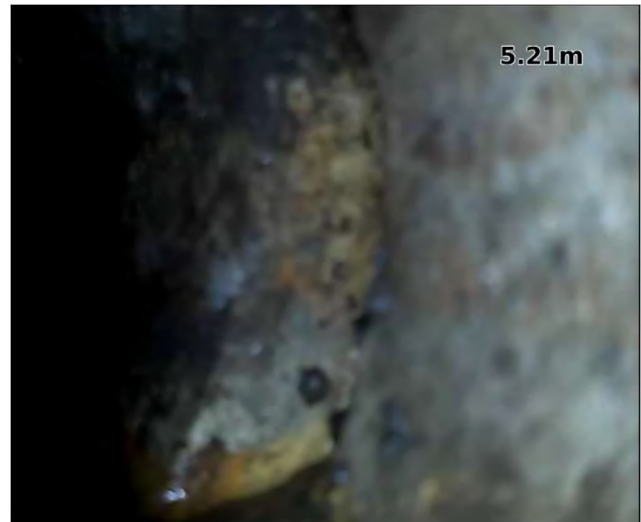
Joint Displaced Large

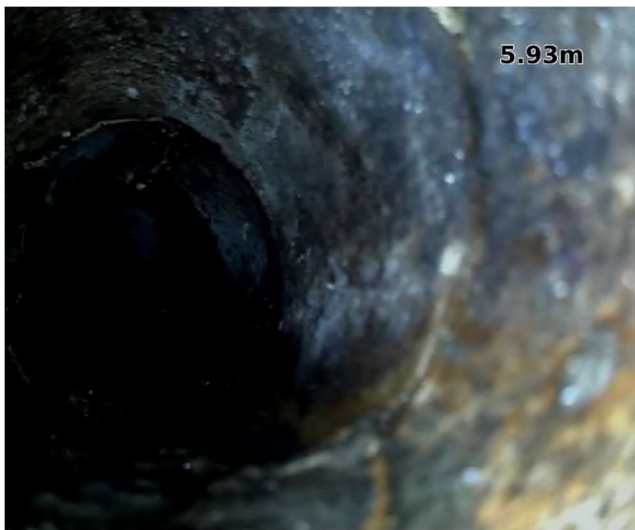
Circumferential Fracture

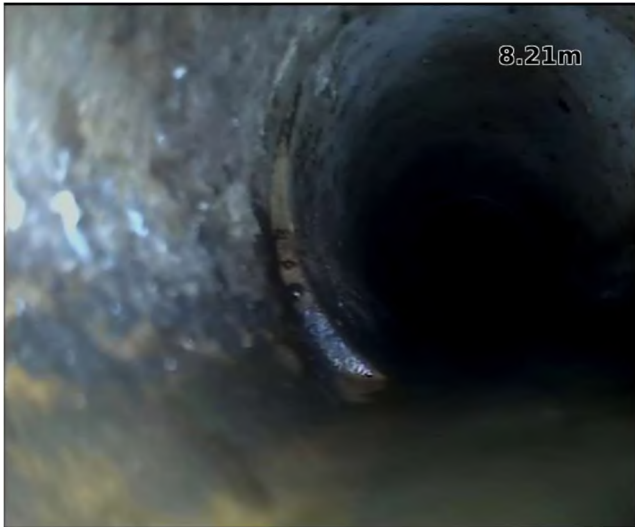
Internal Manhole

Joint Displaced Medium

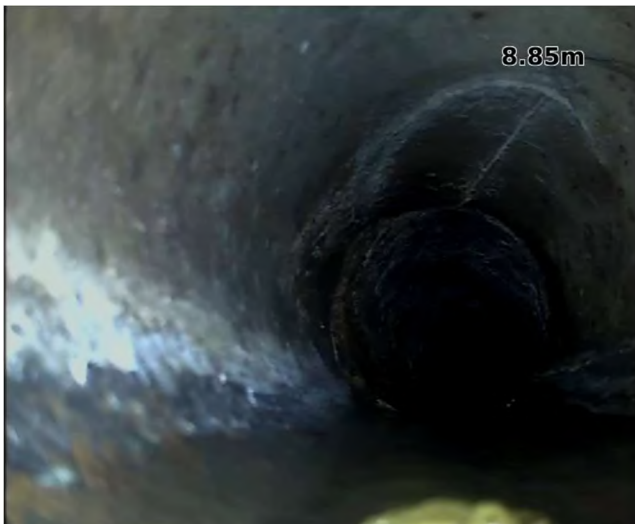
Multiple Fractures

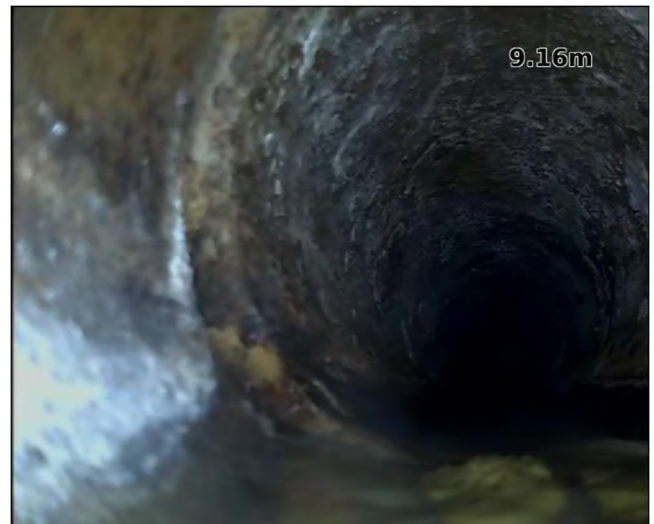
Joint Displaced Large

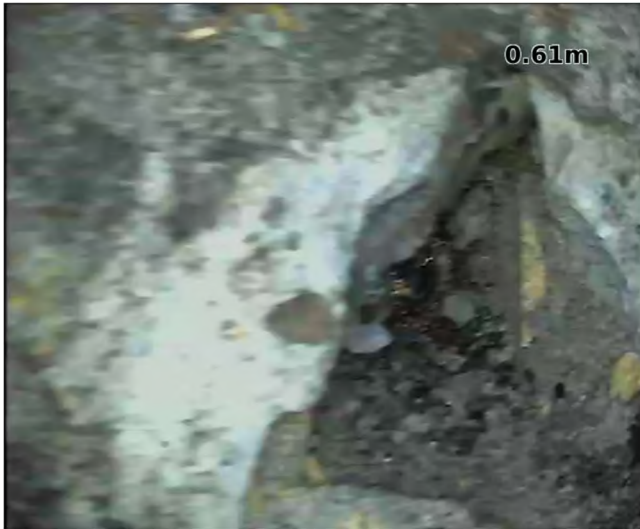
Break-in

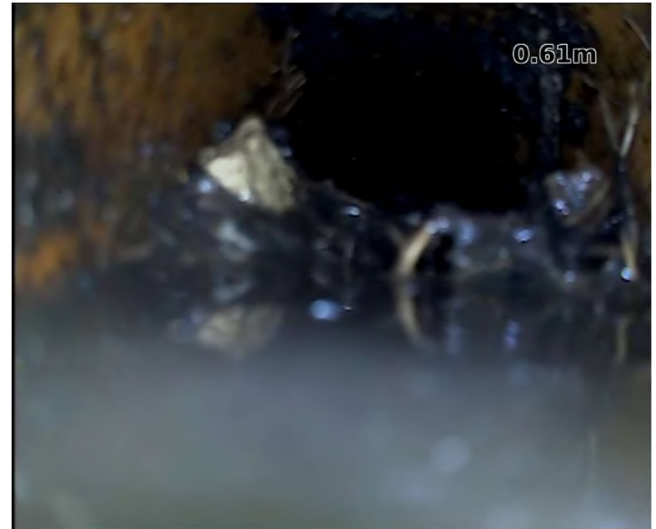
Run 2 – this run was surveyed downstream from the RWG. There is a large displaced joint on the run as it levels out. The camera could not pass this, and the survey was abandoned.

Survey Abandoned

| <i>Rate code</i> | <i>Description</i> | <i>Unit</i> | <i>Qty</i> | <i>Rate</i> | <i>Amount</i> |
|---|---|---|---|---|---|
| Run 2 excavate rest bend of RWP jet and resurvey. | | | | | |

The gully and joint would need to be excavated to complete the survey.
