## 1 SUMMARY

This report has been commissioned to assess the condition of a Common Lime tree (*Tilia x europea*) located outside the entrance of Coleridge Primary School East, N8 8DN. This detailed inspection follows on from a routine visual inspection in March.

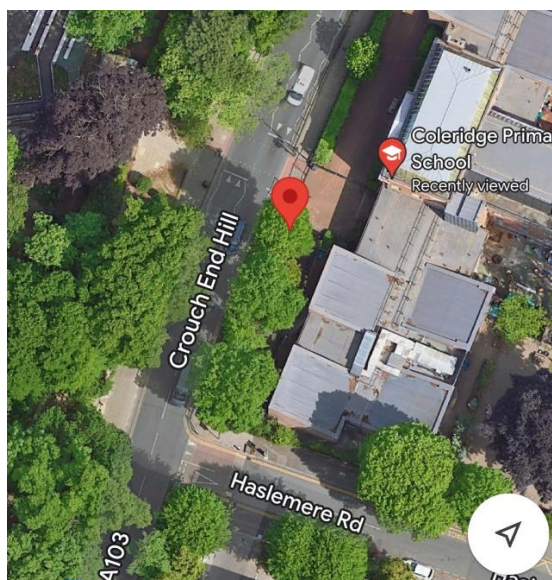
Figure 1: The location of the Lime tree

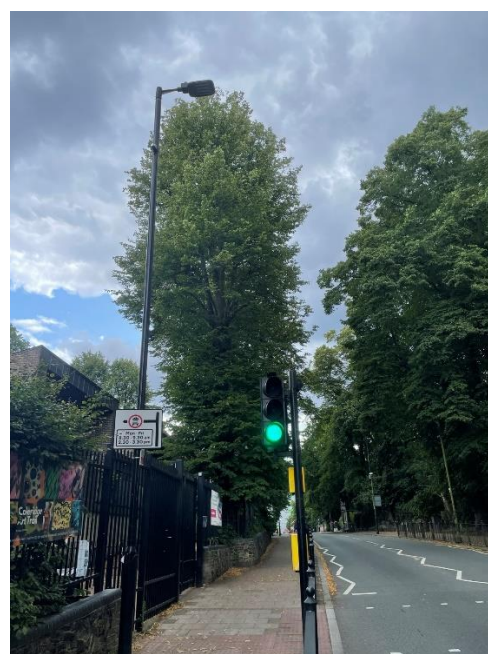
Figure 2: The location of the tree

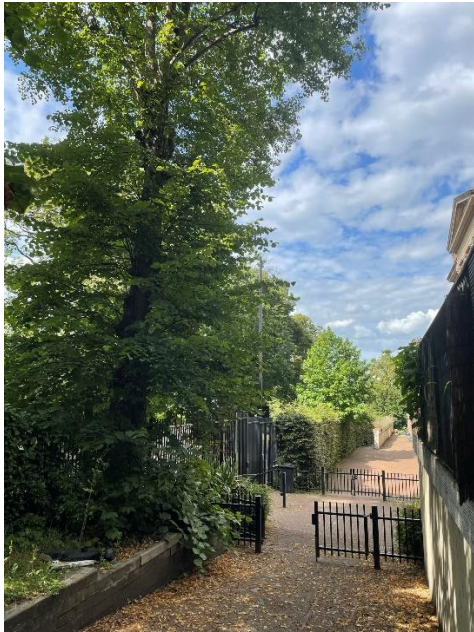
*Figure 3: The base of the tree on the school side*

The base of the tree has no pronounced buttressing.

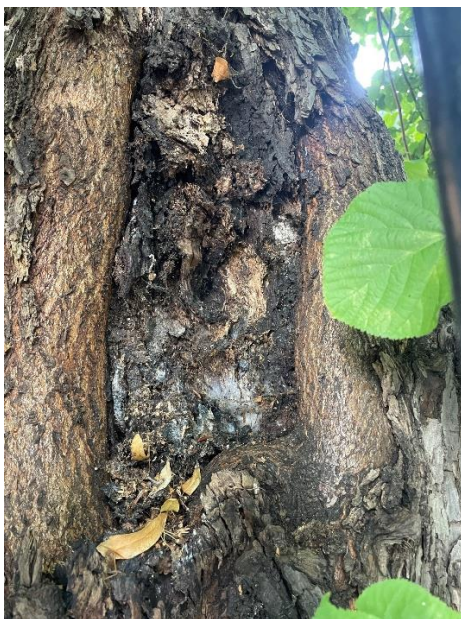
There is a historic wound on the west of the stem at about 1m measuring approximately 53cm high by 31cm wide. Decayed and dysfunctional wood is visible. No fungal fruiting bodies were visible at the time of inspection. The callus formed around the wound is good, indicative of normal vitality.

*Figure 4: Historic wound on the west side of the stem*

The recommended option is to fell the tree within 3 months.

If there is a strong desire to retain the tree, re-pollard to the previous pollard point within 3 months.

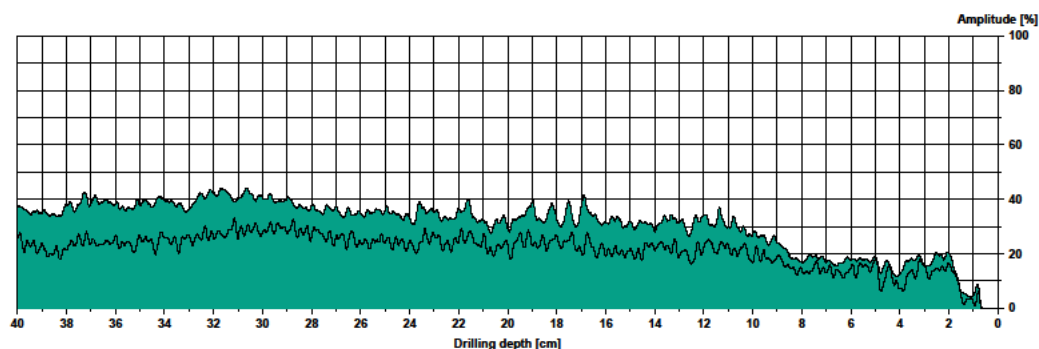
The reading at 2m is consistent with normal wood to 32cm and then minor degradation of the wood structure after 32cm.

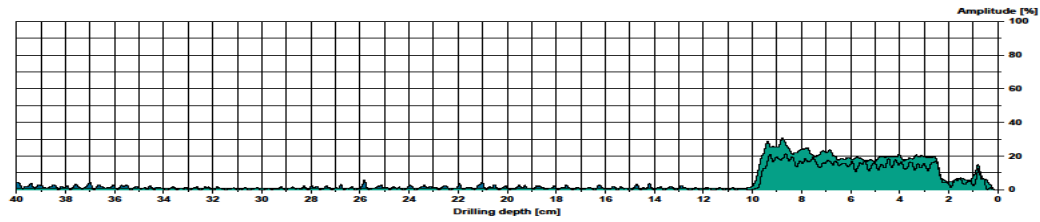
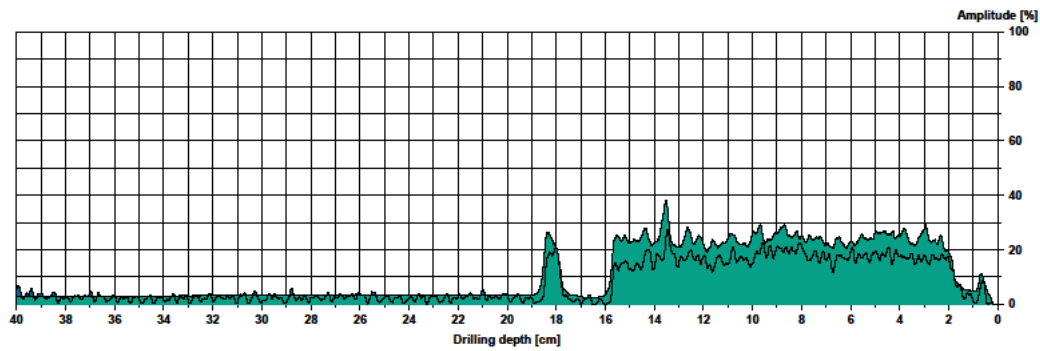
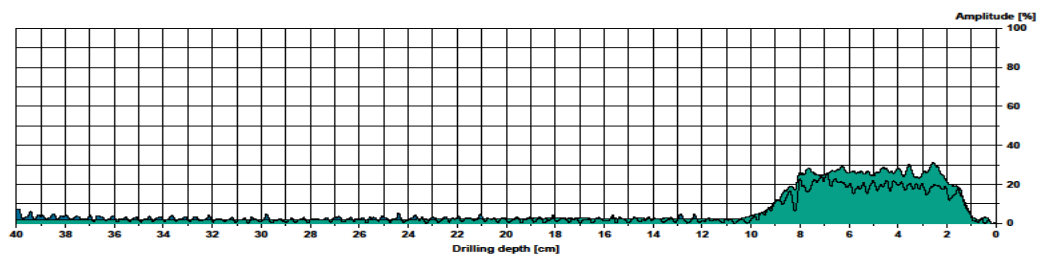
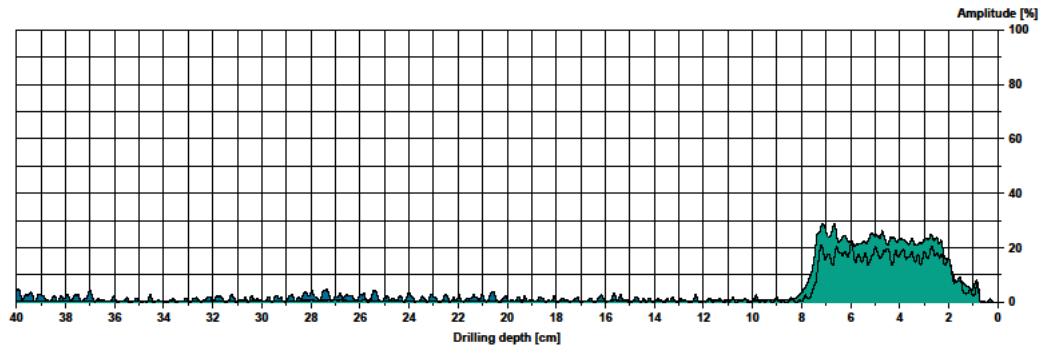
At ground level the measured residual walls are much reduced, ranging from 5cm to 14m which is likely to reduce wind load capacity.

Mattheck (1995) states that a full canopy tree with a residual wall less than 30% of it's radius can be vulnerable to failure. The thinnest residual wall measured was at ground level on the western side as being 18.5%. This will reduce the wind load capacity if the tree has a full crown.

The condition of the tree below ground is unknown and given that there may have been excavation in the rooting zone and the decay column widens towards the base and the lack of any pronounced buttressing, I don't have a high degree of confidence in the wind load capacity of the base of the tree.

Re-inspect annually.
