139 Hornsey Lane  
LONDON  
N6 5NH

**INSURANCE CLAIM**

**CONCERNING SUSPECTED SUBSIDENCE**

**ENGINEERING APPRAISAL REPORT**

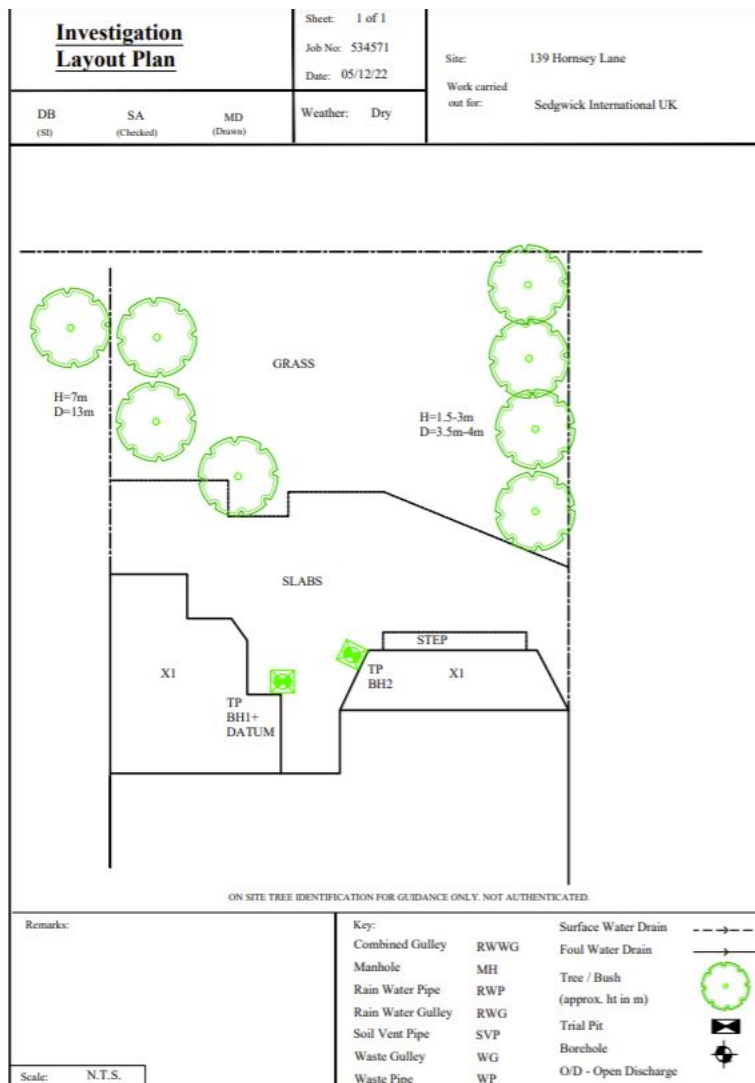
Trial pit and borehole (reference 1 below) were excavated to the rear left of the house. The foundations are 600mm thick brickwork at a depth of 900mm. The subsoil is firm orange, brown very silty clay. The clay is highly plastic. Roots were noted under the foundations but could not be identified.

Trial pit and borehole (reference 2 below) were excavated to the rear right of the house. The foundations are 420mm thick brickwork at a depth of 900mm. The subsoil is firm orange, brown very silty clay. The clay is highly plastic. Roots were noted under the foundations but could not be identified.

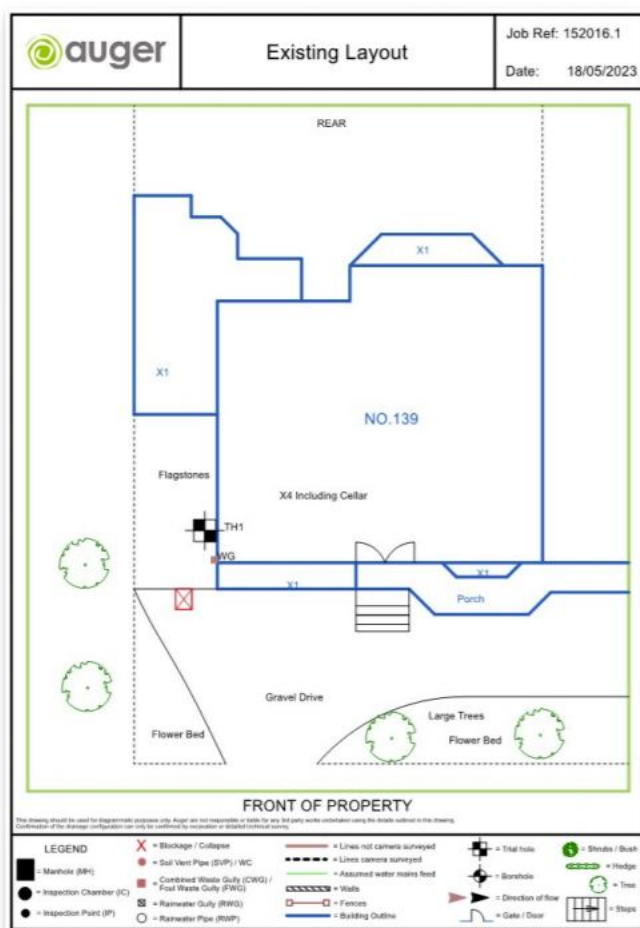
A trial pit and borehole (reference TH1 below) were excavated to the front left of the house. The underside of the foundations was too deep to determine by hand excavation. However, the foundations at this point will be at the underside of the cellar at approximately 2,100mm depth. The subsoil is dry very brown fine to medium gravelly silty clay. The clay is highly plastic. A heave analysis indicates that heave will not be an issue if the trees are felled. Beech roots were noted under the foundations to a depth of at least 3,000mm.

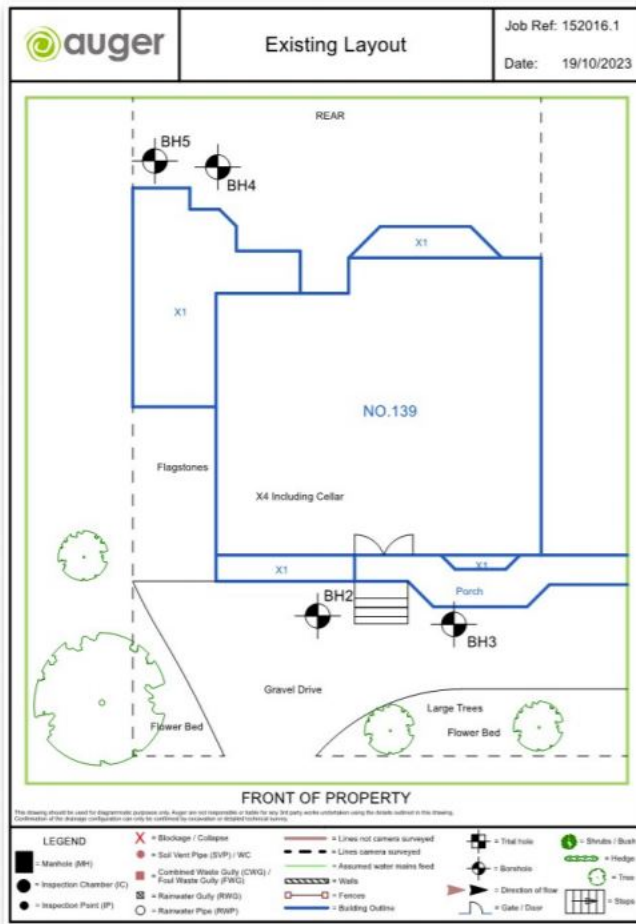
A further site investigation was completed by Auger on 5<sup>th</sup> October 2023. Boreholes were drilled in the locations shown on the plan below, next to the property. The subsoil was as previously identified. Roots were noted in the boreholes as shown below.

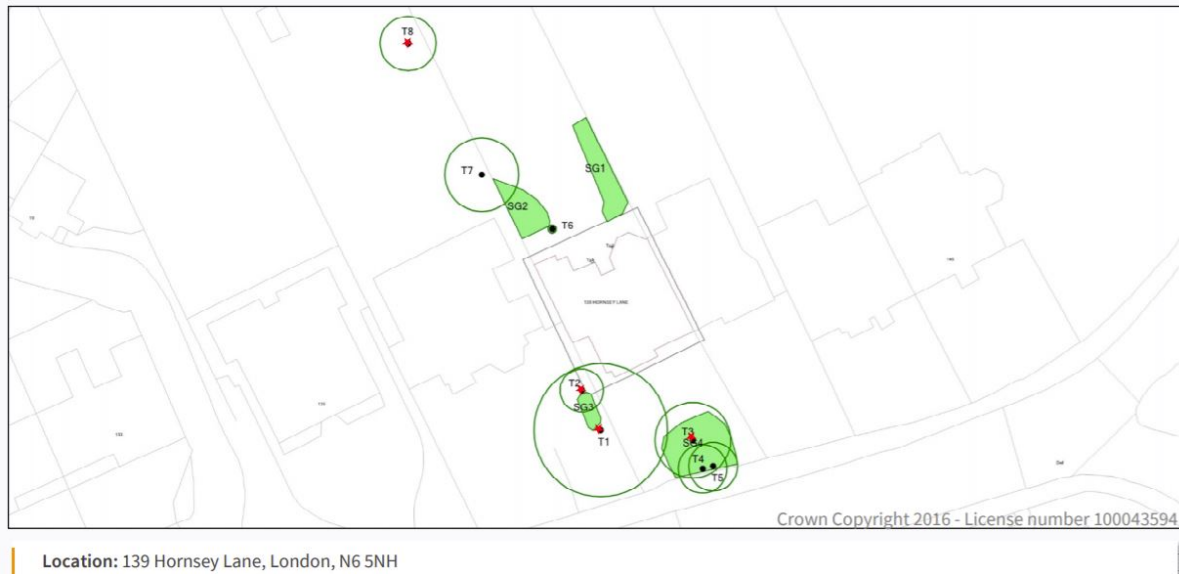
London Borough Of Haringey has confirmed that the implicated Beech T1, T2 and Poplar T8 vegetation are subject to a Tree Preservation Order. There are also Conservation Area controls.

PRI will make applications to fell the TPO protected trees when they have sufficient monitoring data. If approved, they will gain Conservation Area Consent. We will then liaise with the owners to fell the vegetation that is the cause of damage.

In the meantime, PRI will gain Conservation Area approval for the Insured's T3 oak, then arrange to fell if approved.
