Tower Surveys Associates

Section Inspection - 17/10/2023 - RE?

TSA-23-2537 Channing School for Girls CCTV Report\_303\_Issue01

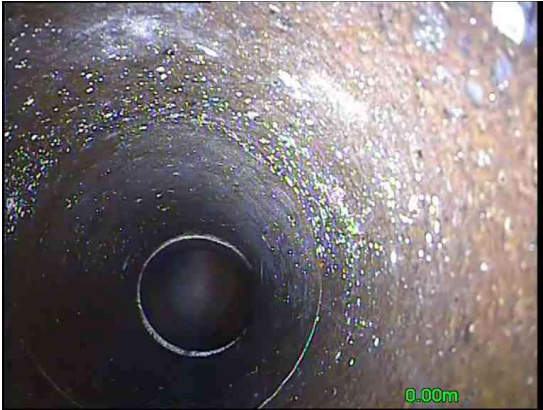
1, 00:00:03, 0.00 m  
Crack, circumferential from 3 o'clock to 9 o'clock

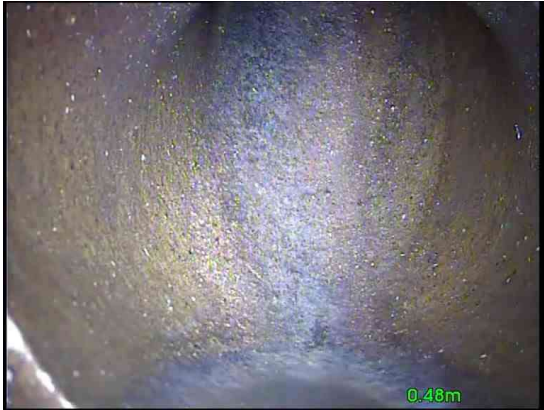
Survey abandoned: Unable to pass upward deviation

2, 00:00:43, 0.48 m  
Line deviates up

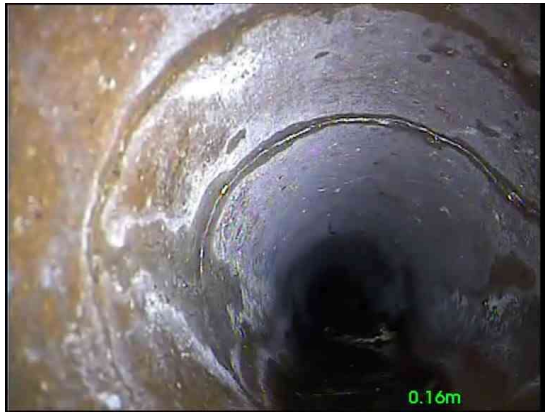
| | 0.16 | CC | | Crack, circumferential from 9 o'clock to 3 o'clock | 00:00:03 | 1 | 2 / 2 |

1, 00:00:03, 0.16 m  
Crack, circumferential from 9 o'clock to 3 o'clock

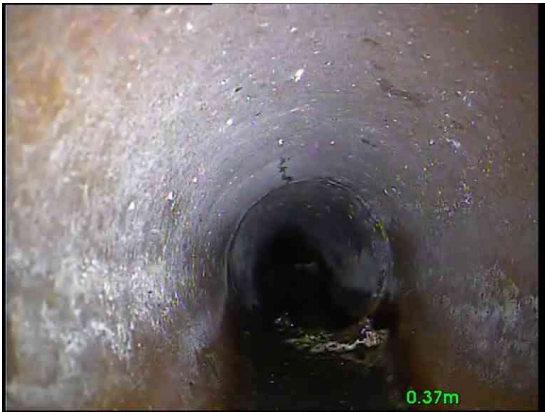
2, 00:00:05, 0.37 m  
Settled deposits, hard or compacted at joint, 10% cross-sectional area loss

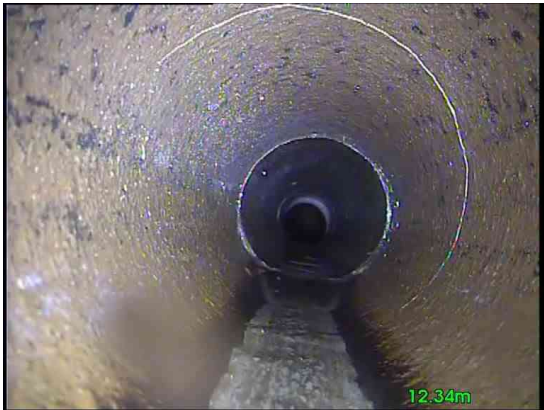
| | 12.34 | CC | | Crack, circumferential from 10 o'clock to 4 o'clock | 00:01:00 | 8 | 2 / 2 |

8, 00:01:00, 12.34 m  
Crack, circumferential from 10 o'clock to 4 o'clock

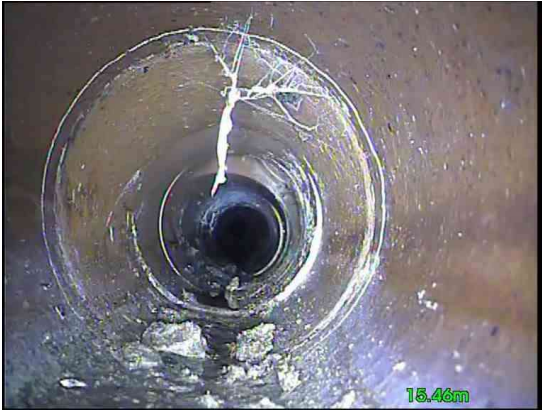
| | 15.46 | CCJ | Crack, circumferential at joint from 8 o'clock to 4 o'clock | 00:01:44 | 13 | 2 / 2 | |

13, 00:01:44, 15.46 m  
Crack, circumferential at joint from 8 o'clock to 4 o'clock

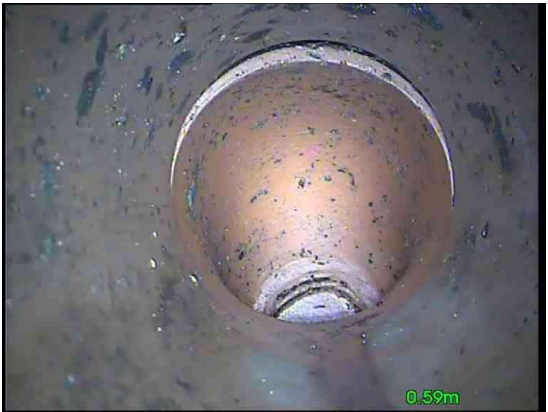
2, 00:00:09, 0.59 m  
Joint displaced, medium, At entry to RWP gully pot

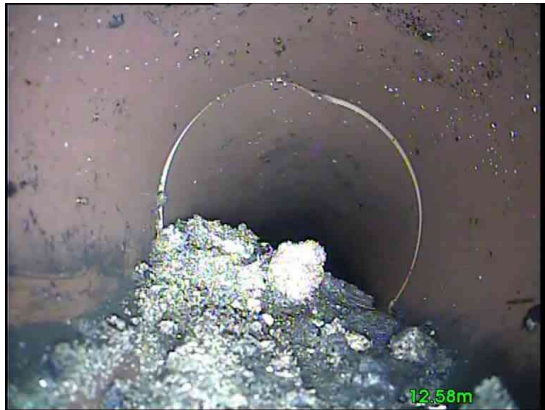
7, 00:00:50, 12.58 m  
Fracture, circumferential from 12 o'clock to 12 o'clock

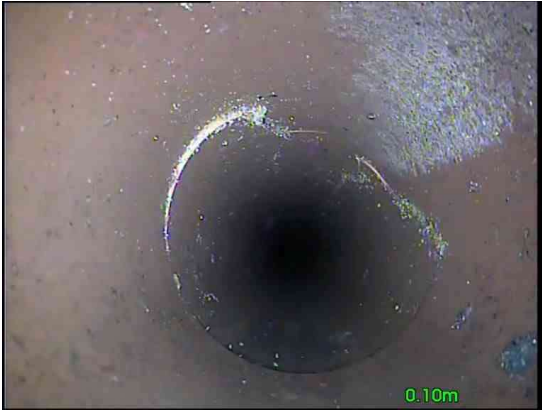
1, 00:00:03, 0.10 m  
Fracture, circumferential from 9 o'clock to 11 o'clock

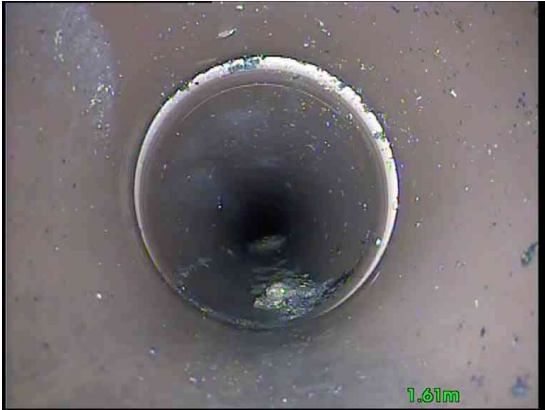
2, 00:00:10, 1.61 m  
Crack, circumferential at joint from 10 o'clock to 2 o'clock

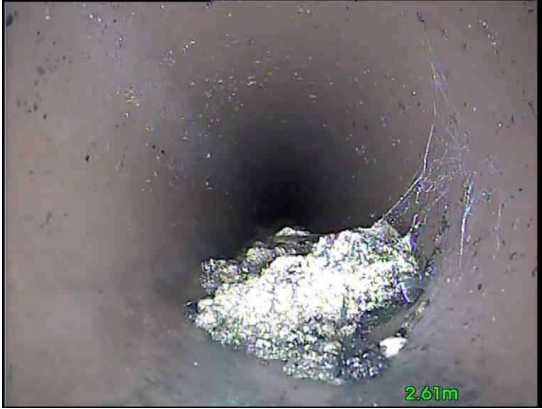
3, 00:00:14, 2.61 m  
Settled deposits, coarse, 20% cross-sectional area loss, start

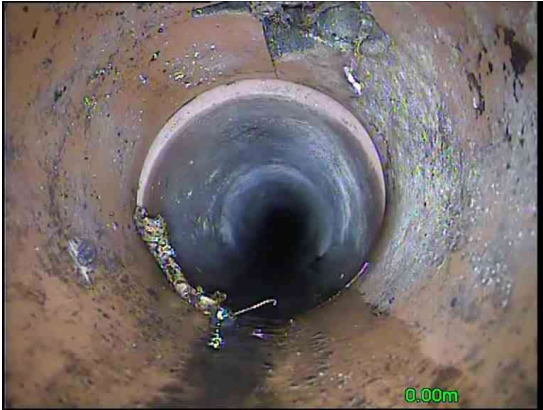
Broken pipe from 11 o'clock to 1 o'clock

1, 00:00:01, 0.00 m  
Broken pipe from 11 o'clock to 1 o'clock

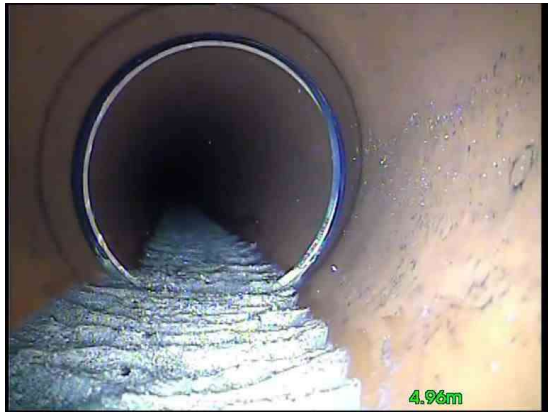
6, 00:00:27, 4.96 m  
Line deviates left

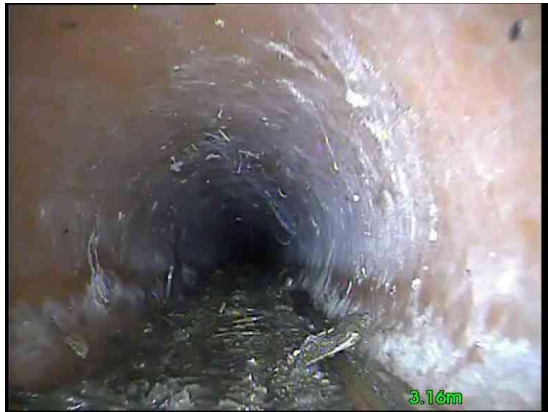
2, 00:00:14, 3.16 m  
Settled deposits, fine, 10% cross-sectional area loss, finish

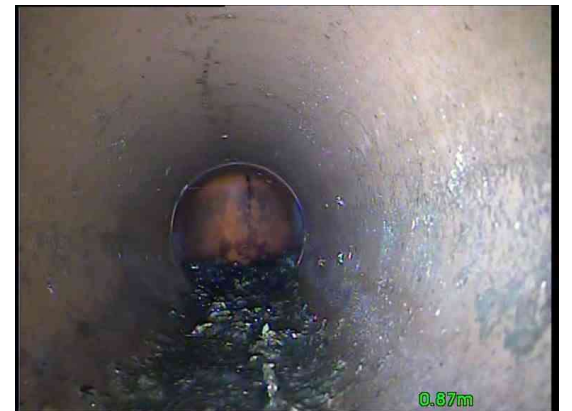
2, 00:00:06, 0.87 m  
Settled deposits, fine, 10% cross-sectional area loss
