## London Borough of Haringey

## Preliminary Flood Risk Assessment

**Channing School for Girls – Senior School**  
CCTV Condition Report

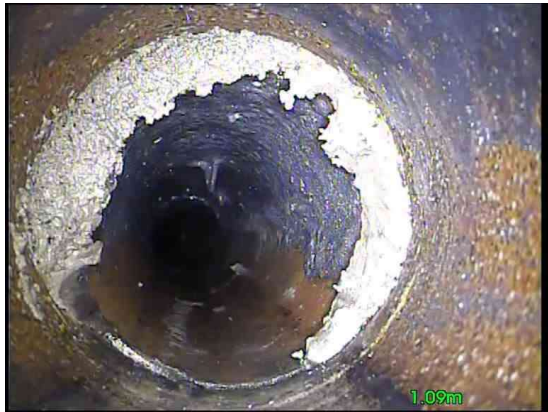
2, 00:00:11, 1.09 m  
Settled deposits, fine at joint, 10% cross-sectional area loss

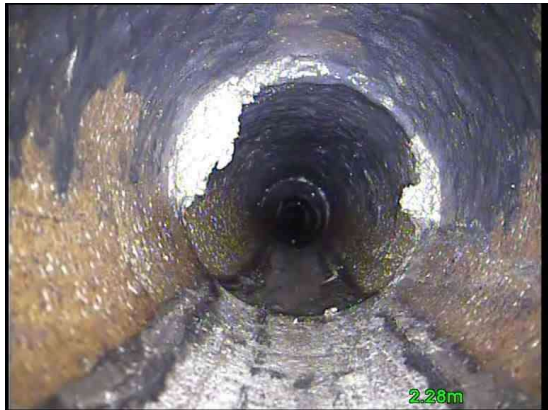
4, 00:00:20, 2.28 m  
Settled deposits, fine at joint, 5% cross-sectional area loss

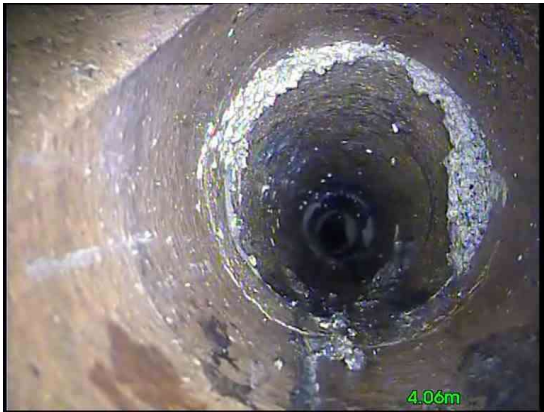
6, 00:00:35, 4.06 m  
Settled deposits, fine at joint, 5% cross-sectional area loss

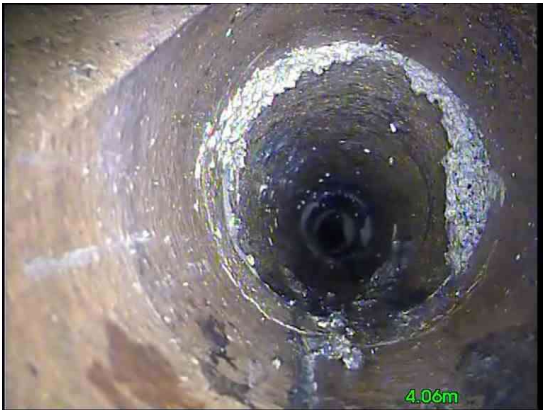
7, 00:00:35, 4.06 m  
Crack, circumferential at joint from 4 o'clock to 8 o'clock

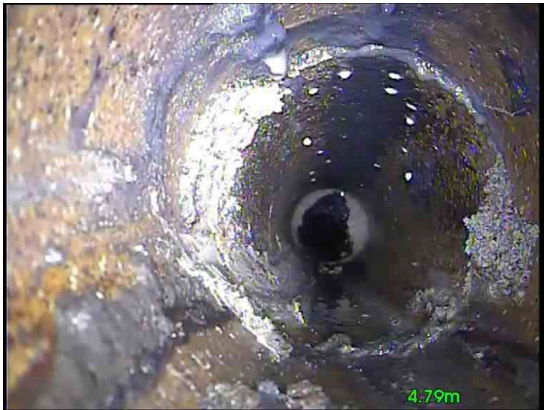
8, 00:00:39, 4.79 m  
Settled deposits, fine at joint, 5% cross-sectional area loss

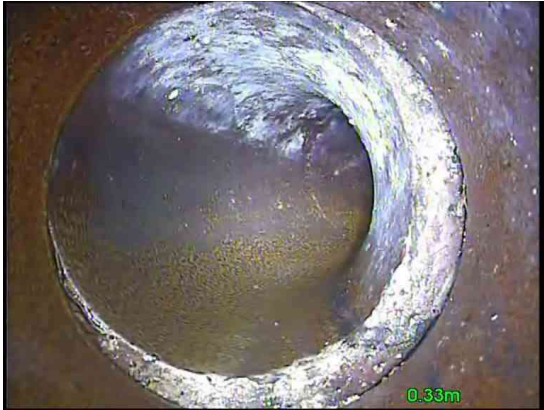
2, 00:00:08, 0.33 m  
Joint displaced, medium

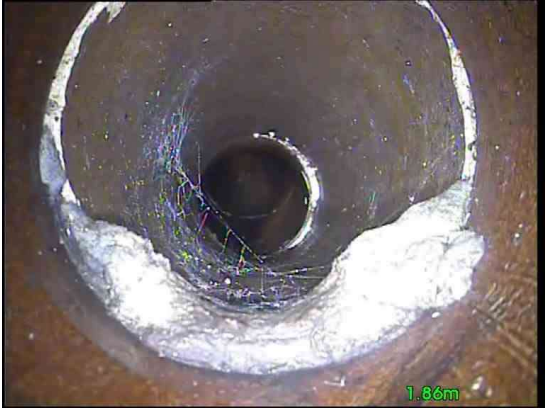
3, 00:00:23, 1.86 m  
Settled deposits, hard or compacted, 10% cross-sectional area loss

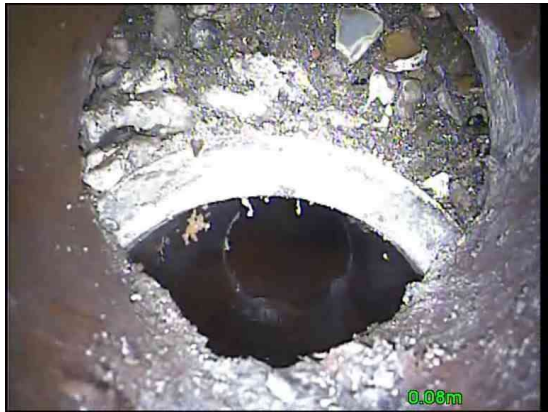
1, 00:00:05, 0.08 m  
Joint displaced, large

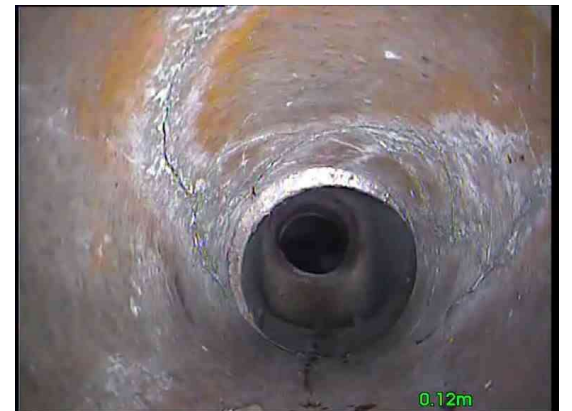
| Structural Defects | | | |
|---|---|---|---|
| 19 | Gully | 3 | Cracks, multiple at joint from 8 o'clock to 2 o'clock |

2, 00:00:03, 0.12 m  
Cracks, multiple at joint from 8 o'clock to 2 o'clock

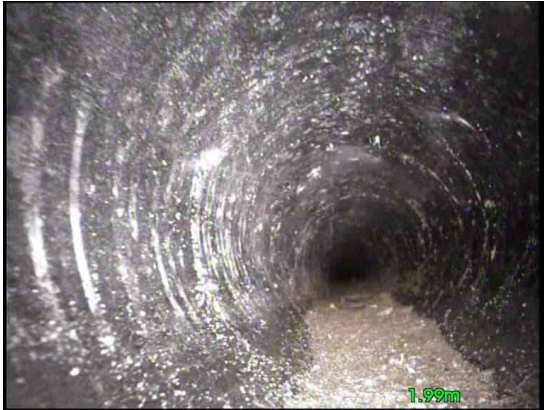
2, 00:00:13, 1.99 m  
Settled deposits, fine, 10% cross-sectional area loss, start

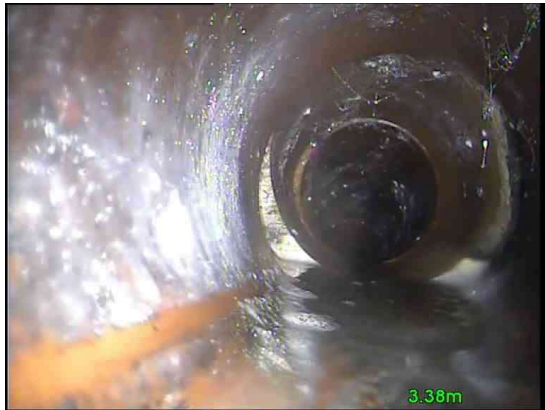
3, 00:00:51, 3.38 m  
Joint displaced, large

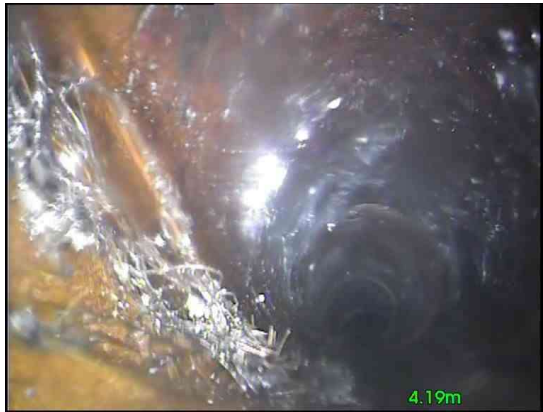
5, 00:02:27, 4.19 m  
Roots, fine

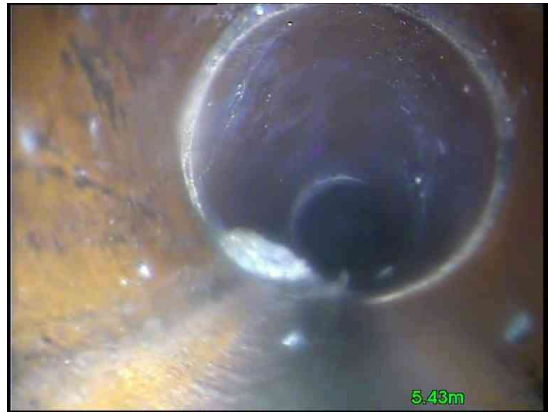
6, 00:02:48, 5.43 m  
Settled deposits, hard or compacted at joint, 5% cross-sectional area loss

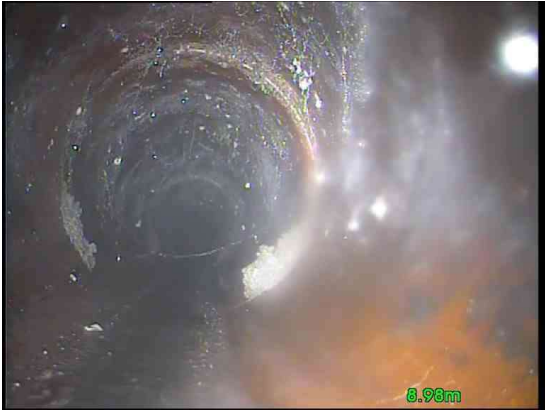
10, 00:05:18, 8.98 m  
Settled deposits, fine at joint, 5% cross-sectional area loss
