**STRUCTURAL CONDITION REPORT**

Vacant Station Building  
Highgate Station  
Priory Gardens  
Highgate  
London

| Job No: | K23127 |
| Date: | 8 December 2023 |

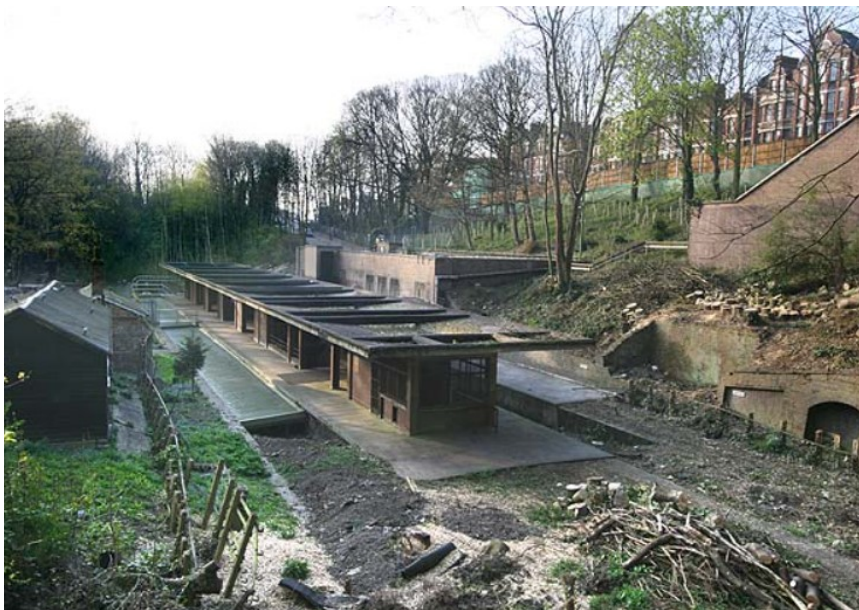
Picture 2 – Highgate Station looking East, circa 2007. The track beds are covered in corrugated plastic to mitigate issues with the Northern Line below. The original 1867 building in question can be seen on the left-hand side

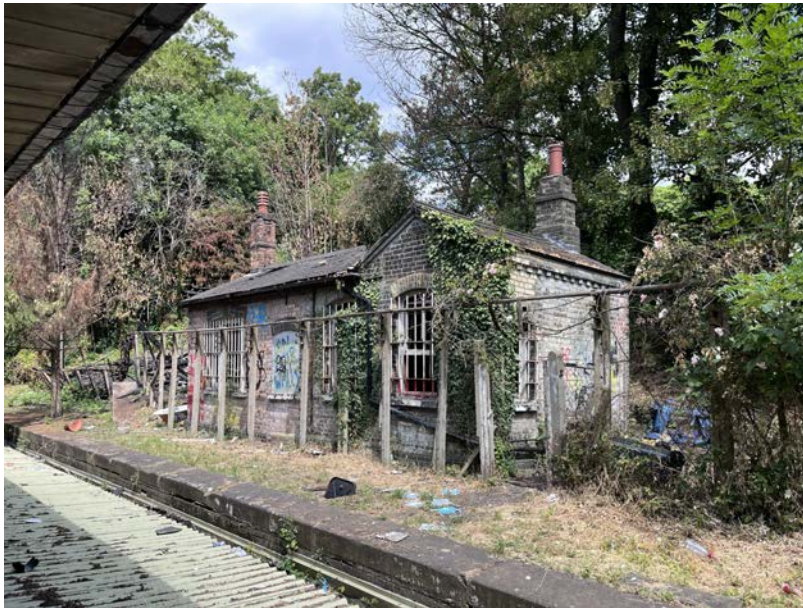
Photo 1 – Front Elevation facing redundant track

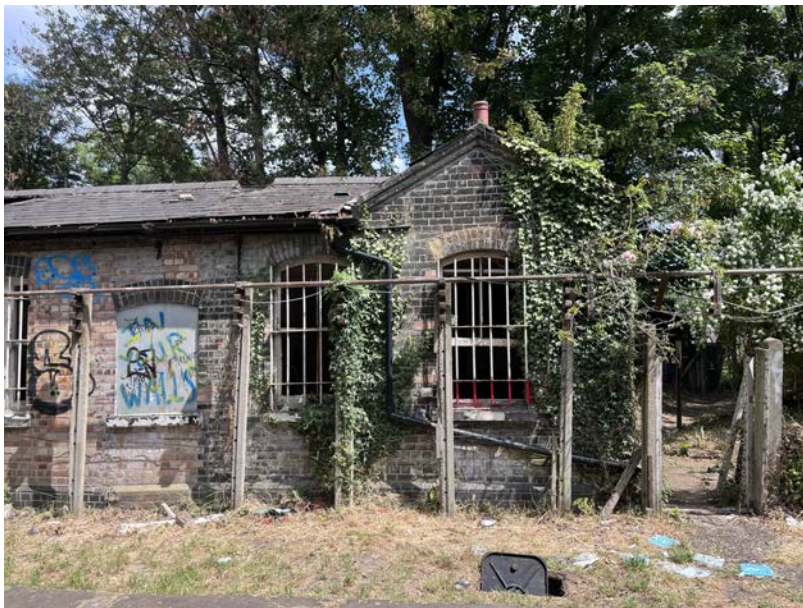
Photo 2 – Front Elevation RHS

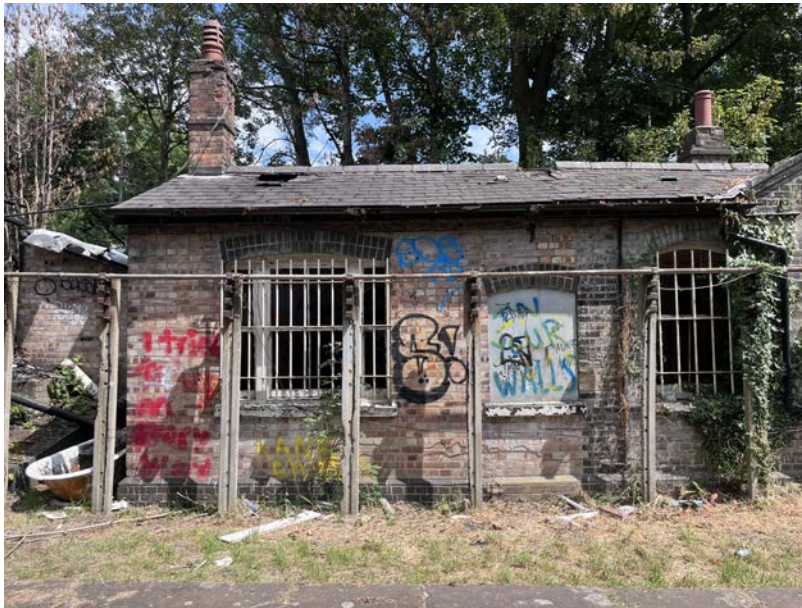
Photo 3 – Front Elevation LHS (SW)

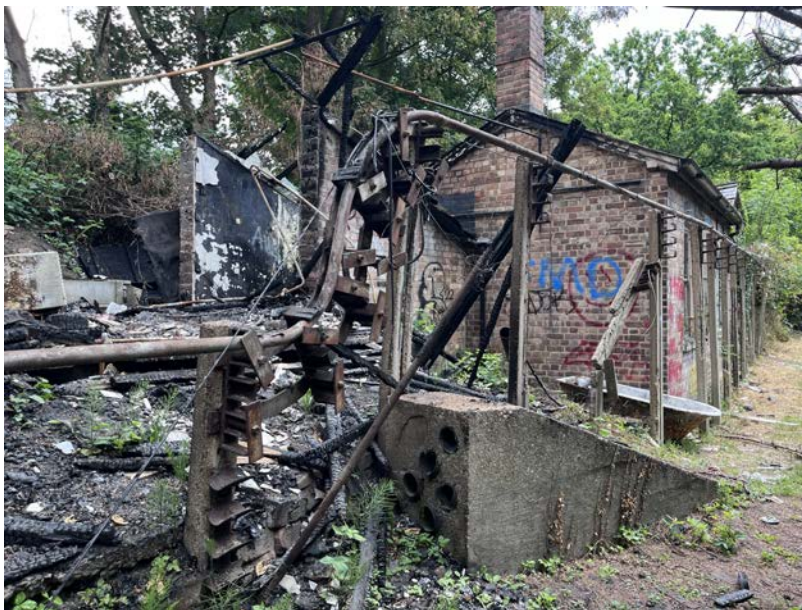
- 3.1. The original timber framed building, as previously noted, was completely razed during our site inspection and no further comments can therefore be made at this stage.

Photo 4 – Side (NW) Elevation showing area of razed Timber Building

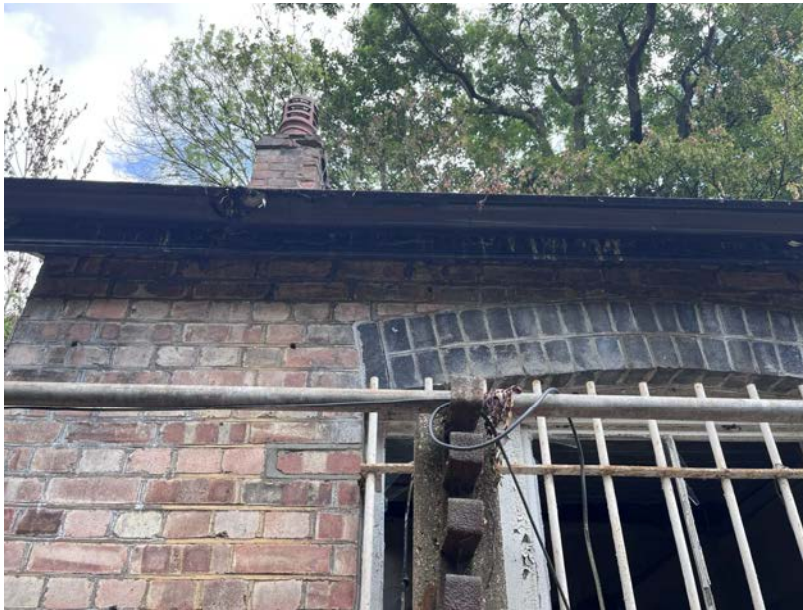
- 5.1. Generally, the remaining property is in a poor structural condition, both internally and externally
- 5.2. The movement to the existing masonry, where noted, is likely to be historical and this issue can be seen from the various areas of stepped cracking in the existing masonry, clear rebuilding of elements of masonry panels, movement across the tops of most windows and the inclusion of previously installed tell-tales.

Photo 5 – Front Elevation movement over top of arched window

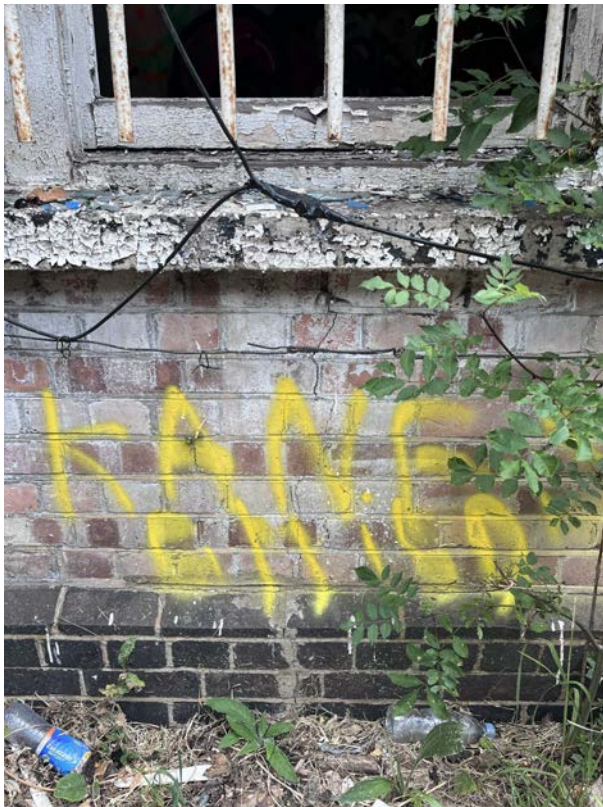
Photo 6 - Front Elevation movement below arched window

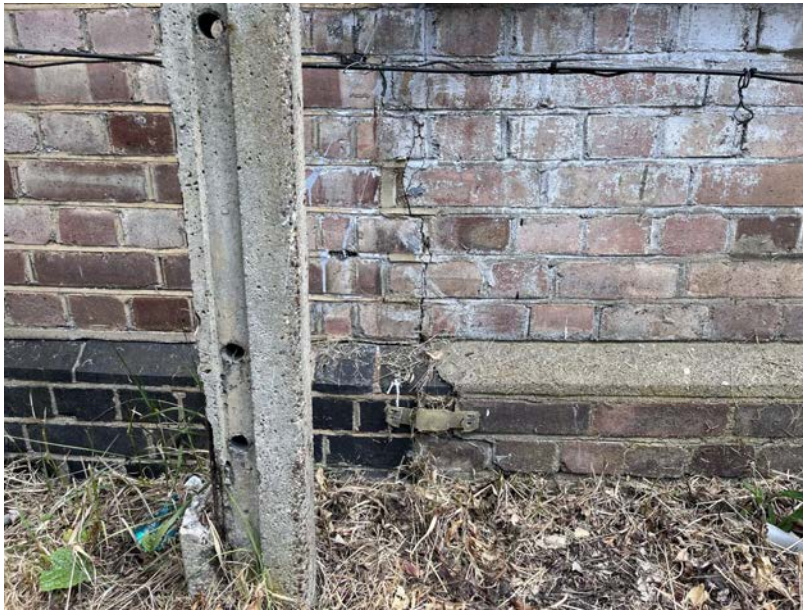
- 3.4. A visual inspection of the vacant station building was carried out externally, with movement apparent to the existing and retained masonry walls; evidentially, this appeared to be not only because of the effects from the fire, but also historical foundation movement and this was noted with regards to historical repair work and monitoring points noted at various locations, which could suggest that previous subsidence had, or has, occurred over time.

Photo 7 – Front Elevation Subsidence crack – note previously installed tell-tale monitoring

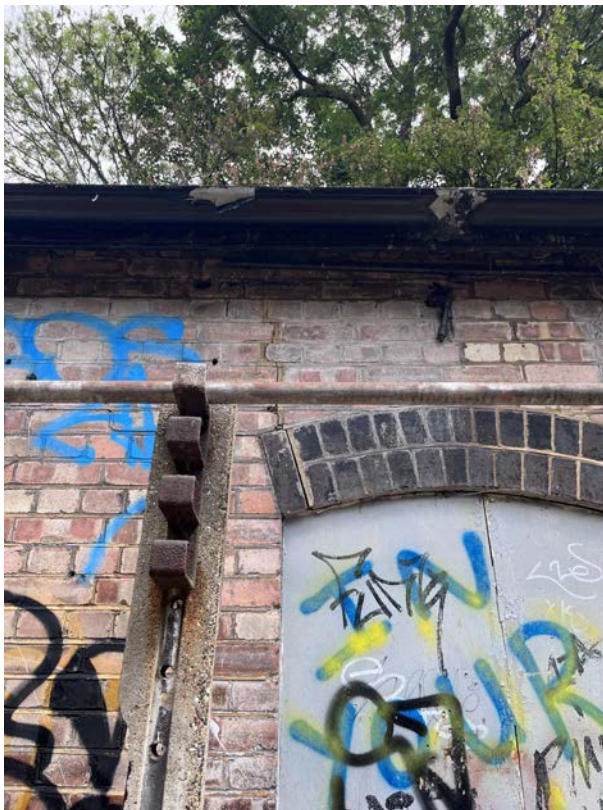
Photo 8 - Front Elevation movement over top of arched window

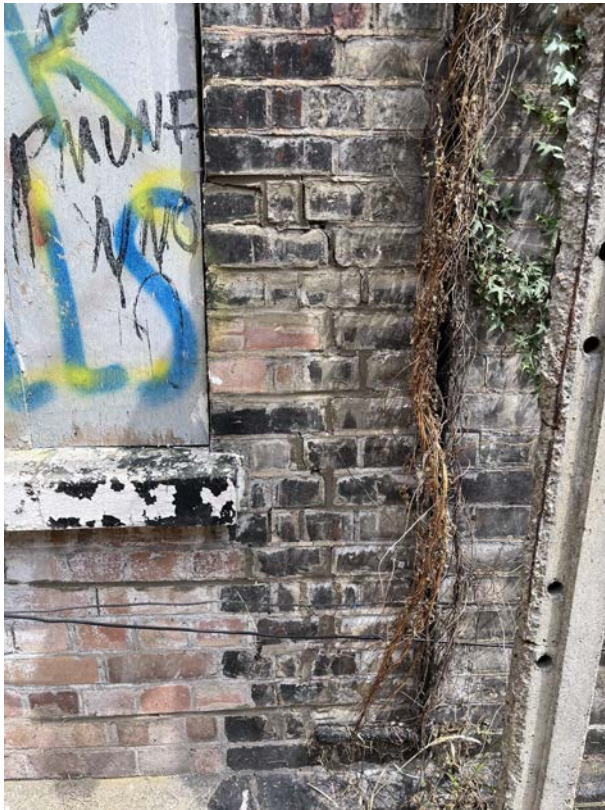
Photo 9 - Front Elevation movement and repointing to RHS of window

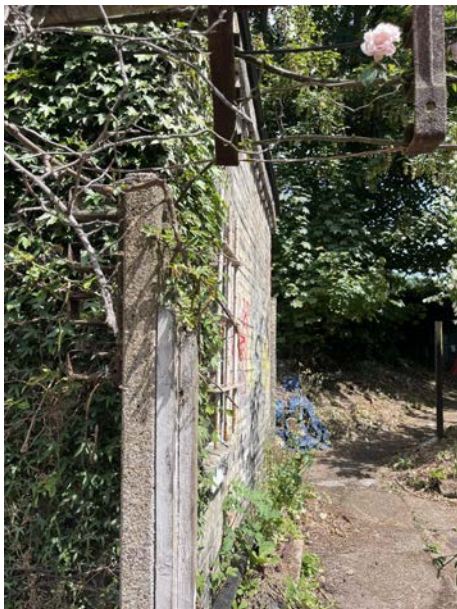
Photo 10 – Side Elevation (SE) – out of plumb wall

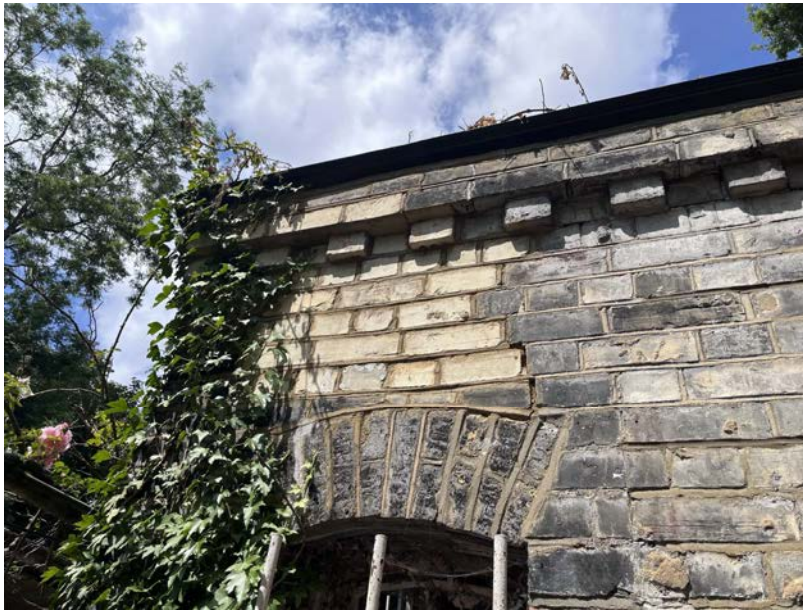
Photo 11 - Side Elevation (SE) movement and rebuilding across top of arched window (note movement still occurring)

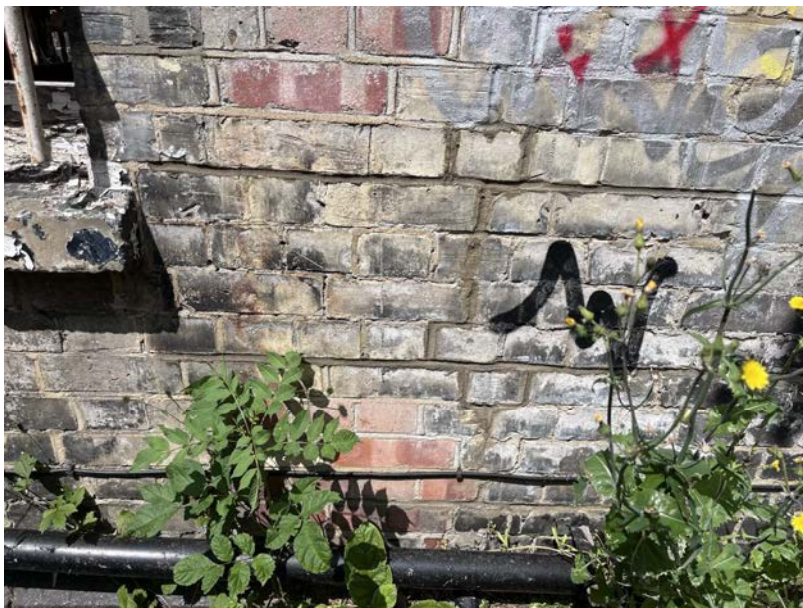
Photo 12 - Side Elevation (SE) movement and repointing at side of arched window

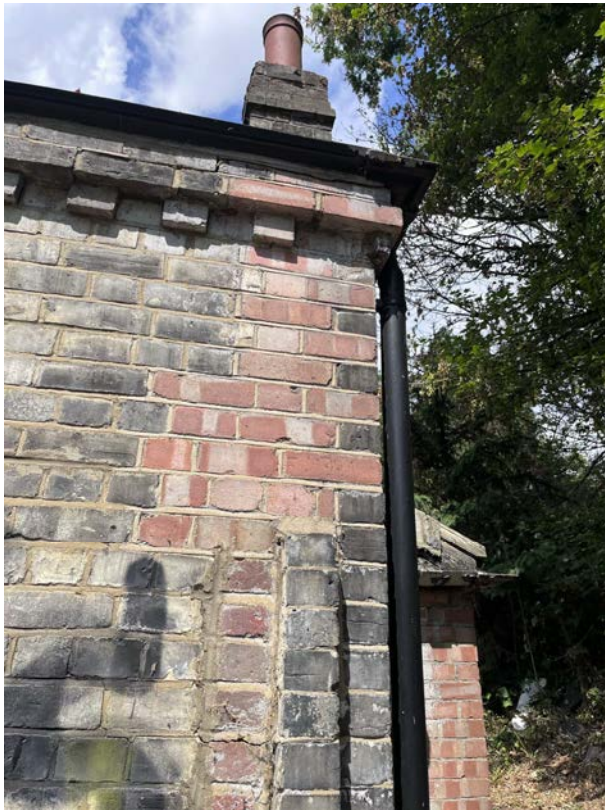
Photo 13 - Side Elevation (SE) showing rebuilt structure at corner with Rear

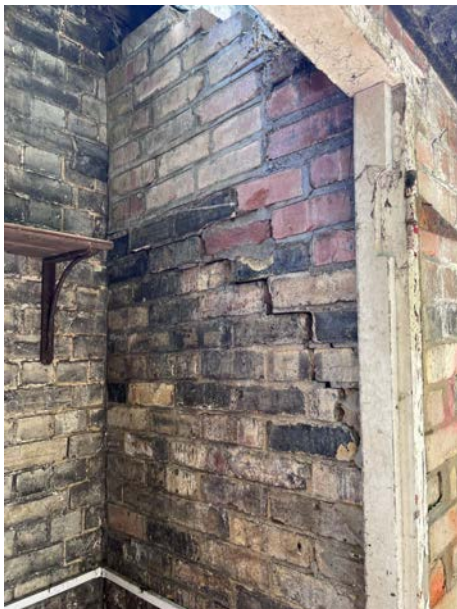
Photo 14 – Rear (NE) Elevation lean-to buttressing wall showing stepped cracking

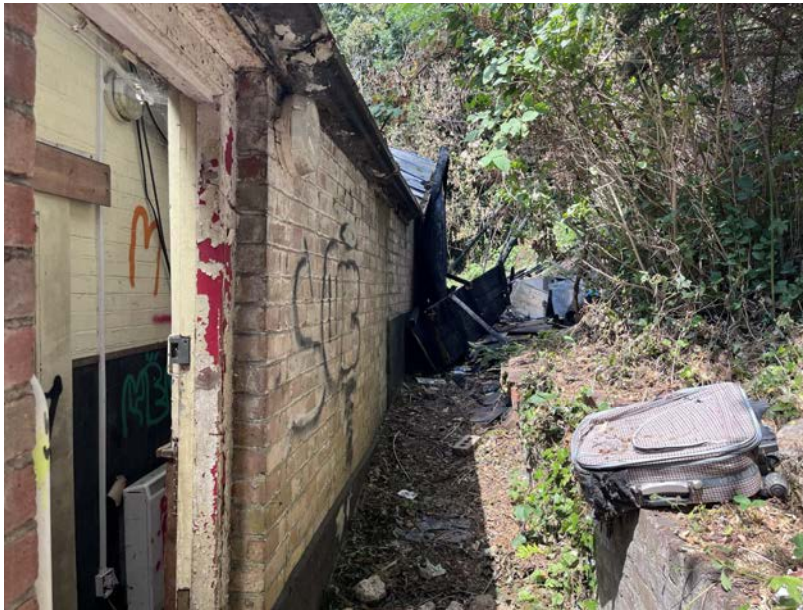
Photo 15 - Rear (NE) Elevation leading to remains of razed timber building

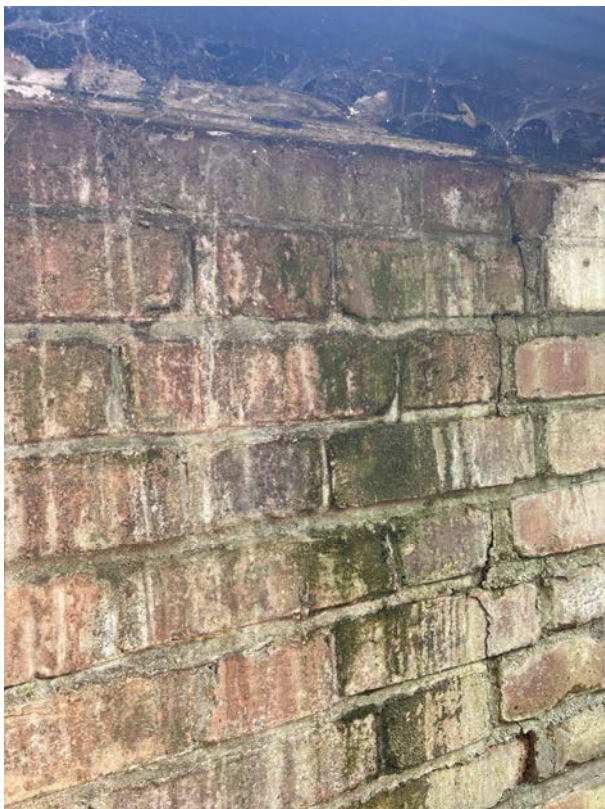
- 5.3. Fire damage is apparent to walls and ceilings throughout, with cracking evident to load bearing walls, in addition to that previously stated.
- 5.4. Movement appears to have occurred at the eaves positions in some locations, which would imply some deflection of the roof structure due to failure because of the fire and associated horizontal spread affecting the top of the existing walls.

Photo 16 - Rear (NE) Elevation showing movement and cracking at eaves

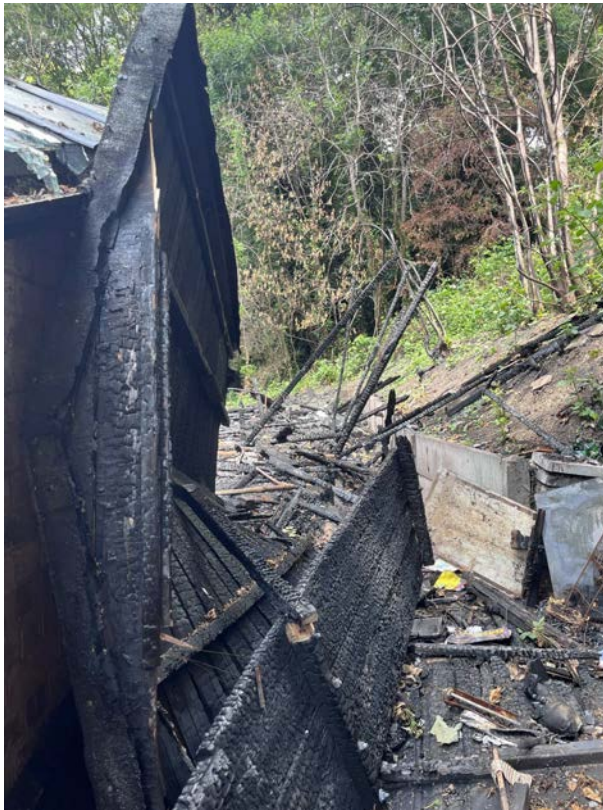
- 3.3. The precast concrete retaining wall structure, located to the rear of the original timber framed building, was inspected as far as practically possible at the time, and appeared to still be robust in its construction.

Photo 17 – Rear Elevation showing remains of razed timber building – note PC retaining structure supporting raised bank to public footpath

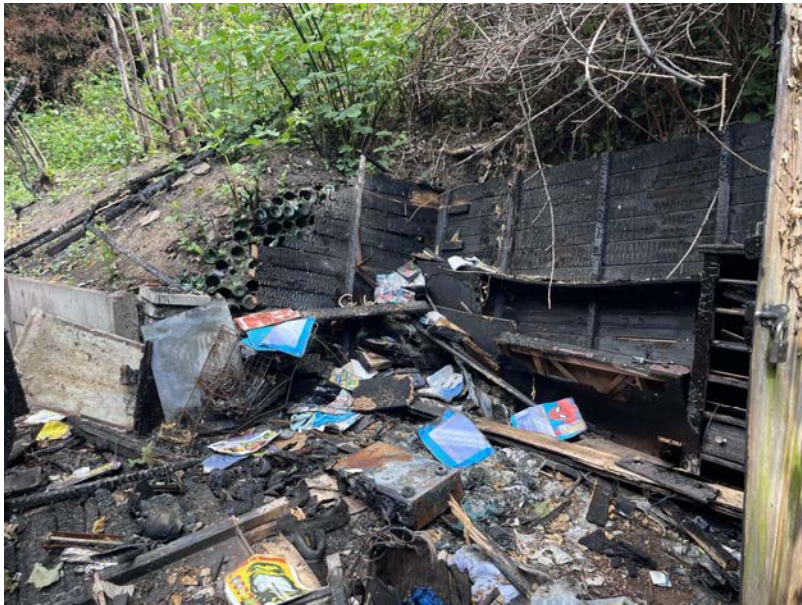
Photo 18 - Rear Elevation showing remains of razed timber building

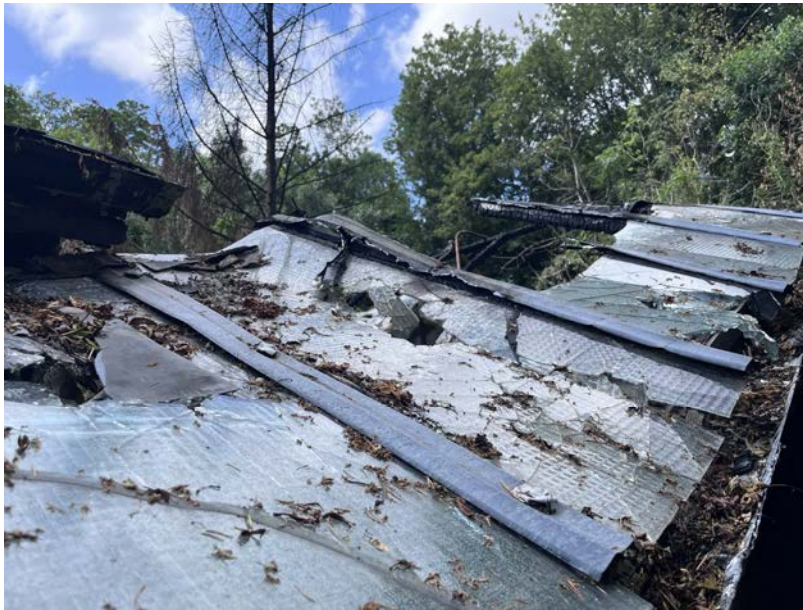
Photo 19 - Rear Elevation lean-to roof in poor condition

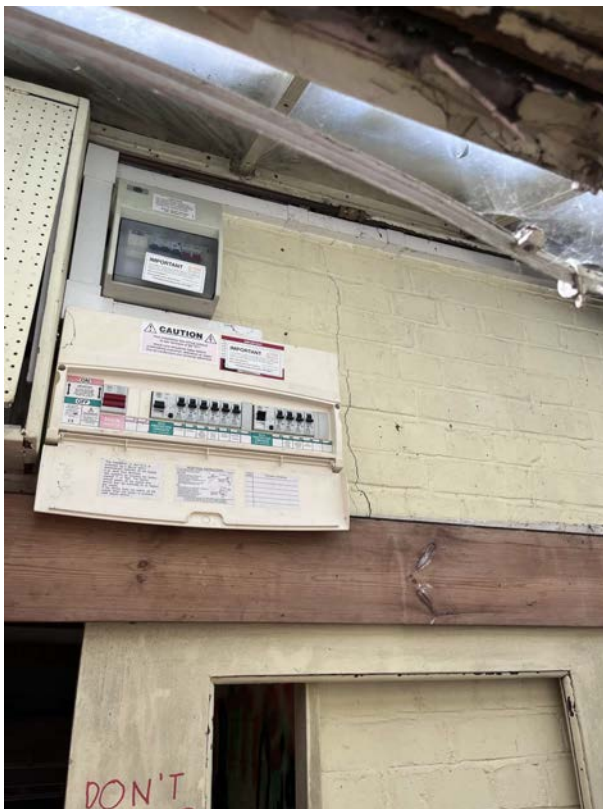
Photo 20 – Internal load bearing wall taken from internal walkway

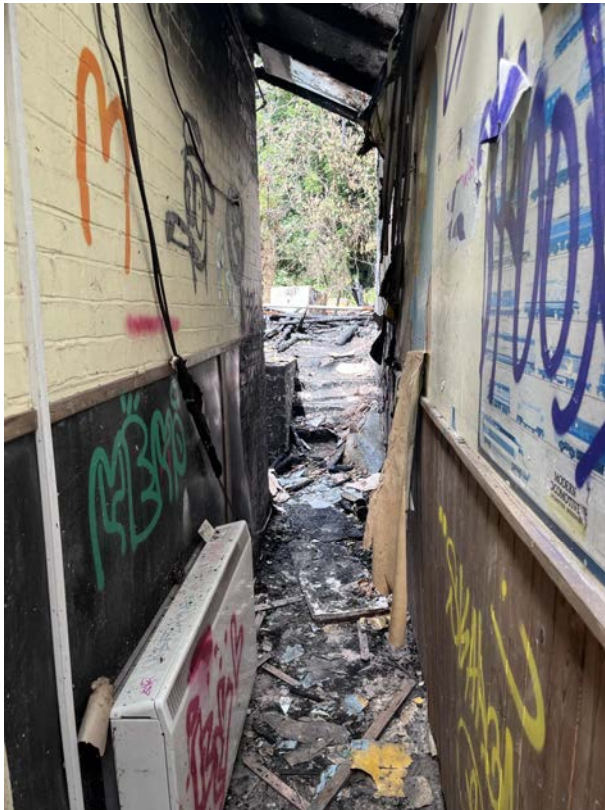
Photo 21 – Internal lean-to walkway to rear/remains of razed timber building

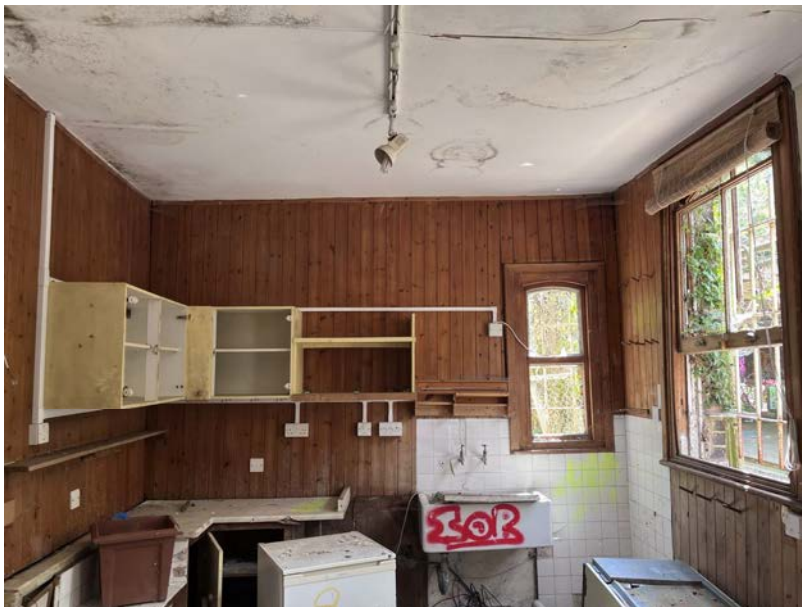
Photo 22 – Internal kitchen area

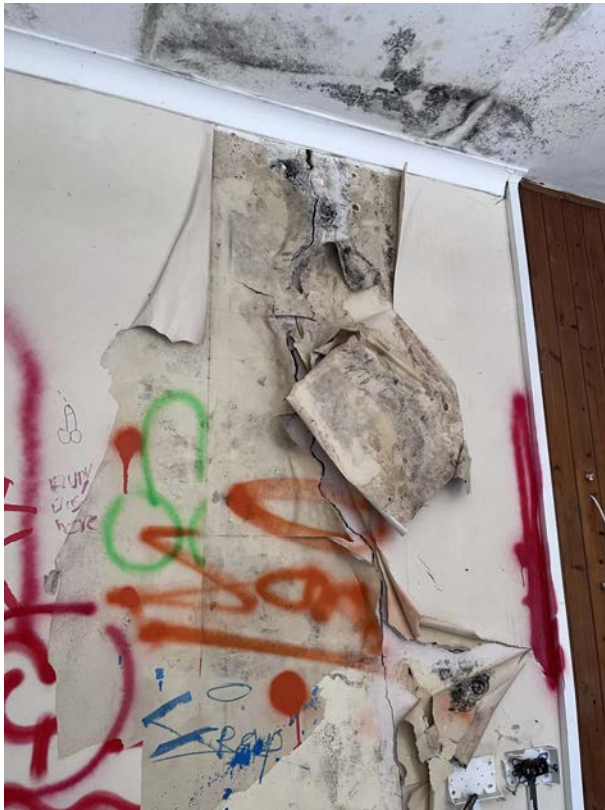
- 4.1. At the rear entrance area, a ground bearing slab was noted, however internally, there appears to be a raised timber structure to most of the building.
- 4.2. The kitchen area appeared to have been effected at both the walls and ceiling, with extensive vertical cracks noted to the rear load bearing wall next to the entrance; the remaining walls were clad in timber boarding, with the structure not visible at the time of the inspection and cracking to the ceiling boards noted above. It should be reiterated that this rear wall is the load bearing element for the existing roof, of which spans front to rear.
- 4.3. Within the remaining room, the ceiling consisted of T&G boards, which had partially collapsed, exposing what appeared to be a close couple roof structure above, with both vertical and horizontal cracking noted to internal walls within this room also.

Photo 23 – Internal kitchen area showing large vertical crack to load bearing wall

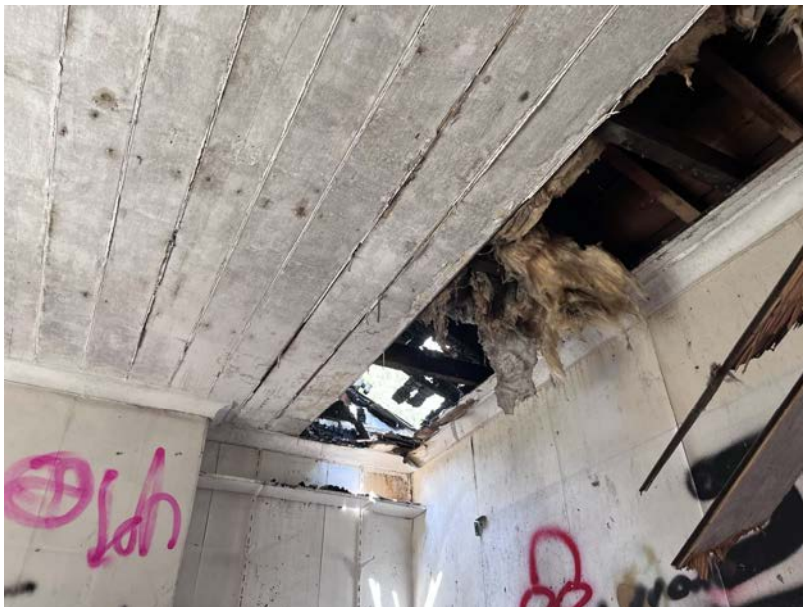
Photo 24 – Internal room off kitchen area showing damage to existing cut roof members

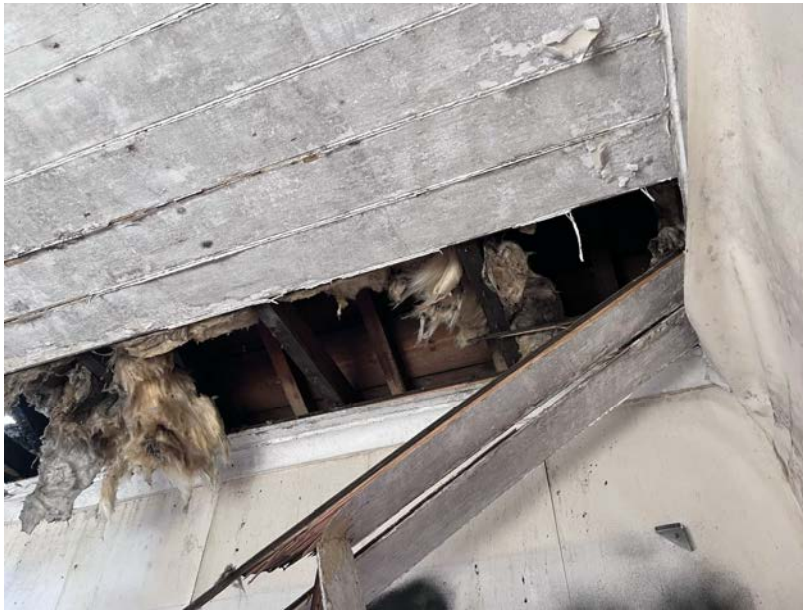
Photo 25 - Internal room off kitchen area showing damage to existing cut roof members

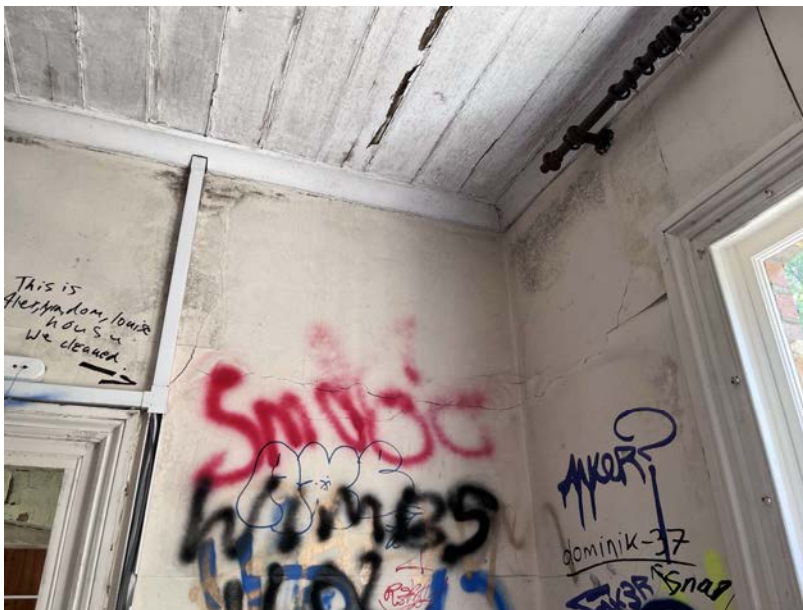
Photo 26 - Internal room off kitchen area showing vertical and horizontal cracking of wall/s

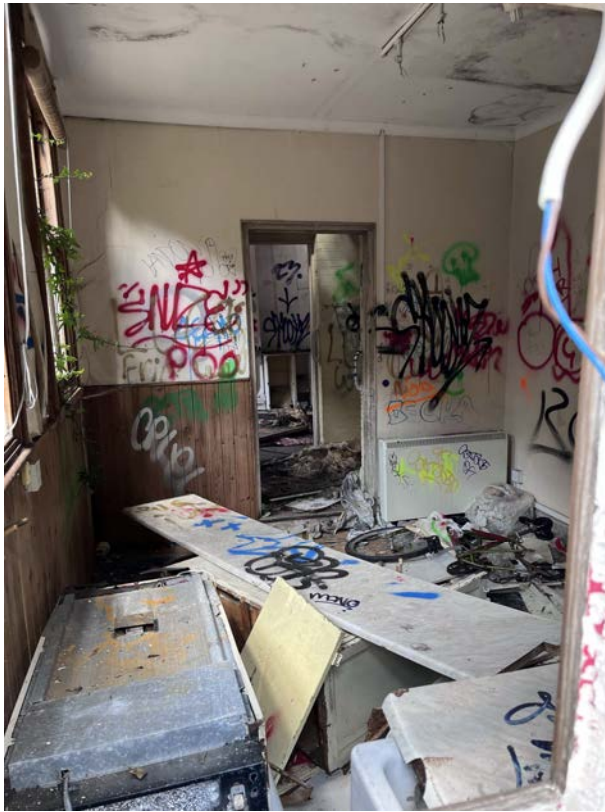
Photo 27 – Kitchen area

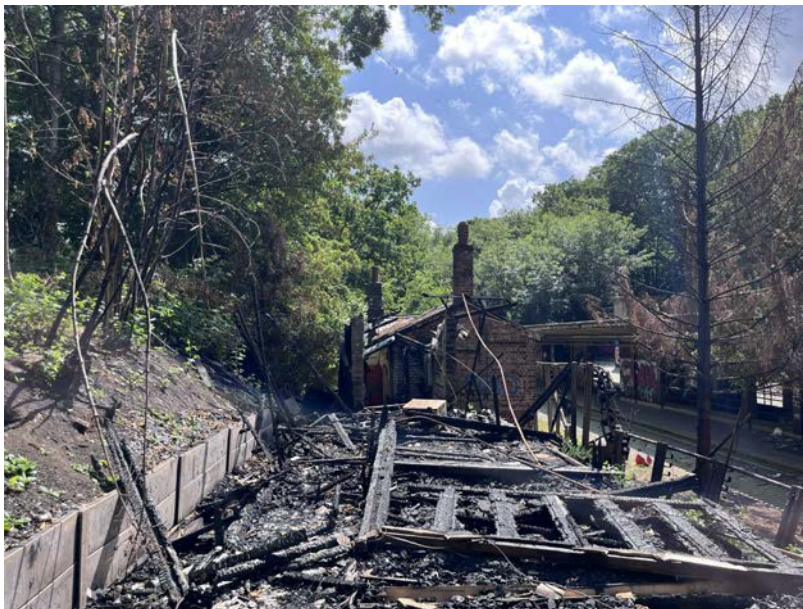
Photo 28 – Rear Elevation showing remains of razed timber building – note PC retaining structure supporting raised bank to public footpath
