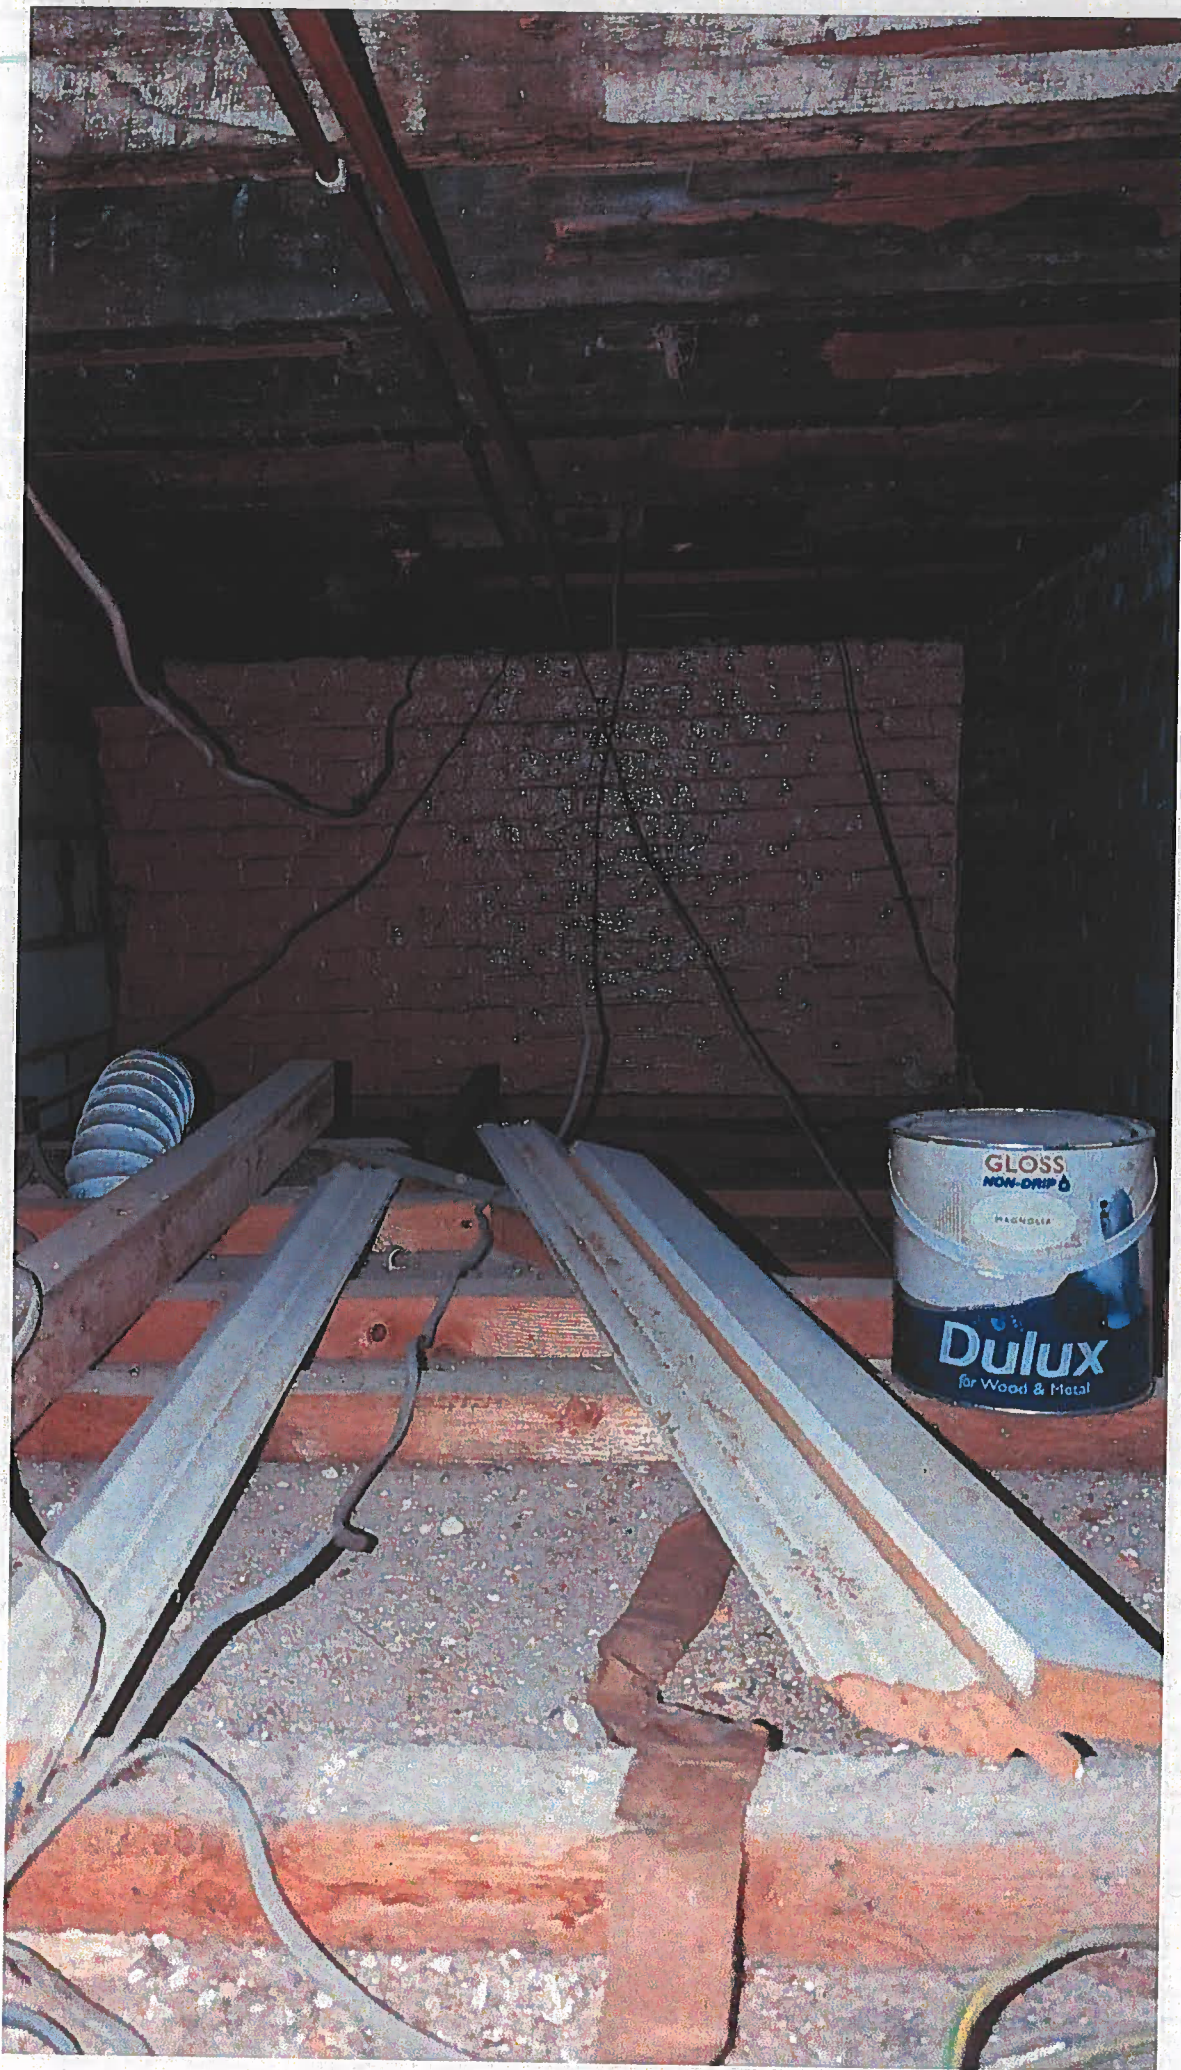
CALCULATED BY T. J. W. ABOVE BATHROOM.

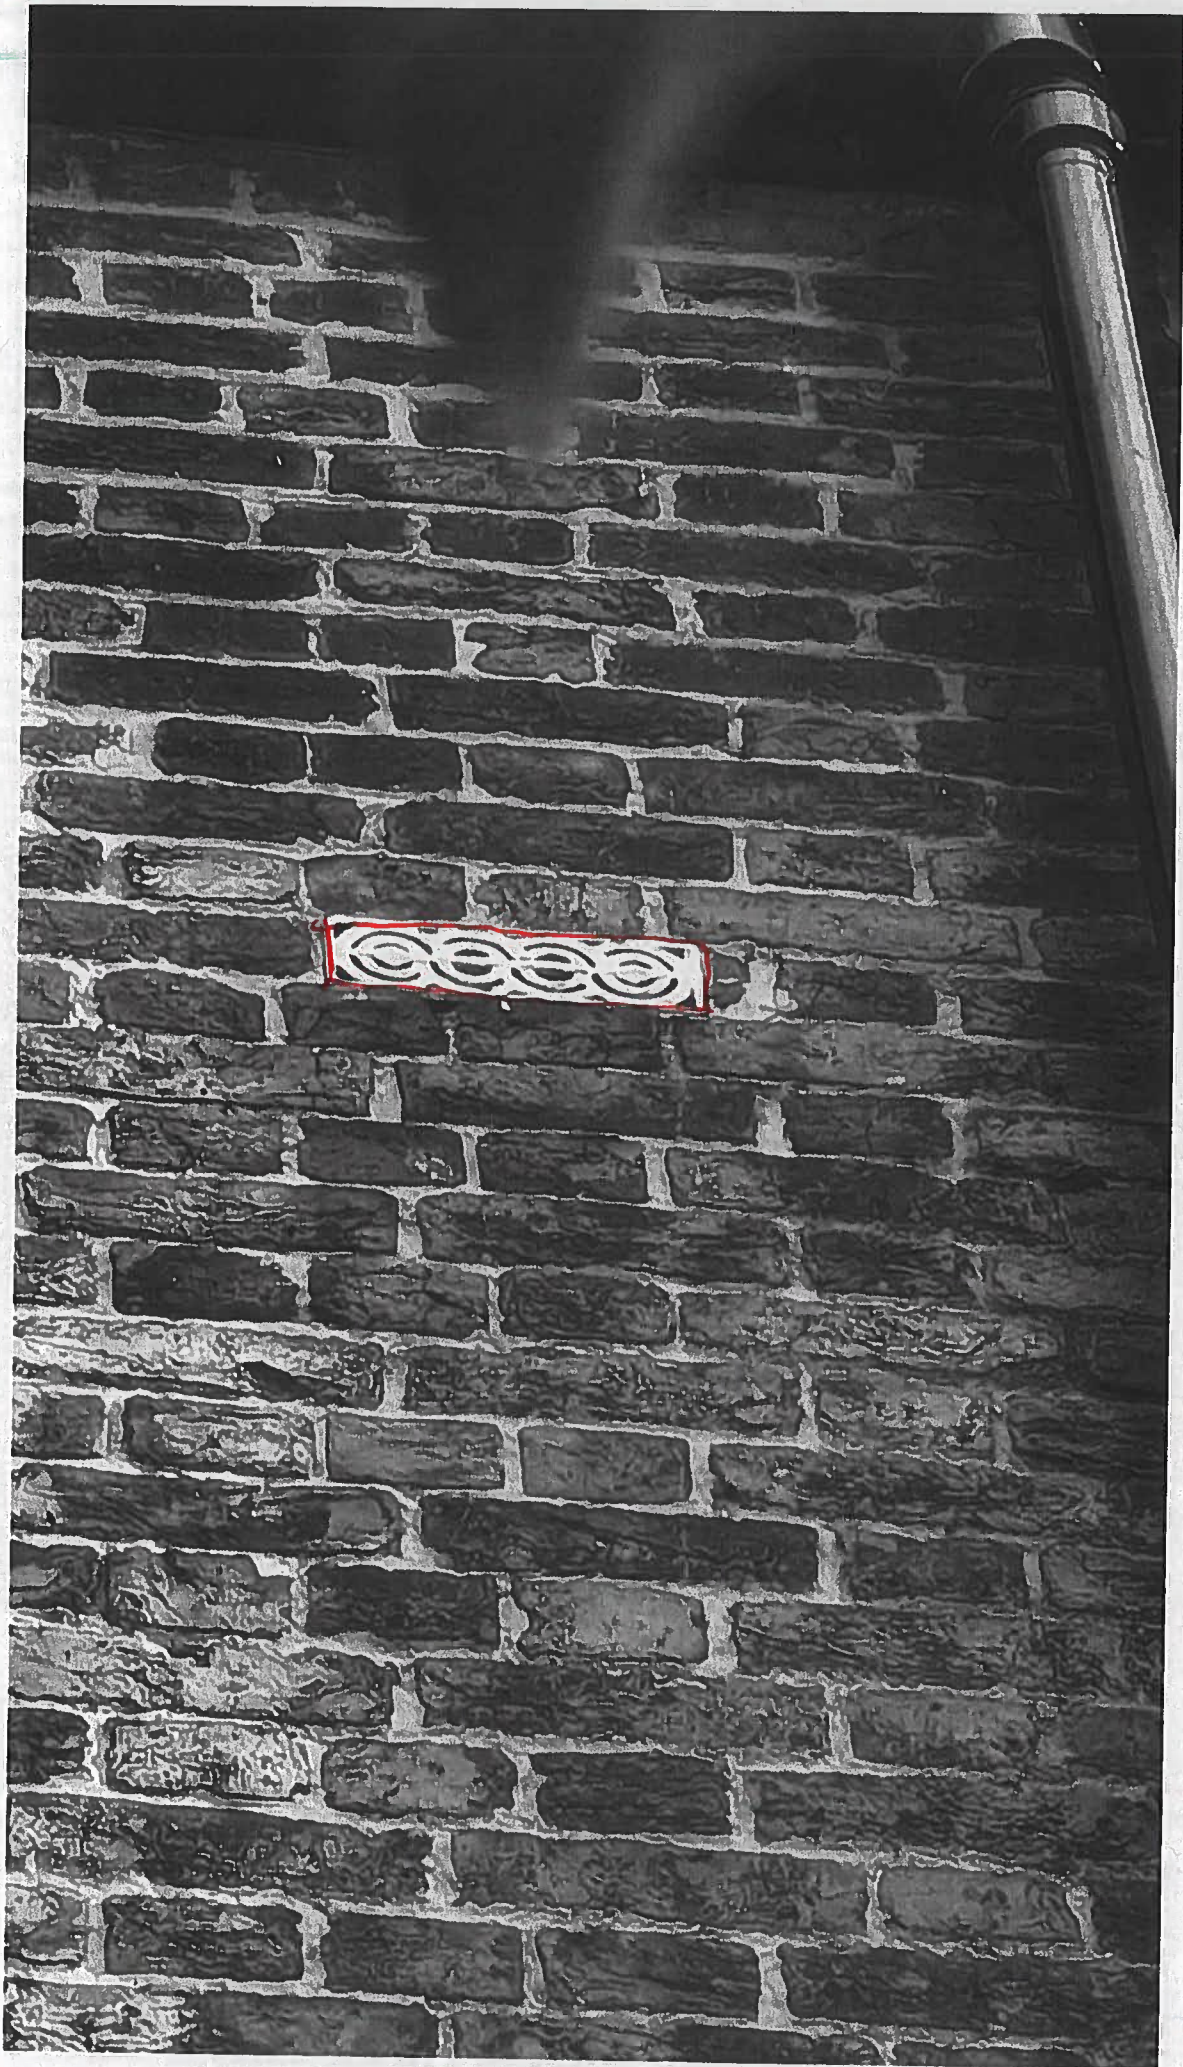
OTHER THIS MASONRY STRUCTURE IS EXISTING.  
EXISTING.

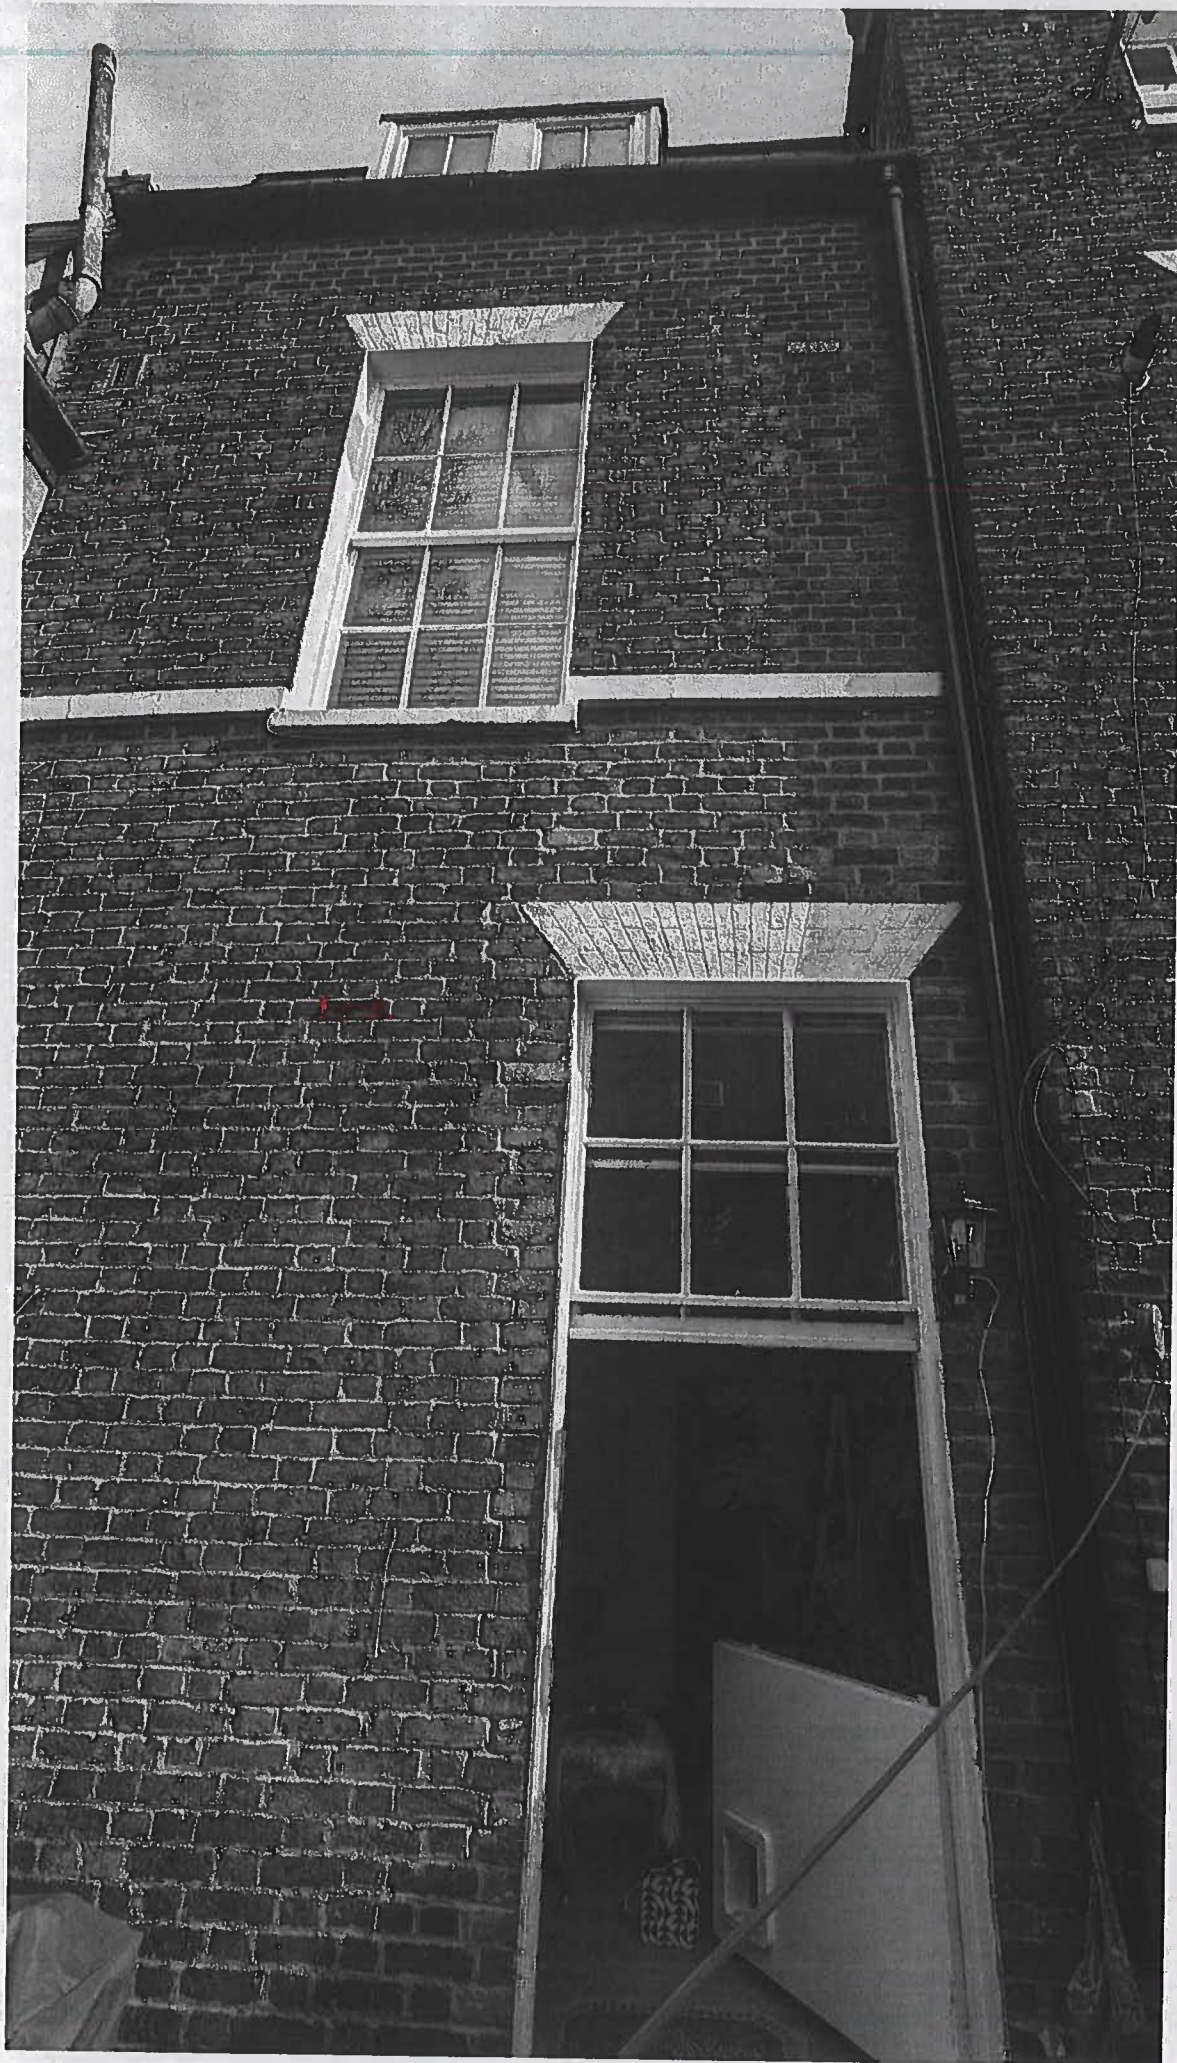
LOCATION FOR ANDY VENT

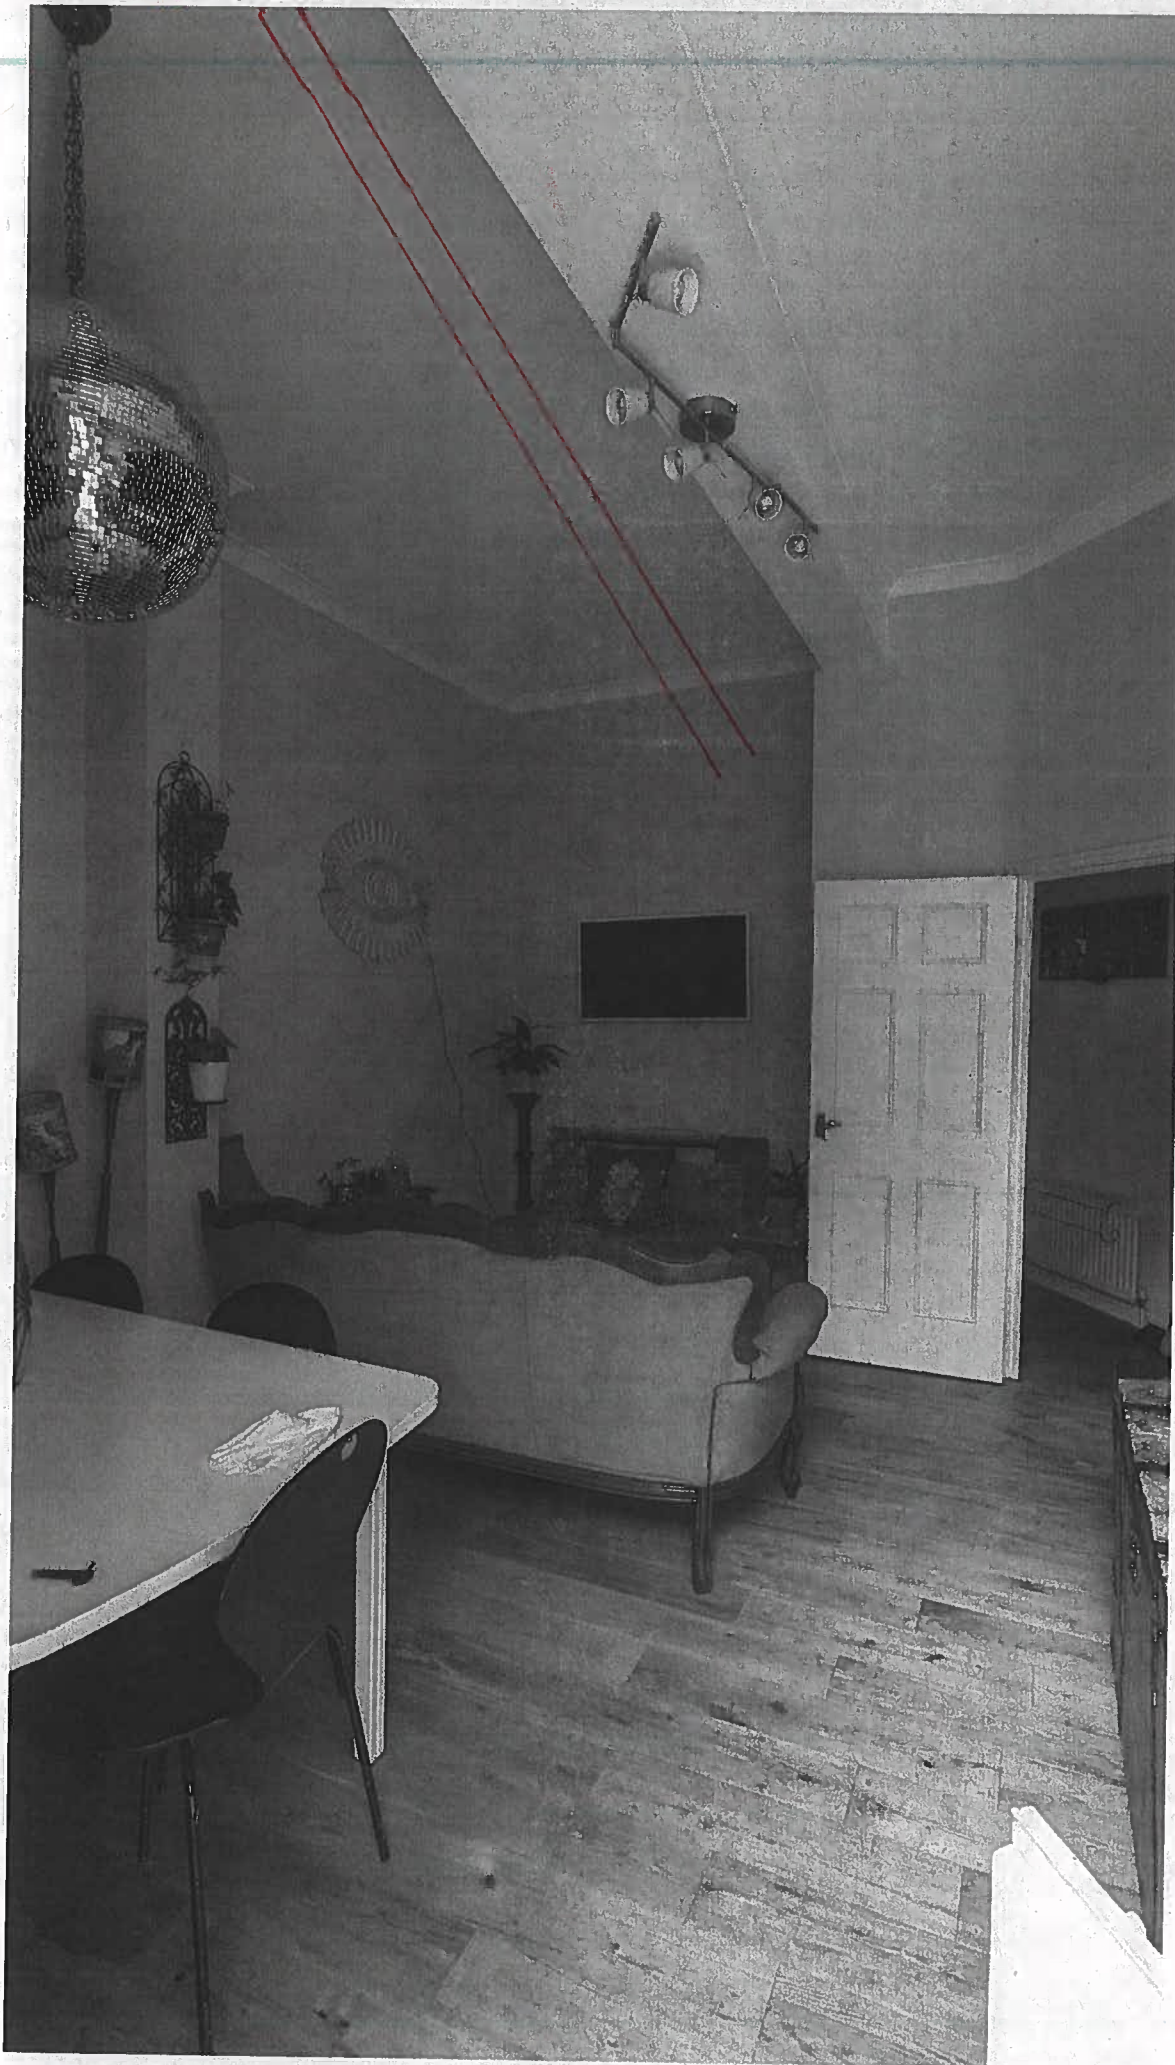
DOCTWORK & BULKHEAD BETWEEN DINING ROOM & KITCHEN  
EXTEND WALL

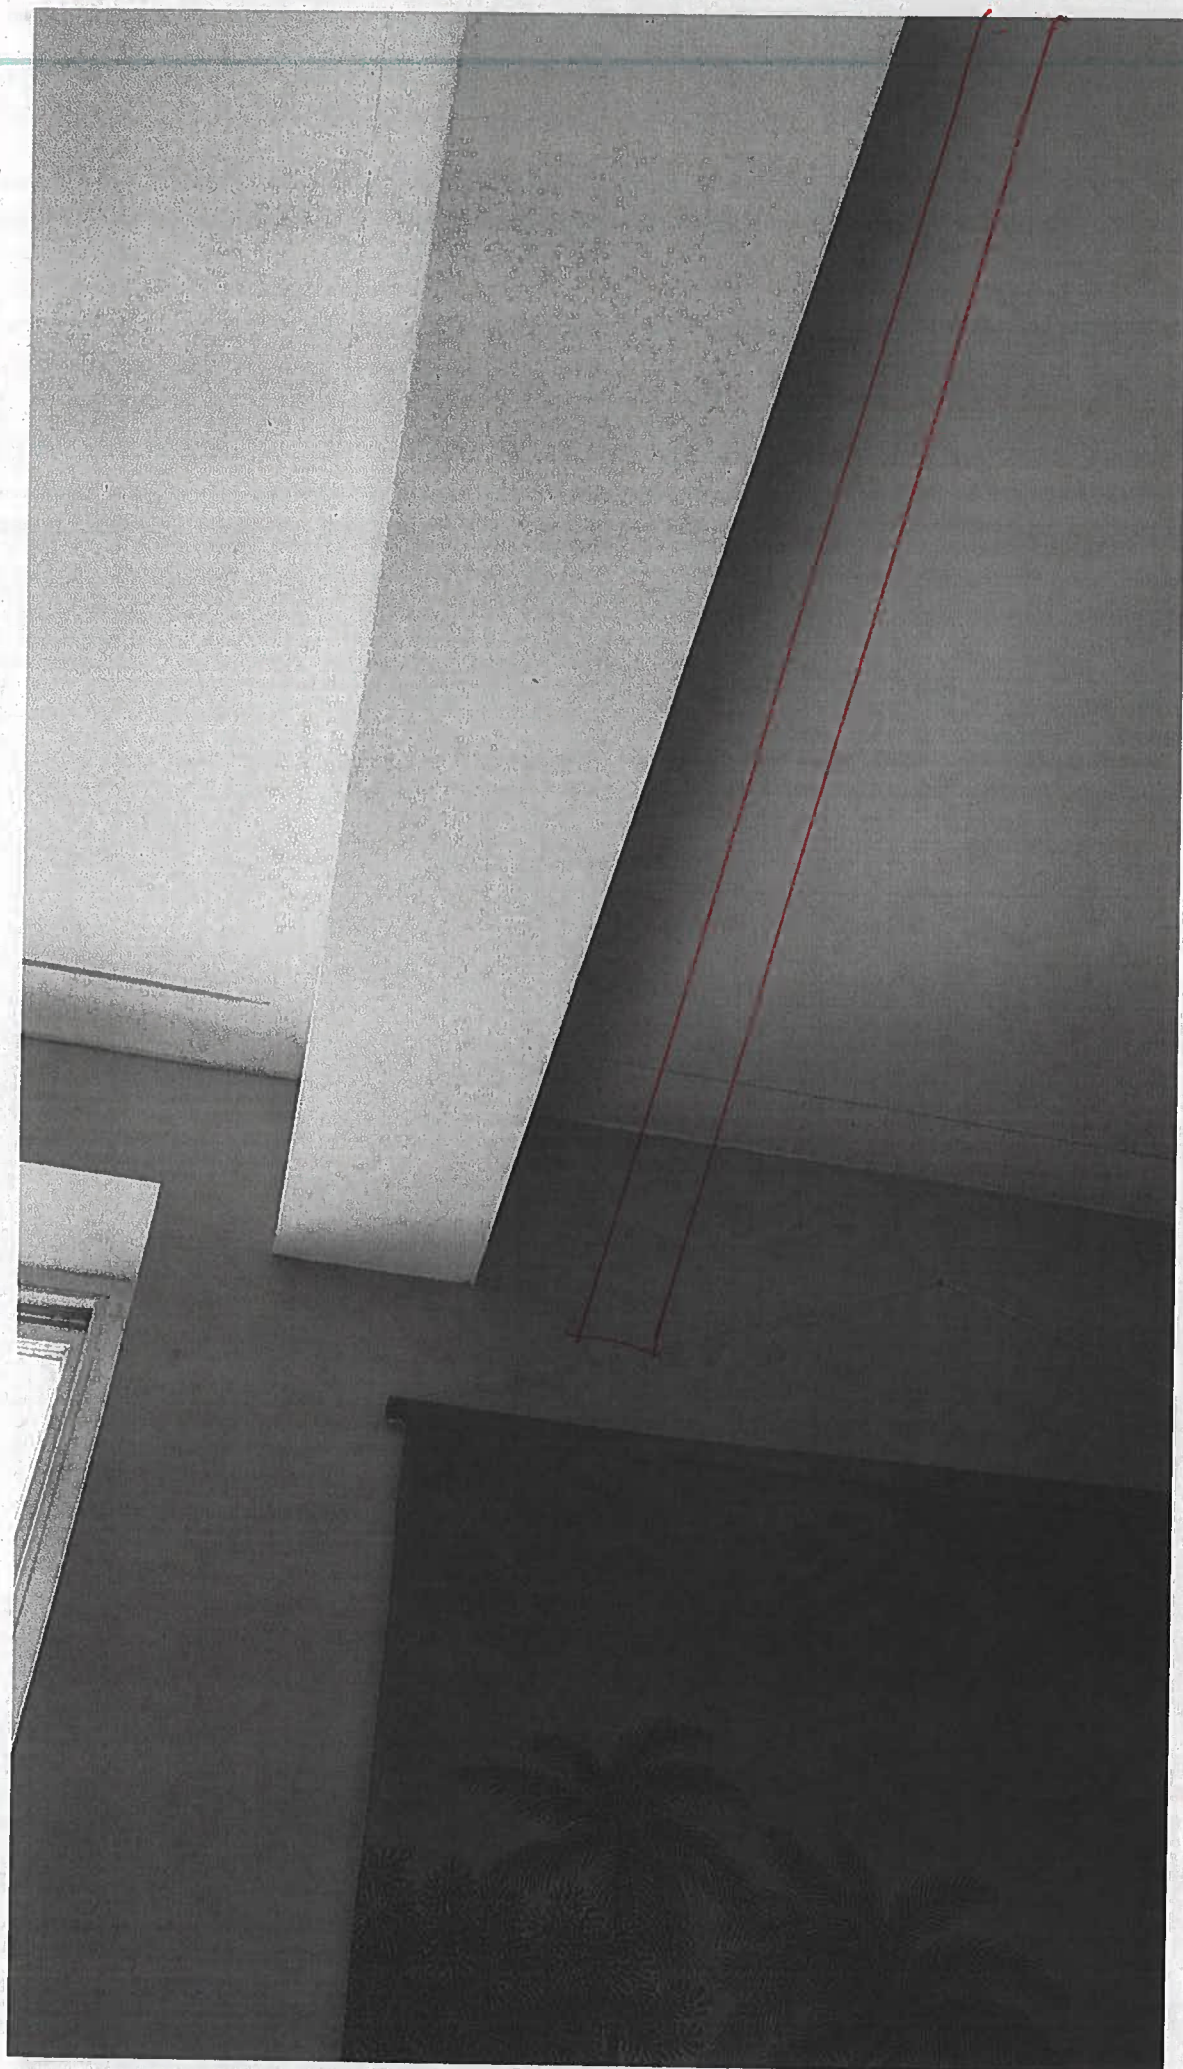
# DUCTWORK TO REPAIR WALL & LICK REMOVAL
