# PROTECTED TREE REPORT (TREE WORKS)

| Application number | HGY/2024/0516 |
| Site Address: | Coleridge Primary School, Crescent Road, Hornsey, London, N8 8AT |

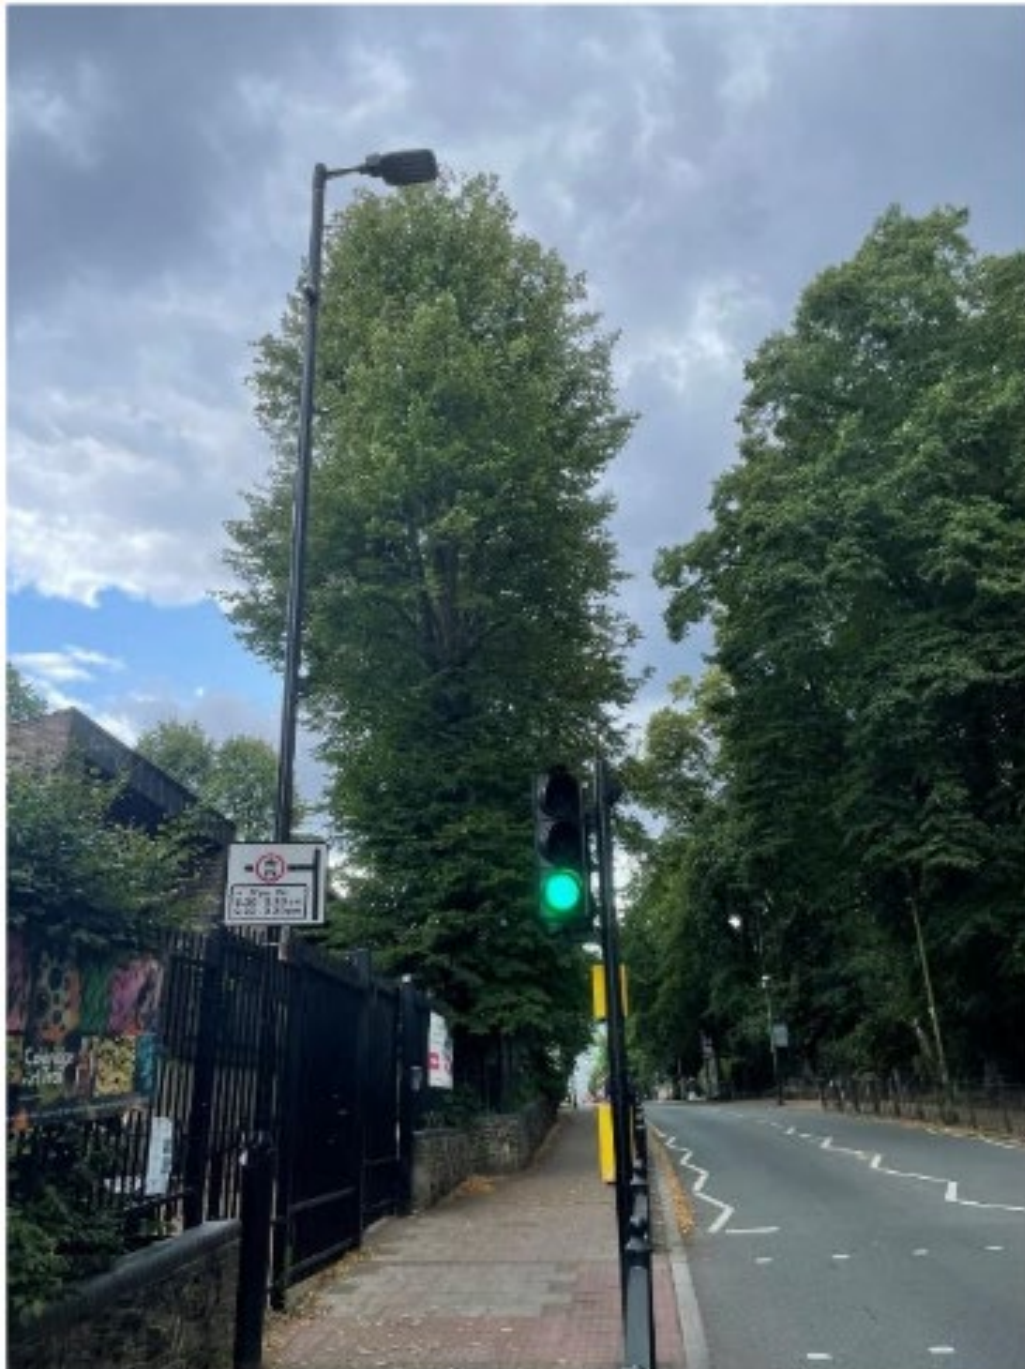
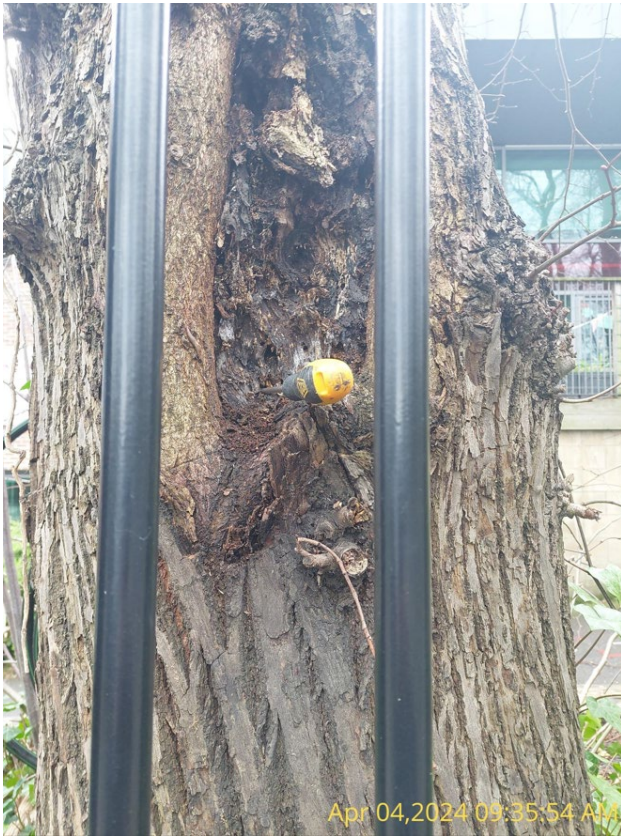
Further mechanical investigations with a decay detection drill (Resistograph) have revealed extensive column decay 2m up the trunk down to ground level with the residue sound wood compromised.

Decay is most extensive at the base (horizontal and vertical plane to buttress roots forming the clamp).

Sound testing with a nylon headed mallet also revealed substantial north, east, west, and south deep hollow sounds (>70% of the trunk circumference and buttresses decayed).

It was noted that this Lime lacked a flared trunk at the base suggesting possible altered and change levels in the past. There is a slight lean towards the school.

The cavity at 2m on the west side, when probed with 46cm probe, was found to have extensive soft simultaneous rot up to the hilt of the probe. There are callusing ribs on either side of the cavity however, their effectiveness given the advanced decay, is insignificant.

I concur with the observation within the report regarding lack of branch system, torsional loading, and torsional failure. However, given the target of the school, adjacent to the highway, the advanced progressive decay, the possibility of the tree collapsing under its own weight, the practicalities of an annual conditional survey the recommendation to remove is prudent.
