## **Bruce Castle: West Boundary Wall Final Report on the Condition and Repairs**

**April 2024**

## **BRUCE CASTLE: West Boundary Wall**

### **Final Report on the Condition and Repair**

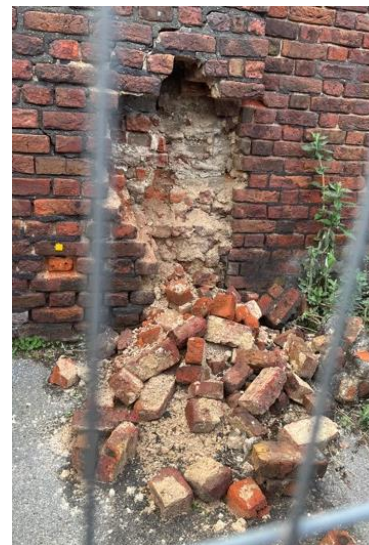
*Image 1: Minor area of collapse*

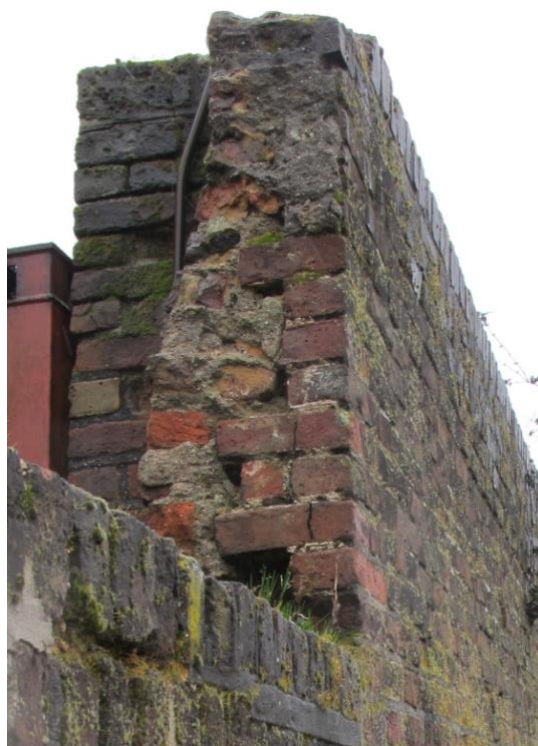
*Image 3: Revealed battered profile*

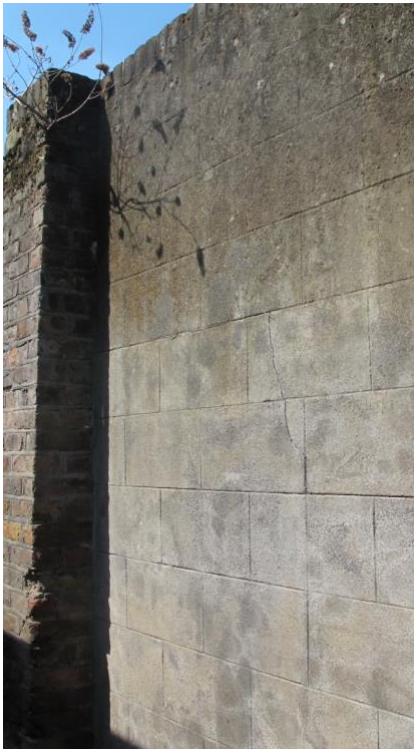
*Image 6: Horizontal crack on render at approximately half its height to all bays of the wall.*

- the cement render to the east face of the wall has horizontal cracks at approx. half height, allowing water to enter the core of the wall
- the cement render is not moisture permeable, forcing any moisture that has entered the wall to its west face

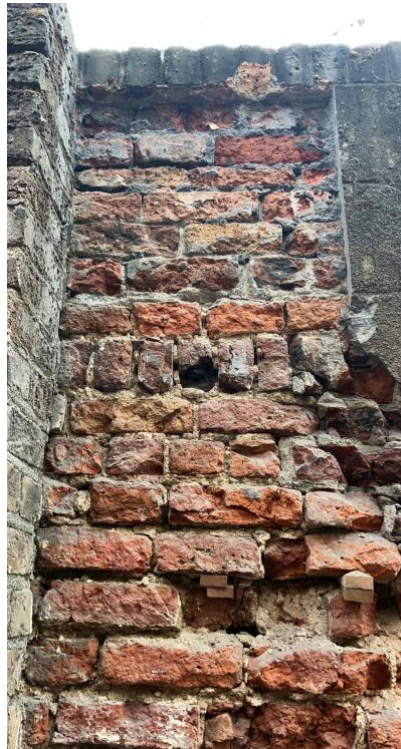
*Image 2: The revealed condition of the core brickwork of the wall*

- 3.3 Investigation to explore the feasibility of removing the render has revealed the condition of the core brickwork of the wall (see image 7). The wall at low level is in a lime mortar and is built in a loose English Garden Wall bond comprising of header and stretcher courses, sometimes alternating, and sometimes mixed with three courses of Flemish bond brickwork. Such a hybrid bonding pattern is common in 18<sup>th</sup> century garden walls (see image 8). The cement render is failing in places and inducing moisture ingress into the wall. The cement render traps any moisture that has entered through cracks in the render in the core brickwork.

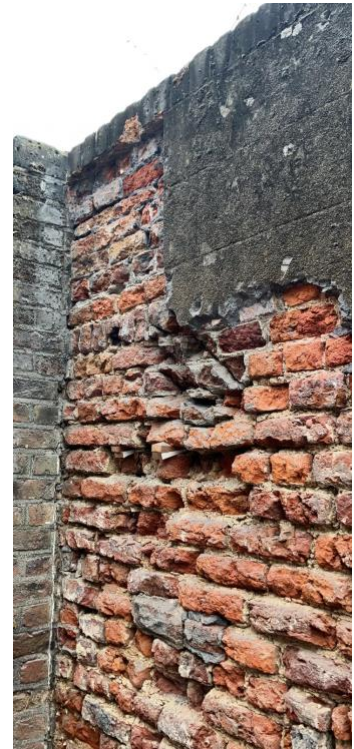
*Image 8: Hybrid bonding pattern, common in 18<sup>th</sup> century garden walls*

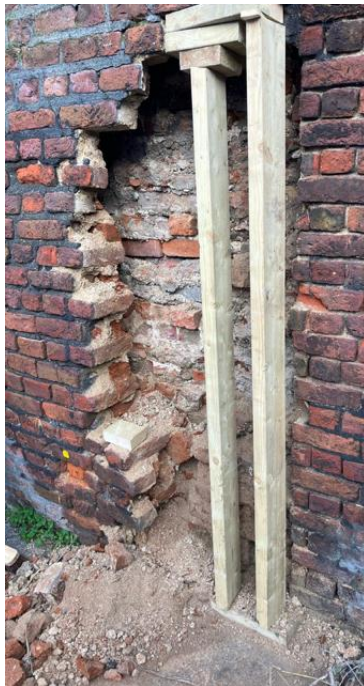
- 3.4 The wall is one and a half brick wide with voids between the skins. The wall's dimension is 400mm wide at its midpoint. This dimension has been taken where a brick has been removed for investigation purposes. This investigation also revealed that there are larger voids in the centre of the wall. This suggests that the wall was possibly laid in two skins with scant attention paid to the bond or fill brickwork. This separation of the bond situation has been exaggerated over time by the snapping of the header that at one time bonded the walls together. This can be seen on the attached photo where there has been an area of collapse (see image 9). In addition, the wall was part of a building and originally the eastern face was an internal face to now demolished buildings, thus setting up significant differential conditions between inner and outer skins of the wall. The result is that the outer skin of brickwork forming the wall has, over a period, separated from the inner skin and course of the wall. This is evidenced by the considerable bulging of the wall in its height at numerous places along its lengths.

*Image 9: Snapping of header causing an area of collapse*

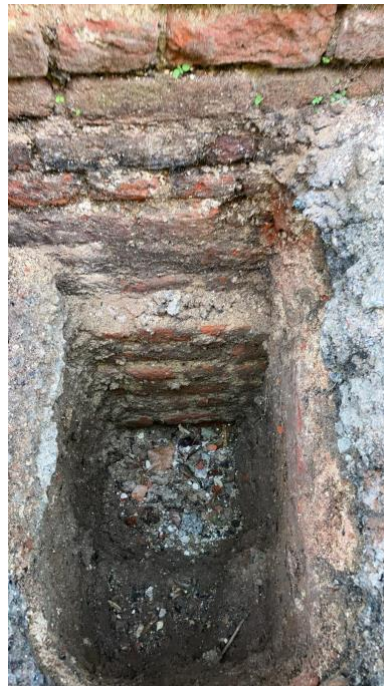
*Image 10: The foundation of the wall*

- 3.6 A trial pit has been dug on the eastern side of the wall to explore the depth of the foundations and generally this has revealed foundations in rather better condition and more consistent than most garden walls. The foundation depth is recorded as 900mm below the existing courtyard level. The foundations have one offset step of 100mm at a depth of 450mm. From the trial pit, it would appear that the foundations of the wall are in extremely good condition (see image 10). Foundations of this depth, and regularity, are possibly a further indicator of the fact that the wall was formerly the western elevation of buildings along its length.

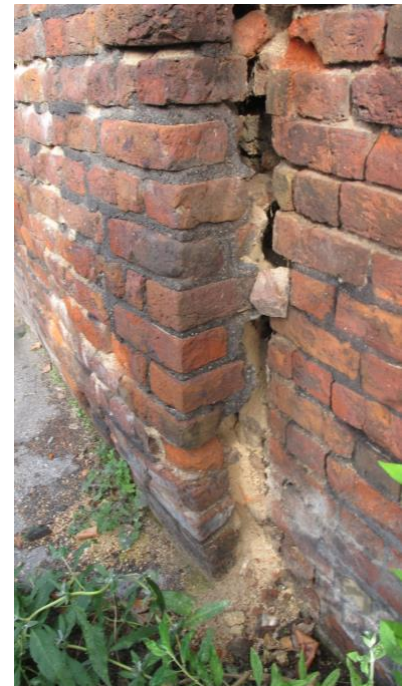
*Image 11: Image of bowed offset prior to collapse*

- 3.7 The bowing of the wall at its maximum on the west side of the wall corresponds to where very sandy loose mortar is being washed out through the brickwork perpend from the wall core. This occurs most profusely at the offset in plan, where the wall bowing is at it worse and where there has recently been a small collapse of the wall. In addition, in this area of the wall, there is considerable cracking of bricks and open vertical perpend and mortar missing from the bedding joints (see image 11).

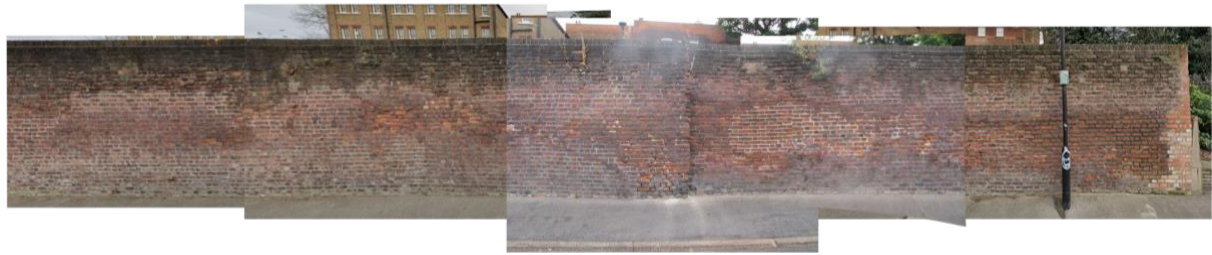
*Image 12: Photographic elevation showing water damage.*

- 3.8 The photographic record elevation of the wall has also revealed an important aspect that is contributing to the current problems of the wall: the photographs of the west side of the wall reveal a wide band in the wall at a mid-height that is considerably wetter than the top or bottom of the wall (see image 12). This indicates that moisture is entering either the top of the wall or through the cracks in the cement render on the east face and migrating through the core of the wall to the western face. The wall has buddleia growing from its top and in other places along the wall. Removing some of the internal render has revealed an extensive matrix of fine roots at the top of the wall that is contributing to moisture entering the course of the wall.

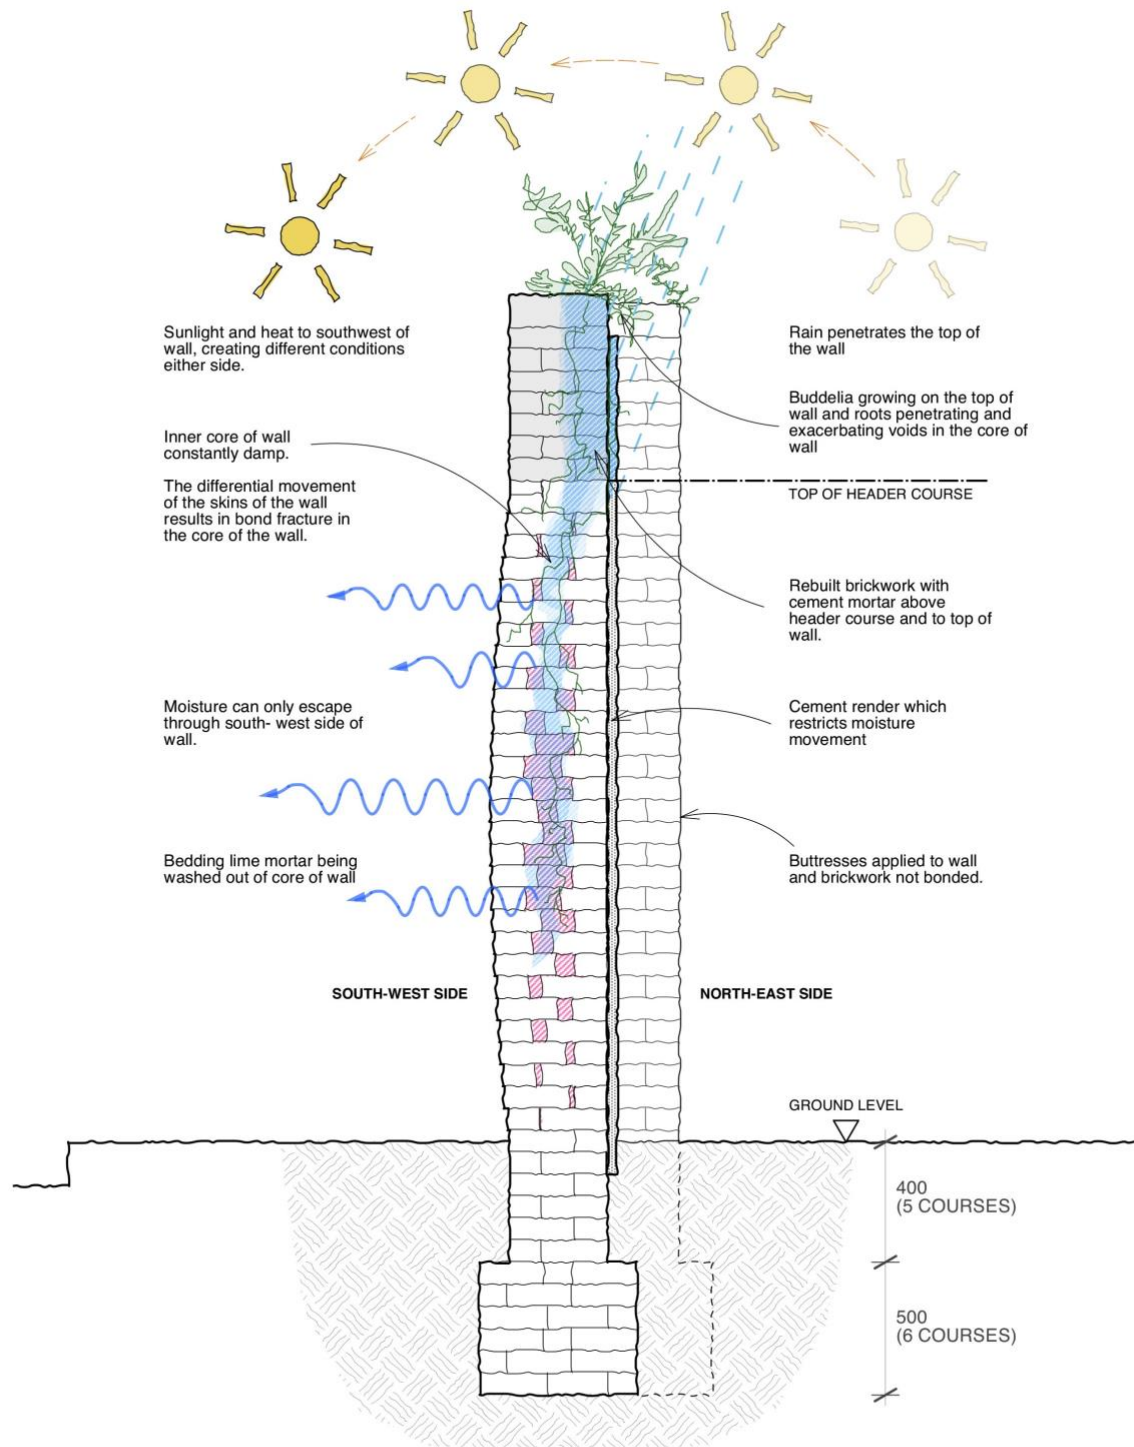
Image 13: Bruce Castle West Boundary Wall Analytical Section

- east west orientation creating differential micro environmental conditions either side of the wall
- the east side of the wall was once an internal face of earlier buildings. These buildings have now been demolished, and the wall and its brickwork are likely to reflect the different conditions

- in the 20<sup>th</sup> century, the cement render has been applied to the east face of the wall, exacerbating the variety of the conditions on either side of the wall

- an open and inconsistent brick bond pattern through the thickness of the wall creates voids within the wall
- the wall is one and half brickwork, and the outer western 'skin' of facing bricks has not been particularly well bonded to the rest of the wall, which was built with central voids filled with mortar, rather than a coherent bonded mass of brickwork

- the top of the wall has been rebuilt
- the top of the wall to the east side has a considerable area of brickwork in cement mortar
- the top of the cement render to the east side show signs of excessive water staining

- the top of the wall has a large amount of buddleia growing through the mortar, with an extensive root system embedded through the wall and behind the render which allows water to enter the wall

- the lime mortar of the wall has deteriorated and is now being washed out of the core of the wall to the west side
- the west side of the wall has throughout its length, a middle third band of damp brickwork

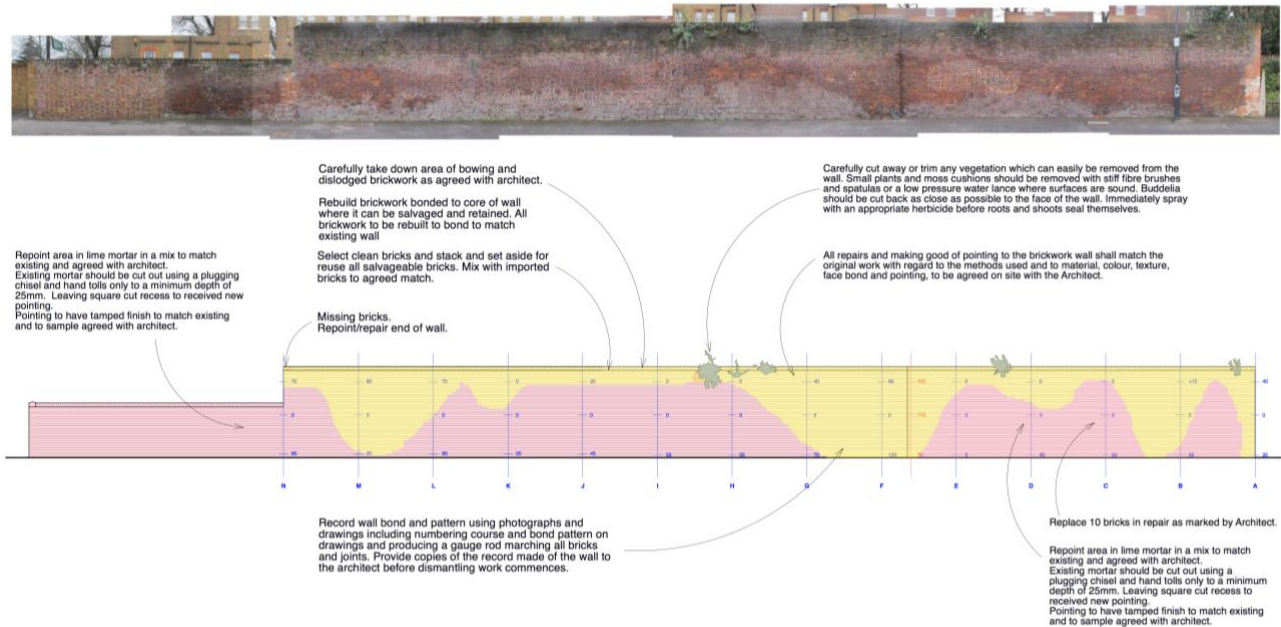
Image 15: Existing External Wall Photo Collage and Indicative Repairs to External Elevation

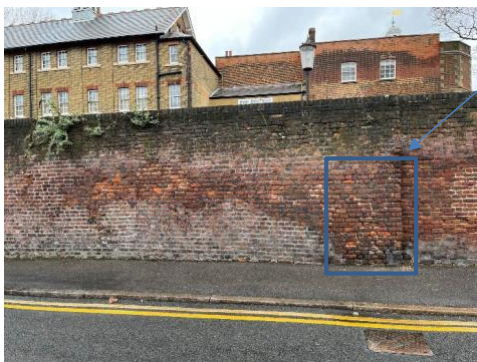
Bulged and delaminating section with visible void and loose bricks. This section is considered to be dangerous with the possibility of failure resulting in uncontained collapse. It is particularly vulnerable to impact damage.

The bulged and delaminating section is considered to be dangerous and has the potential to fail suddenly and in an uncontained manner. It is also vulnerable to impact damage again leading to uncontained failure.

We feel the pavement should be closed and temporary buttresses erected to contain any failure of the wall.  
This should be carried out as a matter of urgency.

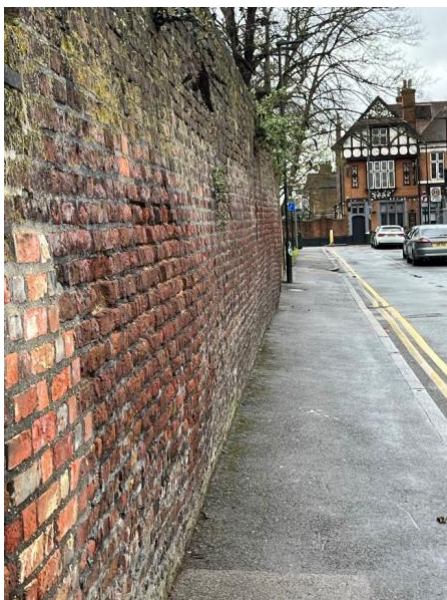
View looking south along the wall showing bulging masonry and a batter to the brickwork.

Missing and inappropriate pointing is also evident.

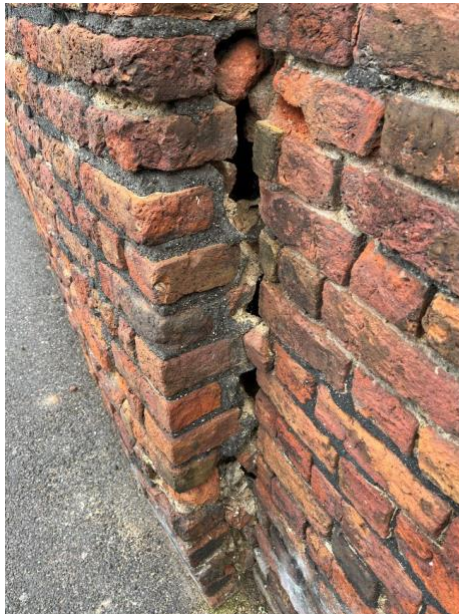
Separation at southern junction showing void to core of the wall and a lack of bond to the facework.

The verticality of the west face varies considerably, some sections being significantly out of plumb..

The opposing face is less out of plumb.
