**VISUAL STRUCTURAL APPRAISAL**

**24 CHOLMELEY CRESCENT**  
**LONDON**  
**N6 5HA**

**DATE: MARCH 2023**

**JOB No 23031**

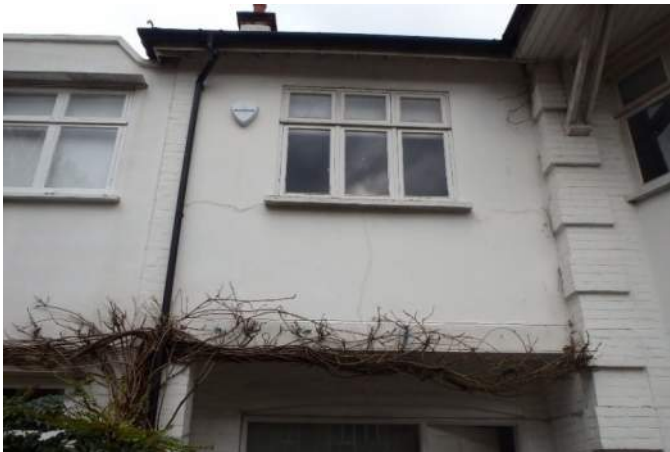
*Figure 11*

There is a beam casing which will contain a beam running over at first floor level carrying the first-floor front elevation to the property above the entrance door.

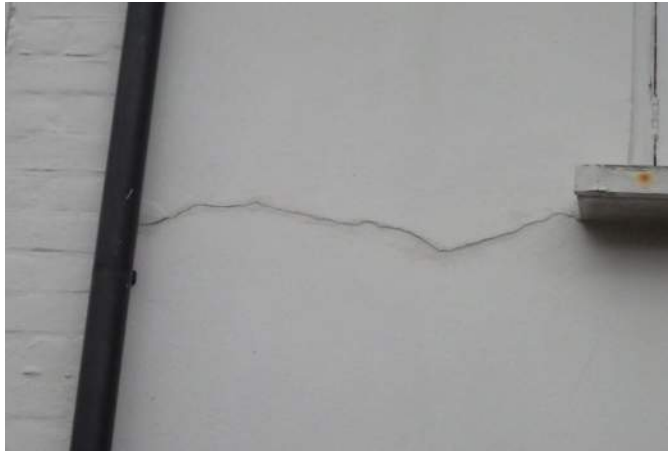
*Figure 12*

The front elevation at first floor level above the beam is finished with white painted render. Cracking was noted to the render finish as follows:

- crack running horizontally to the left of the first-floor window sill.

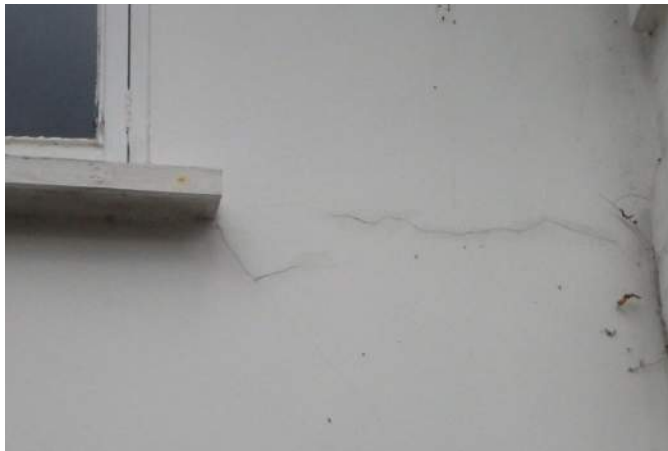
*Figure 13*

- Crack, twice forked, running out from the right-hand end of the first-floor window sill.

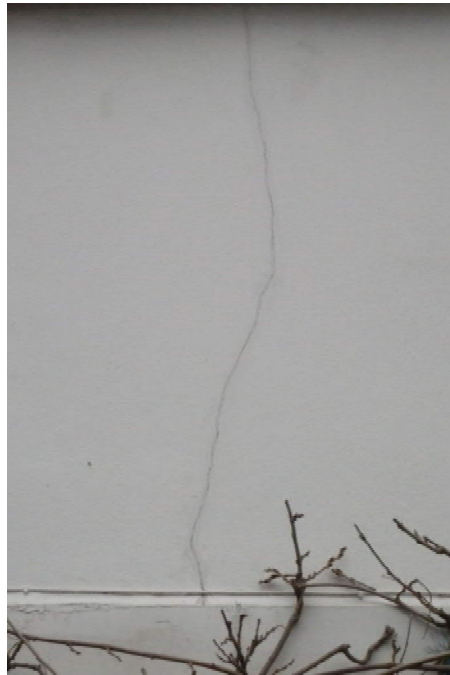
*Figure 14*

- Vertical crack running vertically down from first floor window sill to top of beam casing at base of first floor elevation.

10. Cracking was noted to the render finish on the front elevation above the front door opening.

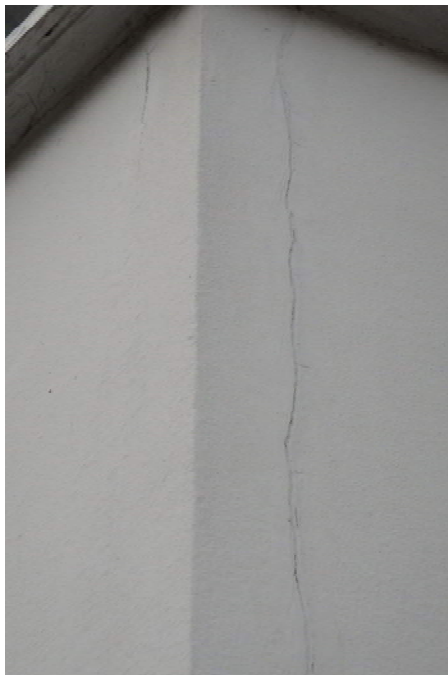
*Figure 16*

The following cracking was noted to the front elevations of the bay.

- Crack at junction between left-hand splayed wall to bay and white painted facing brick main elevation.
- Vertical crack on front wall to bay at left-hand side at junction with left-hand splayed wall, running from first floor window sill down to ground floor window head.
- Similar cracking noted to right-hand side of front wall to bay at first floor level at junction with right-hand splayed wall.

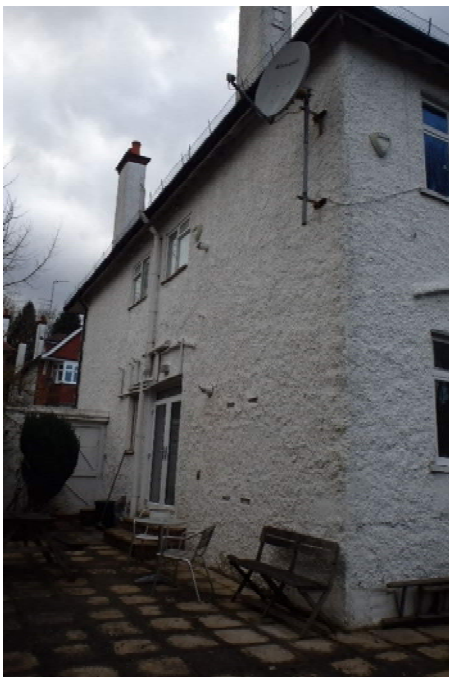
*Figure 21*

Cracking was noted to the rear section of the right-hand flank wall.

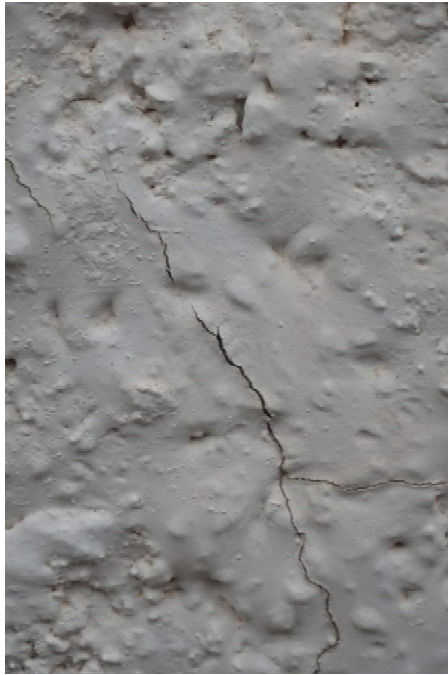
*Figure 22*

- Crack from ground level located approximately 1m to rear of steps down to ground level from French door in side elevation, with the crack rising up to the underside level of the boiler flue before appearing to peter out.

The surface of the render appears to have been cement filled previously, suggesting that the crack may have occurred previously and been refilled and then subsequently reappeared.

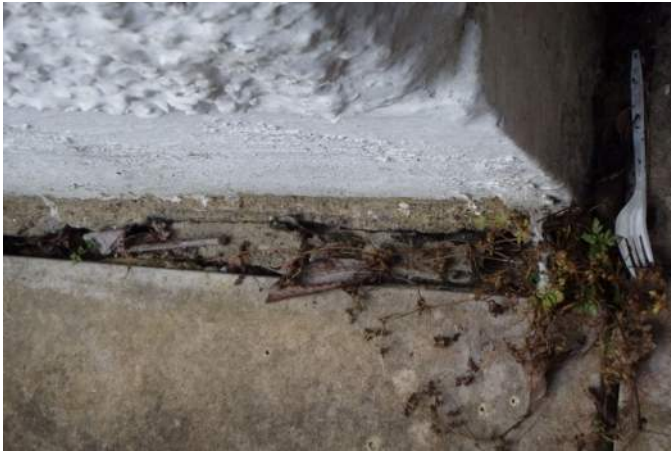
*Figure 26*

At the rear left hand end of the terrace area, there is a significant open joint, perhaps 15-20mm wide, suggesting that the paved terrace area has moved laterally away, downslope from the rear elevation of the property at this end.

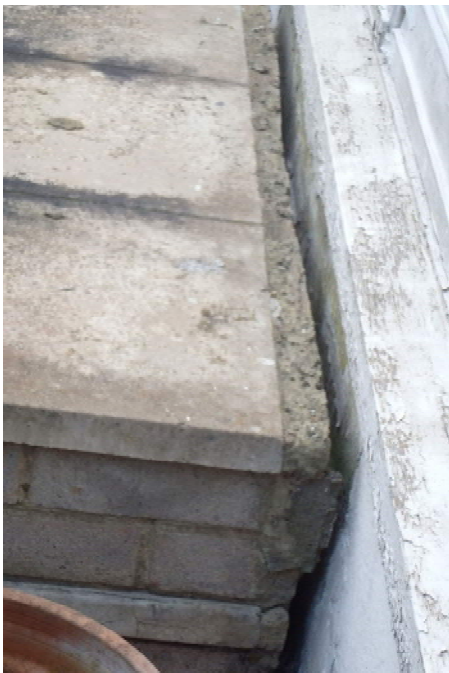
*Figure 27*

There is a large open joint between the back face of the steps and the face of the rear elevation again suggesting that the terrace structure and the step structure have together moved horizontally away from the rear elevation to the property.

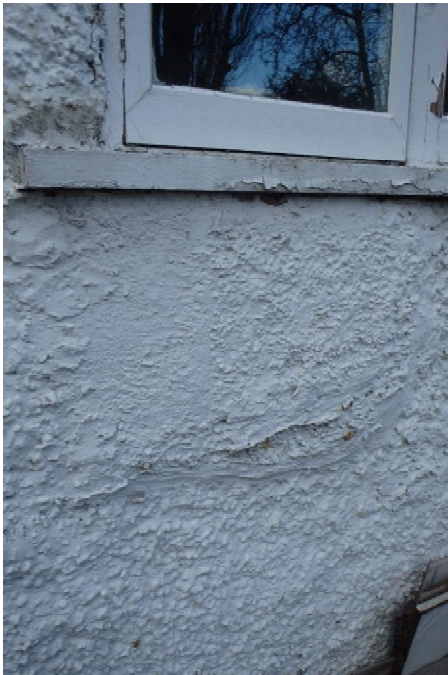
*Figure 29*

A patch repair to the pebble dash render is located beneath the left-hand side of the ground floor window sill of the window on the left-hand side.

A vertical crack is present through the pebble dash render running down from the right hand of the pair of mullions to the window to the left-hand side of the elevation, the crack extending from window sill level at ground floor level down to the base of the elevation.

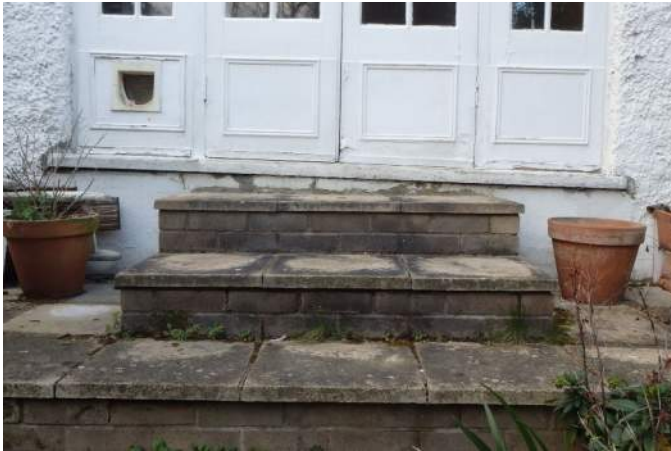
*Figure 30*

The structural opening containing the French doors towards the right-hand end of the elevation at ground floor level is misaligned so that the right-hand end of the opening has dropped considerably compared to the left-hand end.

Assuming the paved terrace area across the rear elevation to be relatively horizontal, the drop appears to be of the order of 45mm or so from end to end of the opening.

The differential foundation movement is clearly visible in misaligned sill and heads to openings and also in the finished floor levels when the floor is viewed from the corner of the room.

5. The magnitude of the differential settlement and subsidence is such that underpinning of the house will be required, particularly noting the ongoing nature of the cracking noted in the report above.

The scope of underpinning required is such that serious consideration should be given to the reconstruction of the property on adequate foundations.

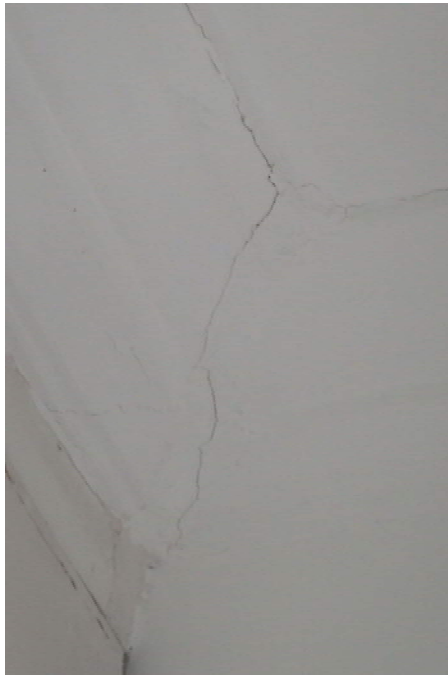
*Figure 35*

- Diagonal crack running down from mitre joint in ceiling coving to front right of bay window when viewed internally, petering out before reaching bay recess.

- Further crack running vertically up from right hand side of head of bay recess.

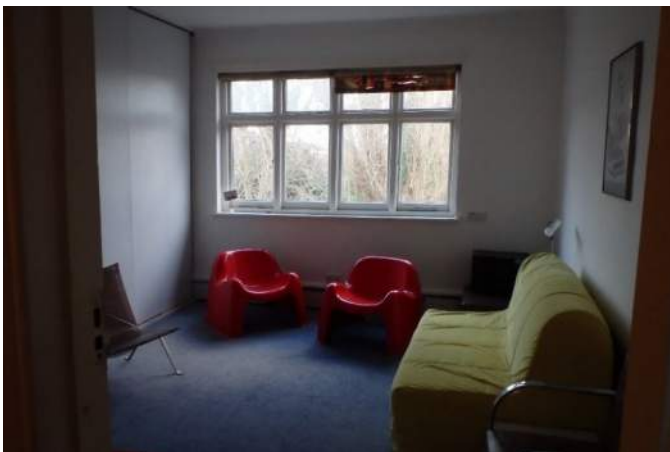
*Figure 39*

The floor to the bedroom has a noticeable slope downwards from right-hand side to left-hand side, corresponding to foundation movement previously noted in the rear external elevation around the French door opening in the rear wall.

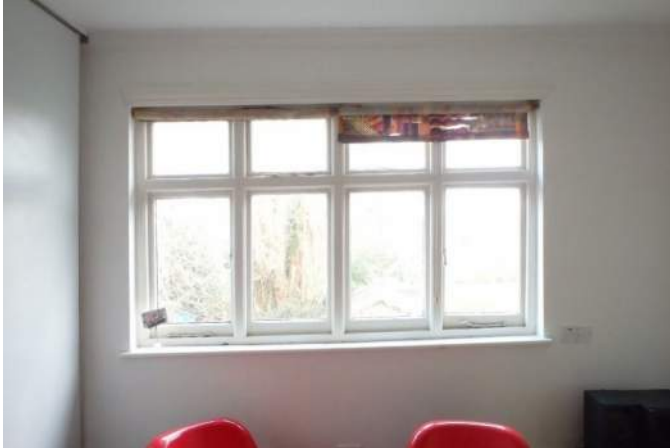
*Figure 40*

The window set in the rear wall is misaligned so that the left-hand end of the window sill is considerably lower than the right-hand end, as is the window head.

A vertical crack was noted to the right-hand side of the right-hand end of the window sill to the window opening.

Open cracking was noted at head of cornice in rear wall at junction with ceiling across rear elevation with further cracking noted at the junction between cornice and ceiling at junction with right-hand wall to room.

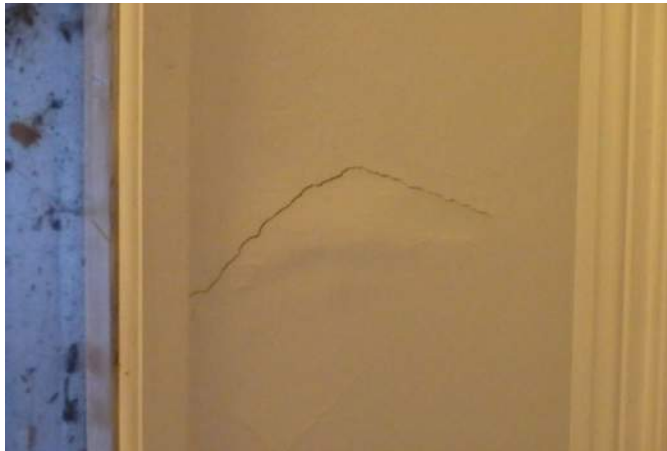
*Figure 44*

- Cracking noted to mitre joints to ceiling cornice and at junctions between ceiling cornice and ceiling.
- Vertical crack rising up from top left of door head in to bedroom 3, the crack peters out before reaching ceiling cornice level.
- Diagonal crack running up from top left of door head in to office, petering out before reaching ceiling cornice.
- Further diagonal crack noted running down from ceiling cornice above centre of door opening through to office, petering out before reaching door head.

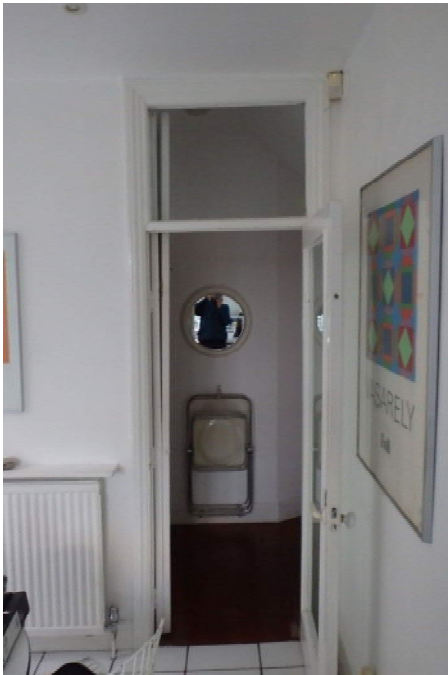
*Figure 51*

The framing to the glazed door opening appears to be historically misaligned with the left-hand end being lower than the right-hand end.

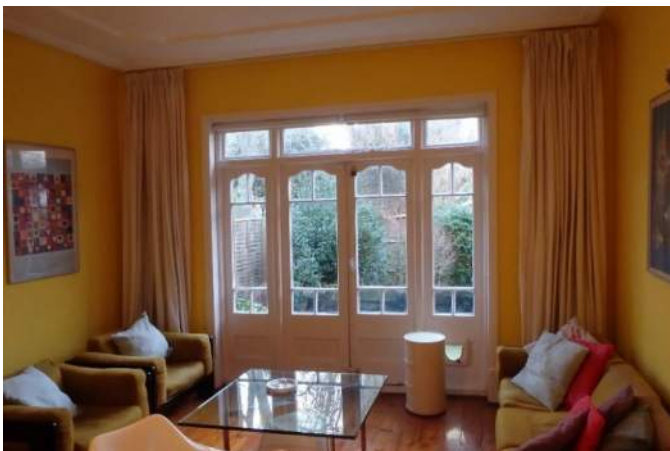
*Figure 52*

There is a noticeable slope in the floor down to the left-hand side rear corner of the room.

- Vertical crack through paper finish above French door opening in rear elevation just to left of centre of opening running up to ceiling cornice level.
- Open jointing at junction between cornice and rear wall ceiling paper, not clear whether or not a crack.
- Diagonal crack through ceiling towards front of room above door opening through to central hallway area.

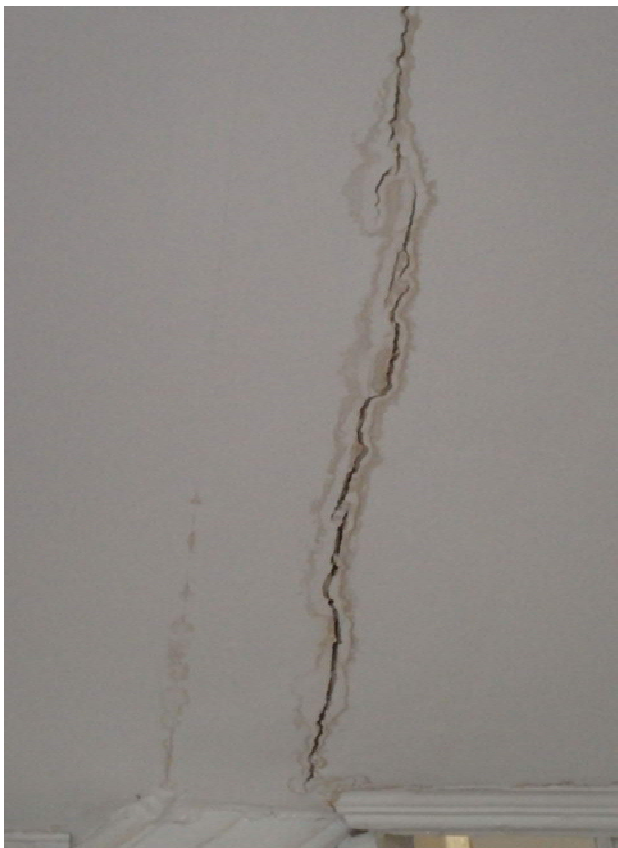
*Figure 57*

- Open crack running out from left-hand end of stairwell towards left-hand extension from corner of stairwell opening.
