**VISUAL STRUCTURAL APPRAISAL**

**24 CHOLMELEY CRESCENT**  
**LONDON**  
**N6 5HA**

**DATE: MARCH 2023**

**JOB No 23031**

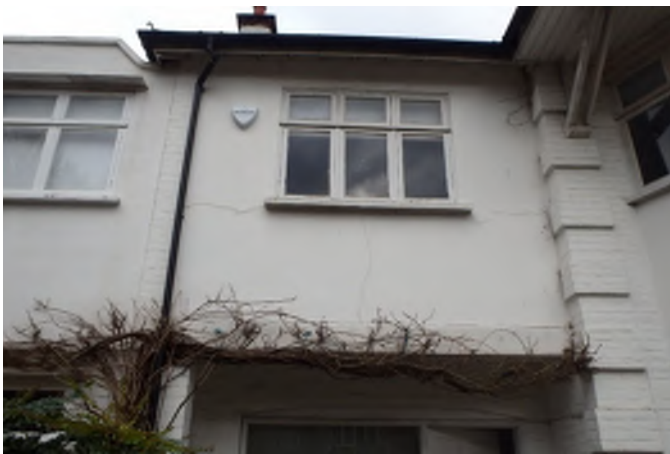
*Figure 11*

There is a beam casing which will contain a beam running over at first floor level carrying the first-floor front elevation to the property above the entrance door.

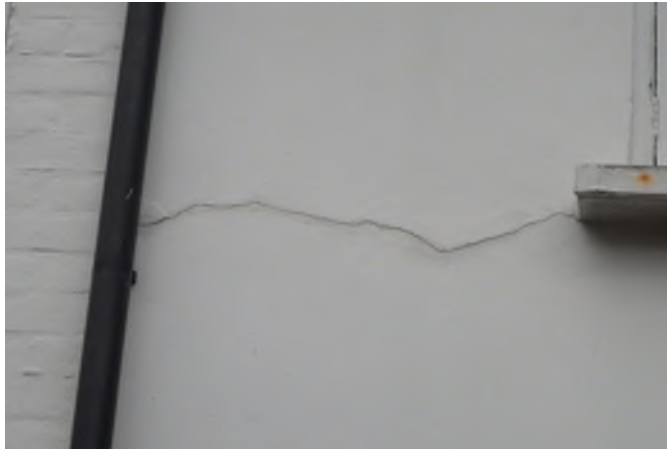
*Figure 12*

- crack running horizontally to the left of the first-floor window sill.

The most likely cause of the cracking to the white painted rendered finish is flexure within the beam supporting the elevation and possible foundation movement.

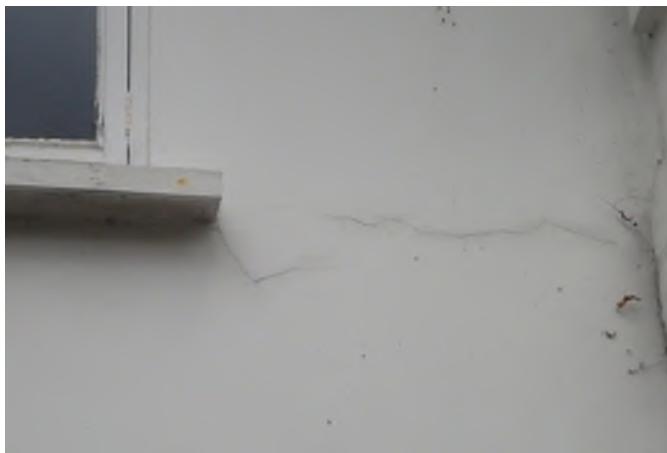
*Figure 13*

- Crack, twice forked, running out from the right-hand end of the first-floor window sill.

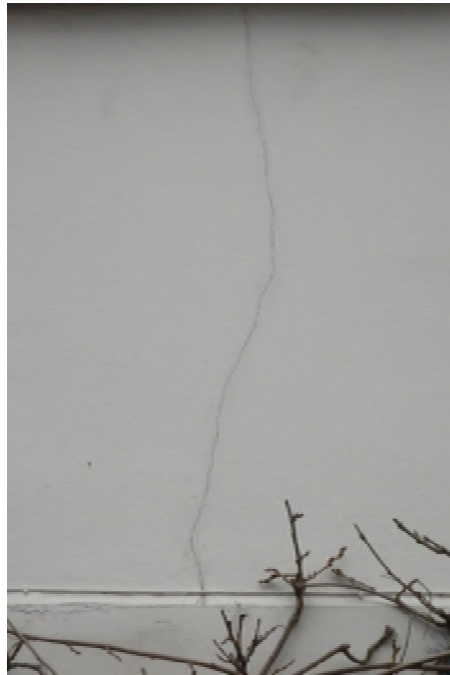
*Figure 14*

- Vertical crack running vertically down from first floor window sill to top of beam casing at base of first floor elevation.

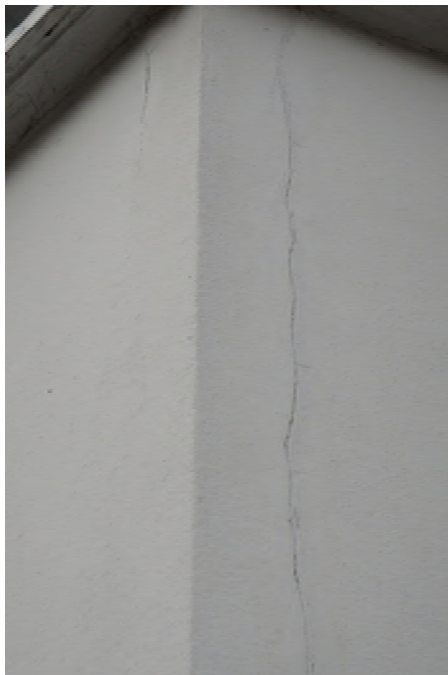
*Figure 16*

- Crack at junction between left-hand splayed wall to bay and white painted facing brick main elevation.
- Vertical crack on front wall to bay at left-hand side at junction with left-hand splayed wall, running from first floor window sill down to ground floor window head.
- Similar cracking noted to right-hand side of front wall to bay at first floor level at junction with right-hand splayed wall.

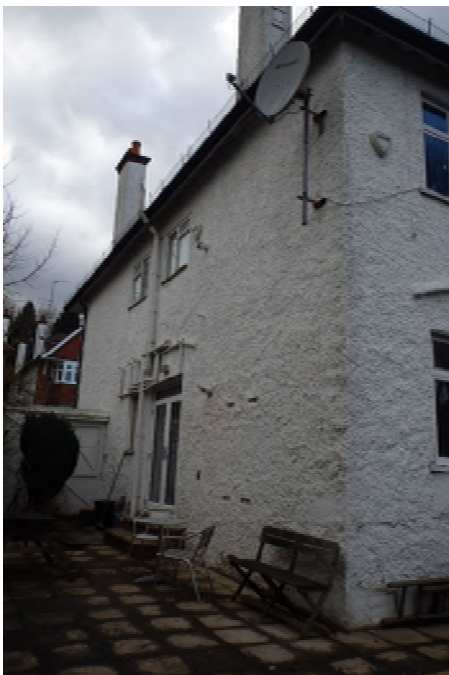
*Figure 21*

Cracking was noted to the rear section of the right-hand flank wall.

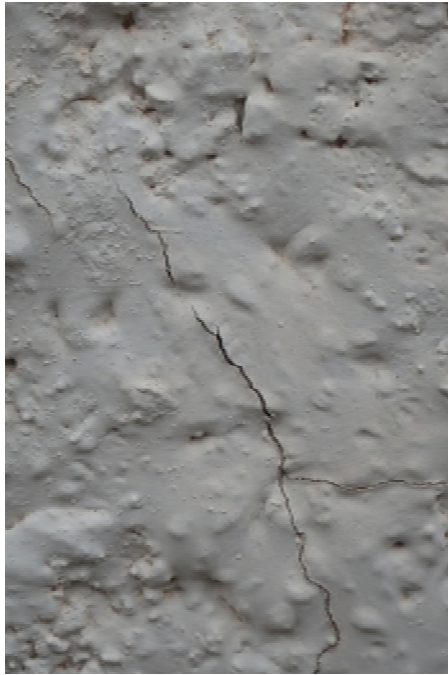
*Figure 22*

- Crack from ground level located approximately 1m to rear of steps down to ground level from French door in side elevation, with the crack rising up to the underside level of the boiler flue before appearing to peter out.

The surface of the render appears to have been cement filled previously, suggesting that the crack may have occurred previously and been refilled and then subsequently reappeared.

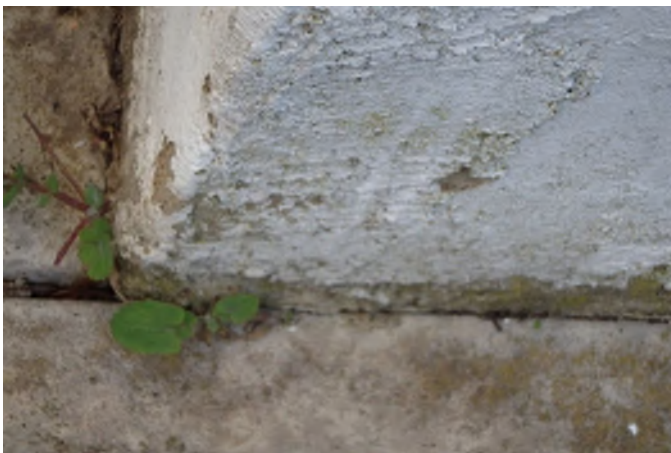
*Figure 25*

At the rear right hand end of the elevation, there is almost no open joint between the paved terrace and the base of the render skirt to the rear elevation.

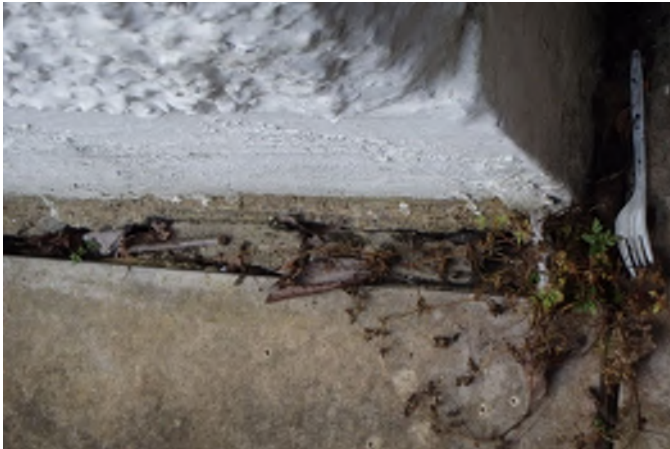
*Figure 26*

At the rear left hand end of the terrace area, there is a significant open joint, perhaps 15-20mm wide, suggesting that the paved terrace area has moved laterally away, downslope from the rear elevation of the property at this end.

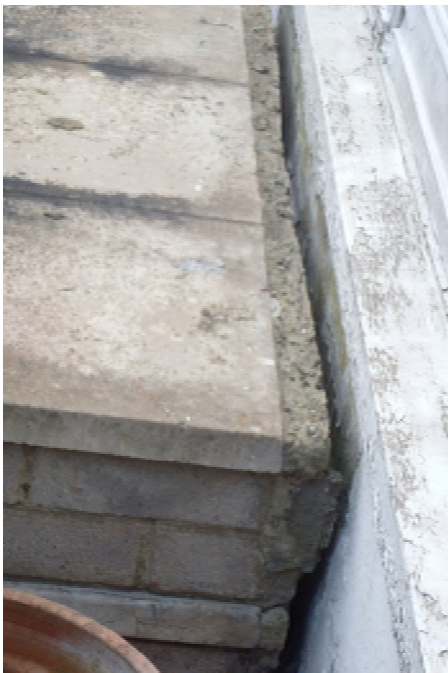
*Figure 27*

There is a large open joint between the back face of the steps and the face of the rear elevation again suggesting that the terrace structure and the step structure have together moved horizontally away from the rear elevation to the property.

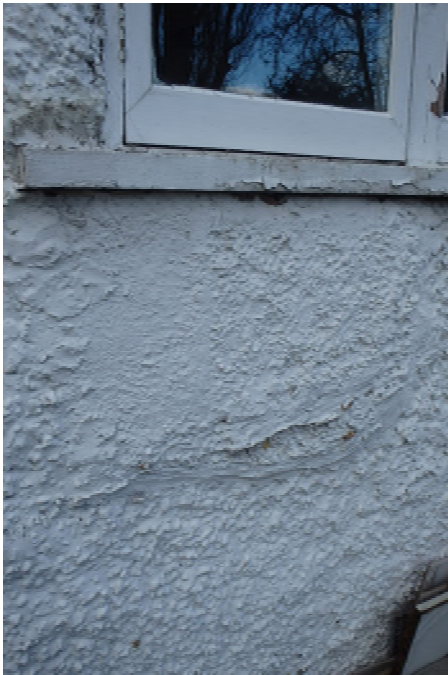
*Figure 29*

A patch repair to the pebble dash render is located beneath the left-hand side of the ground floor window sill of the window on the left-hand side.

A vertical crack is present through the pebble dash render running down from the right hand of the pair of mullions to the window to the left-hand side of the elevation, the crack extending from window sill level at ground floor level down to the base of the elevation.

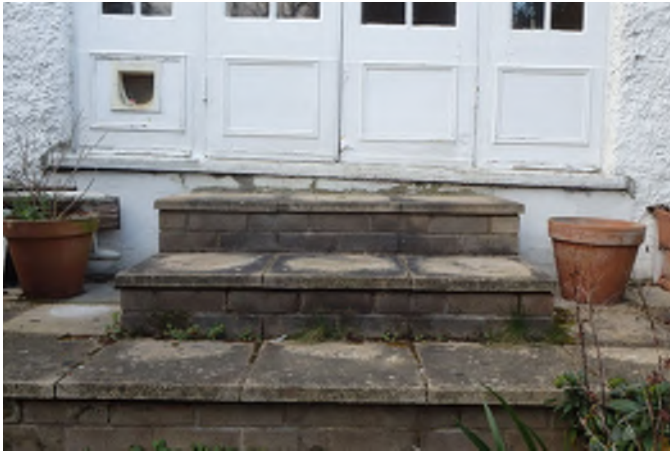
*Figure 30*

The structural opening containing the French doors towards the right-hand end of the elevation at ground floor level is misaligned so that the right-hand end of the opening has dropped considerably compared to the left-hand end.

Assuming the paved terrace area across the rear elevation to be relatively horizontal, the drop appears to be of the order of 45mm or so from end to end of the opening.

The differential foundation movement is clearly visible in misaligned sill and heads to openings and also in the finished floor levels when the floor is viewed from the corner of the room.

5. The magnitude of the differential settlement and substance is such that underpinning of the house is likely to be required, particularly noting the ongoing nature of the cracking noted in the report above.

Careful consideration should be given the likely scope of underpinning that might be required and whether or not to seriously consider reconstruction of the property on adequate foundations.

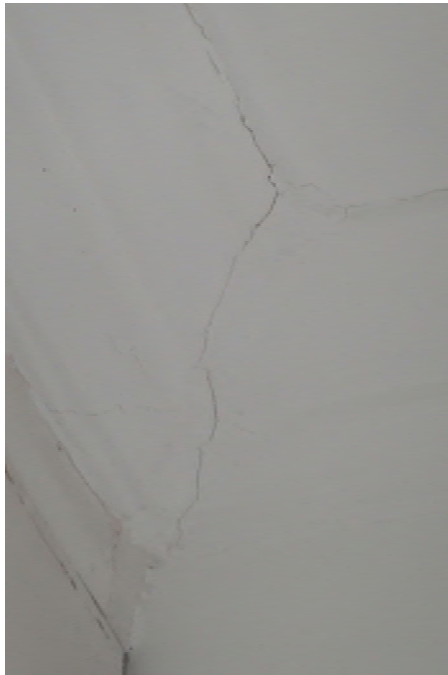
*Figure 35*

- Diagonal crack running down from mitre joint in ceiling coving to front right of bay window when viewed internally, petering out before reaching bay recess.

- Further crack running vertically up from right hand side of head of bay recess.

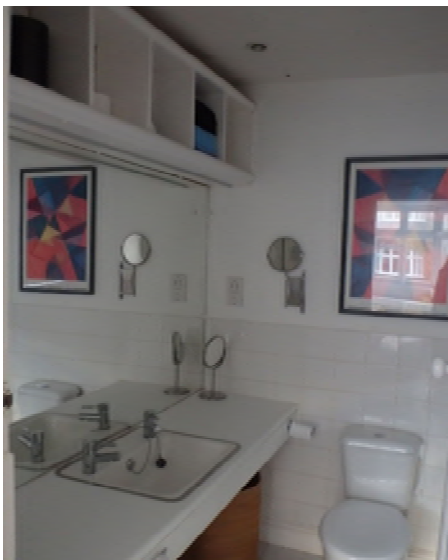
*Figure 36*

Cracking was noted at the junction between outside wall to right hand side of property and rear wall to bathroom.

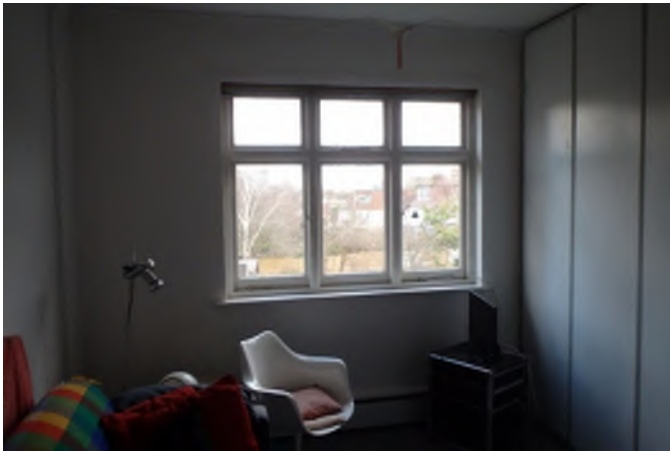
*Figure 37*

- Open crack at junction between ceiling and head of cornice to rear wall to room.
- Crack noted generally at junction between head of cornice and ceiling to left-hand wall and front wall to room.

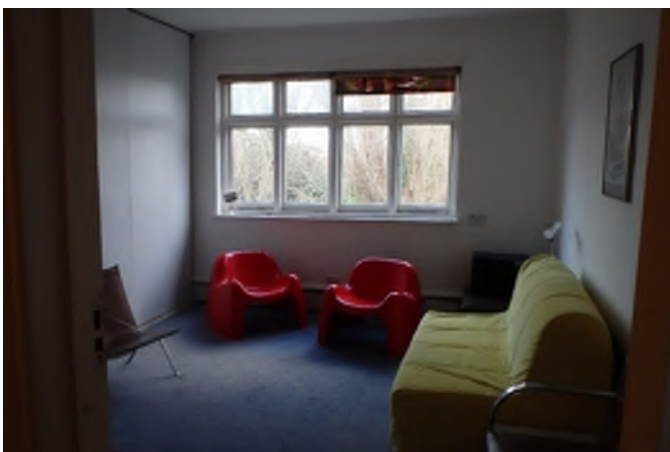
*Figure 39*

The floor to the bedroom has a noticeable slope downwards from right-hand side to left-hand side, corresponding to foundation movement previously noted in the rear external elevation around the French door opening in the rear wall.

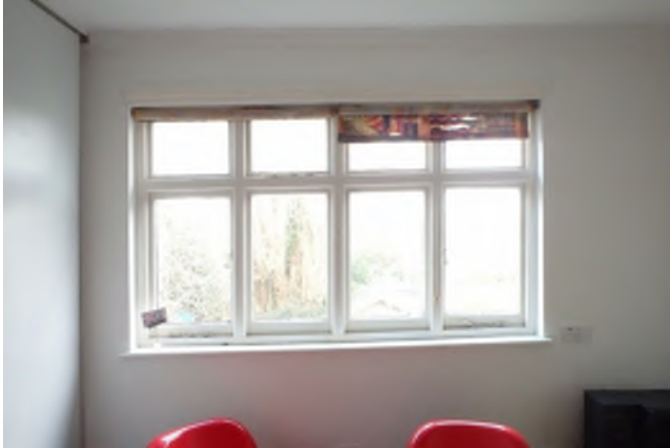
*Figure 40*

The window set in the rear wall is misaligned so that the left-hand end of the window sill is considerably lower than the right-hand end, as is the window head.

A vertical crack was noted to the right-hand side of the right-hand end of the window sill to the window opening.

Open cracking was noted at head of cornice in rear wall at junction with ceiling across rear elevation with further cracking noted at the junction between cornice and ceiling at junction with right-hand wall to room.

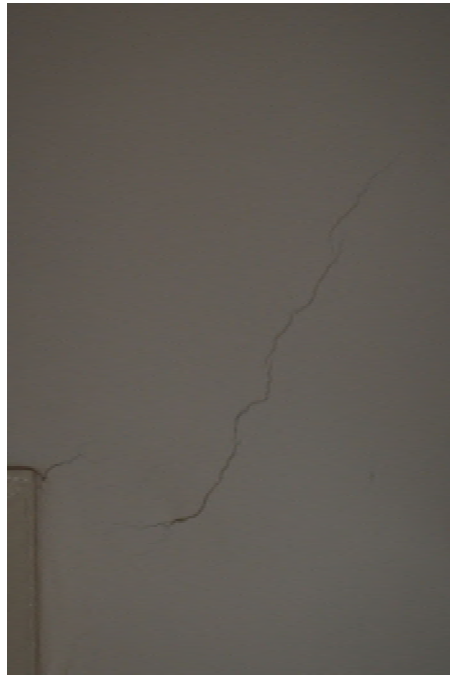
*Figure 42*

- Crack at junction between top of cornice to front wall and junction with ceiling
- Similar intermittent cracking at junction between cornice and ceiling to right hand side of room and to left hand side of room, and to rear of room at junction with ceiling
- Diagonal crack rising up from top right of door head out on to hallway.

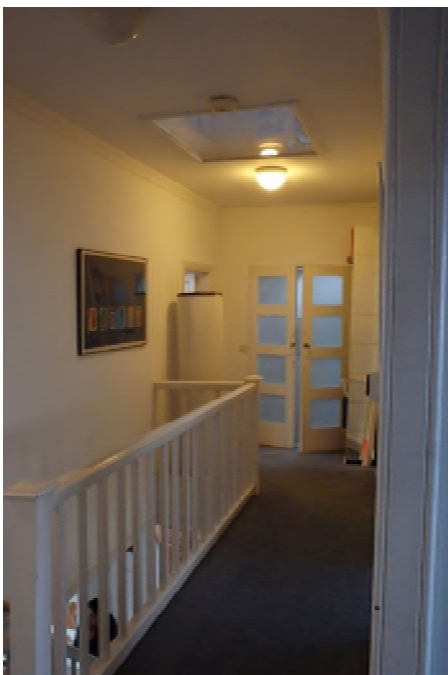
*Figure 43*

- A straight crack was noted in the ceiling running from side to side halfway across the hallway, corresponding to joints in plasterboard sheets.
- A diagonal crack was noted running out from the perimeter of the rooflight towards the front wall of the hallway.

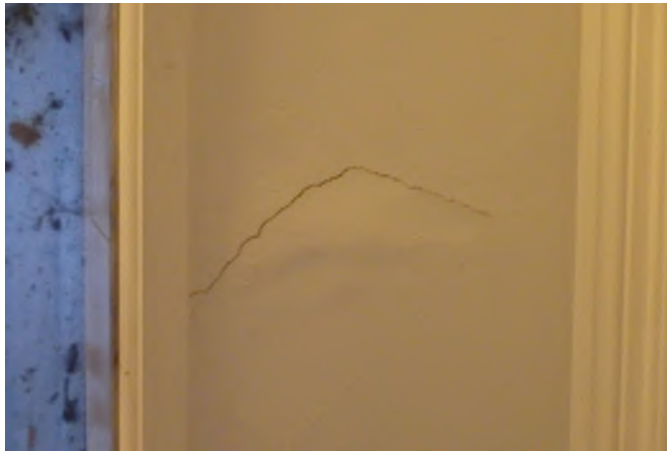
*Figure 44*

- Cracking noted to mitre joints to ceiling cornice and at junctions between ceiling cornice and ceiling.
- Vertical crack rising up from top left of door head in to bedroom 3, the crack peters out before reaching ceiling cornice level.
- Diagonal crack running up from top left of door head in to office, petering out before reaching ceiling cornice.
- Further diagonal crack noted running down from ceiling cornice above centre of door opening through to office, petering out before reaching door head.

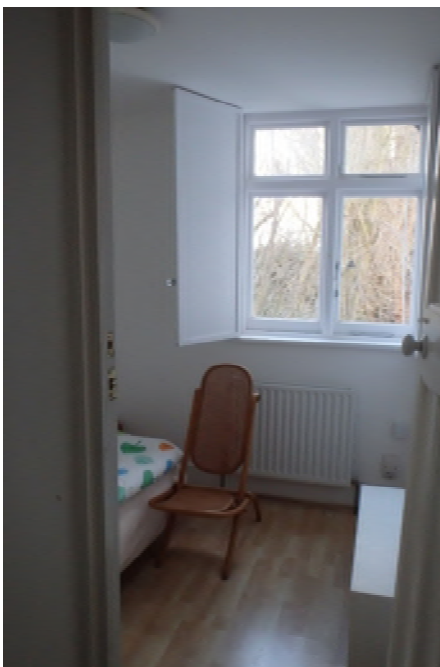
*Figure 46*

- Crack running up from top right of door opening out to hallway at front of bedroom, petering out before reaching ceiling level.
- Crack noted in external left-hand wall to bedroom, approximately 1m from front of room, running from ceiling level to floor level.
- Cracking noted around window opening in rear wall through plaster finishes.

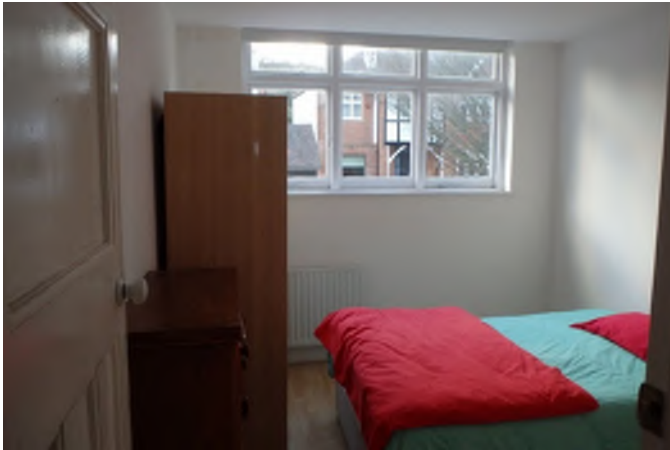
*Figure 48*

- Crack at junction between left-hand outside wall and ceiling, running from front to rear of room.

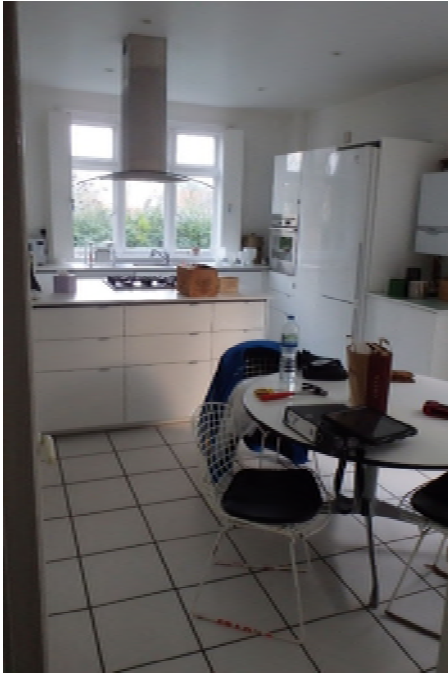
*Figure 50*

- Dry lined panel on right-hand side external wall with open jointing at junction between dry lined panel and wall and ceiling.
- Intermittent cracking at junction between wall and ceiling to front of room.

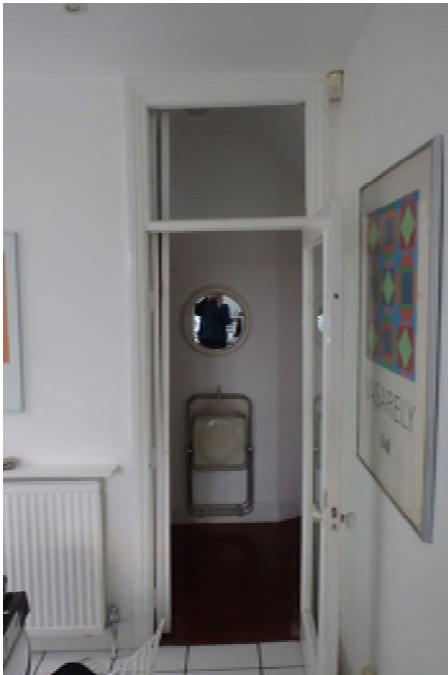
*Figure 51*

The framing to the glazed door opening appears to be historically misaligned with the left-hand end being lower than the right-hand end.

6. The glazed door opening out from the kitchen at the rear to the hallway has a misalignment, suggesting that the property has suffered at this location also from historic foundation movement.
7. Other open cracking has been noted above at various locations within the property.
8. The rear patio paved terrace has a significant slope downwards towards the rear. The patio structure has subsided, particularly towards the rear left-hand corner and moved horizontally away from the footprint of the original house.
9. Cracking was noted to the render finish on the front elevation above the front door opening.

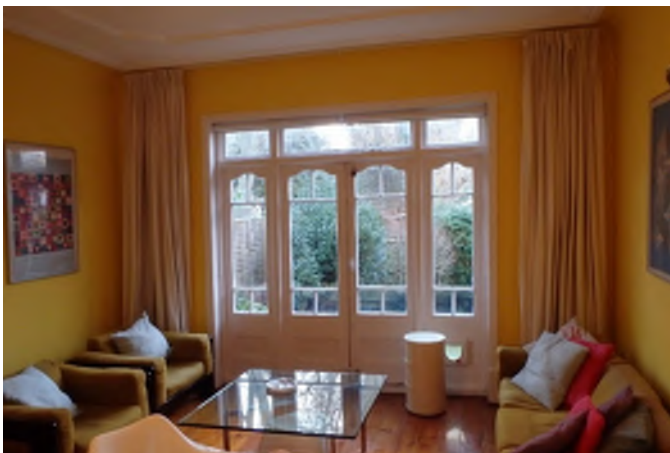
*Figure 52*

There is a noticeable slope in the floor down to the left-hand side rear corner of the room.

- Vertical crack through paper finish above French door opening in rear elevation just to left of centre of opening running up to ceiling cornice level.
- Open jointing at junction between cornice and rear wall ceiling paper, not clear whether or not a crack.
- Diagonal crack through ceiling towards front of room above door opening through to central hallway area.

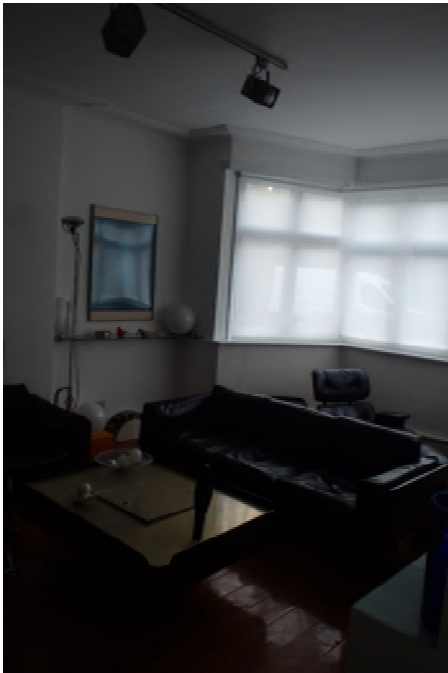
*Figure 53*

- Crack noted running through ceiling cornice to left-hand side of bay window when viewed from inside, running across to left-hand partition wall.
- Similar crack noted running through ceiling cornice to right-hand side of bay window when viewed from internally, running across diagonally to right-hand side of partition wall to room.
- Crack in ceiling, just to left of central lighting track when viewed from front.

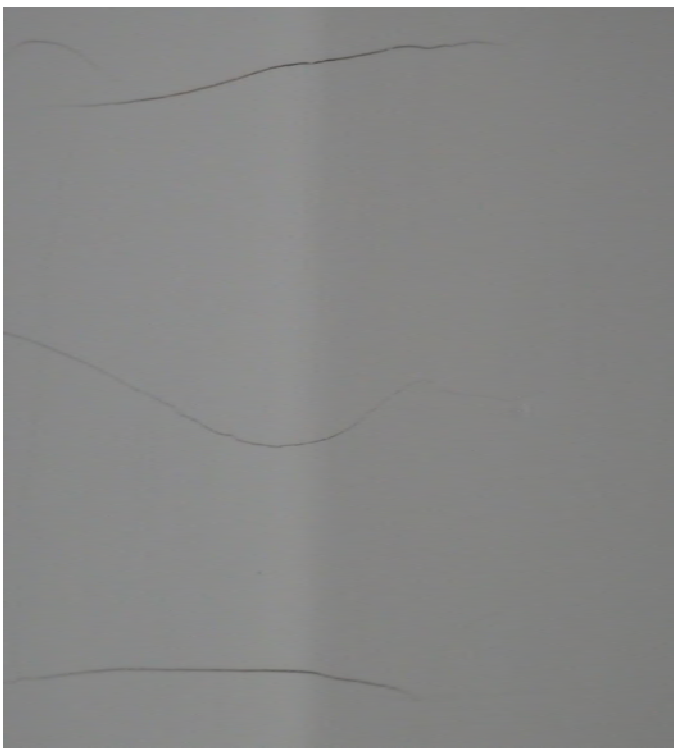
*Figure 54*

- Crack running up from top left of door opening through to central hallway area, most likely on line of paper joint.
- Filled crack in bay window on left-hand side above double socket, running up to ground floor sill.
- Open joint at head of skirting to right-hand side wall when viewed from front to rear of chimney breast.
- Series of horizontal cracks through painted paper curved finish at rear corner of room

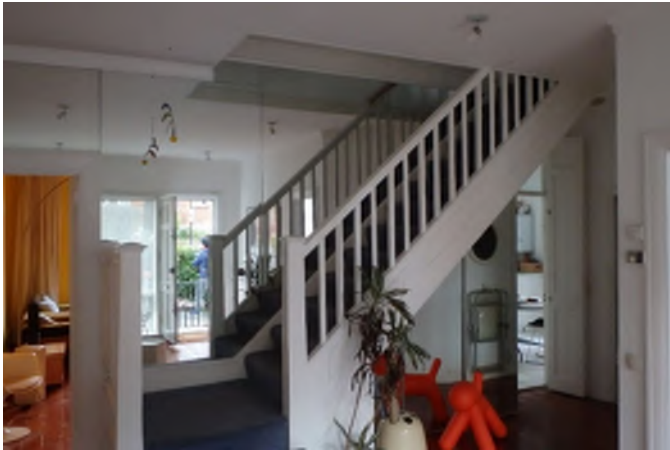
*Figure 55*

- Crack at junction between ceiling cornice and ceiling intermittently around perimeter of room.
- Straight crack running from front to rear of room, commencing above front door opening slightly to the left of centre, and running across to central stairwell opening up to first floor level.
- Open crack running across ceiling on line of partition wall between hallway and reception, extending to rear up to face of stair opening up to first floor level.

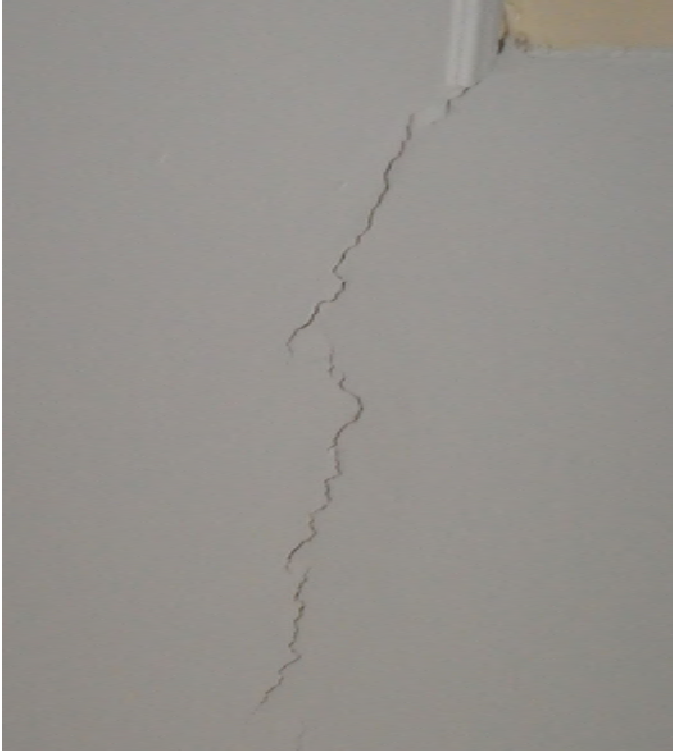
*Figure 58*

- Open crack running out from left-hand end of stairwell towards left-hand extension from corner of stairwell opening.

Two significant open cracks were noted in the ceiling of the hallway in the vicinity of the stair opening up to first floor level.

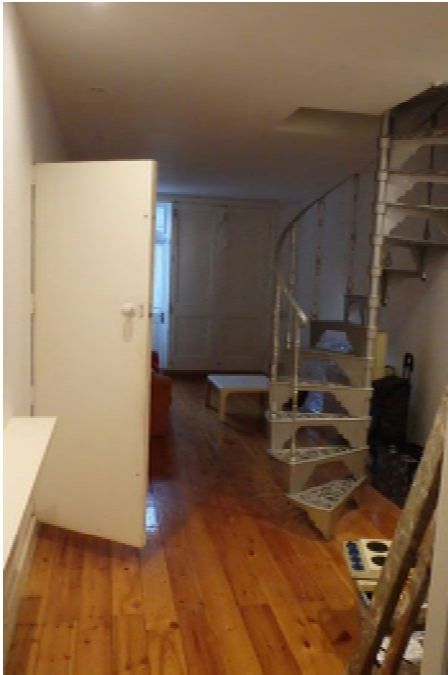
*Figure 60*

- Intermittent open joint at junction between right-hand side wall (original side wall to main house) and ceiling.
- Line of previously filled vertical crack in left-hand external wall approximately 1m to front of spiral stair. Crack not currently open.
- Intermittent open joint at junction between ceiling and front wall to space.
- Vertical cracking noted to left-hand external wall adjacent to base of spiral stair, crack running from floor to ceiling.

There is a projecting boxing on the left-hand side wall to the rear of the spiral stair with some damp staining noted on the front face of the boxing and to the rear of the boxing.
